# Pre-Purchase Timber Pest Inspection Report

89 Mackellar Drive Boronia Heights 4124 Queensland Australia

AS 4349.3-2010: Inspection of Buildings - Timber Pest Inspections

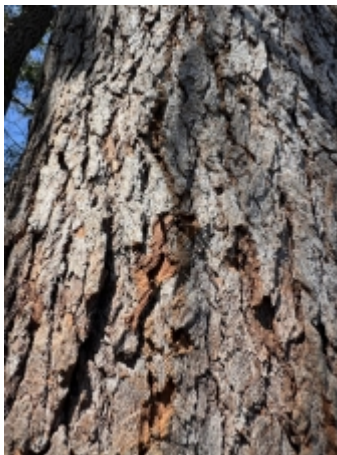
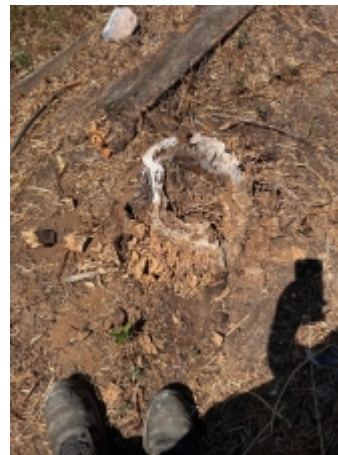
### Termite Damage/Working Photos

Termite working also found ascending rear tree along northern fence line.

No active termites at time of inspection.

A more invasive inspection is highly recommended to be carried out. This is outside the Scope of our Agreement for this Inspection.

It is strongly recommended that the full extent of any such activity and damage be fully understood through the engagement of a Licenced Builder, Structural Engineer or appropriately qualified expert.

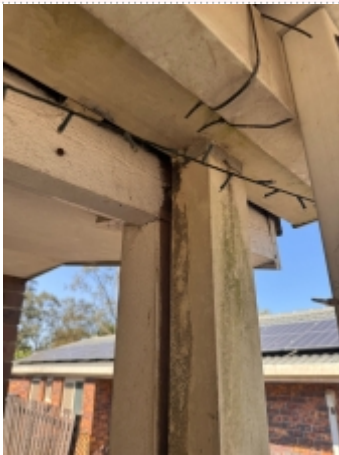
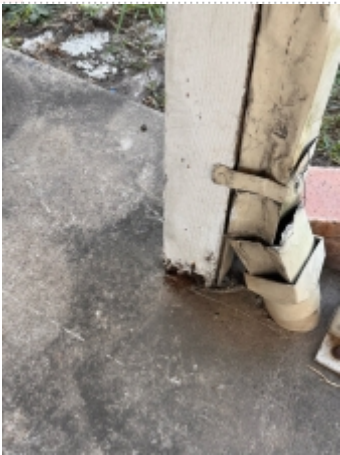
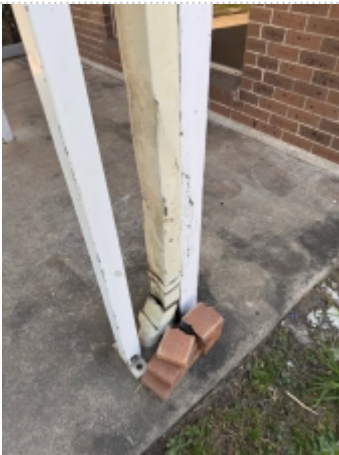
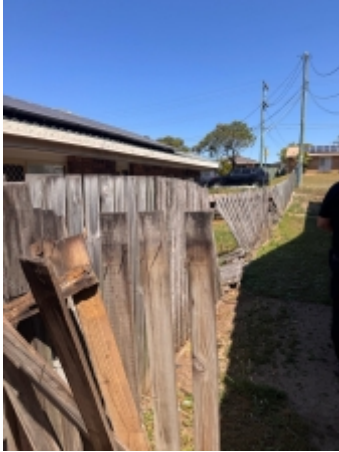
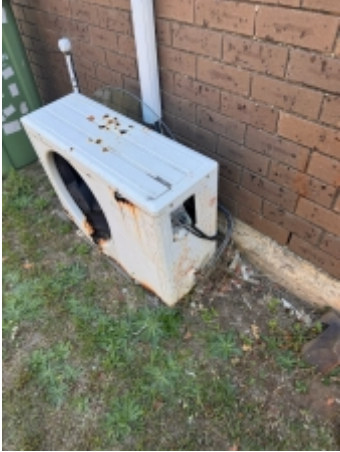
Conductive Condition Photos

| Details & Recommendations: | Minor damage to downpipes it would be wise to possibly replace these downpipes to ensure proper drainage. |

We have also noticed at time of inspection. The fence line needs to be replaced as it is incomplete and damaged.

Air-conditioning unit also needs replacing.
