## **Pre-Purchase Standard Property Inspection Report**

**5 NYANZA STREET  
WOODRIDGE 4114**

| Report number: | 23747 |
| Date of inspection: | 07 Oct 2025 |

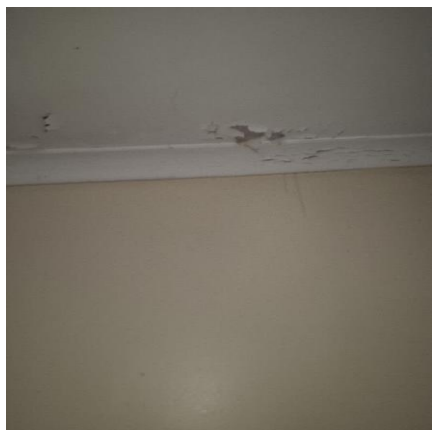
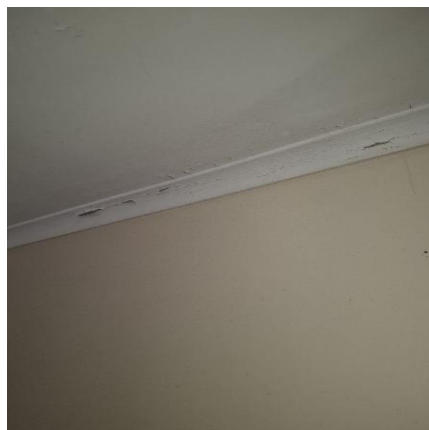
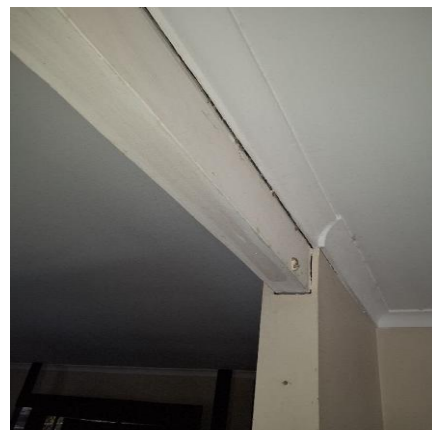
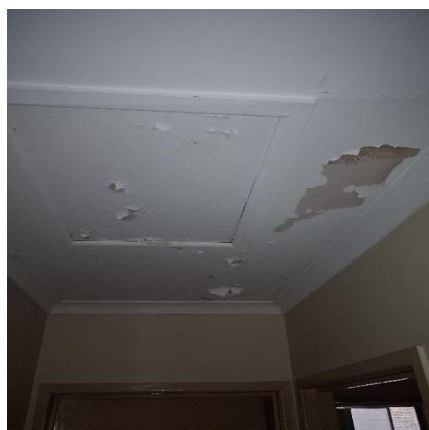
### D2 Ceilings:

No evidence of Major Defects was found.

I noted minor settlement cracking, typical.

I noted paint peeling in the hallway and kitchen ceiling cornices.

**I recommend general patching and painting.**

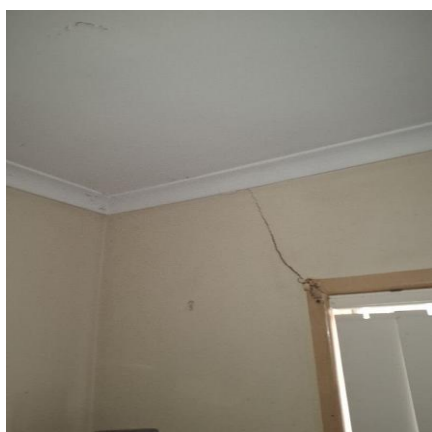
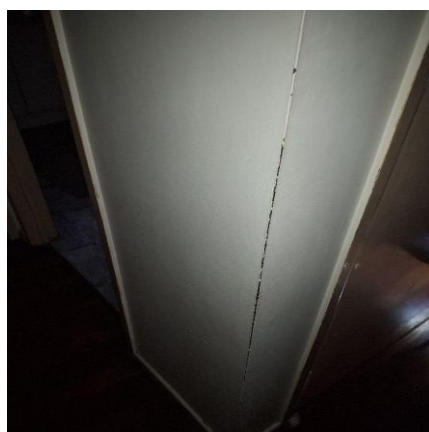
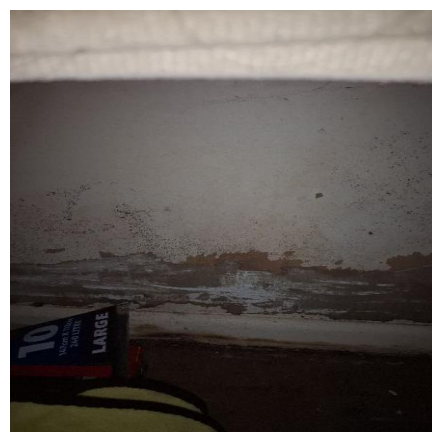
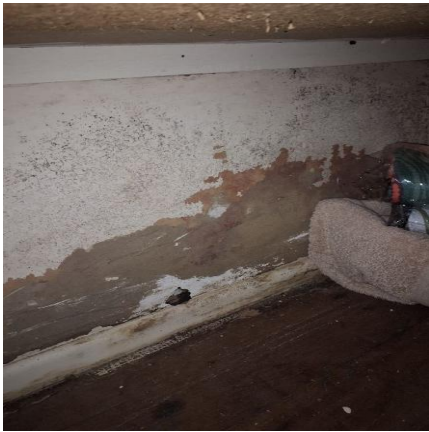
### D3 Internal walls:

No evidence of Major Defects was found.

I noted general wear.

I noted general settlement cracking in the kitchen above the window.

I noted old wet damage in the hallway cupboard behind the shower recess.

**I recommend general patching and painting.**

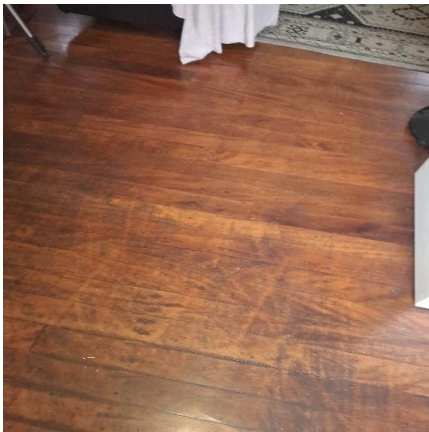
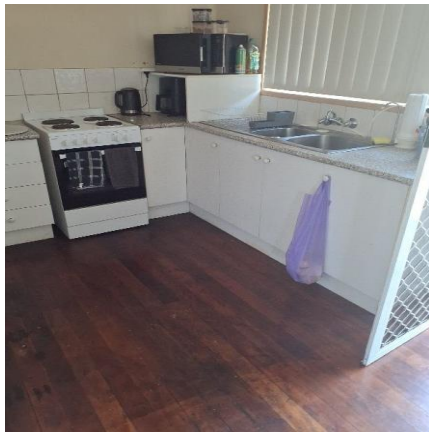
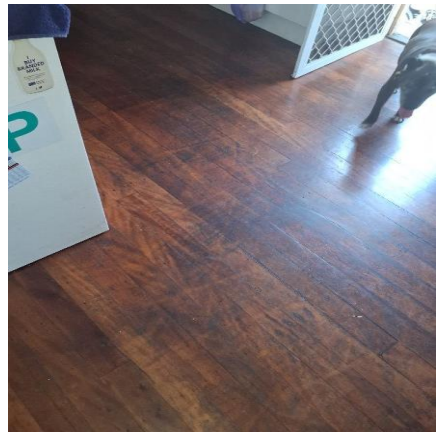
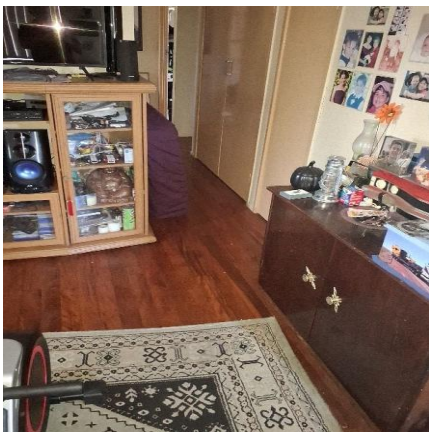
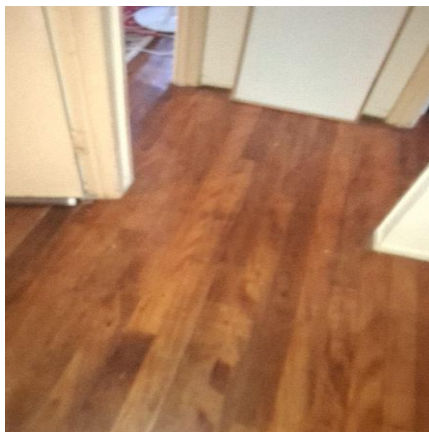
| <p>D4 Floors:</p> | <p>No evidence of Major Defects was found.</p> <p>The timber flooring is in reasonable condition. I did however note that it's not quite level in some areas. This is quite common in a house of this age and this type of construction.</p> <p><b>There is no need for any remedial work.</b></p> |

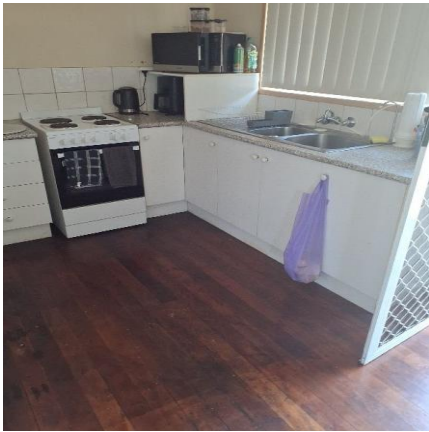
| <p>D6 Built in fittings:<br/>(built in kitchen and other fittings, not including the appliances)</p> | <p>No evidence of Major Defects was found.</p> <p>I noted general wear. typical in a kitchen of this age.</p> |

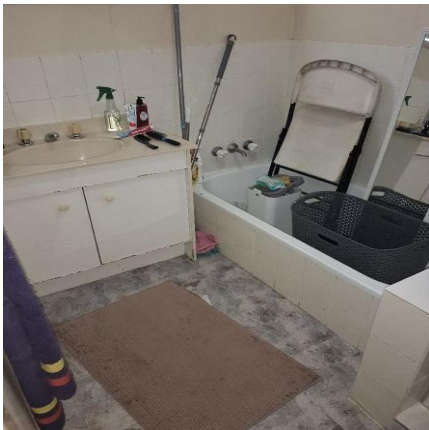
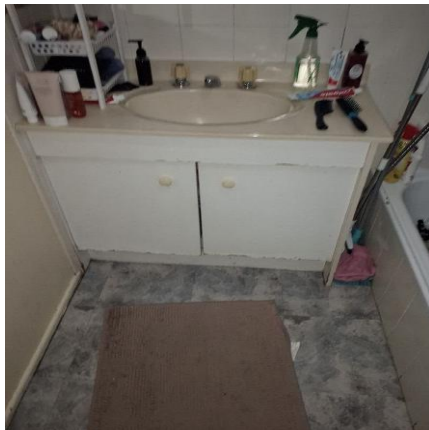
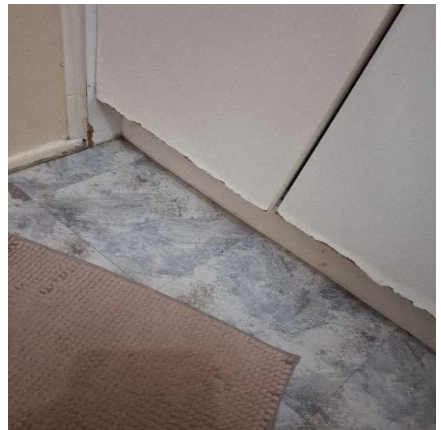
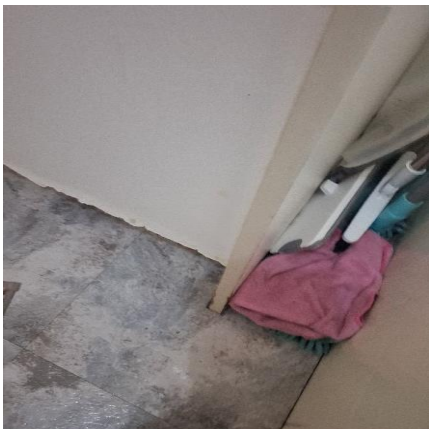
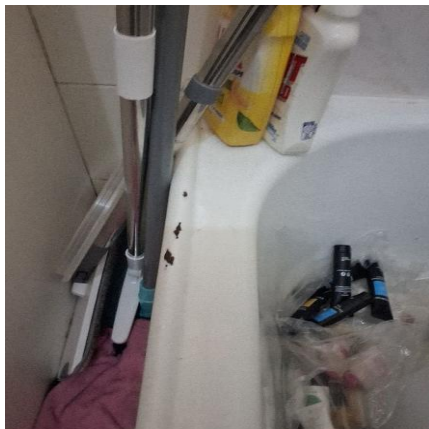
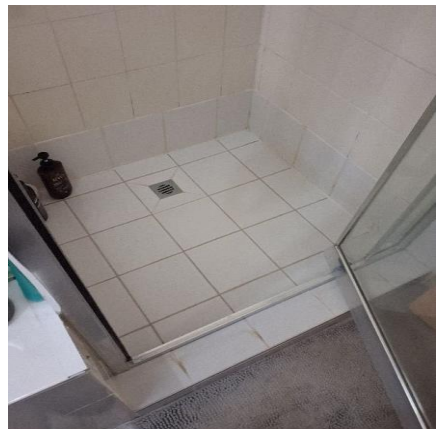
| <p>D7 Bathroom fittings:</p> | <p>No evidence of Major Defects was found.</p> <p>I noted minor damage to the surface of the bathtub.</p> <p>I noted extensive wet damage to the vanity cabinet.</p> <p>I noted the shower recess has already been replaced, most likely to overcome a water leak.</p> <p><b>In my opinion given the age of the bathroom / the defects and the fact that its still functional I wouldn't conduct any remedial repairs but rather replace the entire bathroom in the future.</b></p> |

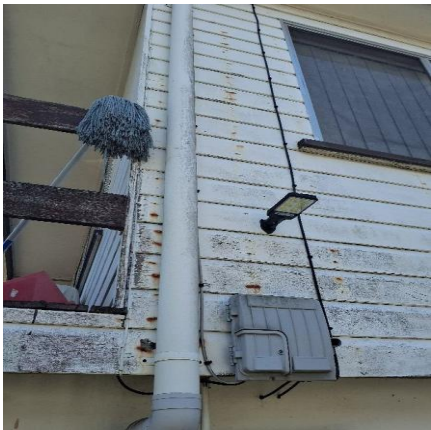
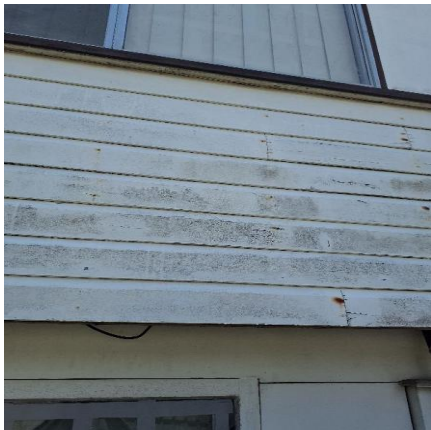
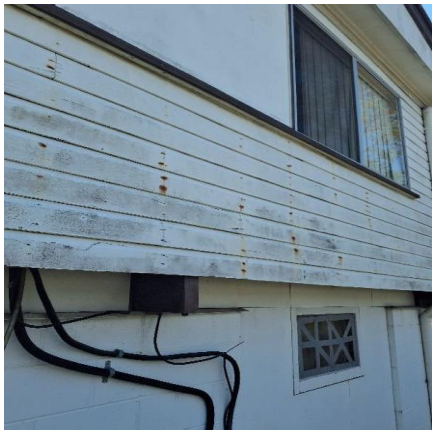
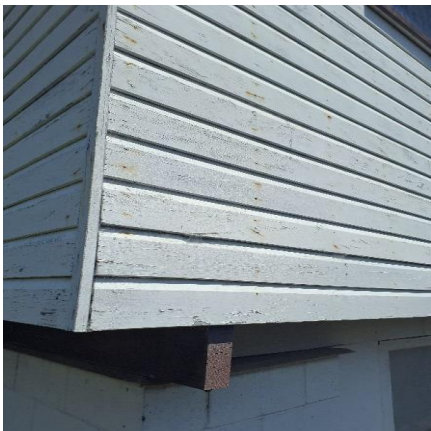
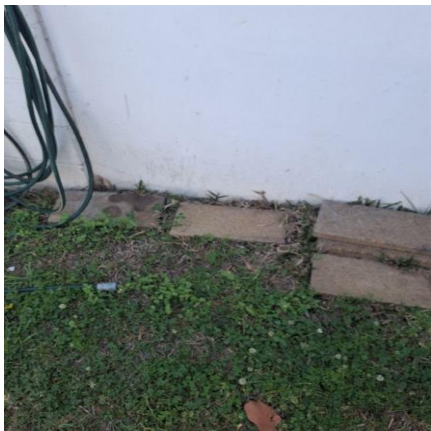
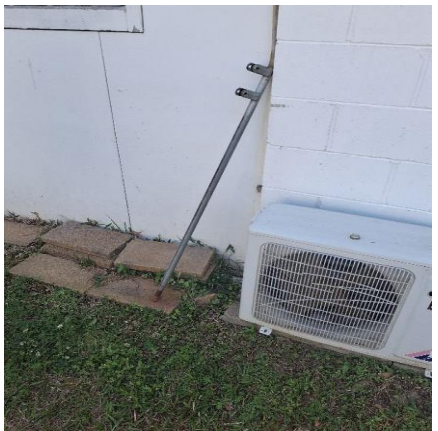
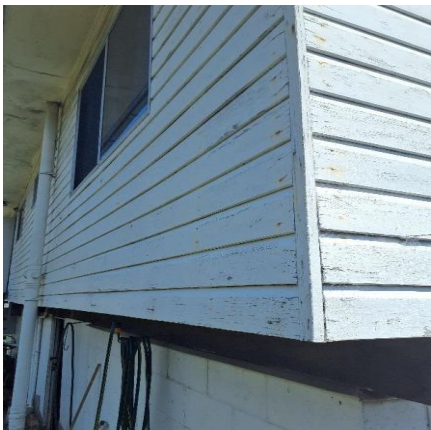
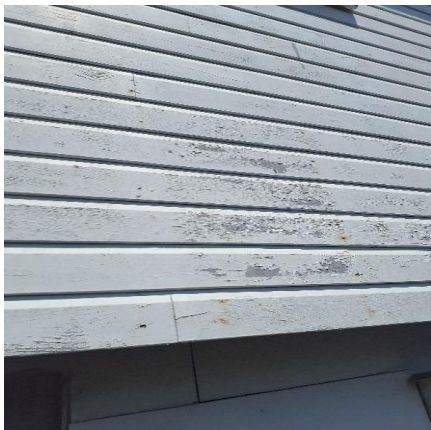
| <p>D11 External walls:</p> | <p>No evidence of Major Defects was found.</p> <p>I noted general weathering.</p> <p>I noted paint peeling some areas.</p> <p>I noted nail corrosion stains.</p> <p><u>All of these issues are quite common in cladding of this type and age.</u></p> <p><b>I recommend a complete external repaint.</b></p> <p>I noted that some of the ground floor cladding is in contact with the ground.</p> <p>This has created a possible ingress point for termites and fungal decay.</p> <p><b>I recommend you discuss this further with the pest inspector</b></p> |

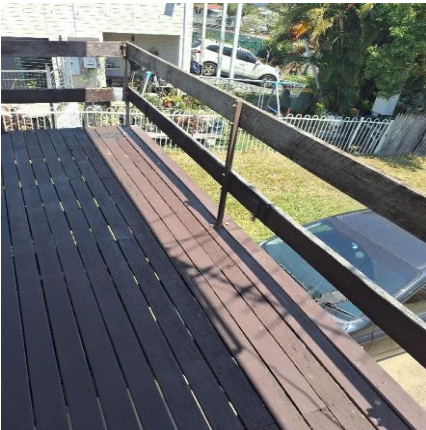
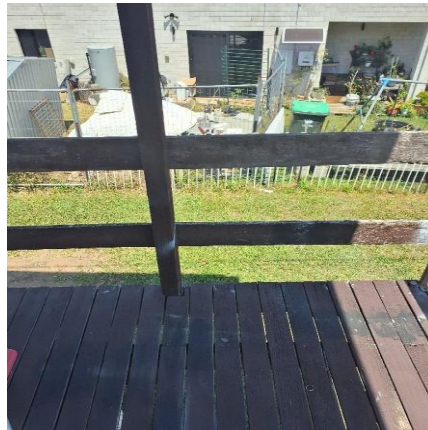
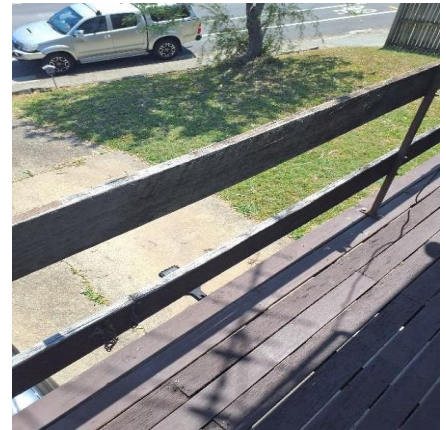
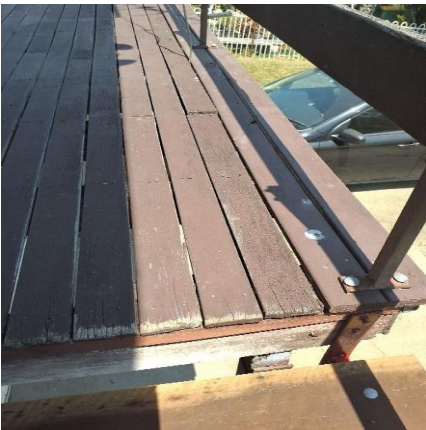
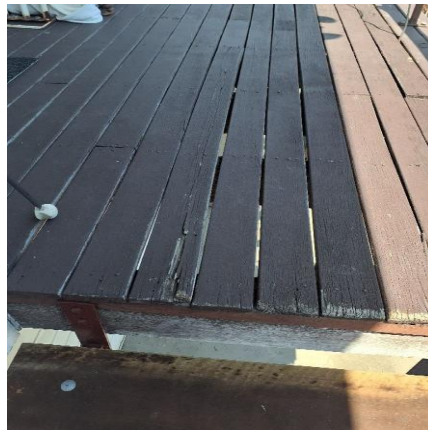
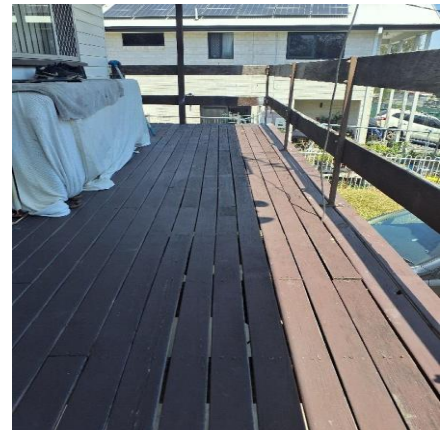
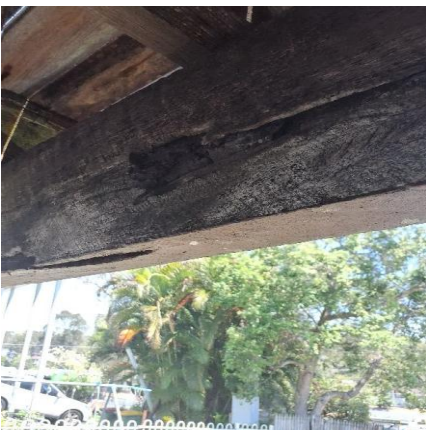
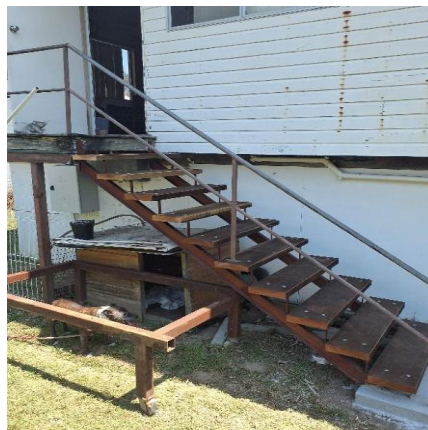
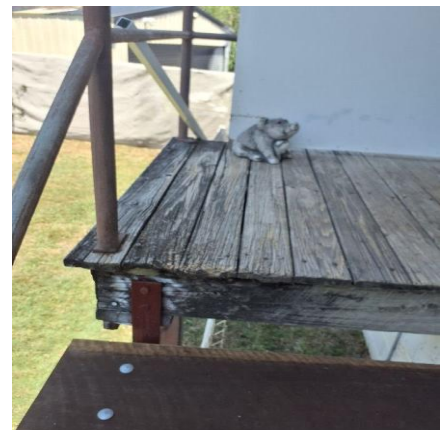
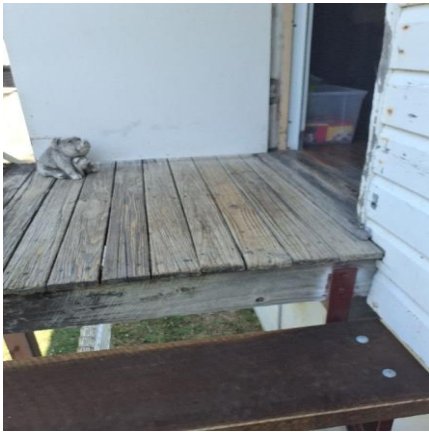
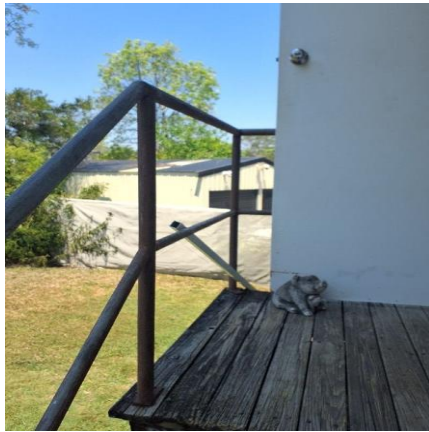
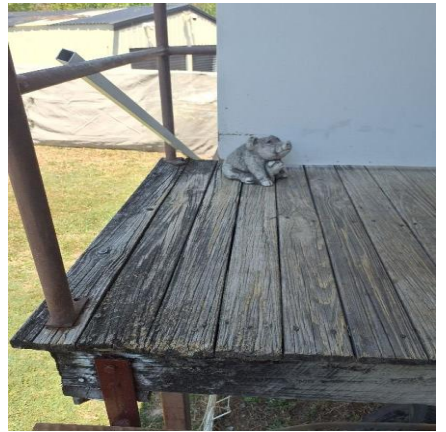
| D14 Platforms:<br>(including verandas, patios, decks and the like) | <p>No evidence of Major Defects was found.</p> <p>I noted that the decking is not is weathered / decayed in the front verandah and rear stair landing.</p> <p>I noted the balustrades in these areas are not complaint because they are less than one meter in height and there are gaps within the framework that exceeds 120 millimeters.</p> <p><b>I recommend that the weather decking boards be replaced.</b></p> <p><b>I recommended the balustrades will be replaced</b></p> <p>I noted weathering and decay on the other edges of the front verandas floor system. At this stage it's still appears to be reasonably sound</p> <p><b>Remedial work is not required at this stage.</b></p> |

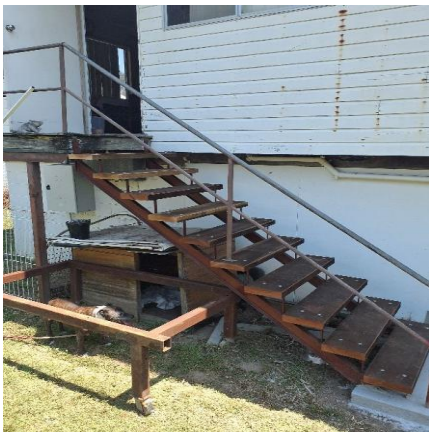
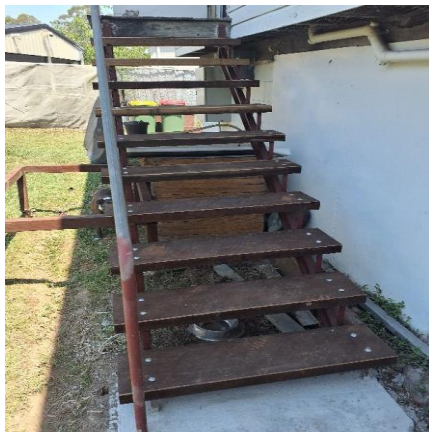
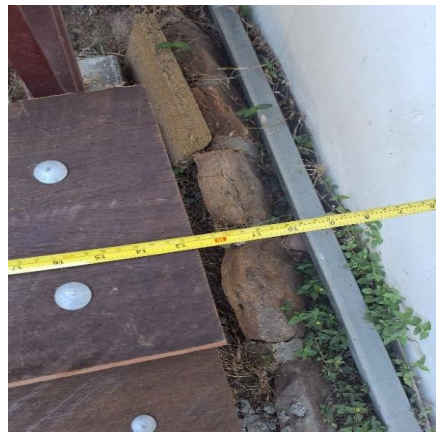
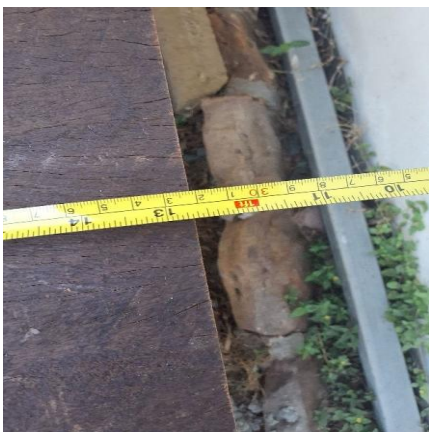
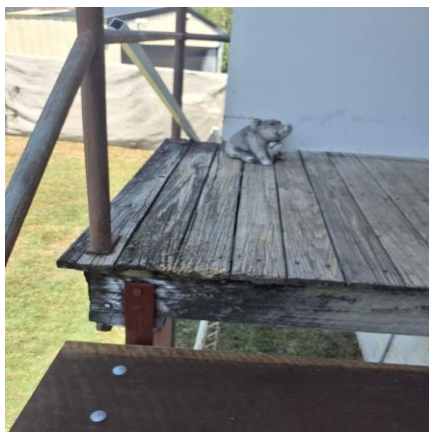
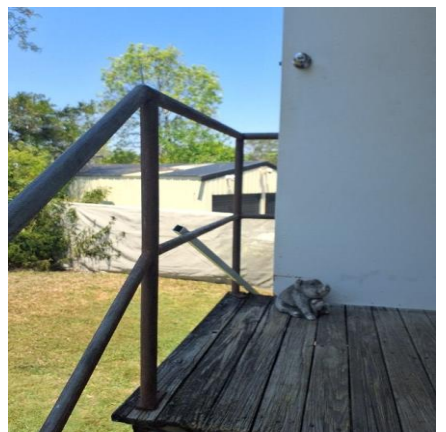
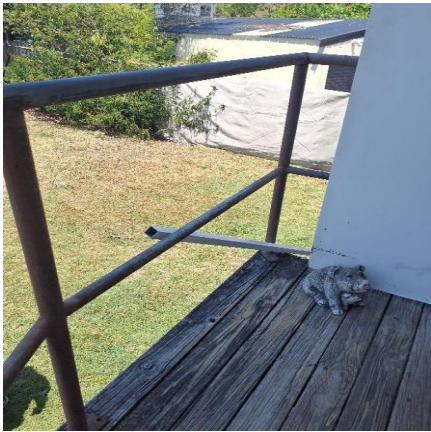
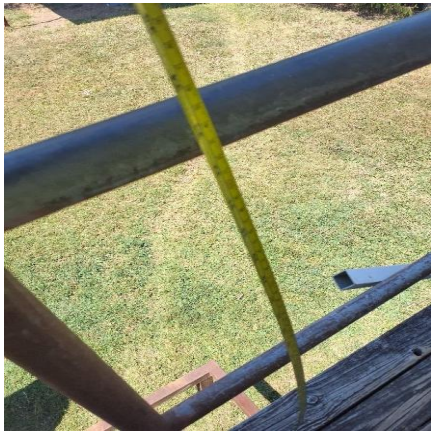
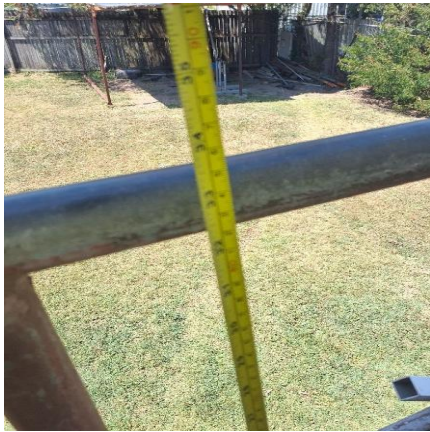
| <p>D15 Other external primary elements</p> | <p>No evidence of Major Defects was found.</p> <p>The state treads in the front and in the rear stairs have been replaced however they are not compliant with the current building code because the tread is greater than 120 millimeters away from the ground floor wall.</p> <p><b>I recommend that the treads be replaced with longer treads.</b></p> <p>The balustrades are sound but not complaint with the current building code because there are gaps within the framework that exceeds 120 millimeters.</p> <p><b>I recommend that these balustrades be replaced.</b></p> |

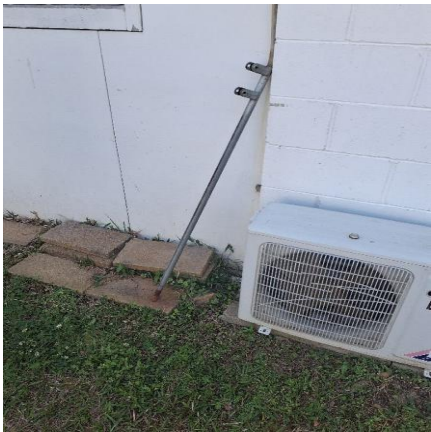
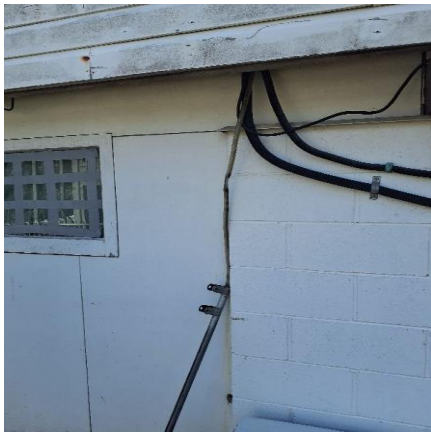
| <p>D16 Other external secondary &amp; finishing elements:</p> | <p>No evidence of Major Defects was found.</p> <p>The air conditioners condensation pipe discharges onto the ground. It is important to note that wet areas May attract termites.</p> <p>I therefore recommend that this pipe be diverted further away from the house.</p> |

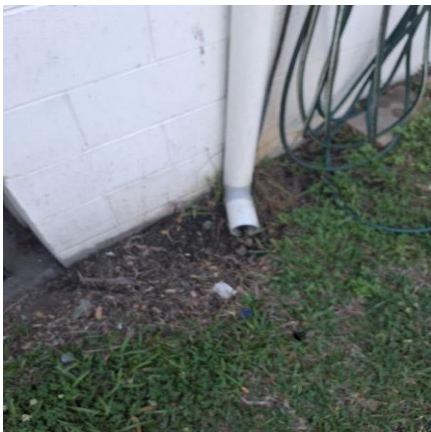
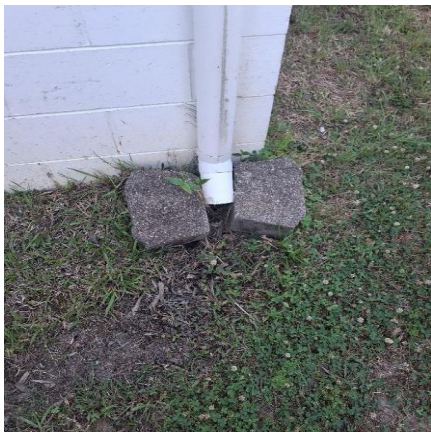
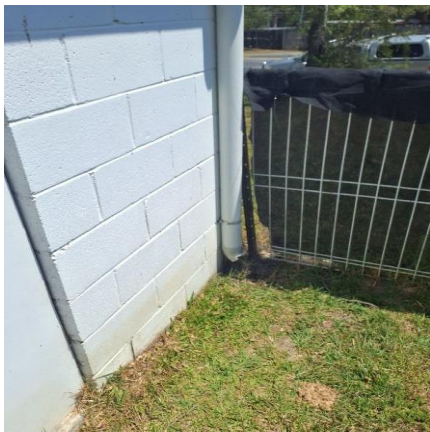
| <p>D18 Rainwater goods:</p> | <p>No evidence of Major Defects was found.</p> <p>The downpipes discharge onto the ground. It is important to note that wet areas May attract termites.</p> <p>I recommend these downpipes be diverted away from the house to the road kurb</p> |

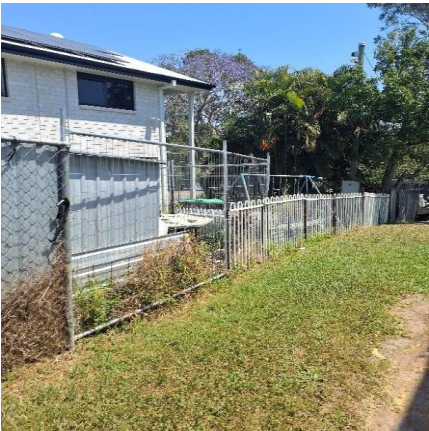
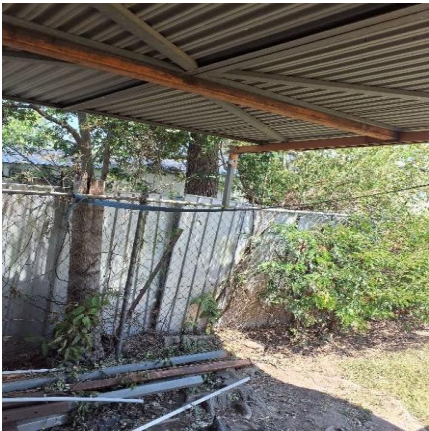
| D20 Walls & fences: | <p>No evidence of Major Defects was found.</p> <p>The fences are weathered and have been patched up but are still functional.</p> <p>I expect that these fences will require replacement in the foreseeable future</p> |

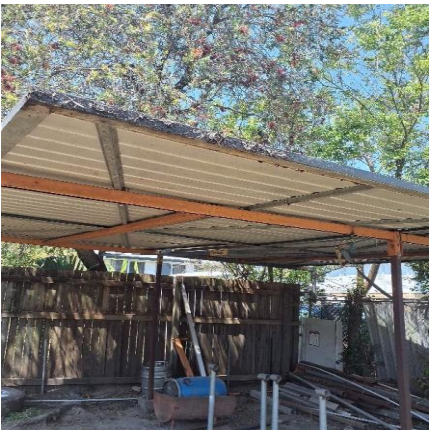
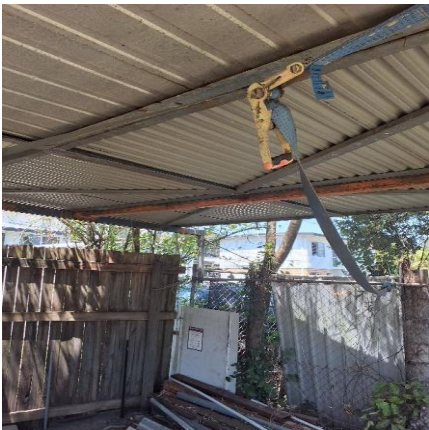
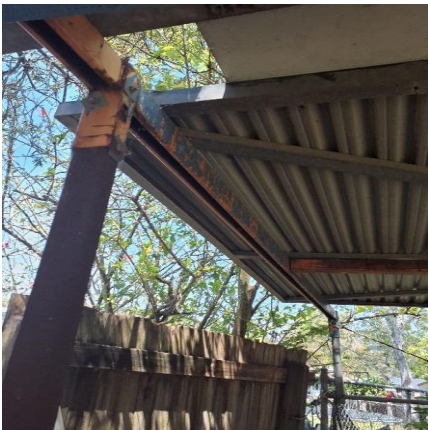
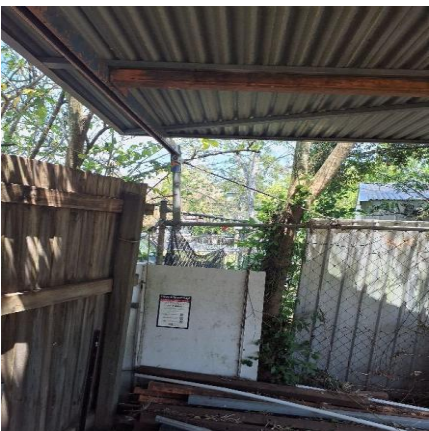
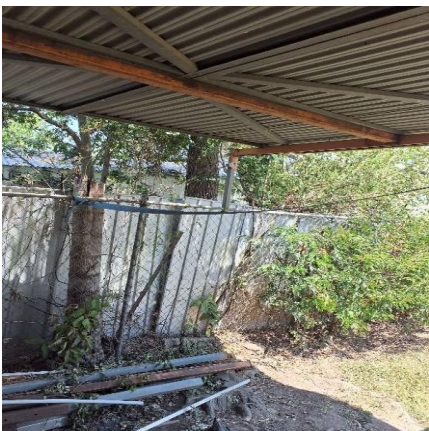
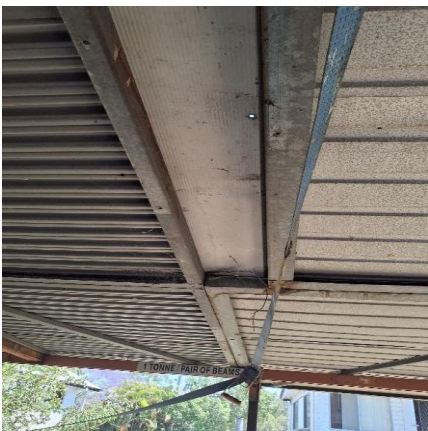
| D21 Outbuildings: | <p>No evidence of Major Defects was found.</p> <p>The rear carport has been built from second-hand materials. It is poorly built and attached to the fence.</p> <p>I recommend that it be replaced</p> |
