# Visual Timber Pest Inspection and Report in Accordance with AS 4349.3-2010

5 Nyanza Street, Woodridge

| Type of inspection: | Pre-Purchase Timber Pest Inspection AS 4349.3-2010 |

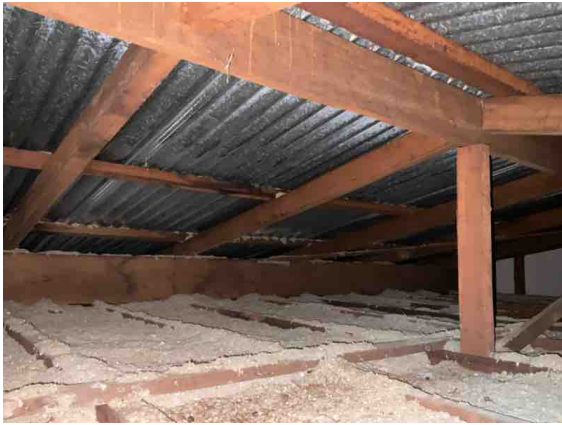
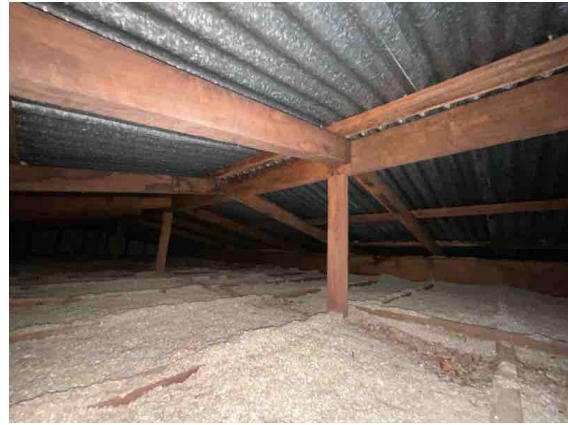
#### ACCESS ISSUE - Roof Void

Insulation in the roof void which restricts the inspection process in this area.

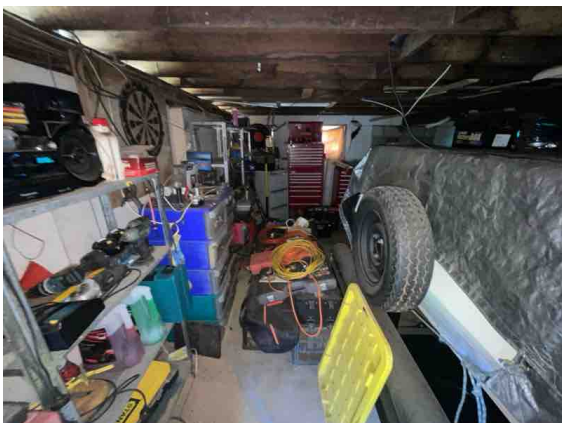
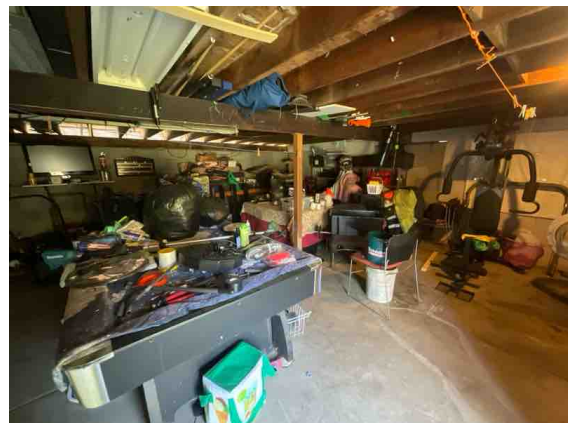
ACCESS ISSUE - Subfloor

Stored items in the subfloor which restricts the inspection process in this area.

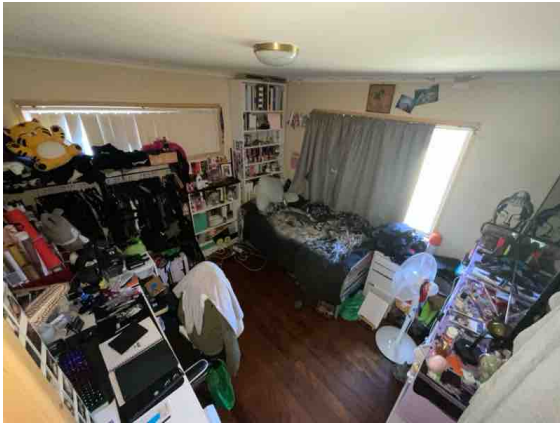
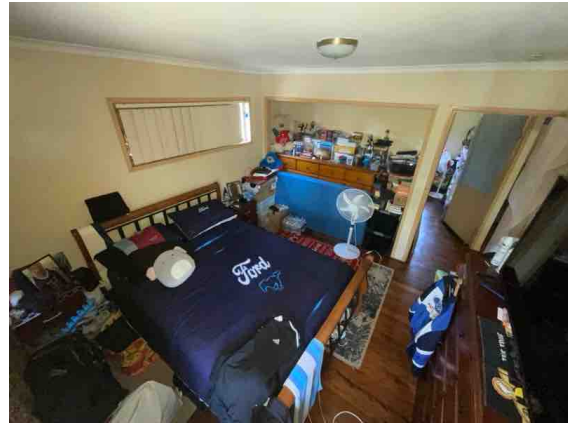
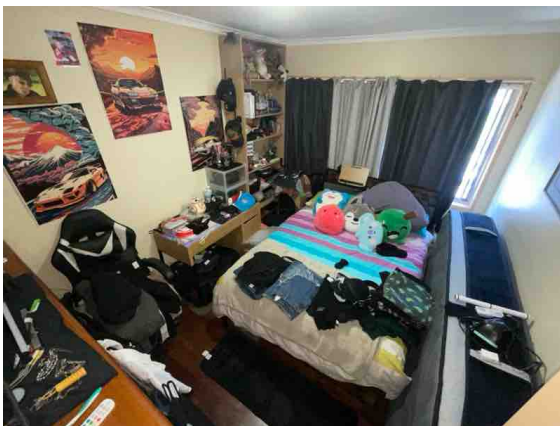
ACCESS ISSUE - All 3 Bedrooms

Stored items in the bedrooms which restricts the inspection process in this area.

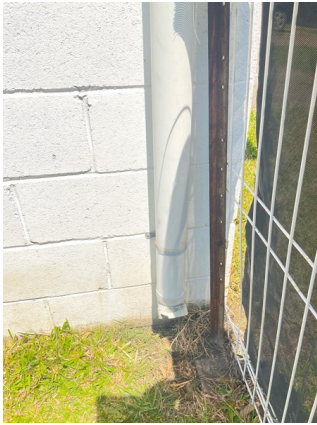
Downpipe not to drain on the left hand side of the home, recommend repairs.

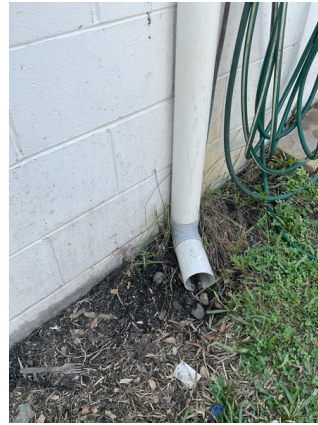
2 x Downpipe's not to drain on the right hand side of the home, recommend repairs.

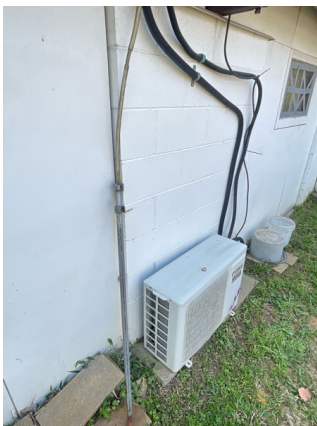
A/C runoff not to a drain, recommend repairs.

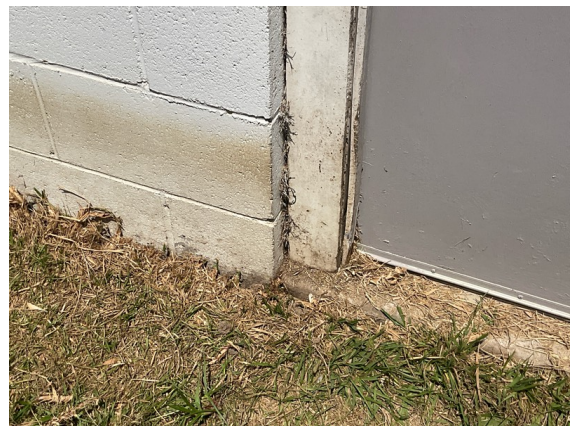
Timber in contact with the ground around the exterior of the home, recommend all timber be a minimum 75mm off the ground.

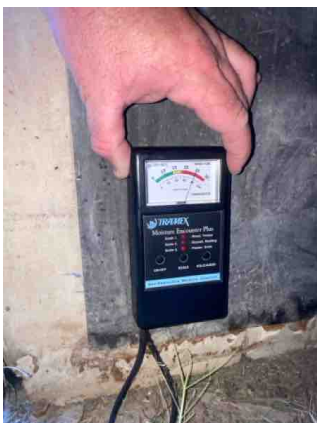
High moisture reading found along the bottom of the downstairs wall at the rear of the home.

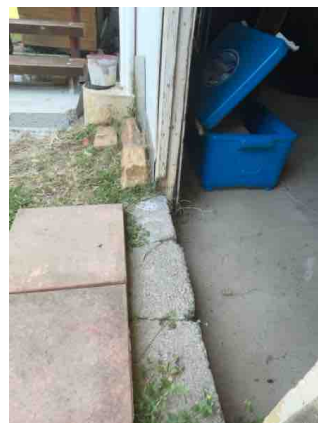
The external ground level is higher than the internal slab along the rear of the building which has lead to moisture issues. Recommend keeping the ground lower than the downstairs slab

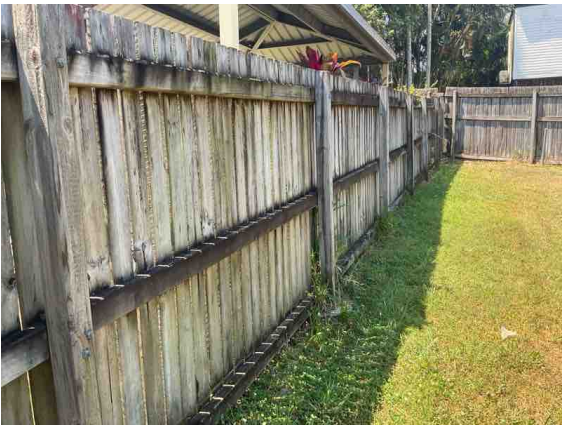
| | Fungal Decay Damage Extent: Moderate to Extensive |

Wood decay (fungal decay) found along the left hand side fence line, recommend repairs.

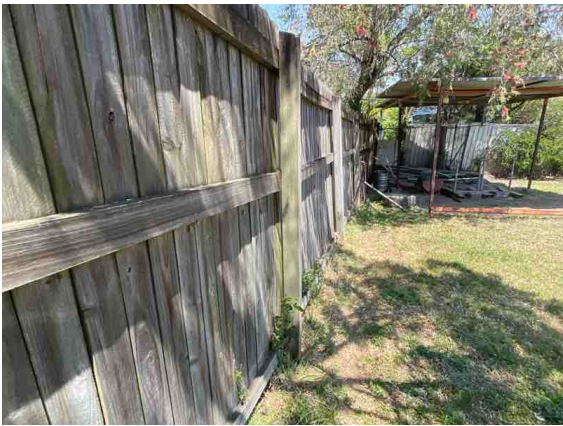
Wood decay (fungal decay) found along the rear fence line, recommend repairs.

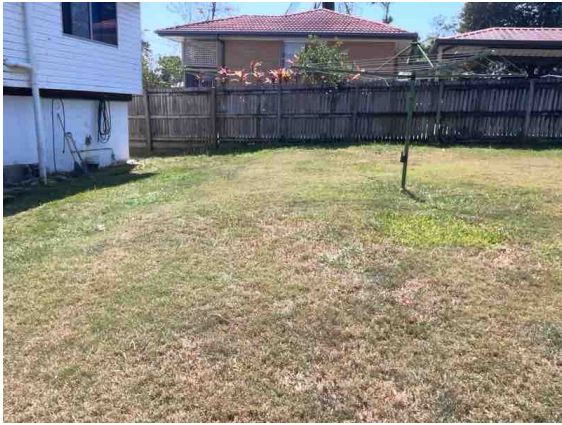
Appears the backyard slopes towards the home, recommend installing adequate drainage to the area to minimise the amount of water that goes towards the home.
