# Visual Timber Pest Inspection and Report in Accordance with AS 4349.3-2010

29 Carinya Street, Crestmead

| Type of inspection: | Timber Pest Inspection AS 4349.3-2010 |

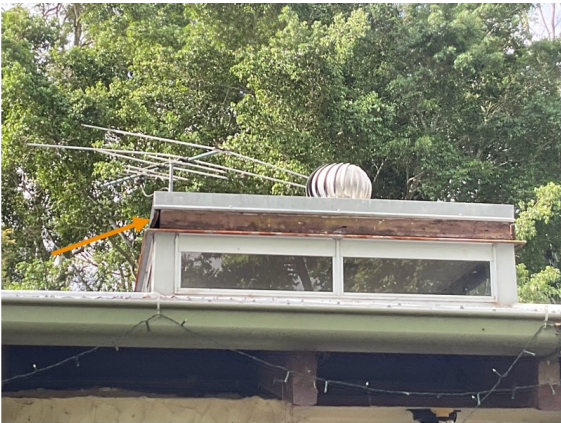
| Fungal Decay: | Fungal Decay Identified |
| | Fungal Decay Damage Extent: Moderate |
| | Fasciboard |

Wood decay (fungal decay) found along the timber fasciboard on the roof, recommend repairs.

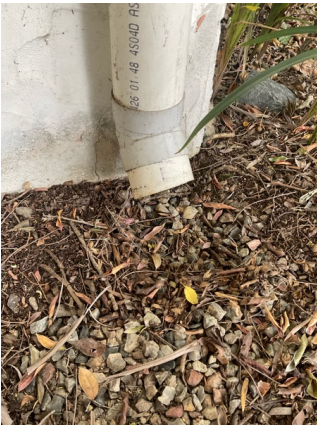
Downpipe not to drain on the left hand side of the home, recommend repairs.

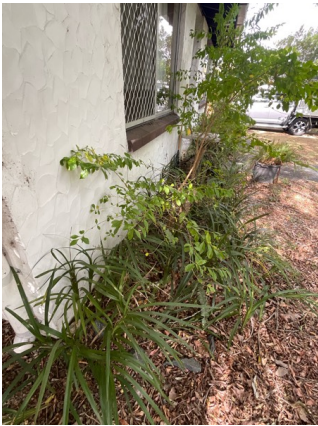
Recommend removing all vegetation off the home.

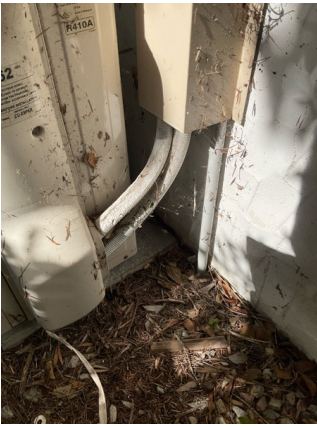
A/C runoff not to drain on the left hand side of the home, recommend repairs.

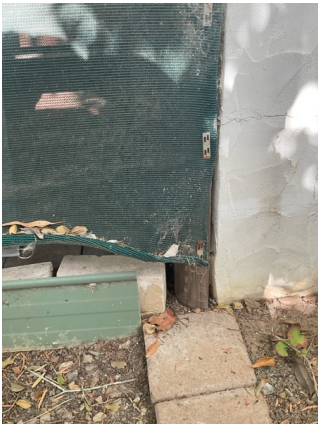
Timber post on the rear patio is in contact with the ground & house, recommend the be a minimum 75mm clearance between the timber & ground.

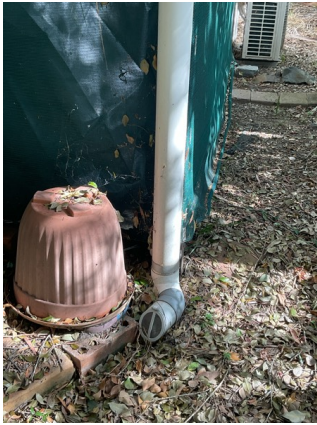
Downpipe on the back patio isn't to a drain, recommend repairs.

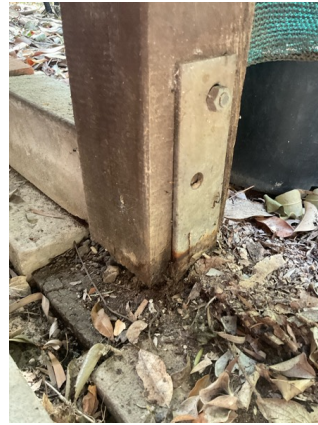
Timber posts on the rear patio are in contact with the ground. Recommend having a minimum 75mm clearance between timber and ground.

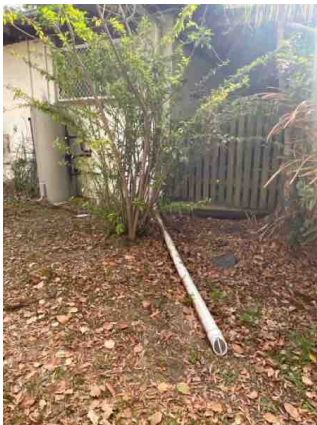
Downpipe not to drain on the right hand side of the home, recommend repairs.

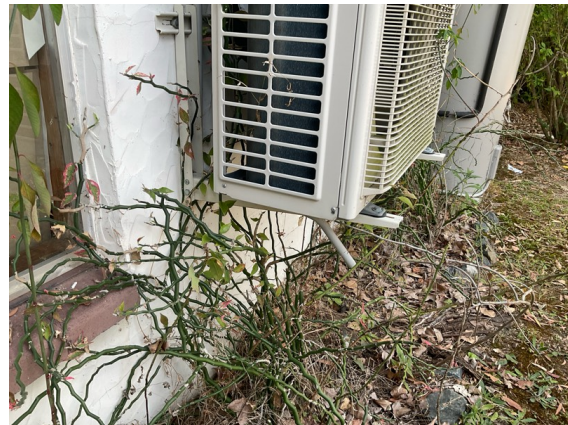
A/C runoff not to drain on the right hand side of the home, recommend repairs.

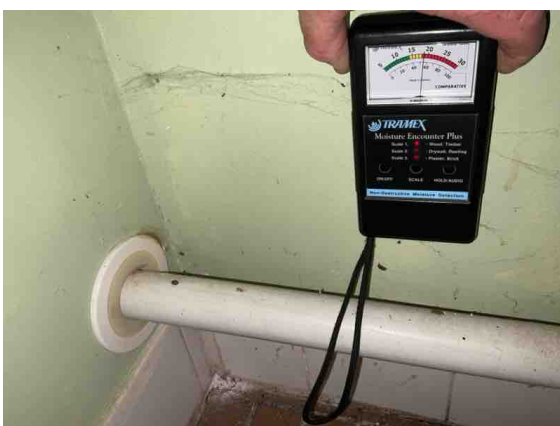
High moisture reading found on the laundry wall, recommend consulting a plumber.

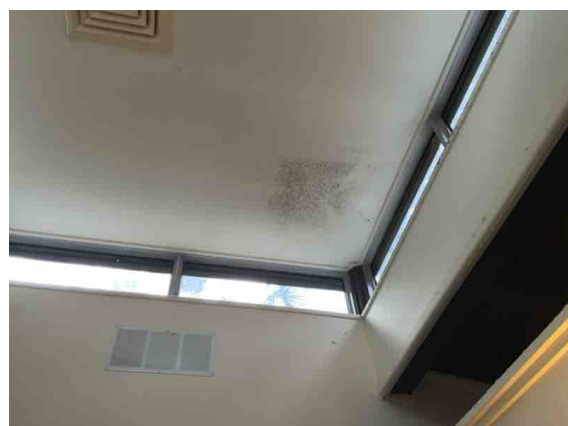
Mould found on the ceiling, recommend repairs.

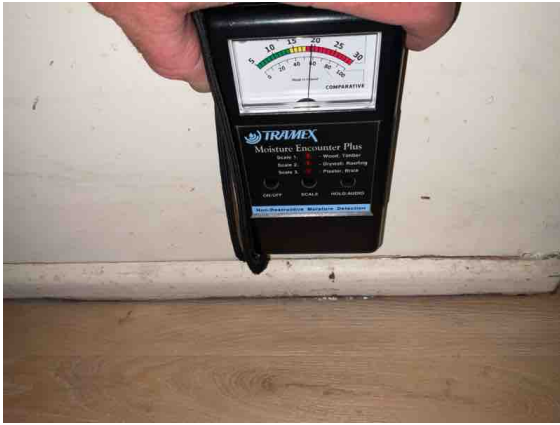
High moisture reading found on the wall adjacent to the shower. Recommend consulting a plumber for repairs.

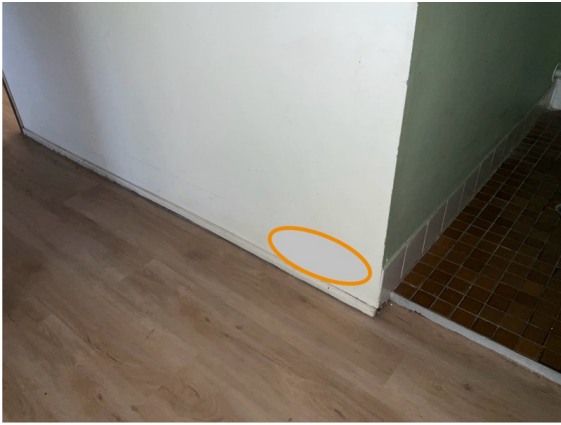
High moisture reading found on the wall adjacent to the shower. Recommend consulting a plumber for repairs.

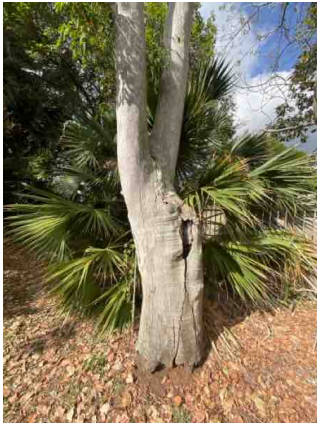
| <b>Termite:</b> | Yes<br>Termite Damage Visible<br>Termite Damage Extent - Moderate |

Evidence of termite damage found in the tree stump on the right hand side of the house, recommend removing

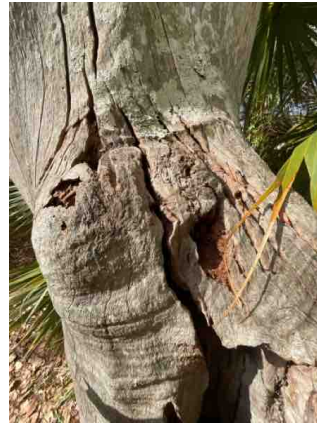
Evidence of termite damage found in the tree stump on the right hand side of the house, recommend removing

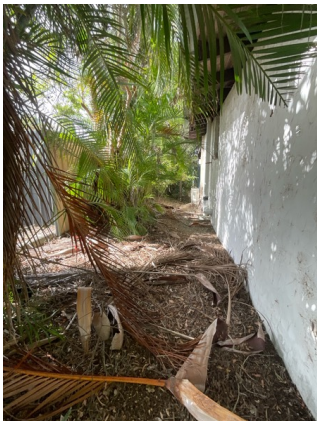
Recommend clearing all vegetation off the home. Recommend removing all trees that a minimum 10 meters in height and within 5 meters of the home.

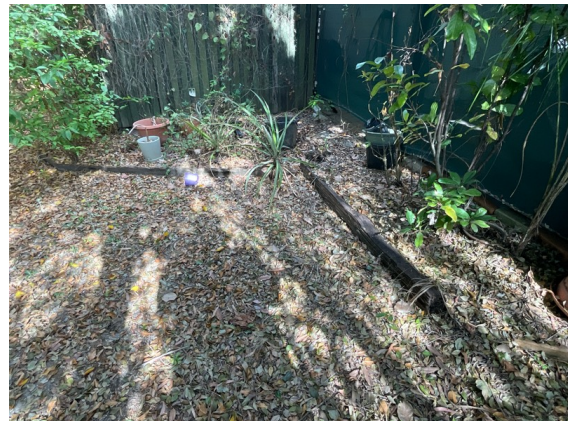
Recommend replacing all timber garden edging with non susceptible termite material.
