## **Pre-Purchase Standard Property Inspection Report**

**29 CARINYA STREET  
CRESTMED 4132**

## PRE-PURCHASE STANDARD PROPERTY REPORT

| Report number: | 23885 |

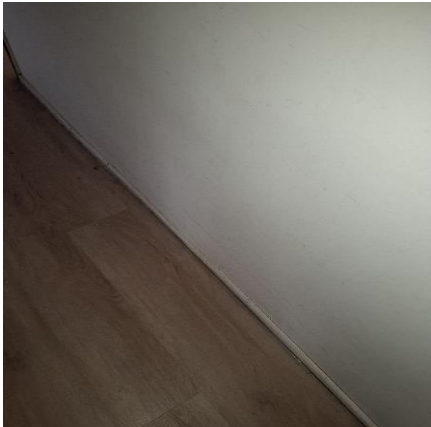
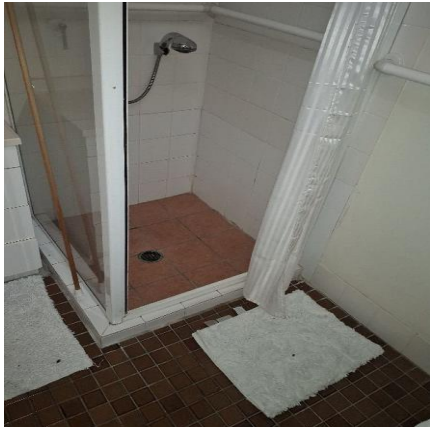
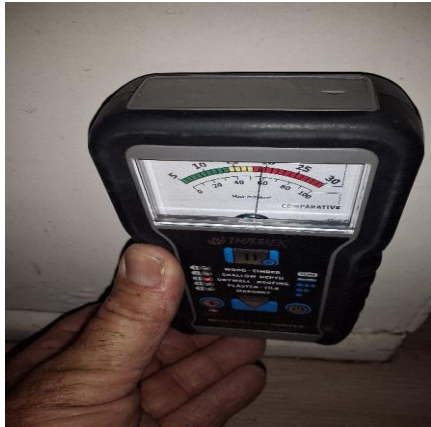
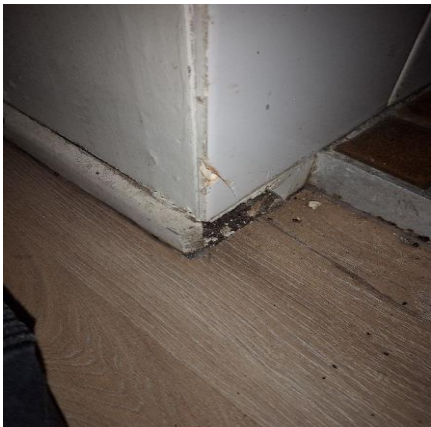
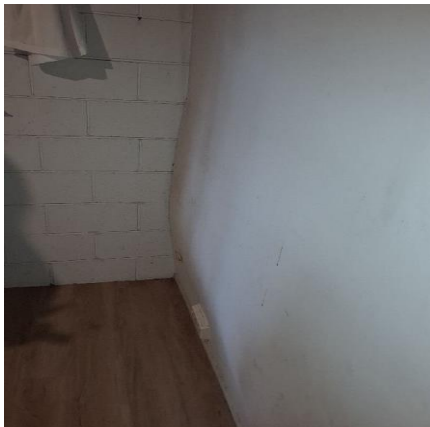
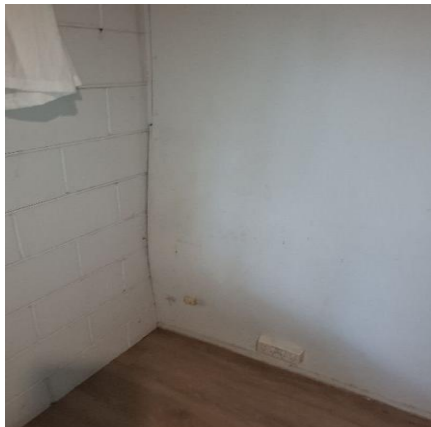
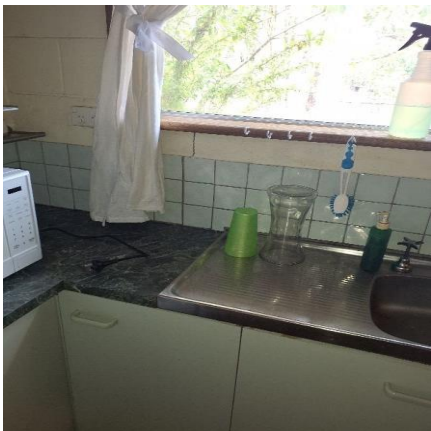
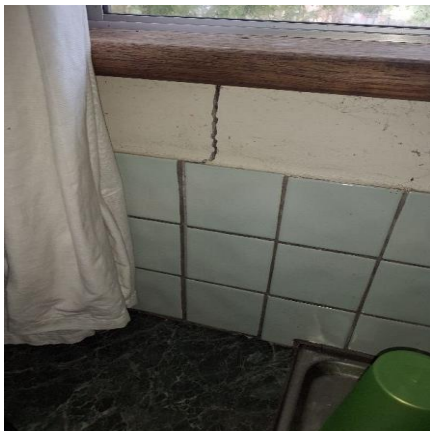
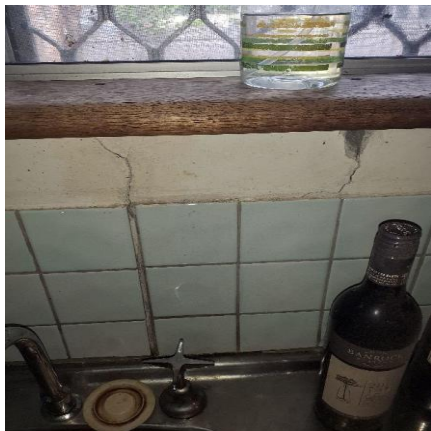
| <p>D3 Internal walls:</p> | <p>No evidence of Major Defects was found.</p> <p>I noted general weathering in the form of scratches and marks, typical in a house of this age.</p> <p>I noted wet damage to the living room wall where the shower is located.</p> <p><u>I expect the shower recess is leaking.</u></p> <p>I noted that the wall lining in the rear left bedroom has bowed outwards.</p> <p>I noted cracks in the wall under and adjacent to the kitchen window. There has obviously been some ground movement in this corner of the house</p> <p><b>I recommend general patching and repainting of all the internal walls once the leaking shower recess has been repaired.</b></p> |

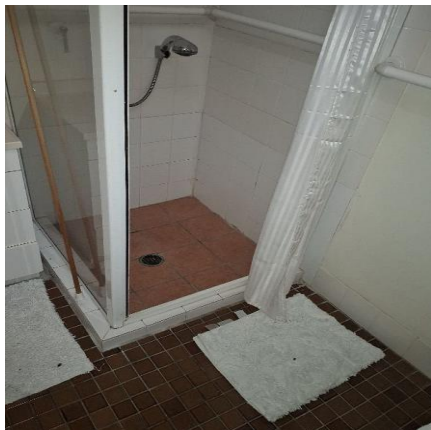
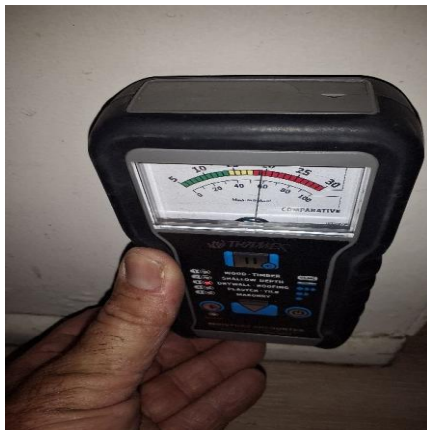
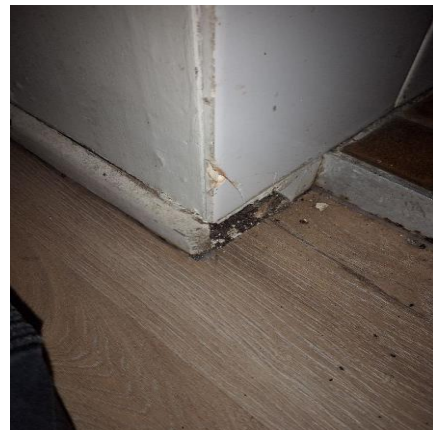
| D7 Bathroom fittings: | No evidence of Major Defects was found.<br><br>I noted general, wear and are leaking shower recess as previously<br>mentioned in the internal wall section,<br><br><b>I recommend that the recess be resealed</b> |

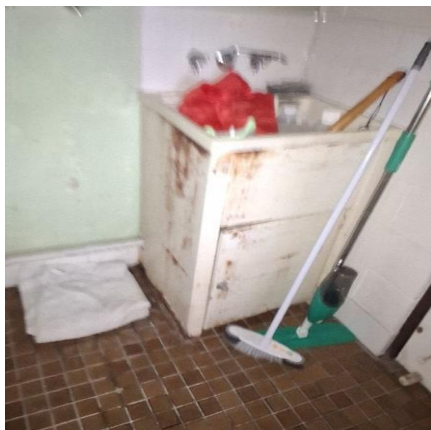
| D8 Other inside detail: | No evidence of Major Defects was found.<br><br>I noted extensive corrosion to the laundry tub cabinet<br><br><b>I recommended this tub cabinet be replaced.</b> |

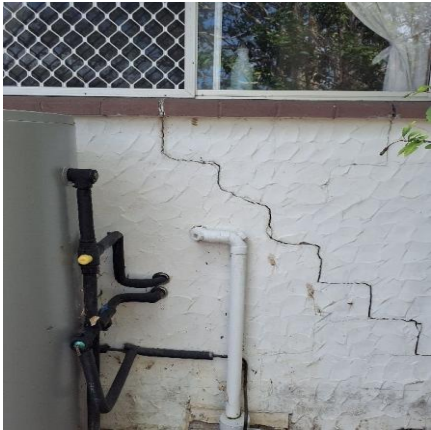
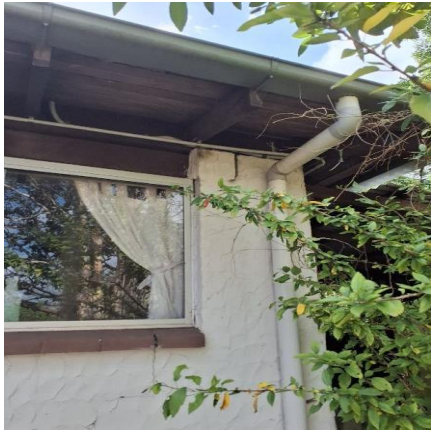
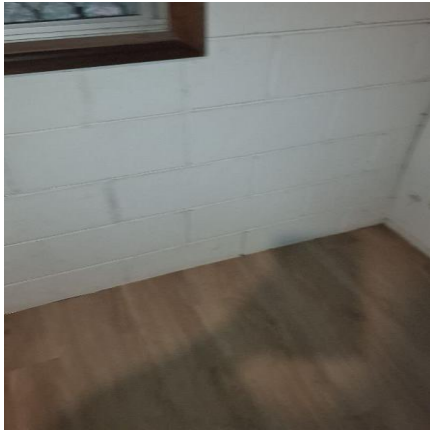
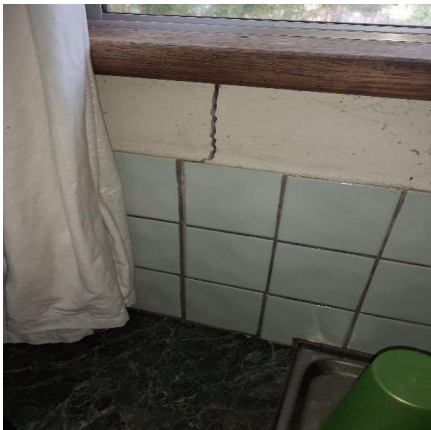
| <p>D11 External walls:</p> | <p>No evidence of Major Defects was found.</p> <p>I noted cracking in the brickwork on the rear wall opposite to the rear left bedroom.</p> <p>I noted cracking in the rear right corner of the house opposite to the kitchen.</p> <p><u>There has obviously been some ground movement in both of these areas.</u></p> <p><b>I recommend that the external and internal cracks be patched up.</b></p> <p><b>I recommend that these cracks be monitored. If the crack in the wall becomes larger that the house may require <u>underpinning</u></b></p> |

| Conclusion comments: | In my opinion this house appears to be reasonably sound. I did however note that there has been some ground movement in the rear right corner of the house however without knowing the full history of this crack it is impossible to confirm whether or not the movement has ceased or whether it will continue |

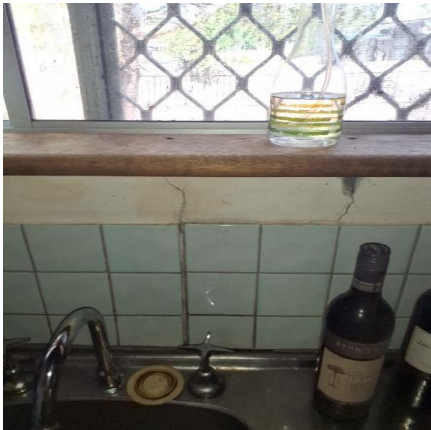
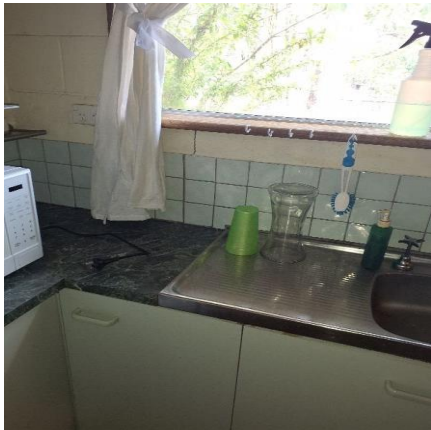
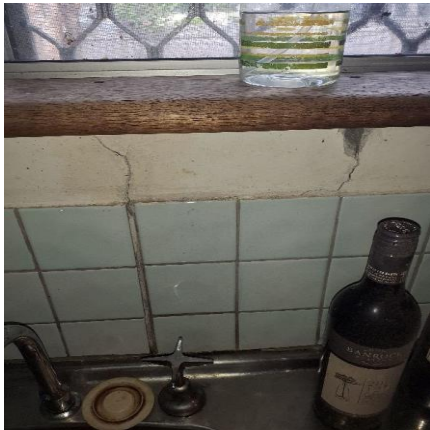
| <p>D12 Windows:</p> | <p>No evidence of Major Defects was found.</p> <p><b>The window is not quite level due to the ground movement</b></p> |

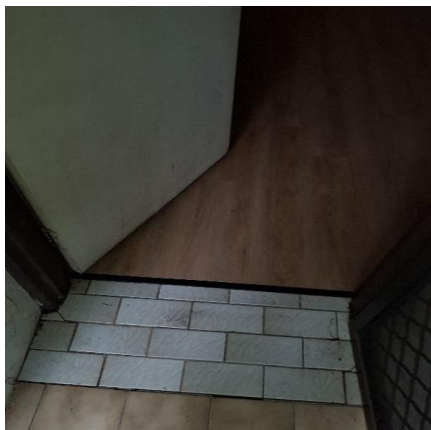
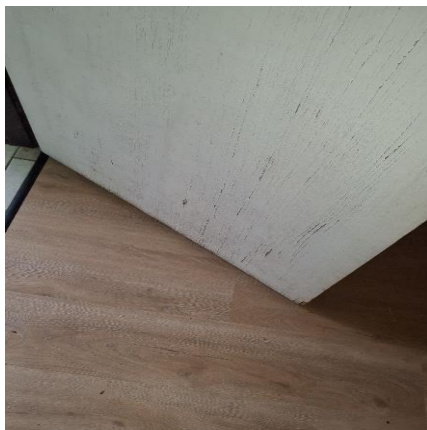
| <p>D13 External doors:<br/>(including patio doors)</p> | <p>No evidence of Major Defects was found.</p> <p>I noted general weathering in the front door</p> <p><b>This door will still last considerable amount of time but it will eventually require replacement.</b></p> |

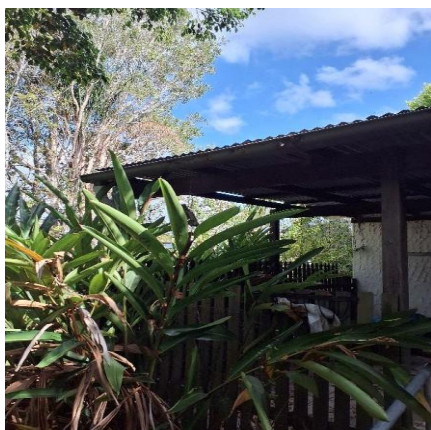
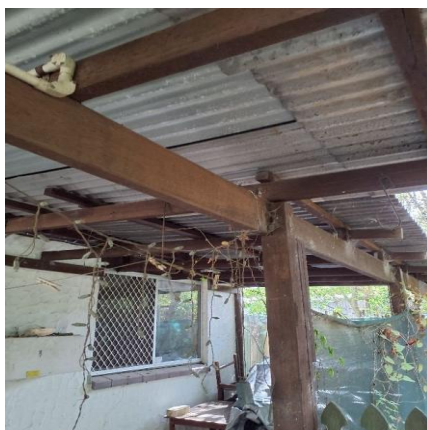
| <p>D14 Platforms:<br/>(including verandas, patios, decks and the like)</p> | <p>No evidence of Major Defects was found.</p> <p>I noted guttering and a downpipe is missing on the left hand side of the rear pergola</p> <p><b>I recommend a gutter and downpipe be installed and the roof water diverted away from the structure.</b></p> |

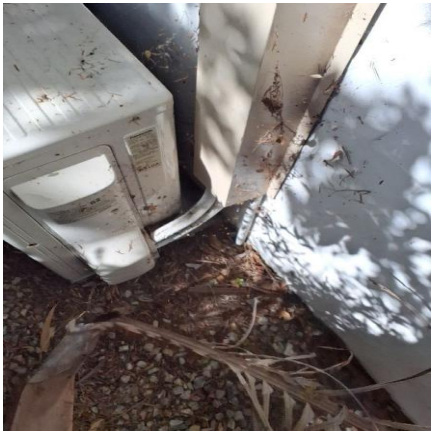
| <p>D15 Other external primary elements</p> | <p>No evidence of Major Defects was found.</p> <p>The air conditioners condensation pipe on the left hand side of the house discharges onto the ground. It is important to note that wet areas May attract termites .</p> <p><b>I therefore recommend that this pipe be diverted into the nearest drain.</b></p> |

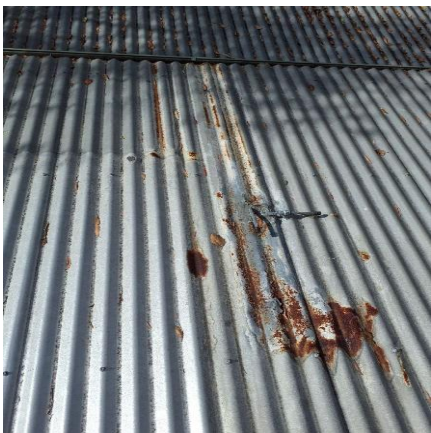
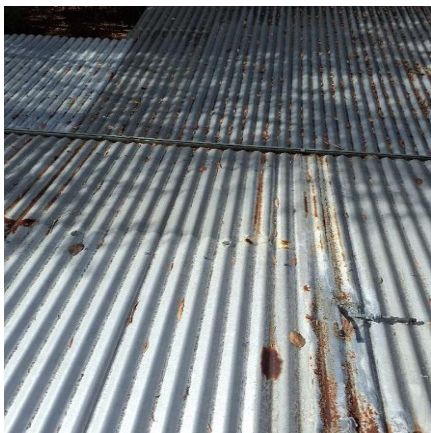
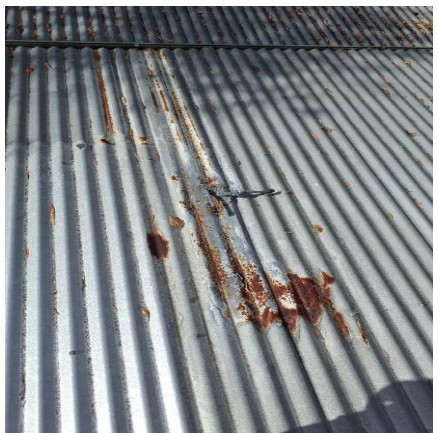
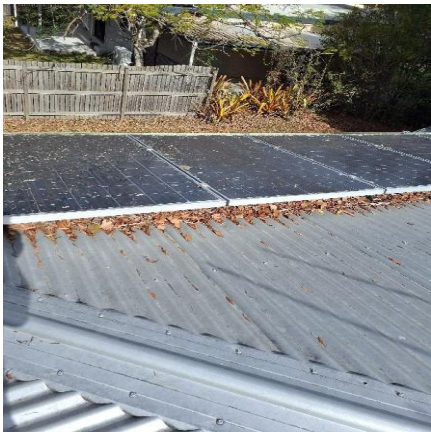
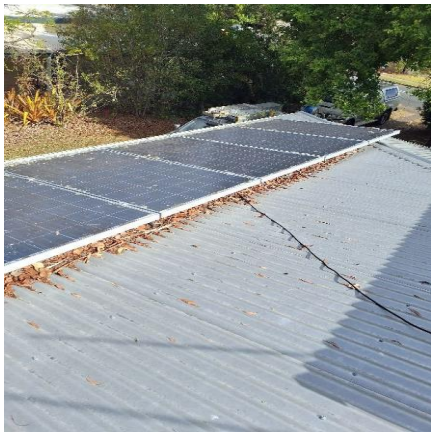
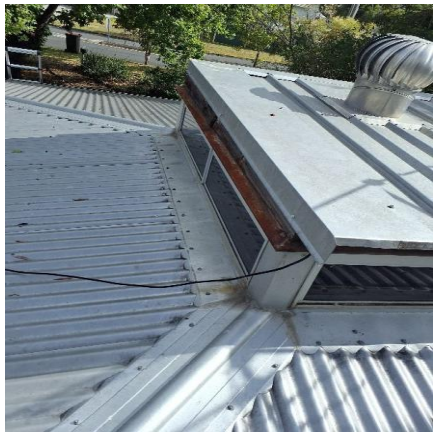
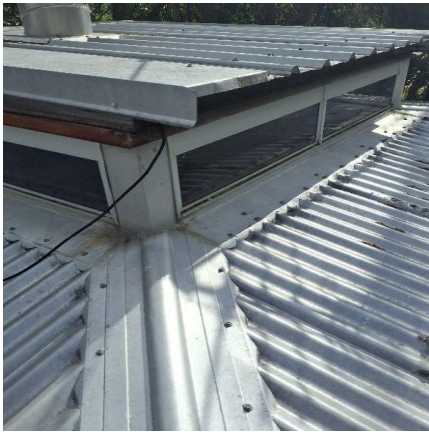
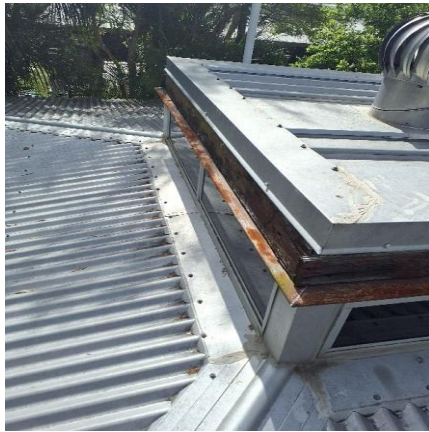
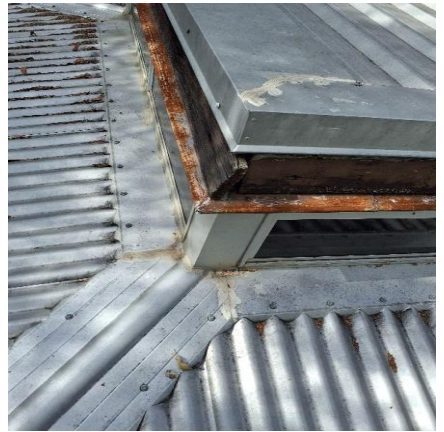
| D17 Roof exterior:<br>(including roof covering, penetrations, flashings) | <p>No evidence of Major Defects was found.</p> <p>I noted corrosion on the rear roof area however it is still appears watertight.</p> <p>I noted that the roof is partially covered up with leaves.</p> <p><b>I recommend that the corrosion on the roof be treated / painted and all of roof washed down.</b></p> <p>I noted surface corrosion on the flashing above the windows on the roof .</p> <p><b>I recommend this flashing be clean and painted with an epoxy paint to prevent further corrosion</b></p> |

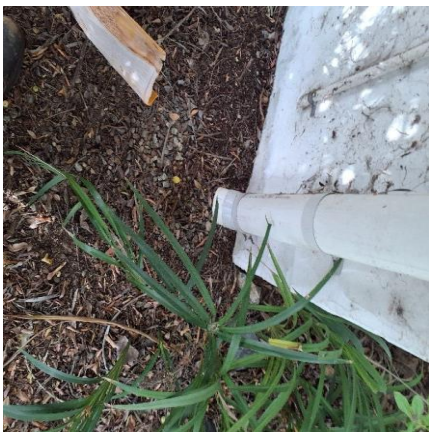
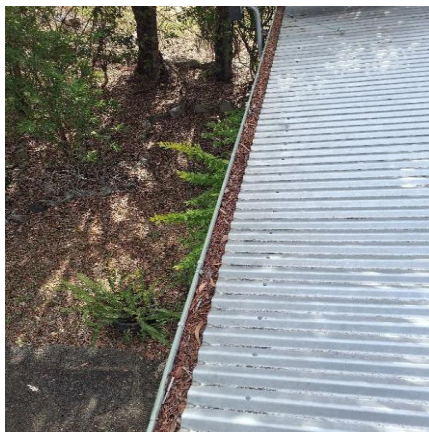
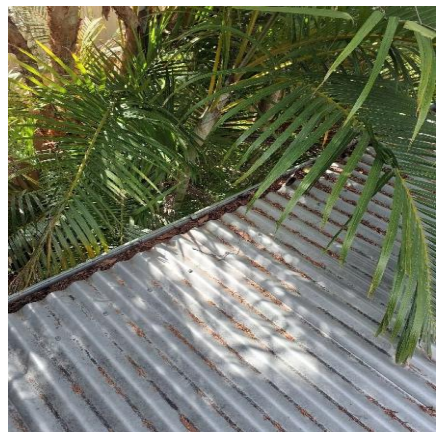
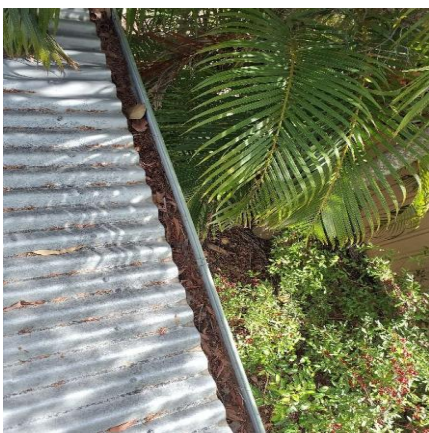
| <p>D18 Rainwater goods:</p> | <p>No evidence of Major Defects was found.</p> <p>The front left downpipe discharges onto the ground. It is important to noted that wet areas by attract termites.</p> <p>I therefore recommend that this pipe be diverted further away from the house.</p> <p>I noted that the gutters are filled with leaves .</p> <p>I recommend that the gutters be cleaned out ASAP</p> |

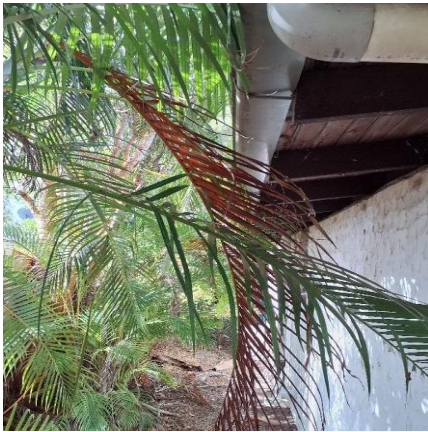
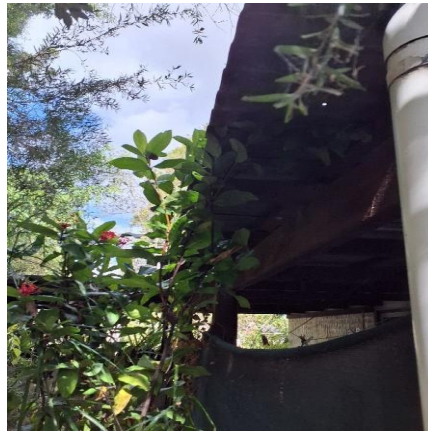
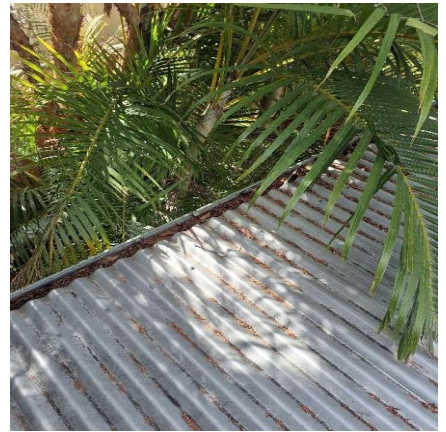
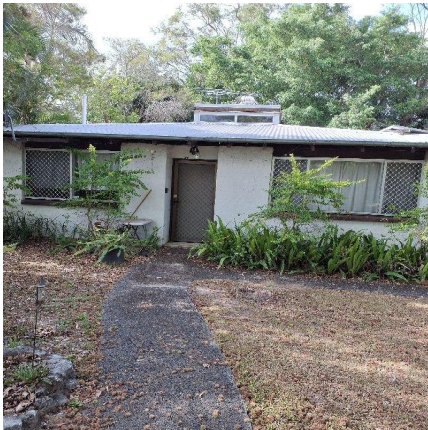
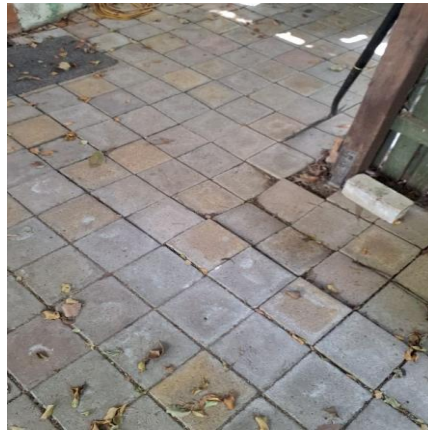
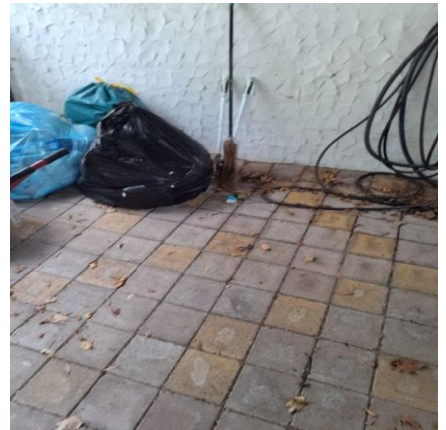
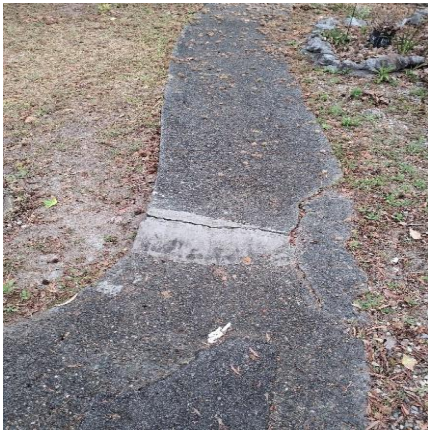
| <p>D19 The grounds:</p> | <p>No evidence of Major Defects was found.</p> <p>I recommend that all trees adjacent to the house be removed as they are filling up the gutters and covering the roof with leaves</p> <p>I noted general cracking and movement on the external paths and rear paver</p> <p>I recommend general maintenance replacement</p> |
