# Property Inspection Report

55 Clearwater Street,  
Bethania, 4205, QLD

Inspection Prepared for:  
Phuong Mai

Date of Inspection: 24/10/2025 | Time: 4:30 PM

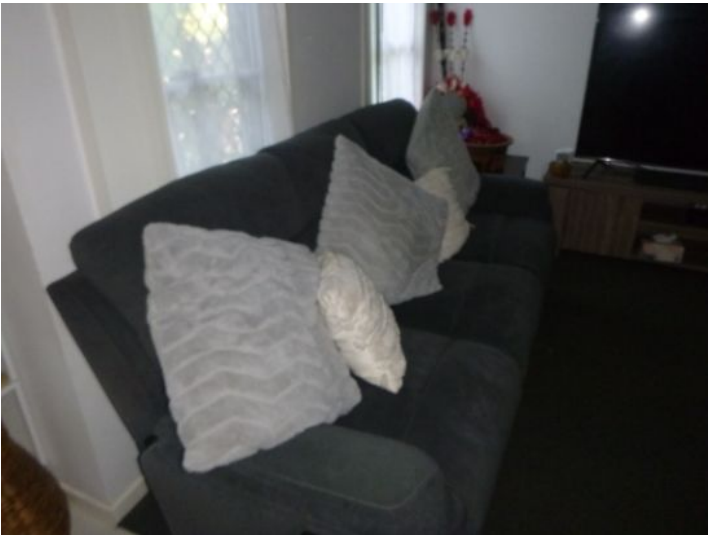
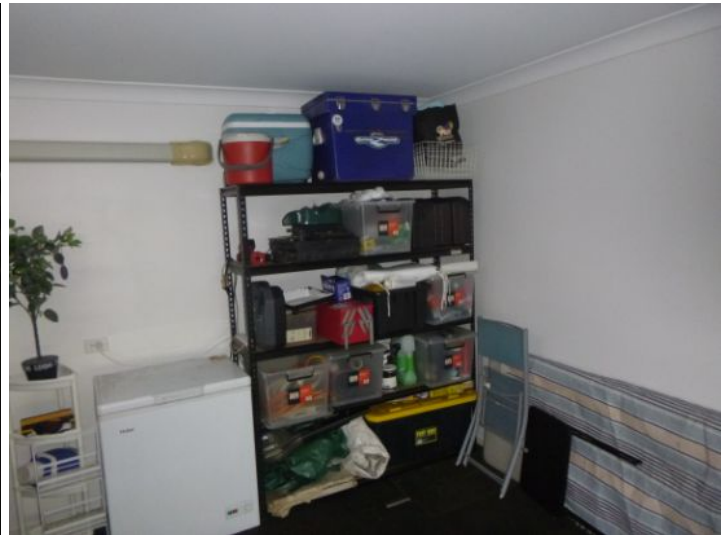
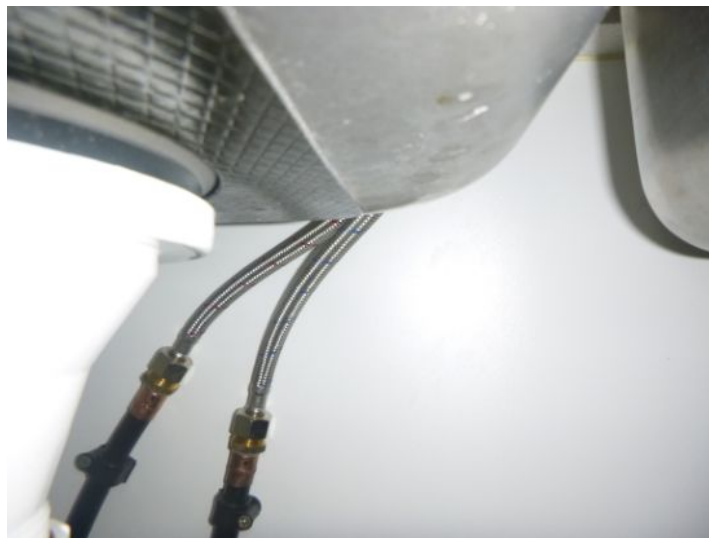
- The interior and garage visual inspection was obstructed or restricted because of stored materials.

- We recommend all braided flexible water hoses in the property be checked regularly and replaced as required to prevent water damage.

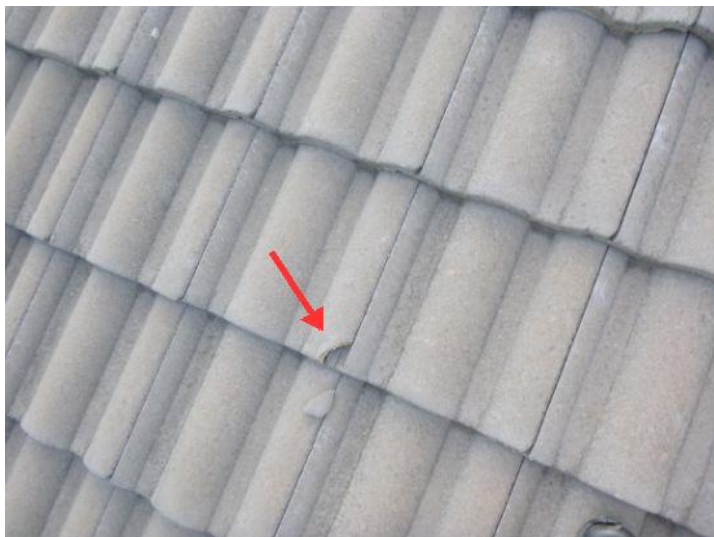
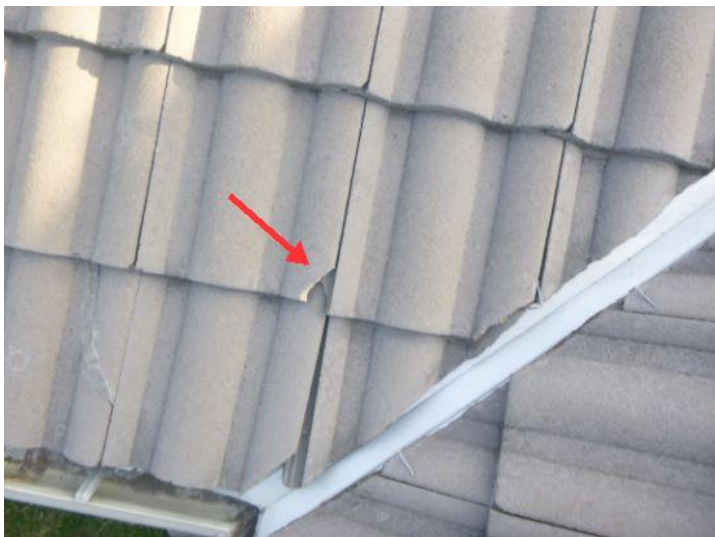
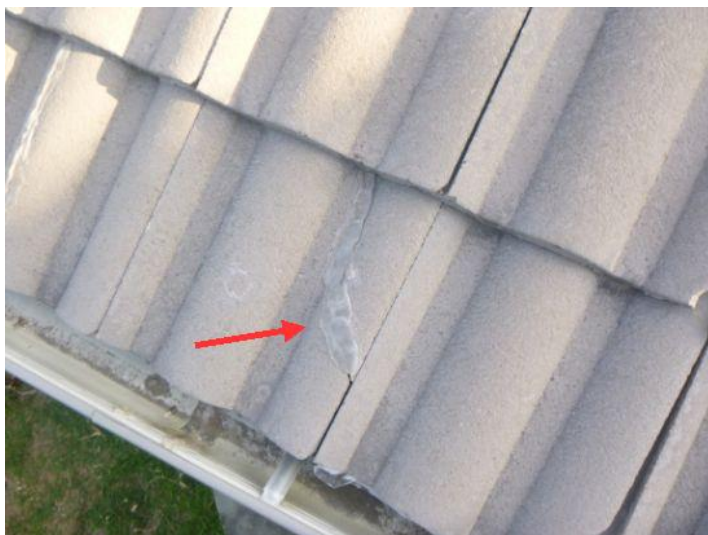
- There are several cracked or chipped tiles, but none of these appear to warrant replacement or repair of the tiles.
- There are previous silicone repairs noted. These tiles should be monitored, and ideally at some stage replaced as silicone can deteriorate over time.

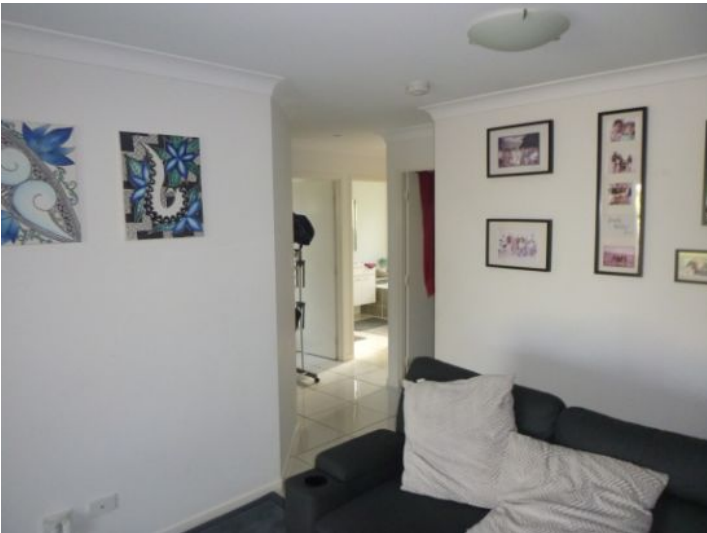
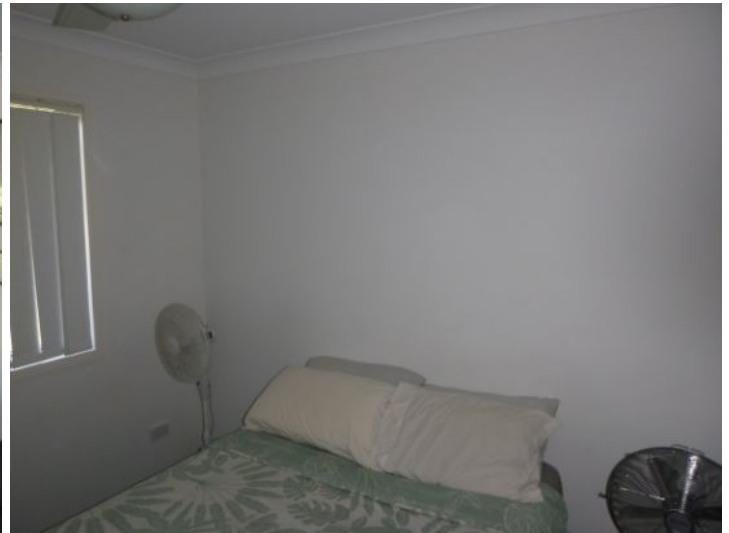
- There are marks and imperfections to the interior walls at various locations. These can be repaired normally.

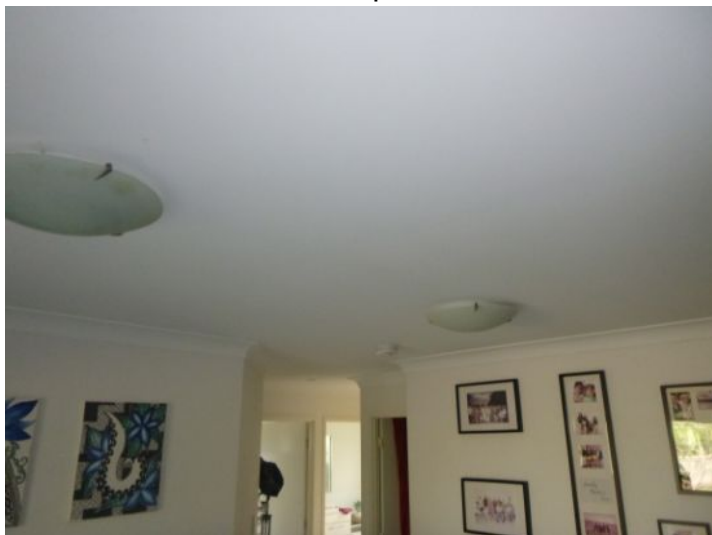
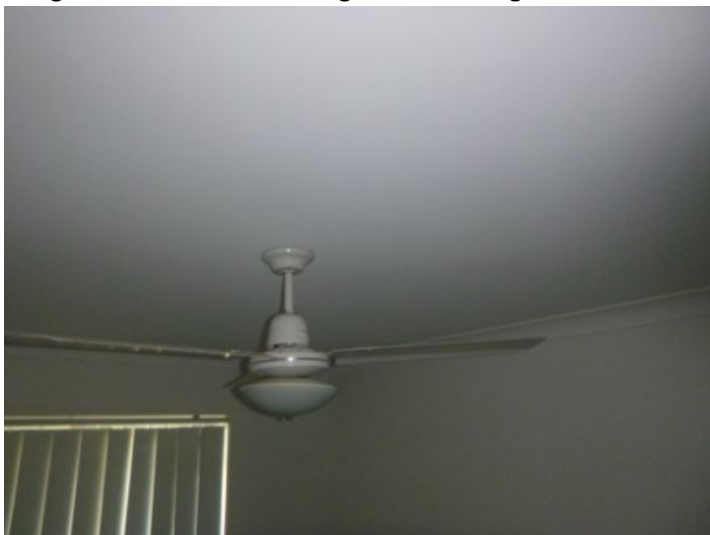
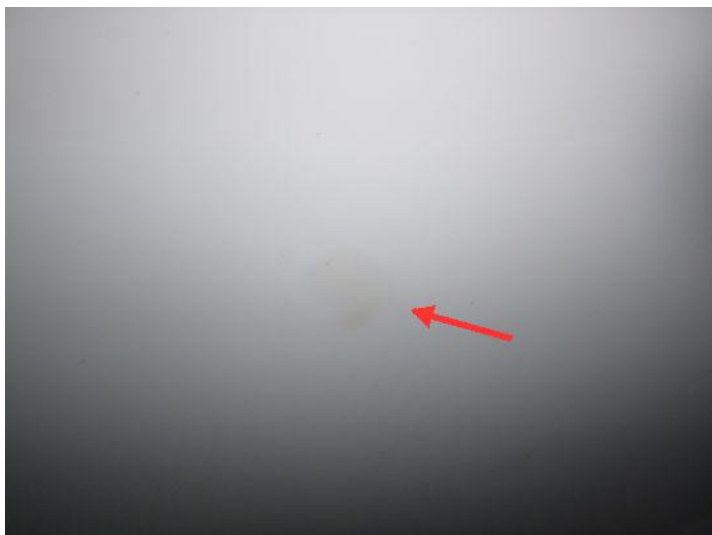
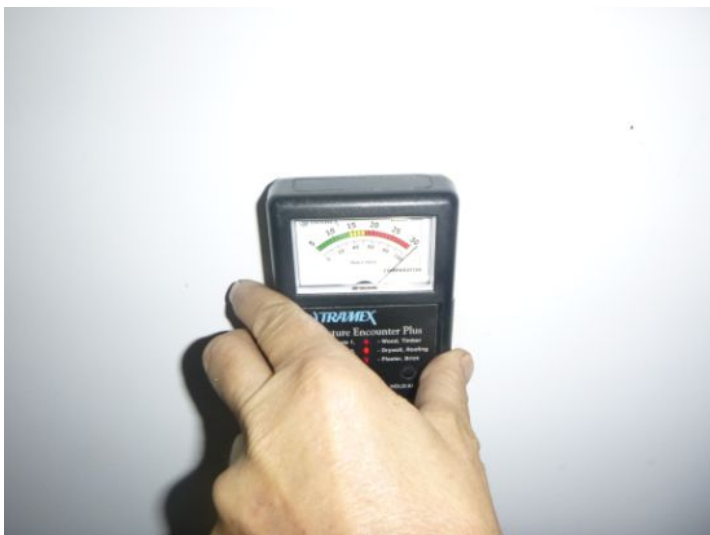
Kitchen area ceiling

- There is what appears to be a moisture stain in the kitchen ceiling covering. Testing with the moisture meter indicated current moisture present. Inspection within the roof space and of the roof covering did not reveal an obvious source of any leak, which is difficult to detect when it is not raining. We recommend that you monitor this area during heavy rainfall to confirm whether any maintenance work is required. This is important because our inspection does not warrant or guarantee the roof against leakage.

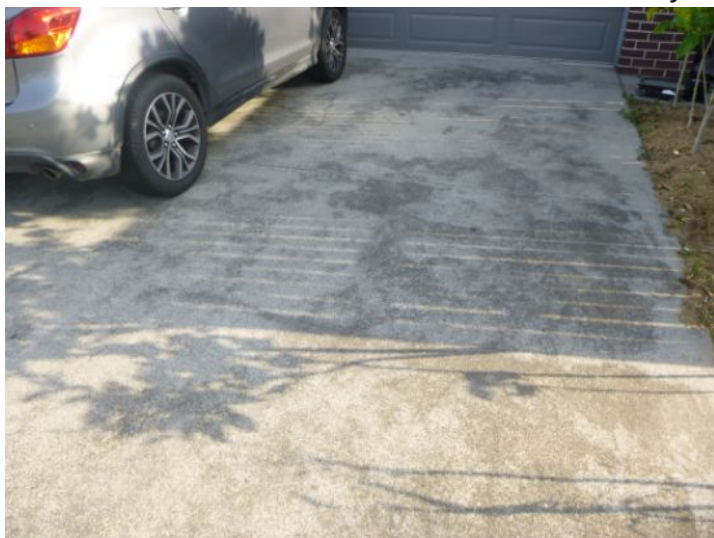
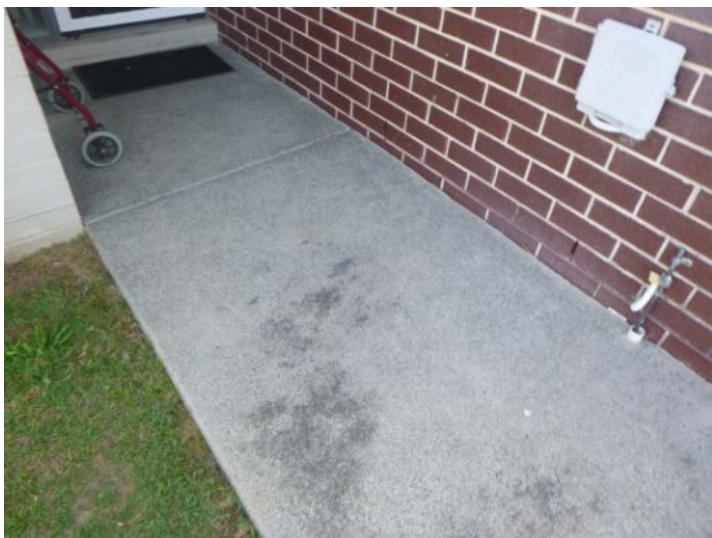
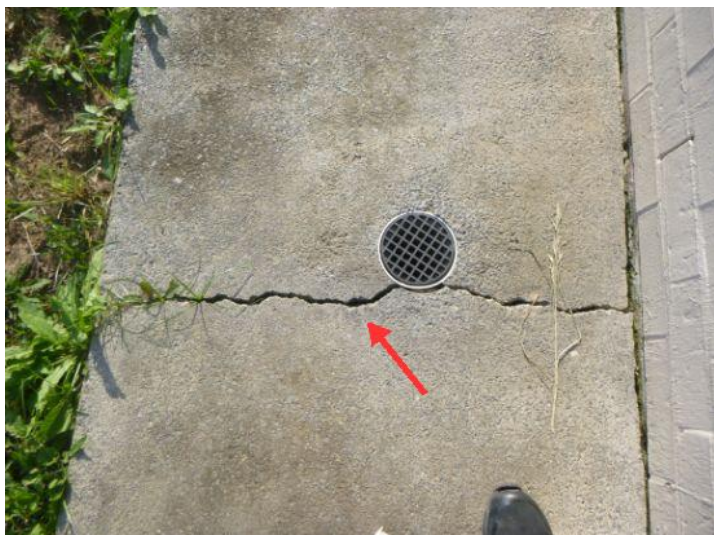
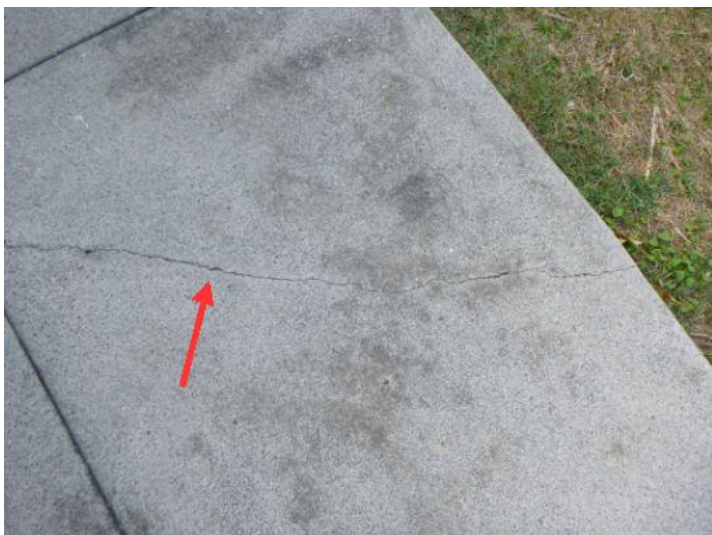
- Some areas of uplift were noted to the southern pathway. This area does not appear to have affected the structural integrity of the home or the function of the pathway and can be repaired/levelled normally.
- Minor settlement or "hairline" cracks in driveways/pathways are normal to properties of any age. They should, however, be monitored for expansion and sealed as necessary.

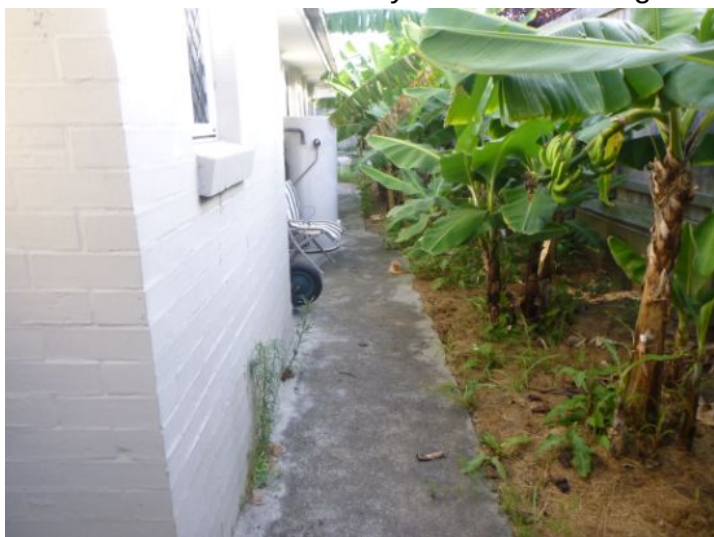
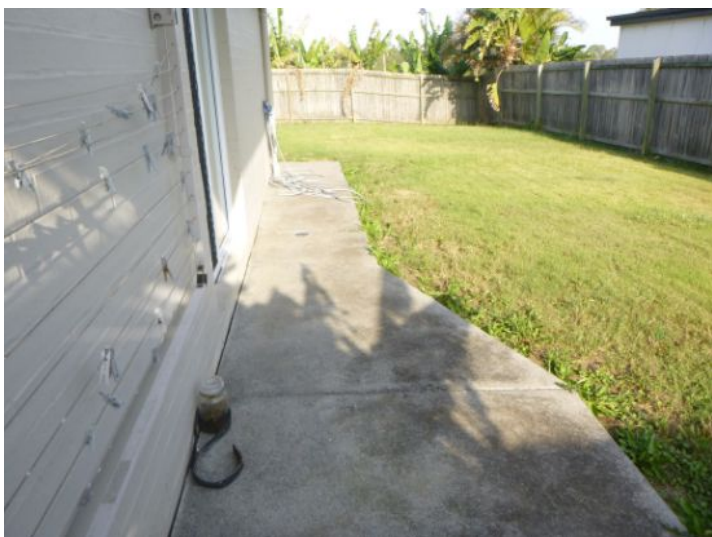
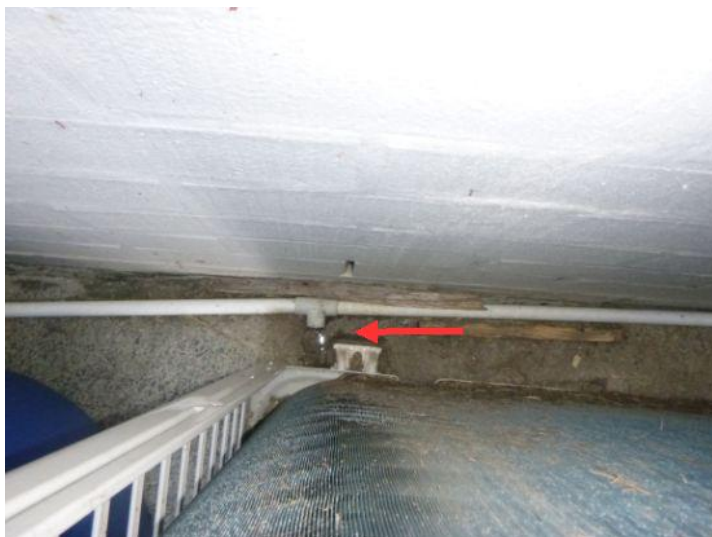
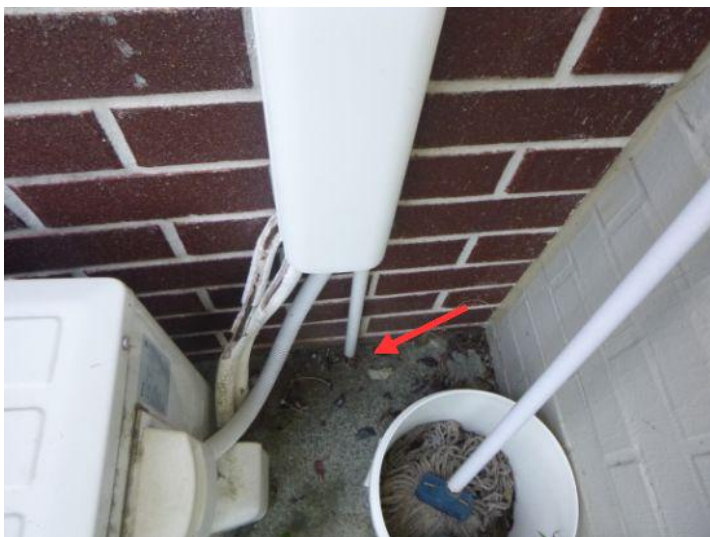
- Surface drainage conditions within 3 metres of the inspected structure appeared satisfactory.
- The air conditioners discharge pipes discharge on or near the foundations. These should ideally be directed into the storm water or at least 3 metres away from the building.

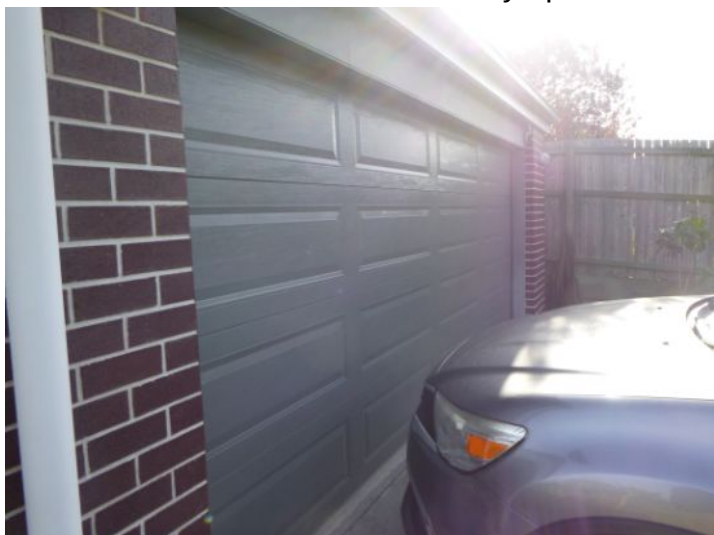
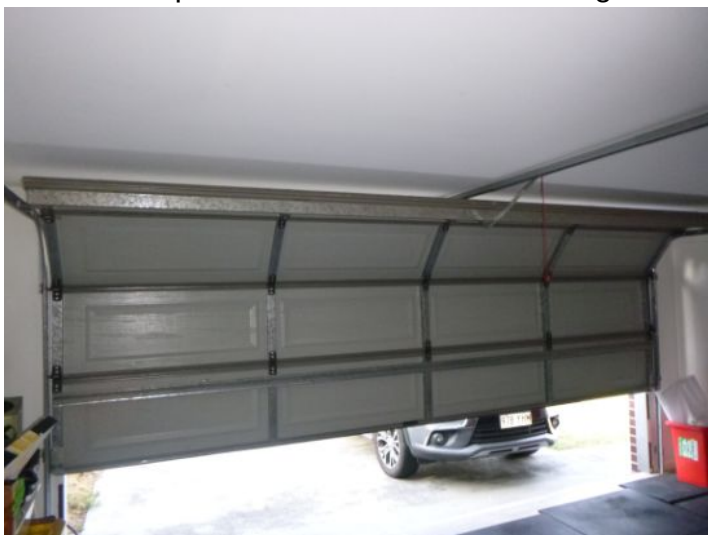
- Did not fully open at the time of the inspection. Recommend servicing.

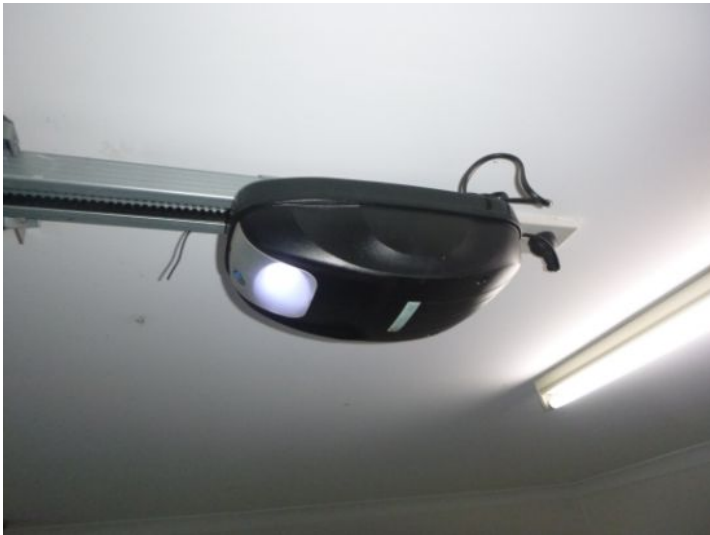
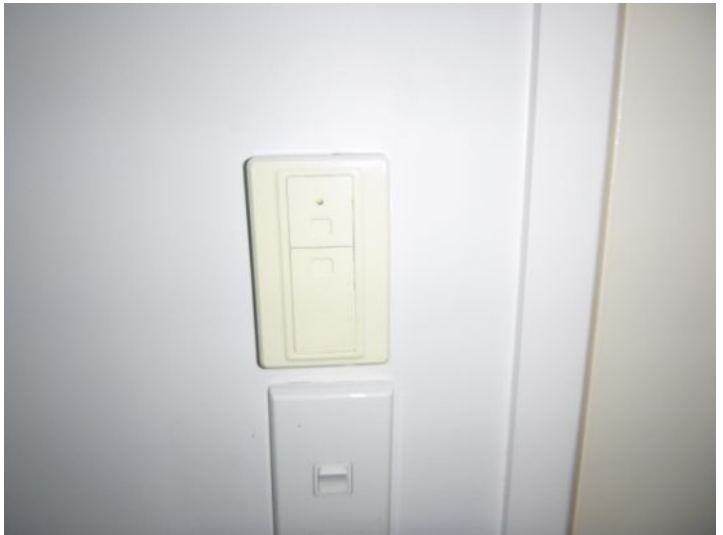
- Appeared functional using normal controls, at the time of inspection.
- Wall opener did not respond at the time of the inspection. Recommend repair/replacement.
