# Timber Pest Inspection Report

55 Clearwater Street,  
Bethania, 4205, QLD

Inspection Prepared for:  
Phuong Mai

Date of Inspection: 24/10/2025 | Time: 4:30 PM

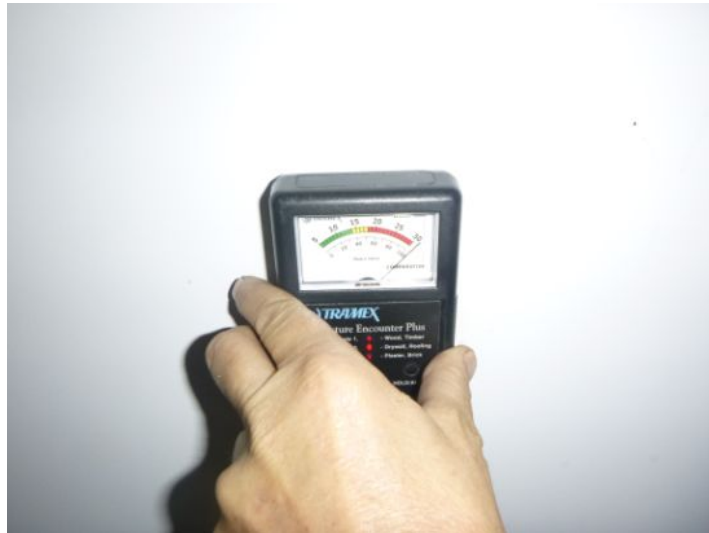
Observations: Excessive moisture conditions were present during the inspection.

A moisture meter confirmed the presence of excessive moisture in kitchen area ceiling.

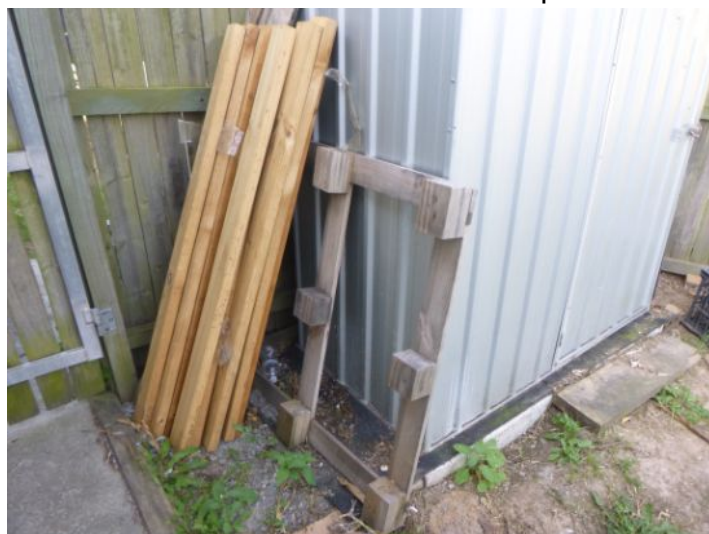
There landscaping/stored timber on the grounds, which may be a termite risk.

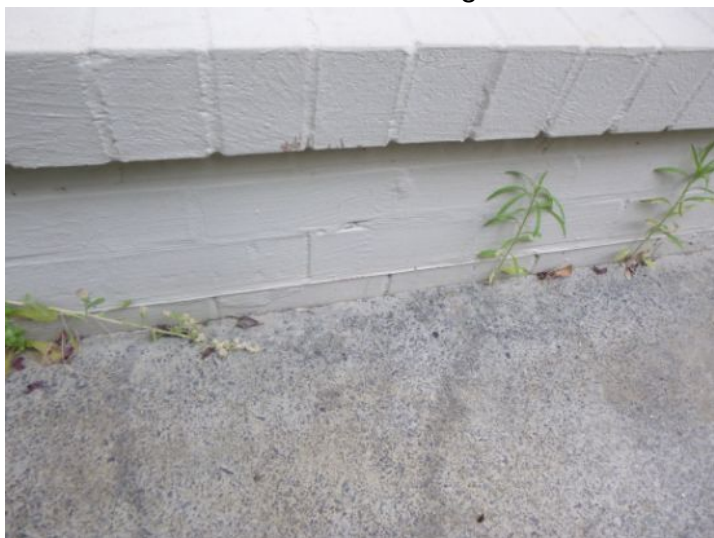
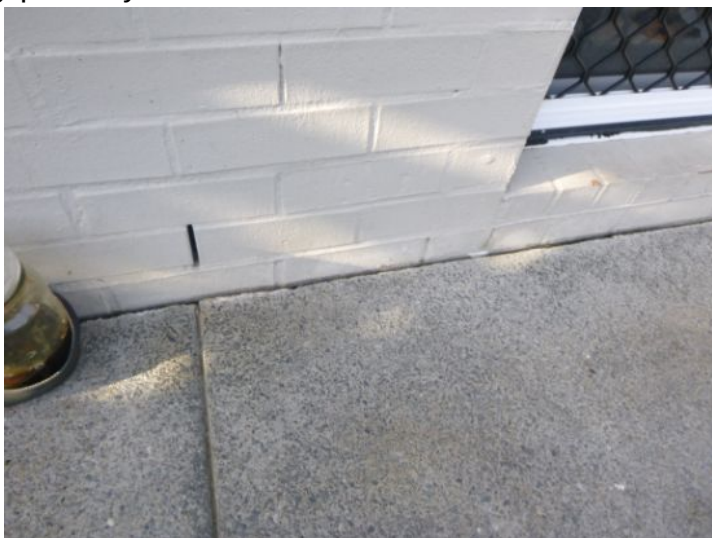
- Slab edges are covered by pathways.

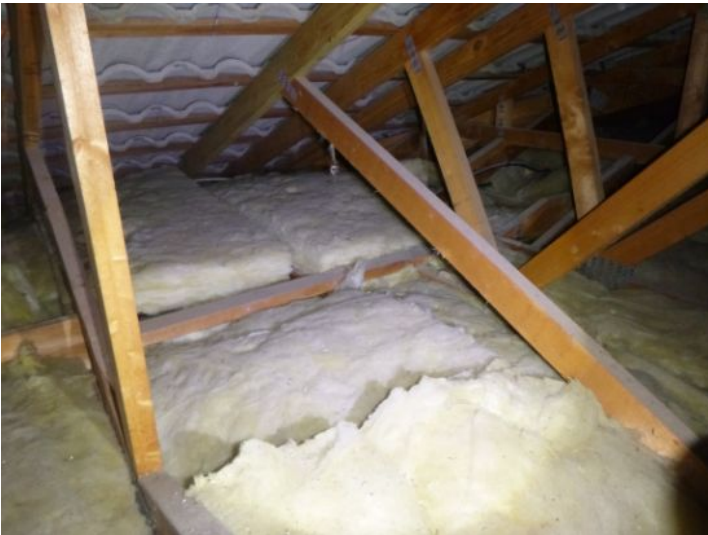
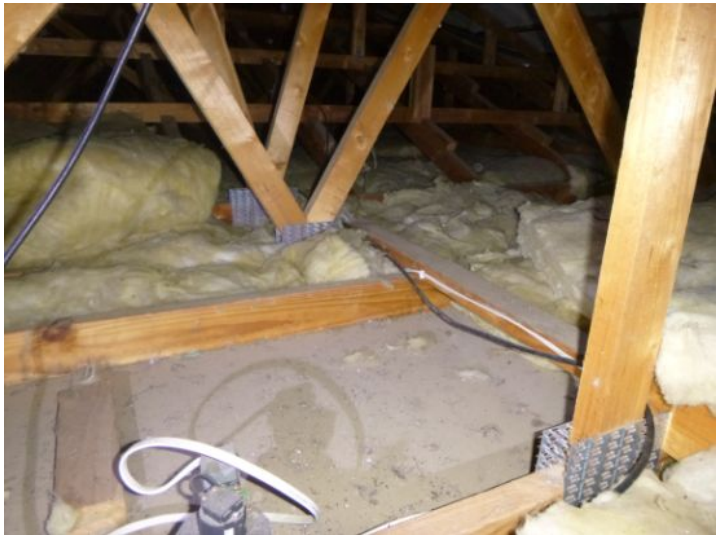
- Access was available through a manhole in the laundry.
- Due to space constraints the inspection of the internal roof space was limited.
- Limited visibility and access due to insulation and pitch.

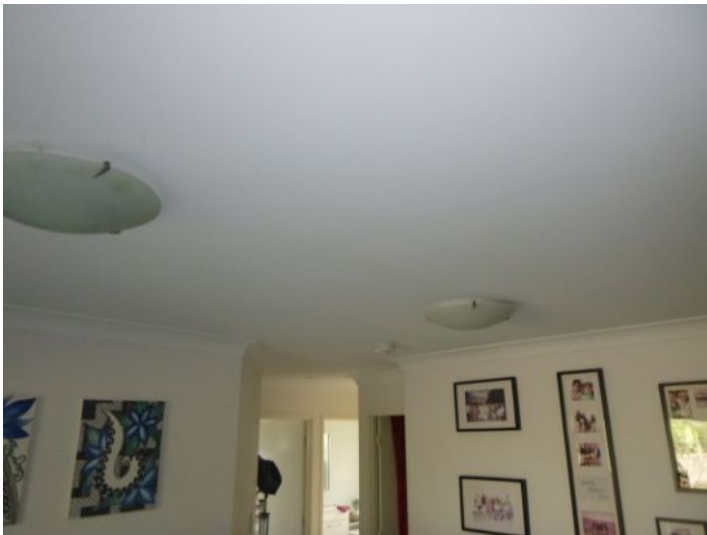
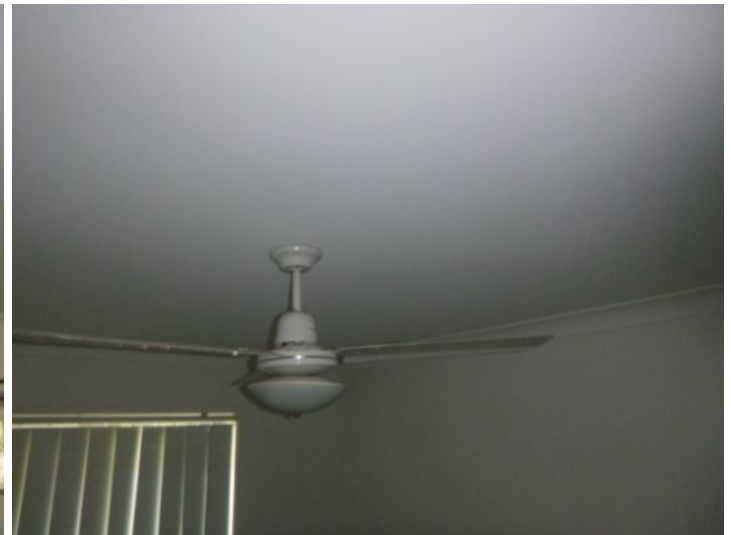
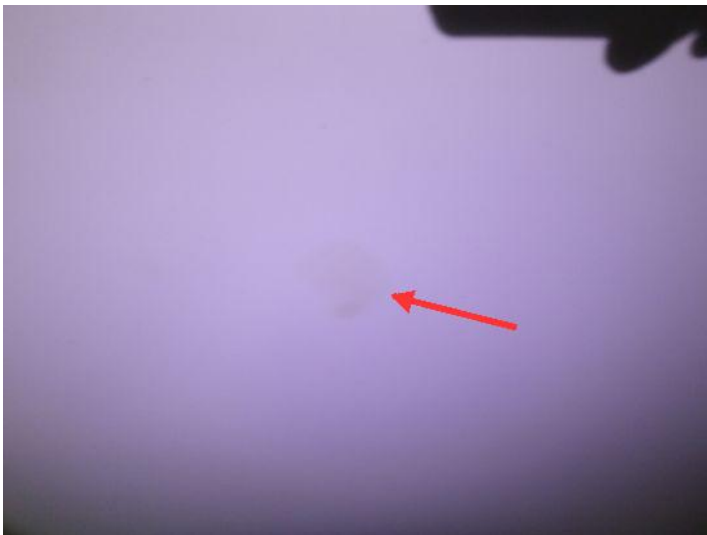
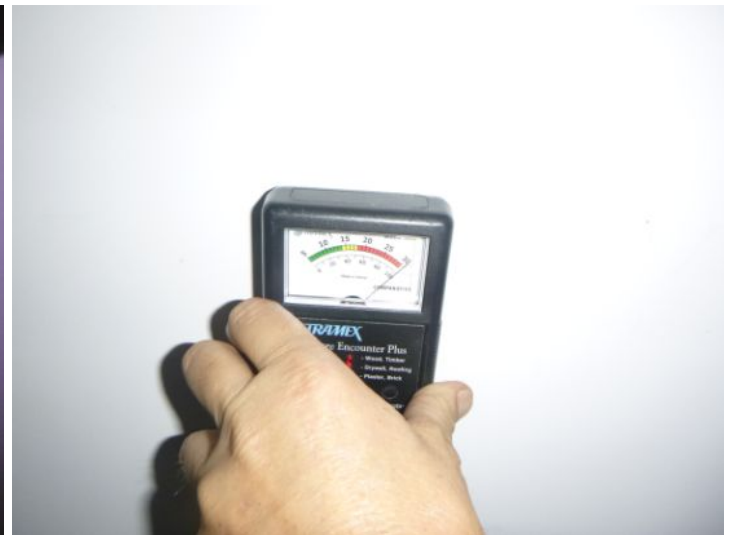
Kitchen ceiling

- There is what appears to be moisture stains in the kitchen ceiling covering. Testing with the moisture meter indicated current moisture present. Inspection within the roof space and of the roof covering did not reveal an obvious source of any leak, which is difficult to detect when it is not raining. We recommend that you monitor this area during heavy rainfall to confirm whether any maintenance work is required. Dampness provides a conducive environment for timber pest attack.

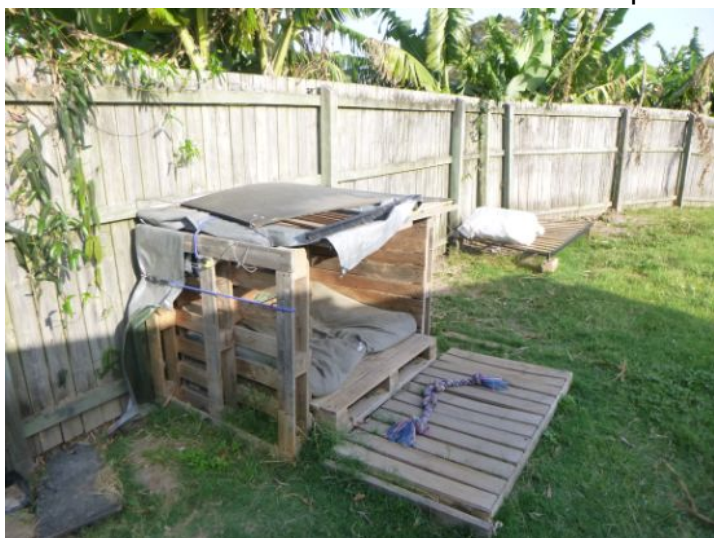
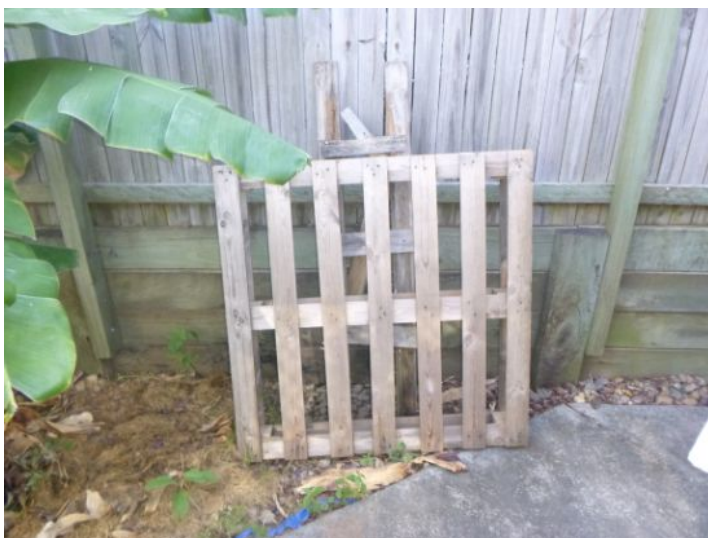
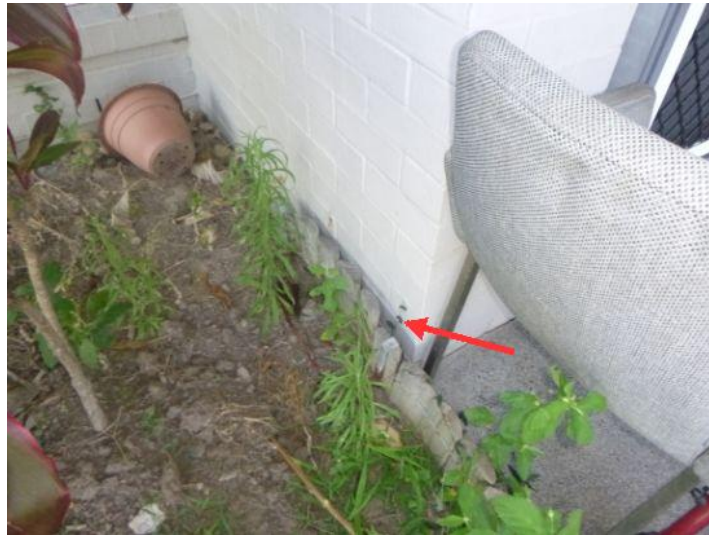
- There is stored timber in contact with the ground that may provide possible breeding grounds for subterranean termites. These should be removed.
- There is timber landscaping materials used on the property or against the edge of the home, which could attract termites or provide possible entry points for termites into the home. These should be removed or replaced with a material less susceptible to termite attack.

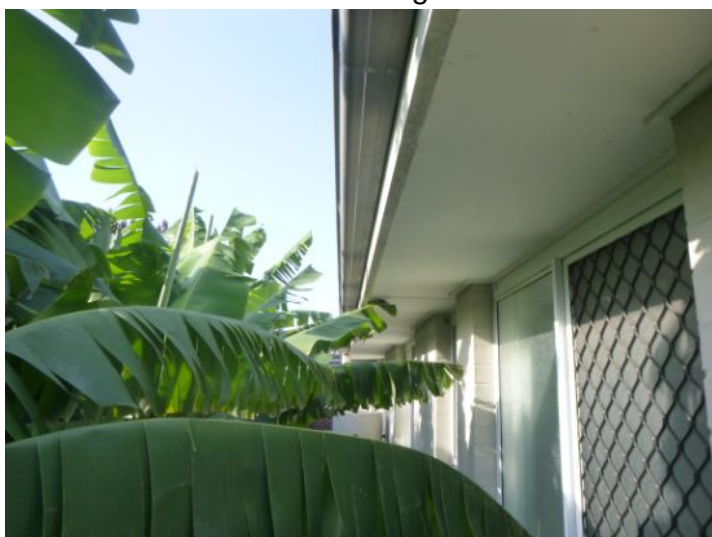
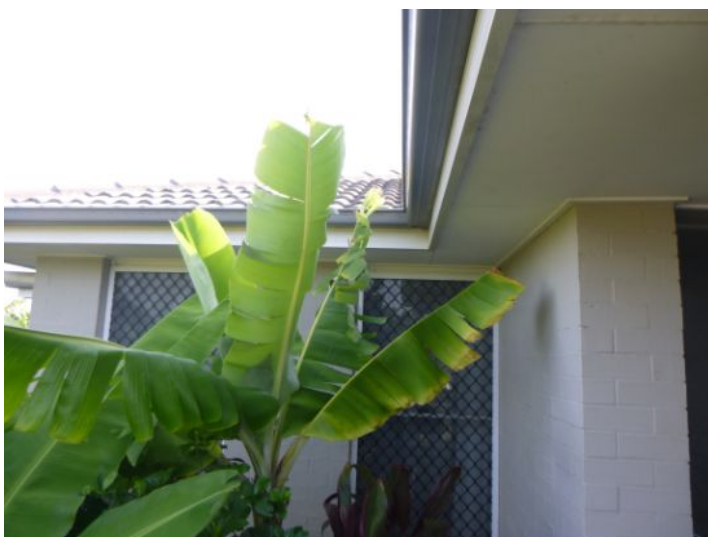
- Tree limbs within 3 metres of roof should be trimmed away to provide air and sunlight to roof, while minimizing debris, dampness and abrasion damage.
