# Property Inspection Report

5 Woodrose Street,  
Kingston, 4114, QLD

Inspection Prepared for:  
Little Lachie Group Pty. Ltd.

Date of Inspection: 5/11/2025 | Time: 3:30 PM

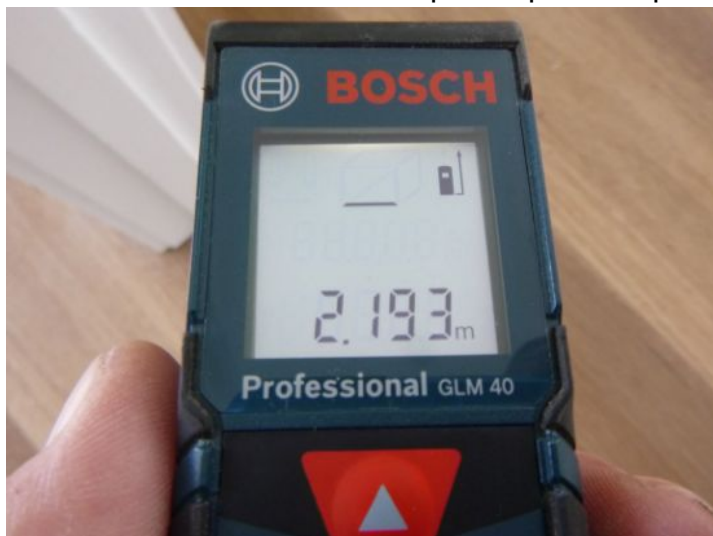
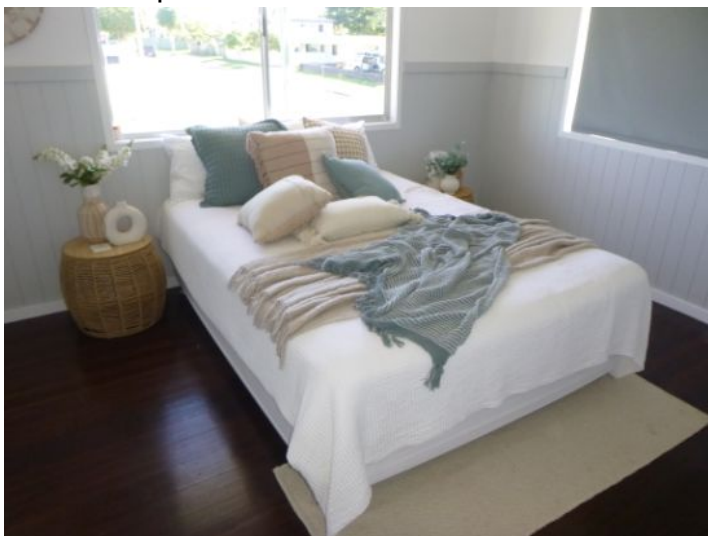
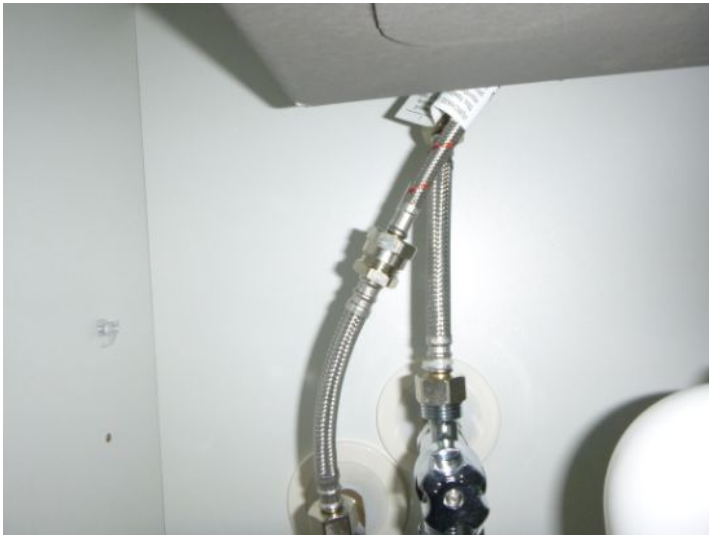
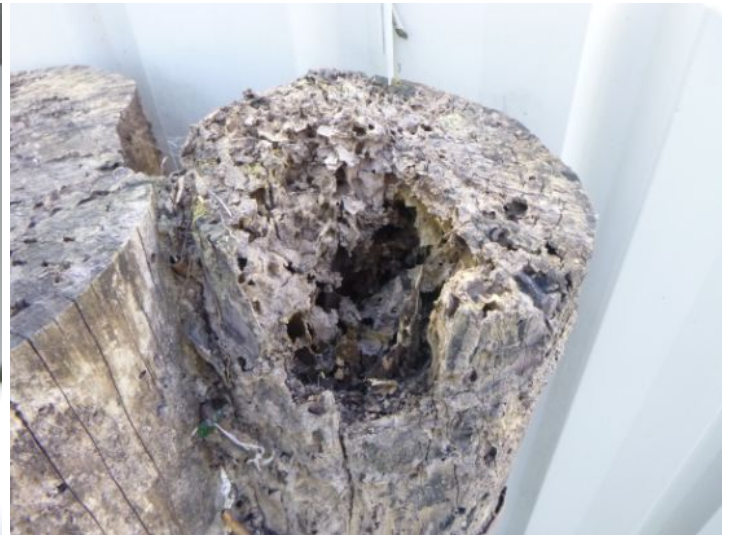
- There have been changes and additions which have been carried out to the original property. Built in rooms noted in the sub-floor area. The ceiling height to these areas is approximately 2200mm which is below the required height for a habitable space.

- Evidence of termite activity noted to the exterior of the house. Refer to the timber pest report completed at the inspection.

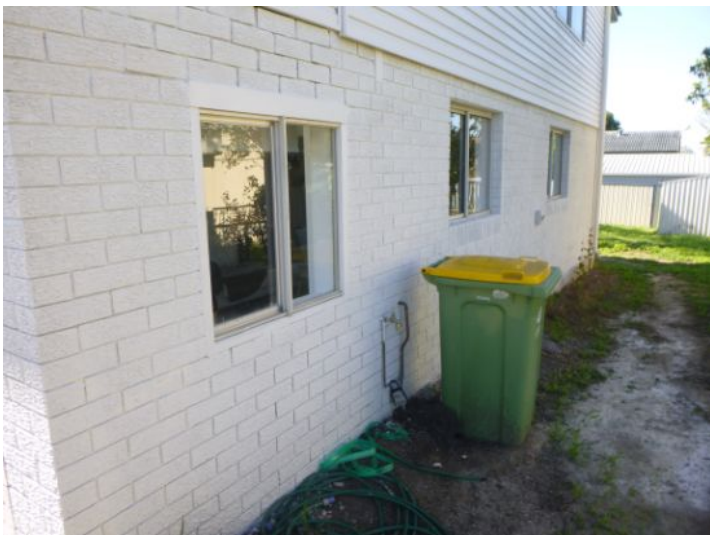
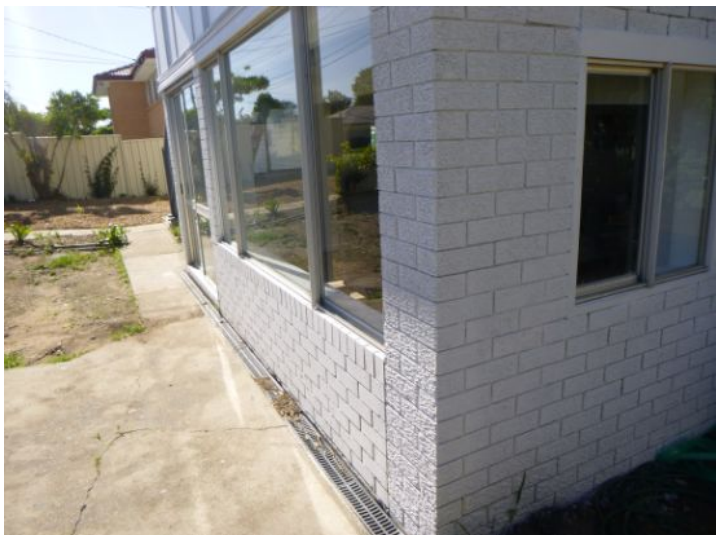
Observations:  
• Brick foundation walls noted.

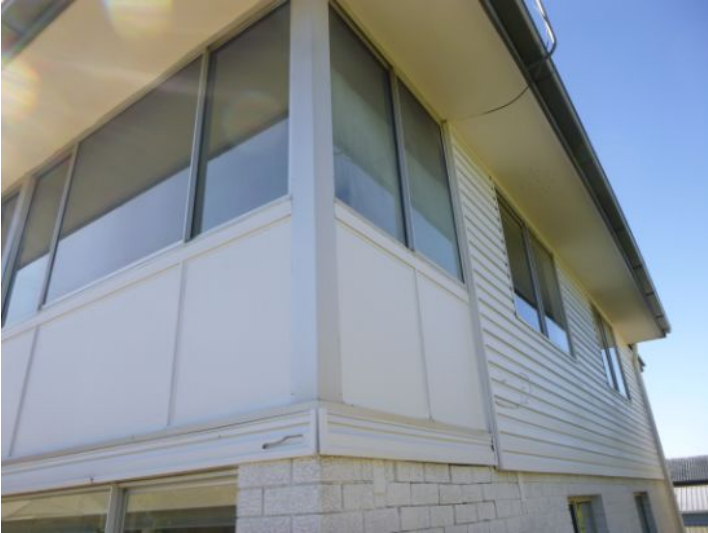
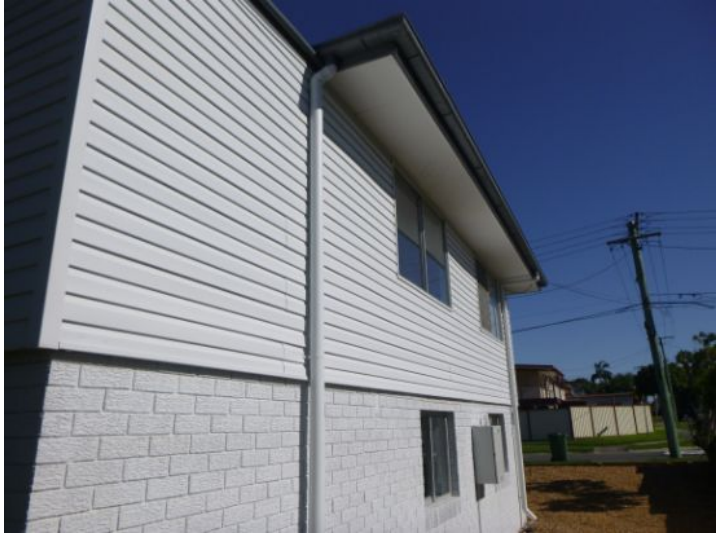
- The wall structure components appeared functional.
- External walls are of a timber frame with a cladded construction.

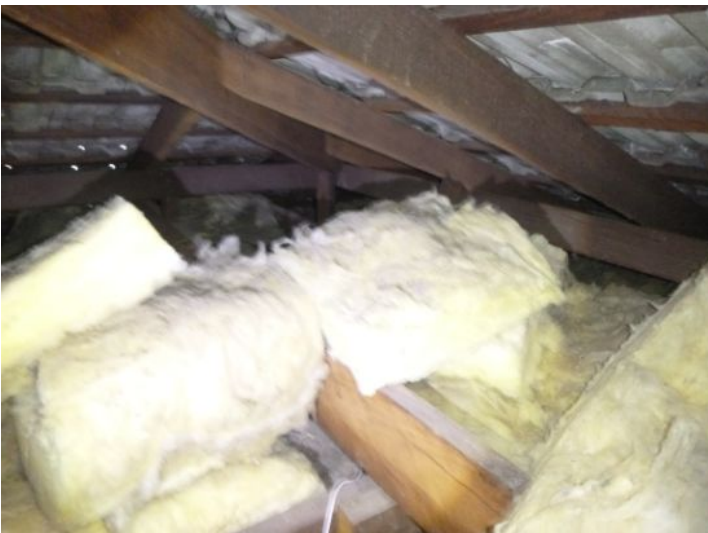
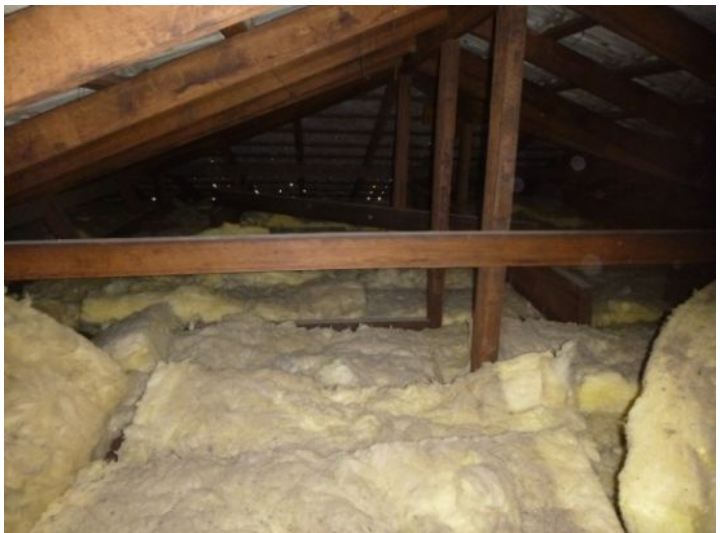
- The ceiling structure appeared functional.
- Due to the placement of insulation on the top of the ceilings it is not possible to fully inspect the condition of the ceiling structure and supports. Inspection was limited and based on what was visually accessible at the time of the inspection.

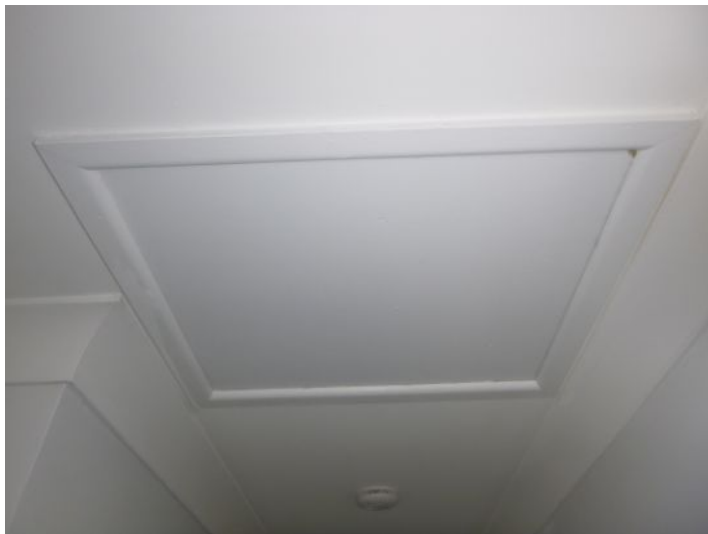
- Access was available through a manhole in the bedroom hallway.
- Due to space constraints the inspection of the roof space was limited.

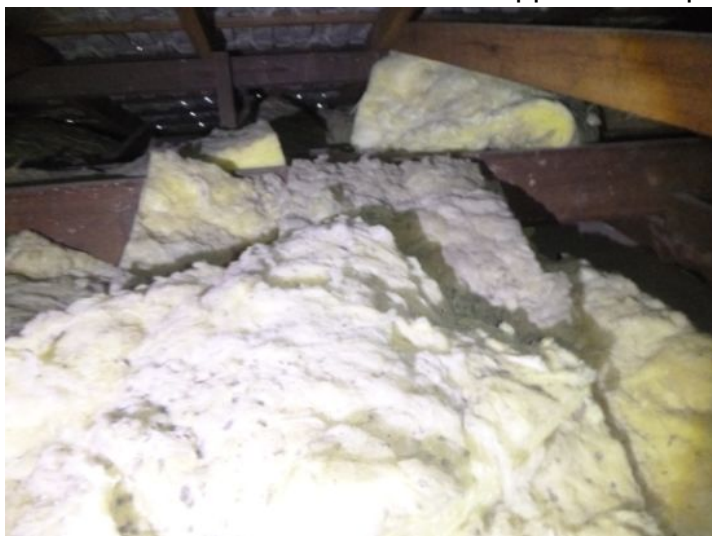
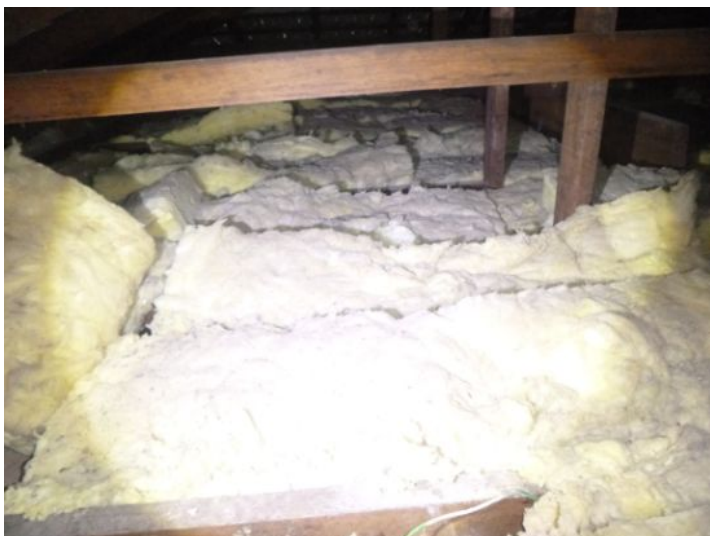
- Insulation averages about 150mm in depth.
- Insulation appears adequate.

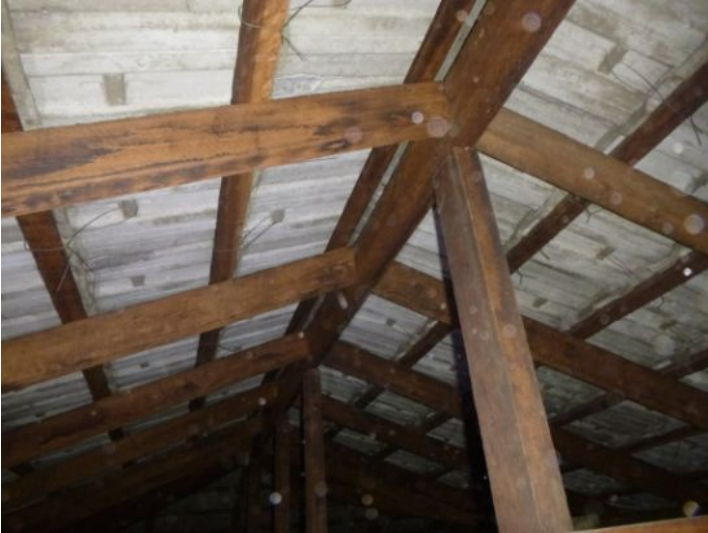
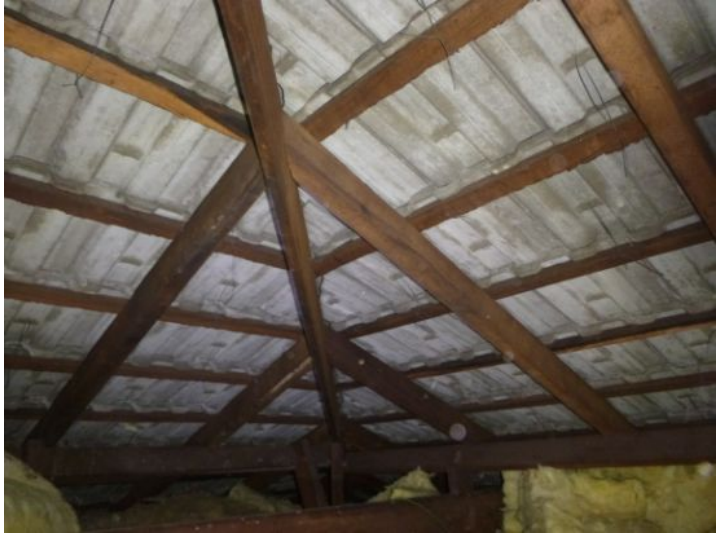
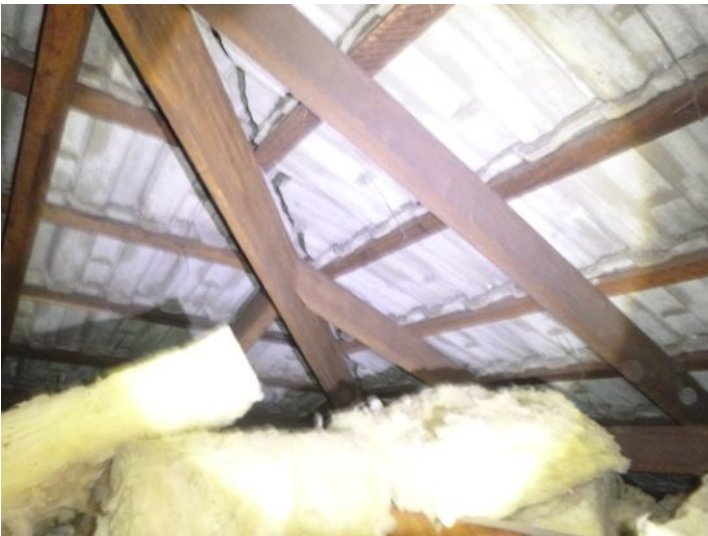
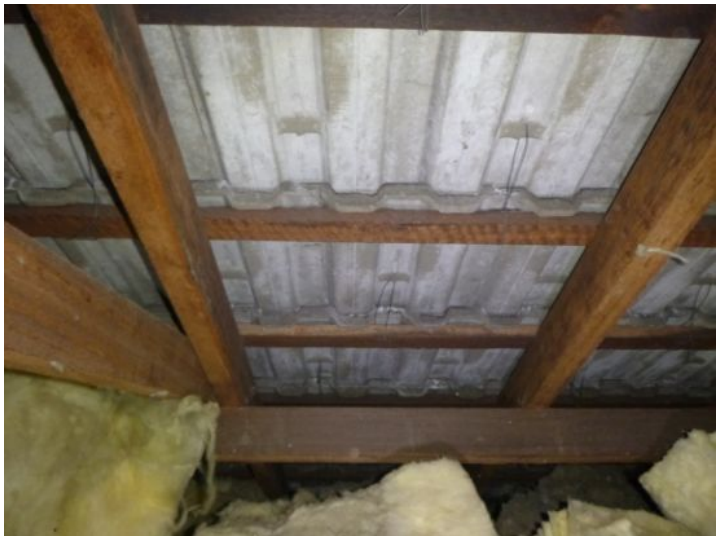
- The timber roof structure appears sound.
- Could not access all areas of the roof space due to limited space.

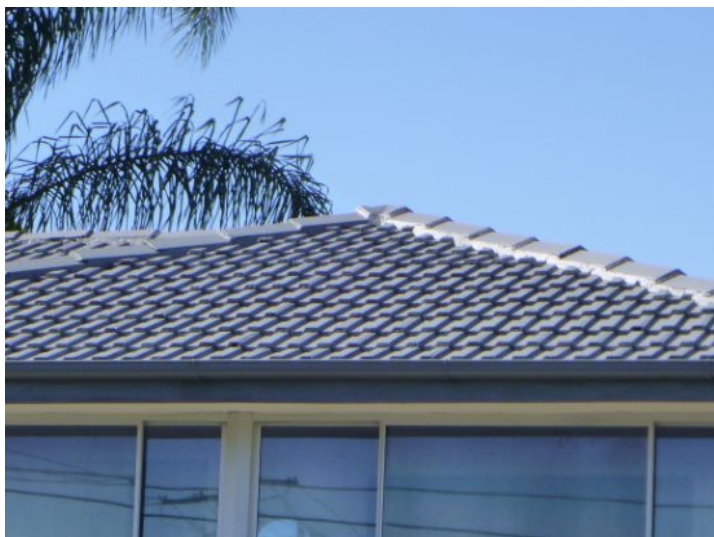
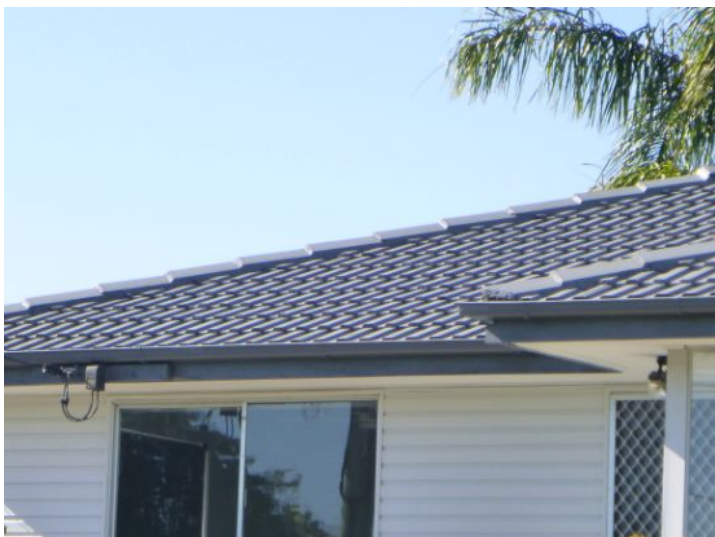
- The concrete tile roofing material appeared to be in satisfactory condition other than noted.

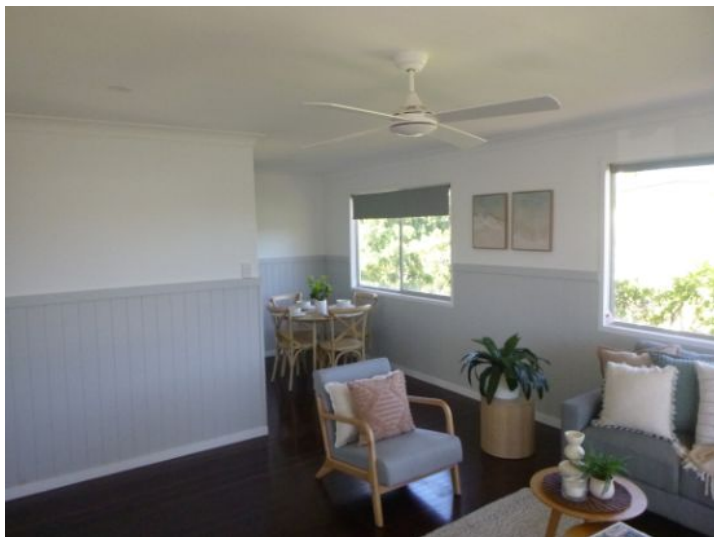
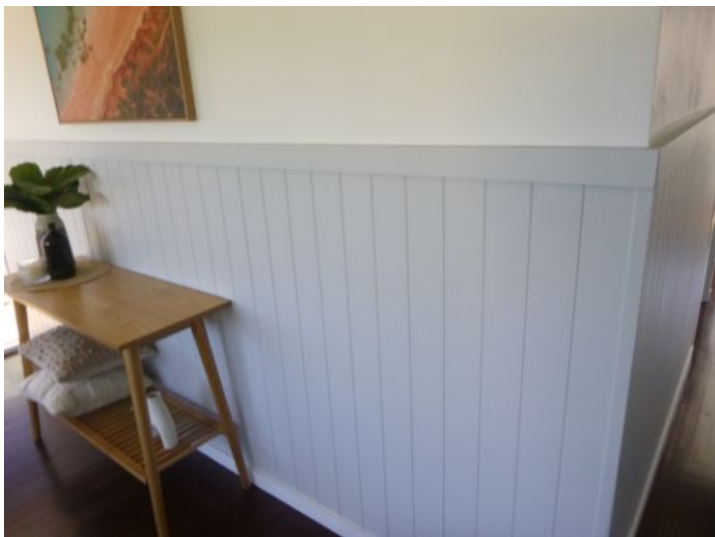
- Plasterboard/gyprock and what appears to be asbestos clad walls in the bathroom which appear to be functional.
- Some walls are clad in timber panelling (wainscoting), which appeared functional.

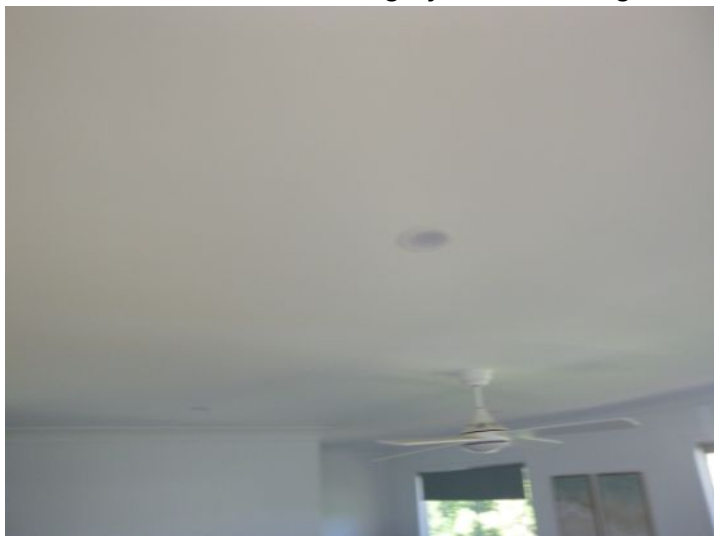
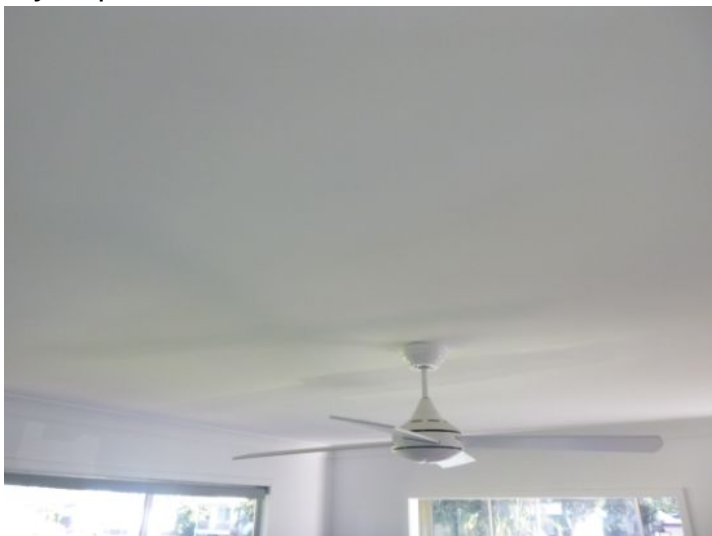
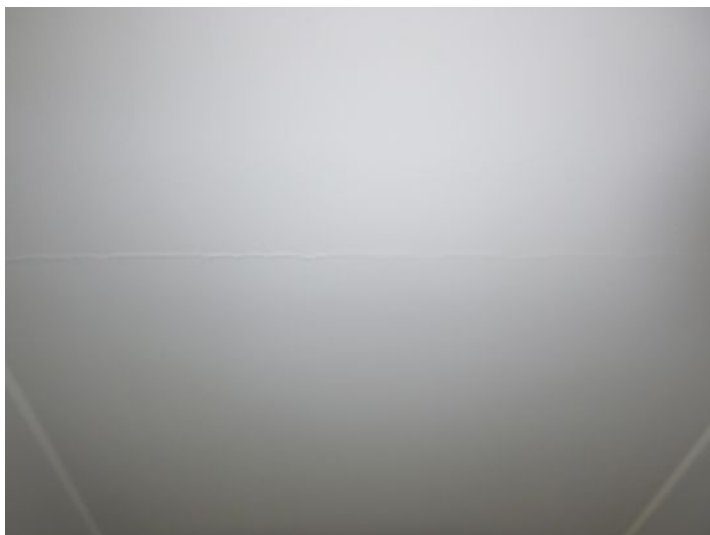
- The ceiling has minor hairline joint cracks between the joints of the sheets. This is normally due to minor movement in the roof structure and can be repaired normally. This does not appear to have affected the structural integrity of the ceilings but may require some maintenance in the future.

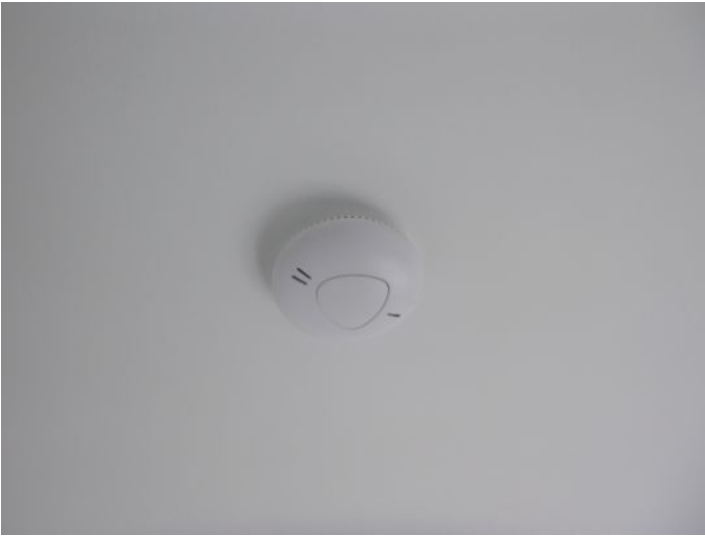
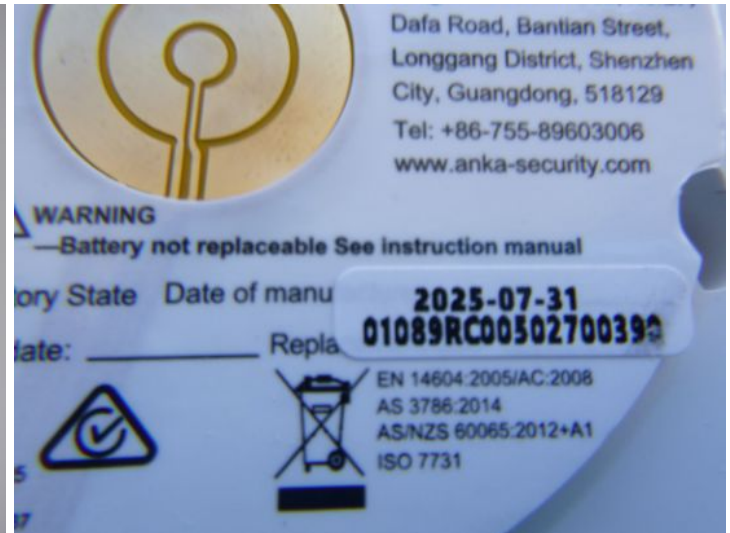
- Testing of smoke alarms is not included in this inspection. Pushing the "Test" button only verifies that there is power at the alarm--either a battery or hardwired to the house power--and not the operational workings of the alarm. The operational check is done by filling the sensor with smoke and is beyond the scope of this inspection. Battery operated smoke alarms should be checked routinely and the batteries changed frequently.
- From 1 January 2022, all dwellings being sold in Queensland require hardwired and or non-removable 10-year battery interconnected, photoelectric, smoke alarms installed in every bedroom, in hallways which connect bedrooms and the rest of the dwelling, and on each storey.
- There appears to be interconnected smoke alarms installed in the hallways and bedrooms of the home. The service replacement year is noted as 2035

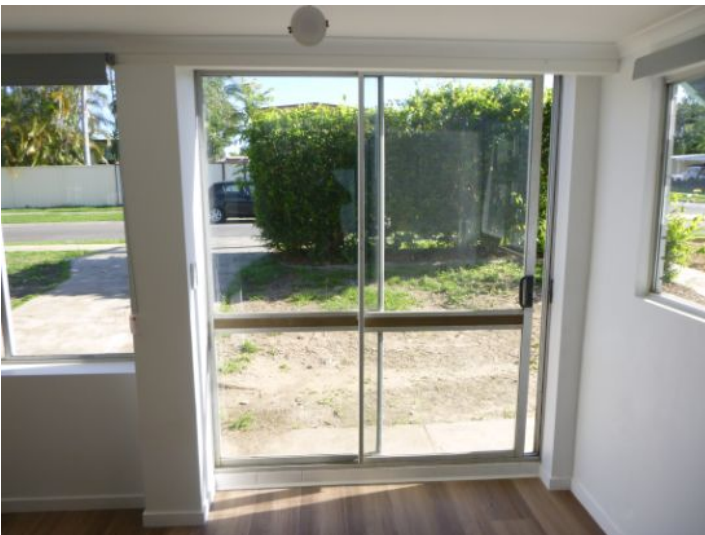
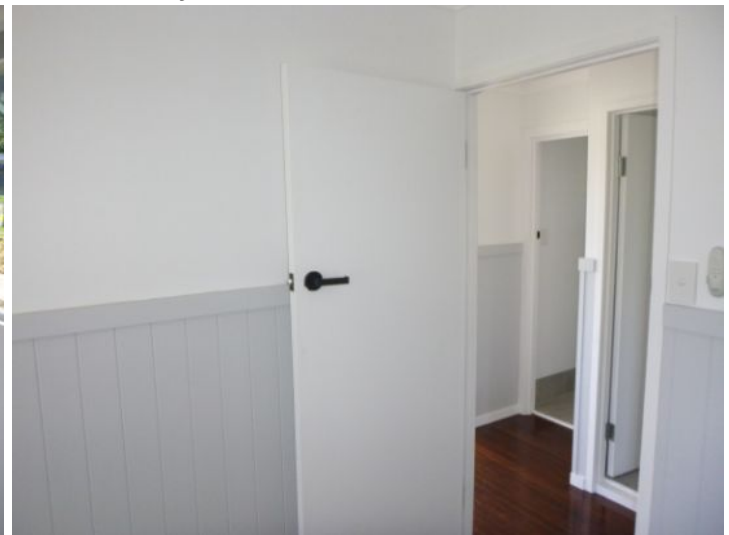
- The exterior doors function satisfactorily.
- The interior doors function satisfactorily.

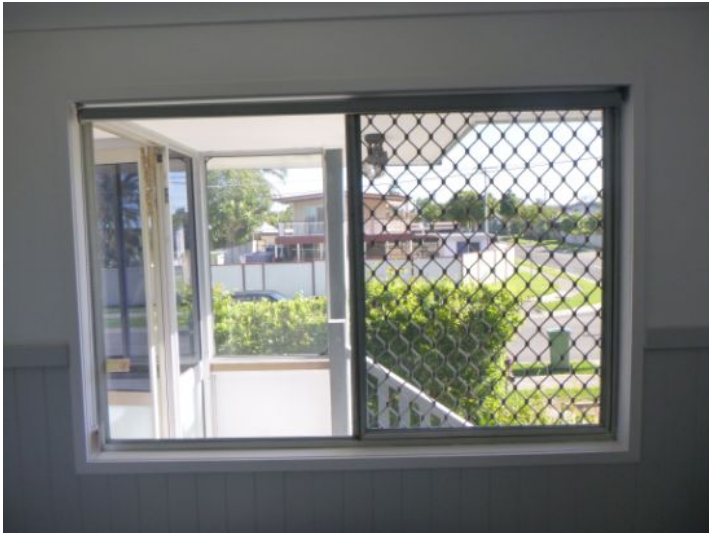
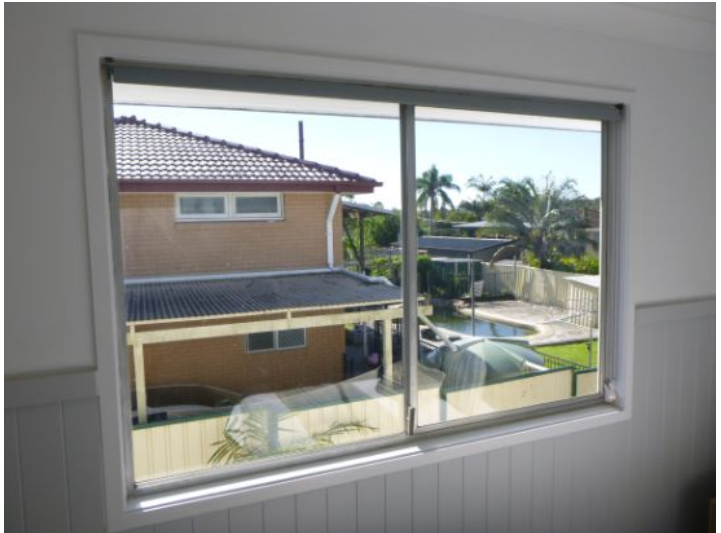
- Windows operated during the inspection appeared functional.
- Even though the window openings may have met building regulations at time of construction, current building legislation requires that windows lower than 1700mm above floor level and where a child could fall more than 2m shall have opening limited to 125mm maximum. Windows in the bedrooms do not meet these current safety requirements and should be fixed to limit opening to 125mm maximum or fitted with security screens.

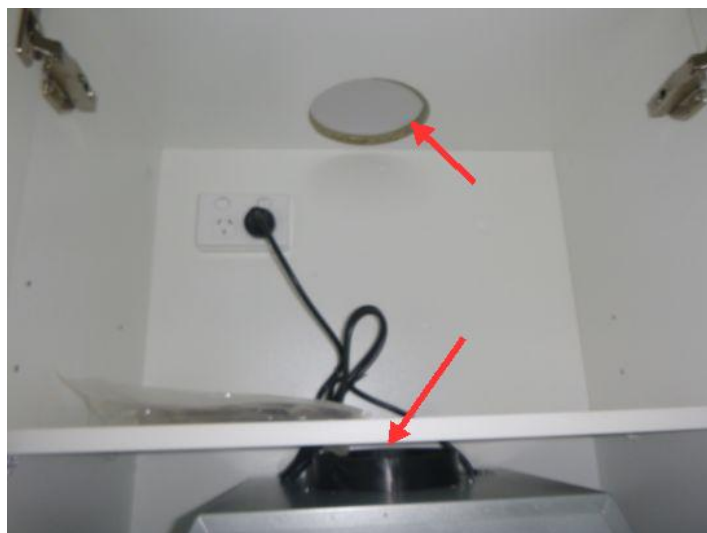
- Range hood ducting not in place. Recommend installing.

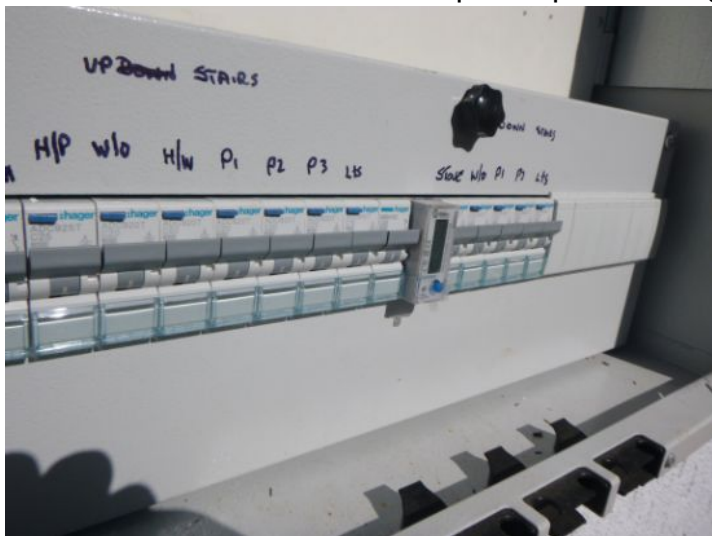
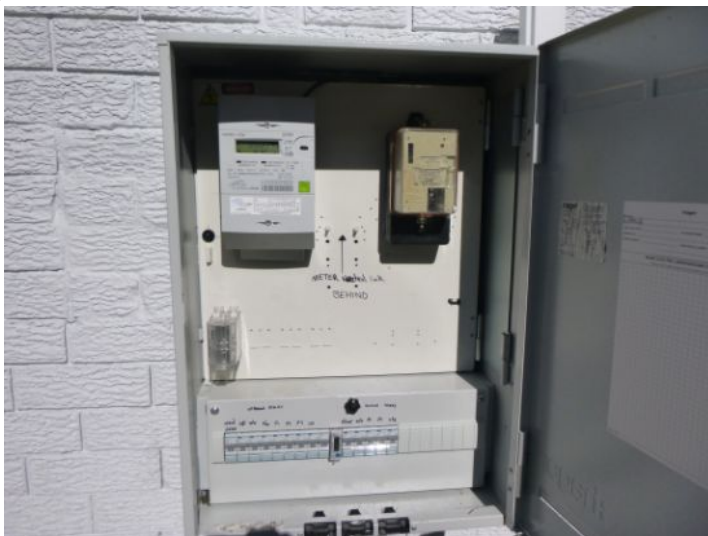
Observations: There are at least 2 RCD's installed which appear to protect both the power point and light circuits.

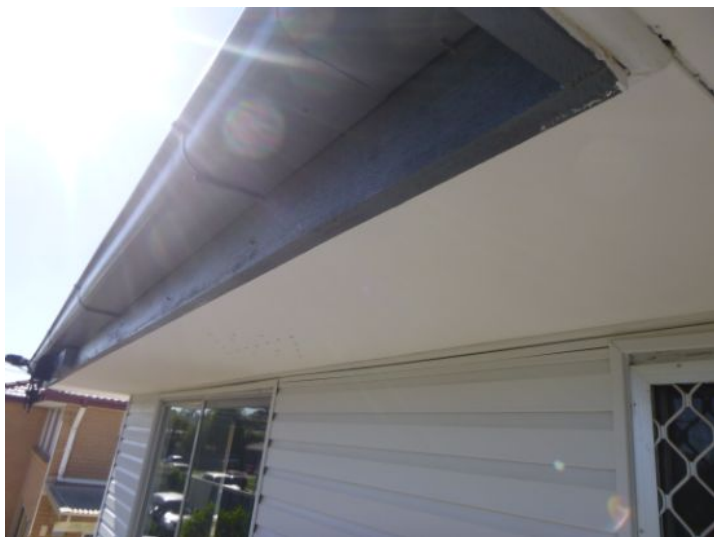
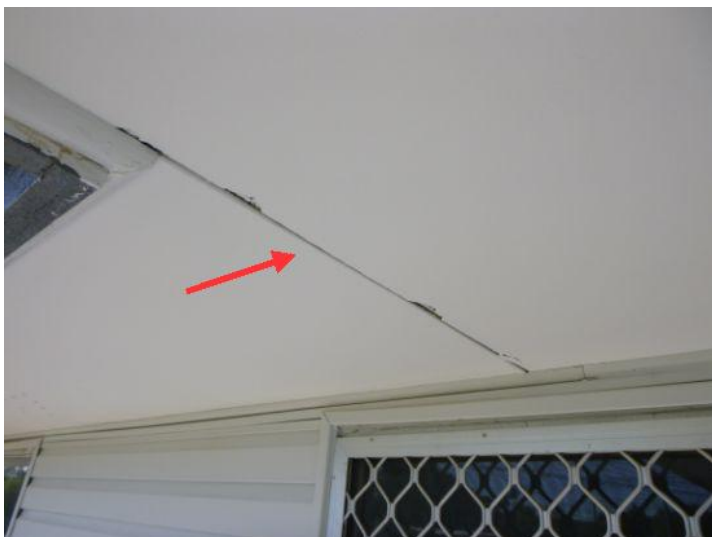
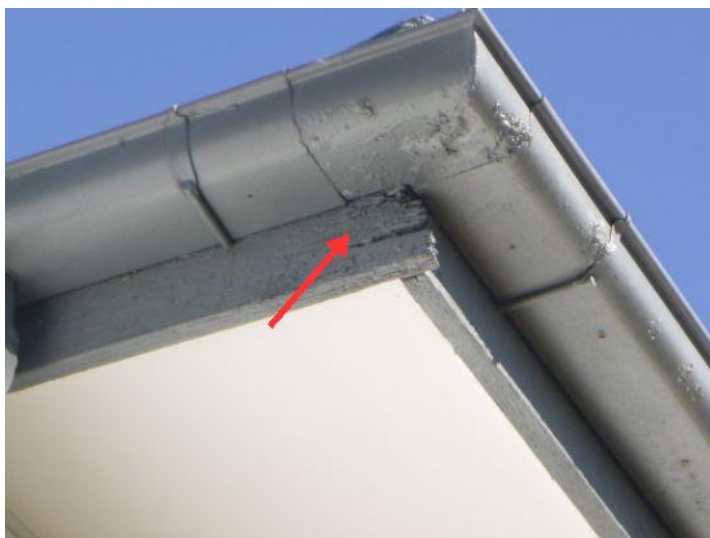
Northwest corner timber fascia

- There appears to be some asbestos eaves material on the property.
- The eaves are in satisfactory condition.
- Missing joint strip noted at the front entry.
- Fascia covering the ends of rafter or truss tails appeared to be in generally serviceable condition at the time of the inspection. Wood decay observe at the northwest corner fascia board.

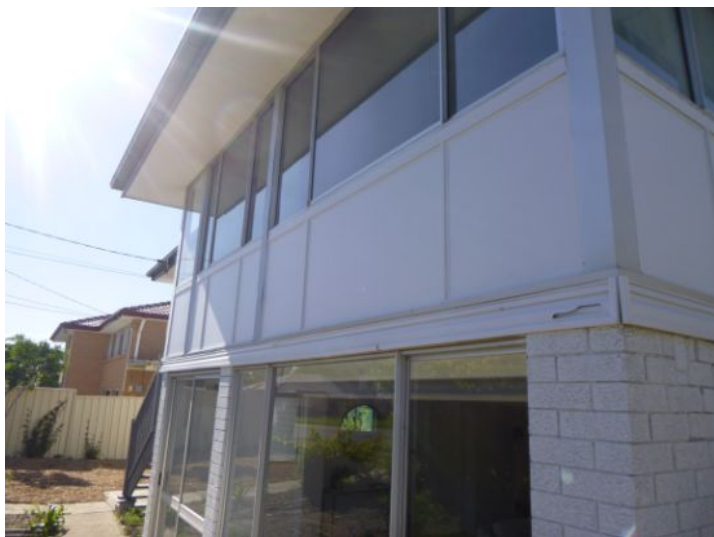
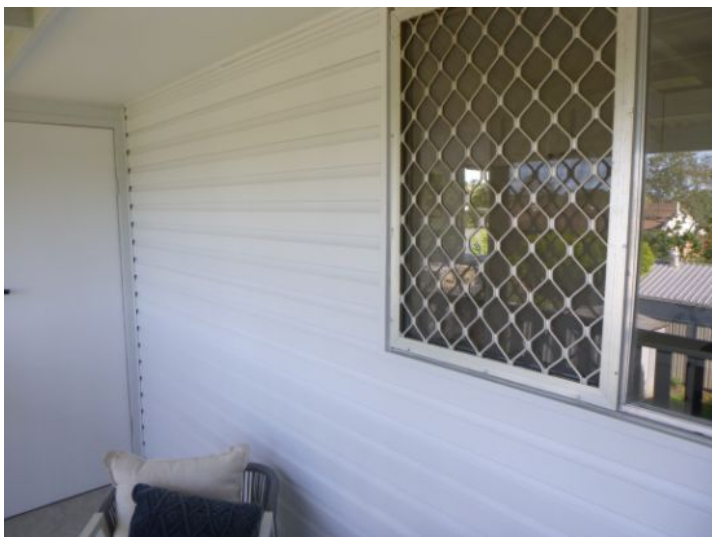
- External cladding appears to be in satisfactory condition relative to its age.
- Minor damage noted to the PVC cladding at the south side of the home.

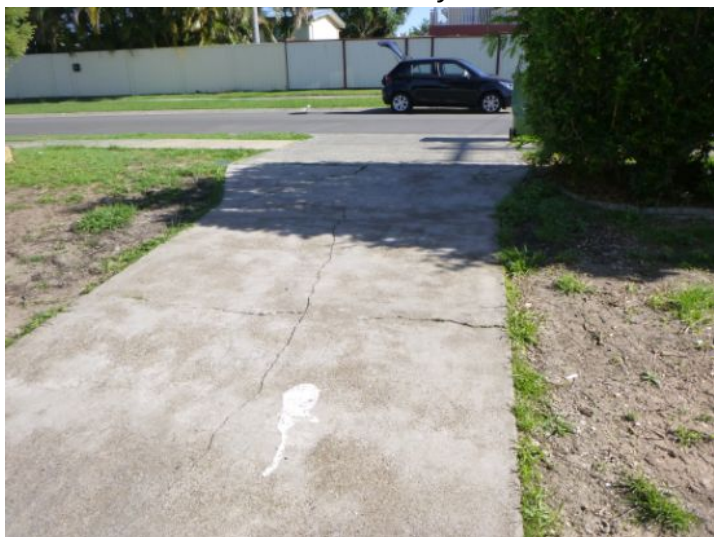
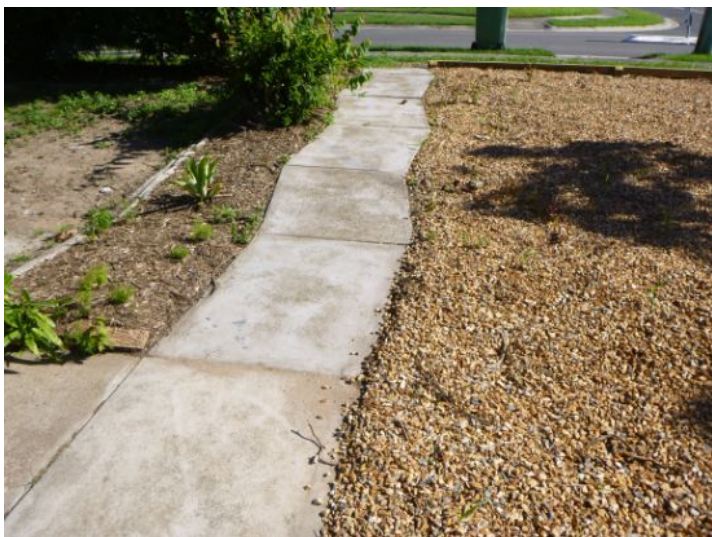
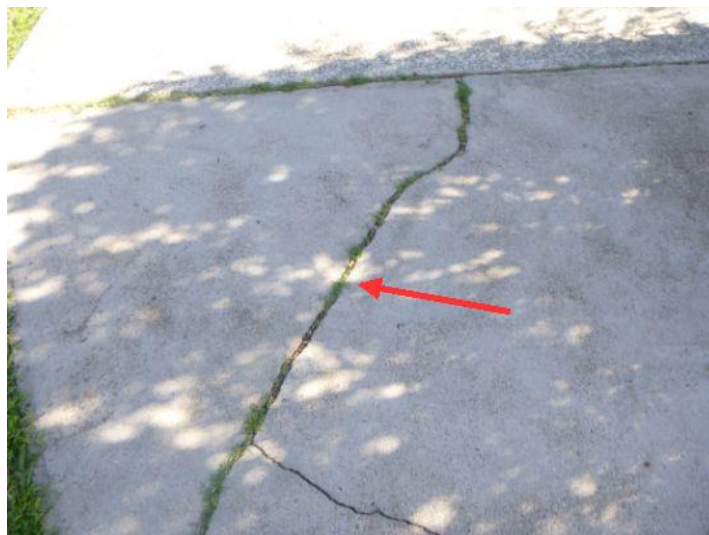
- Some areas of settlement and uplift were noted on the driveway. These areas do not appear to have affected the structural integrity of the home or the function of the driveway in any way and can be repaired/levelled normally.

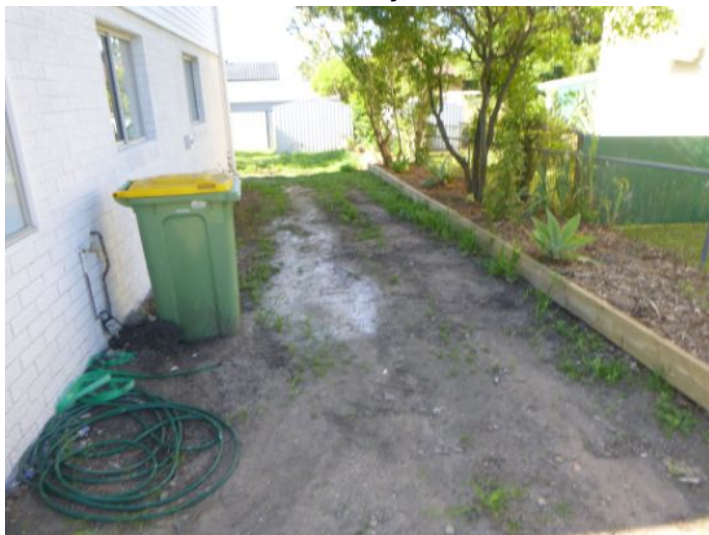
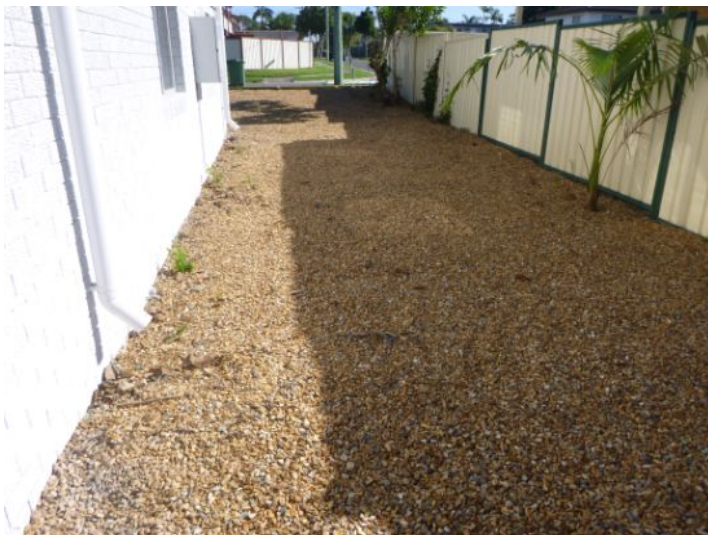
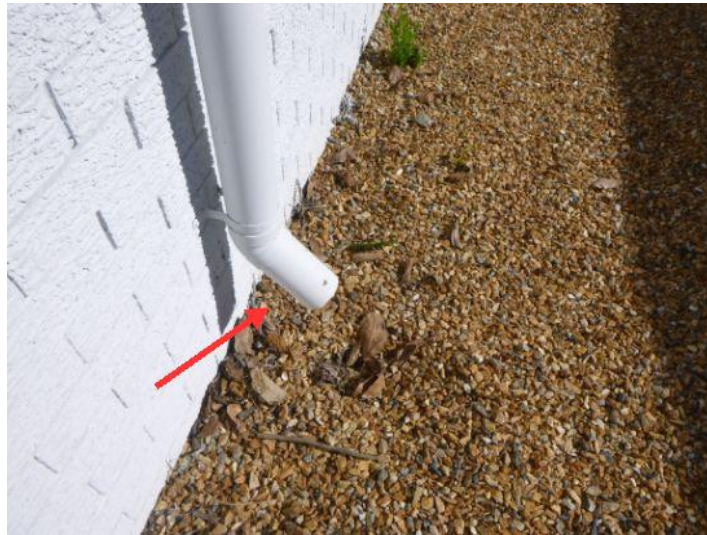
- Surface drainage conditions within 3 metres of the inspected structure appeared satisfactory.
- Some of the down pipes discharge adjacent to the external foundation wall. This may allow water to pool beside the walls and soak in adjacent to the structure. This can cause foundation settlement, dampness in external walls and can create an ideal environment for termites. It is recommended that the down pipes be connected to the storm water or directed at least 3 metres away from the external walls.

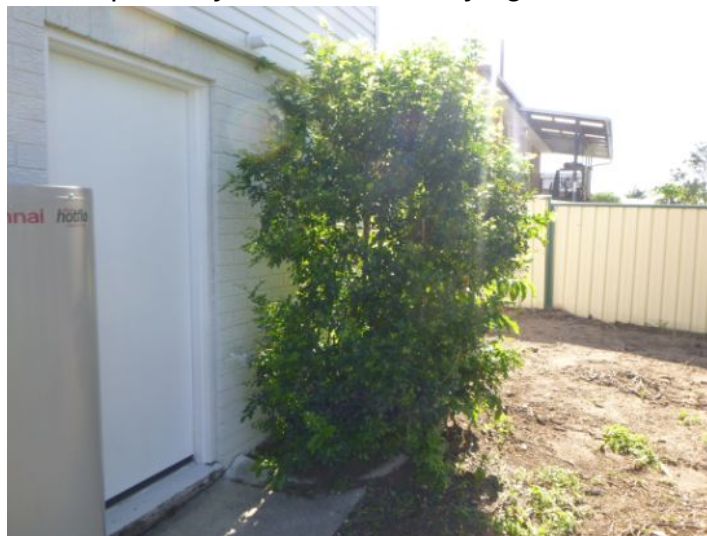
- Prune or remove any plants that are in contact or proximity to home to eliminate pathways of wood destroying insects.

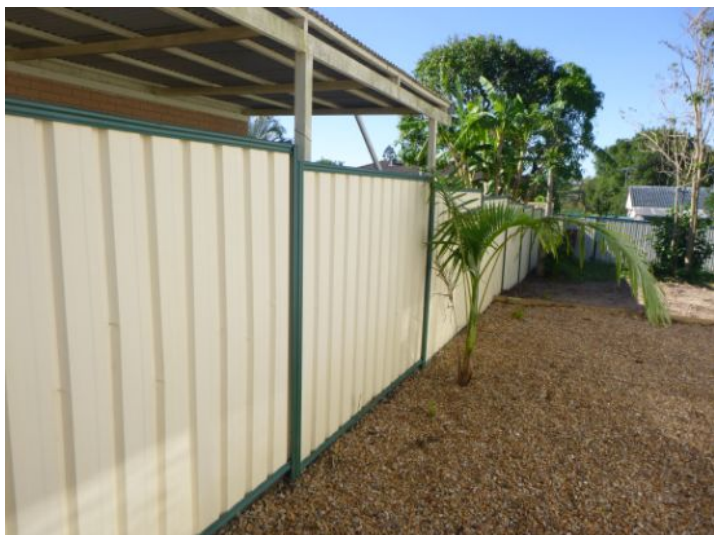
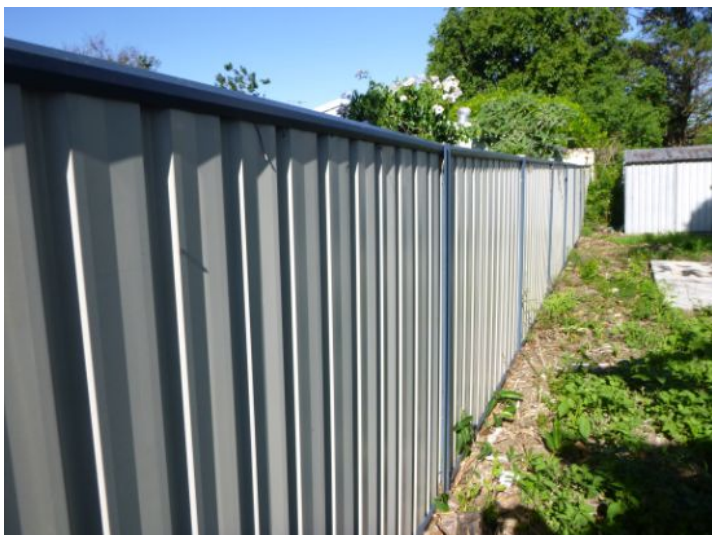
- Colourbond and metal/wire.
- Unless otherwise noted, the perimeter fence appeared functional at the time of the inspection.

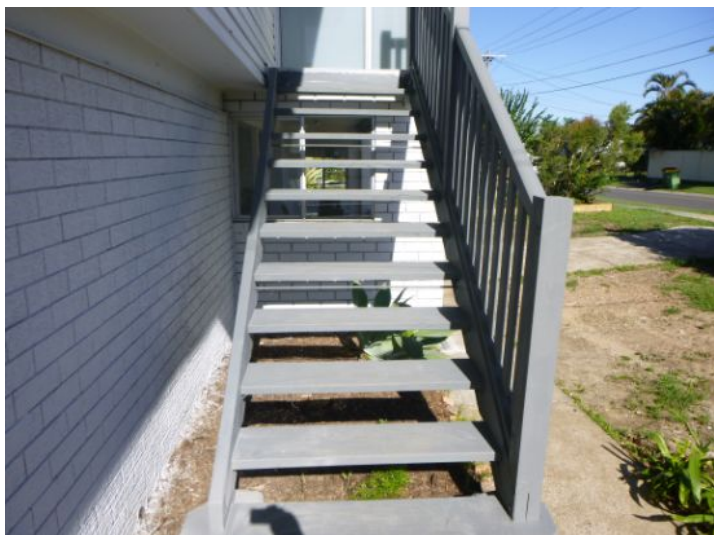
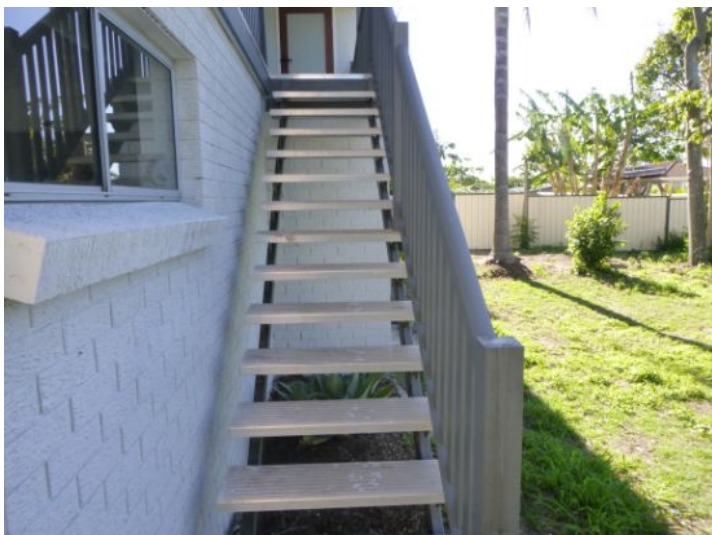
- Inspected stairs were in good condition at the time of the inspection.
