# Timber Pest Inspection Report

5 Woodrose Street,  
Kingston, 4114, QLD

Inspection Prepared for:  
Little Lachie Group Pty. Ltd.

Date of Inspection: 5/11/2025 | Time: 3:30 PM

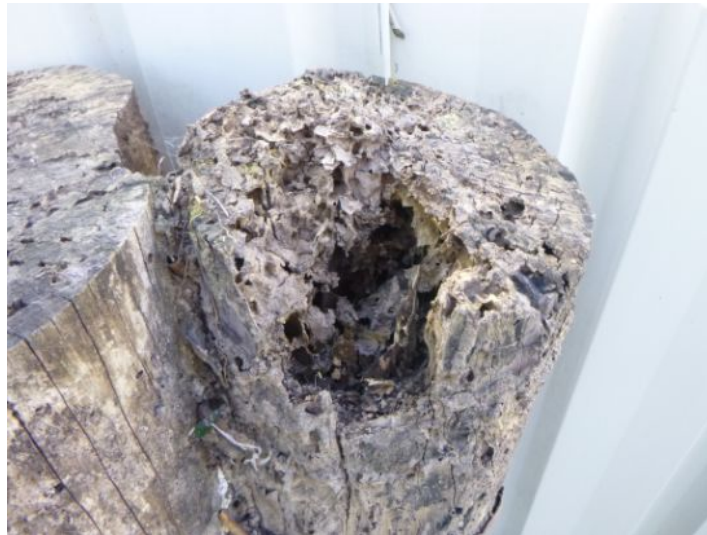
- There were no live termites found at the property inspected at the date and time of the inspection.
- Evidence of inactive termite damage and/or workings was detected in a timber stump at the northwest corner of the property.

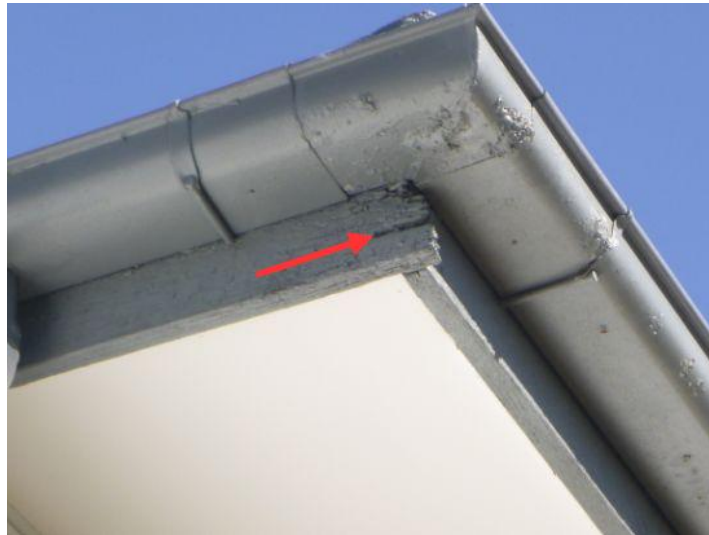
Northwest corner timber fascia

- Wood decay/fungus was detected in the northwest corner timber fascia board.
- Fungal decay damage appears to be localised.
- Timber condition is decayed but sealed.

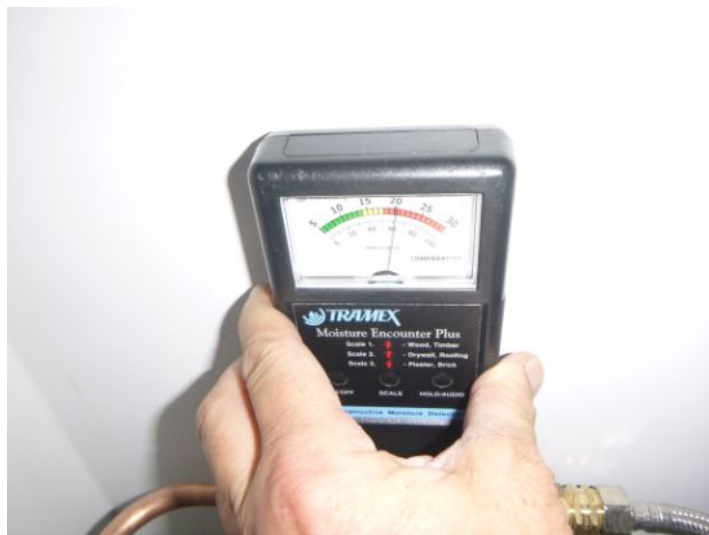
Observations: Excessive moisture conditions were present during the inspection.

A moisture meter confirmed the presence of excessive moisture in the sub-floor walls at the entry and bathroom areas.

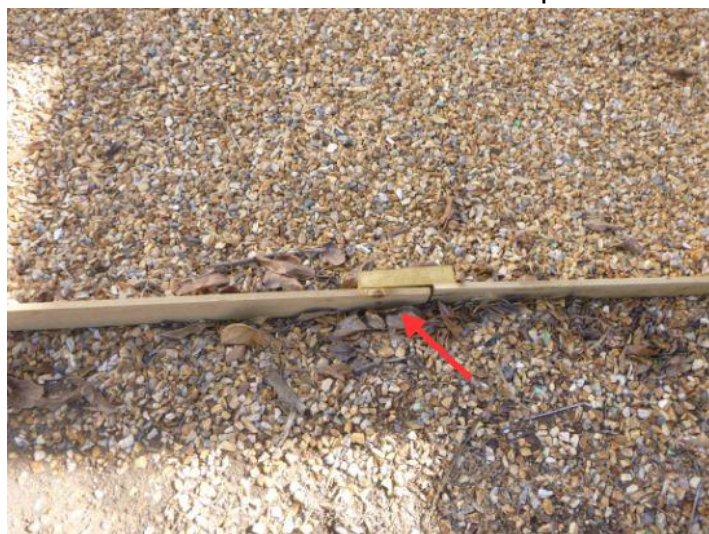
There are landscaping/stored timbers on the grounds, which may be a termite risk.

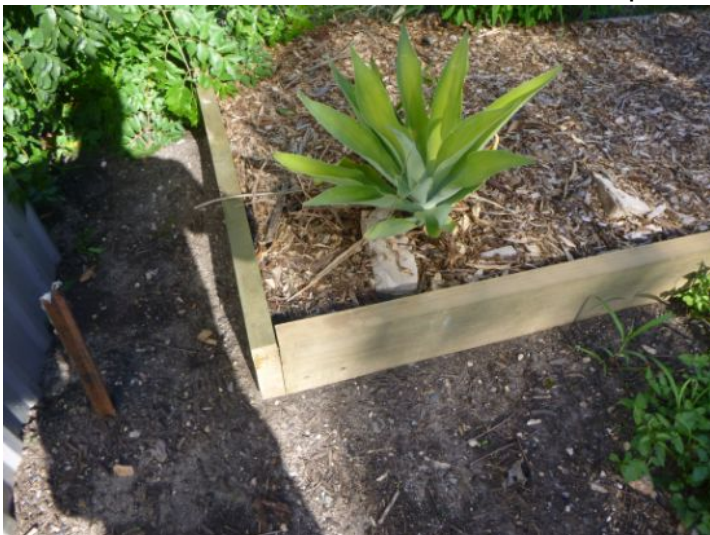
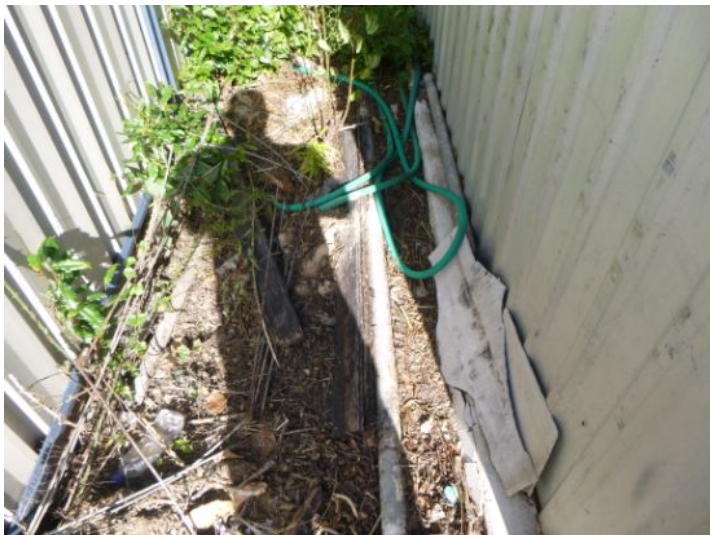
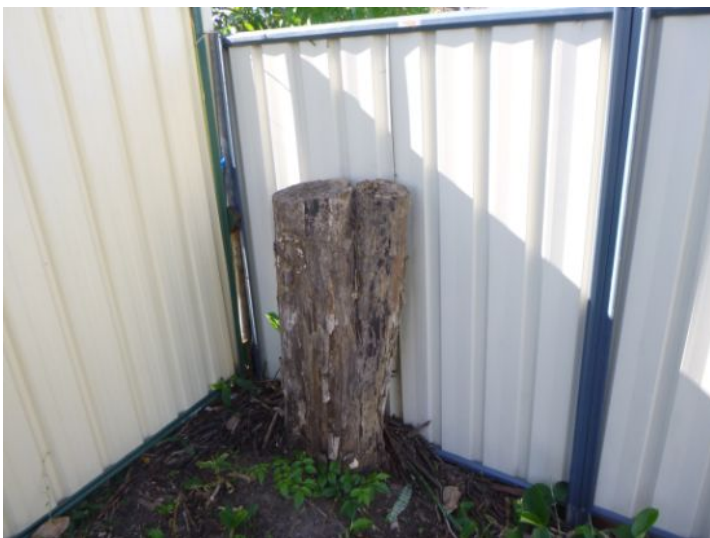
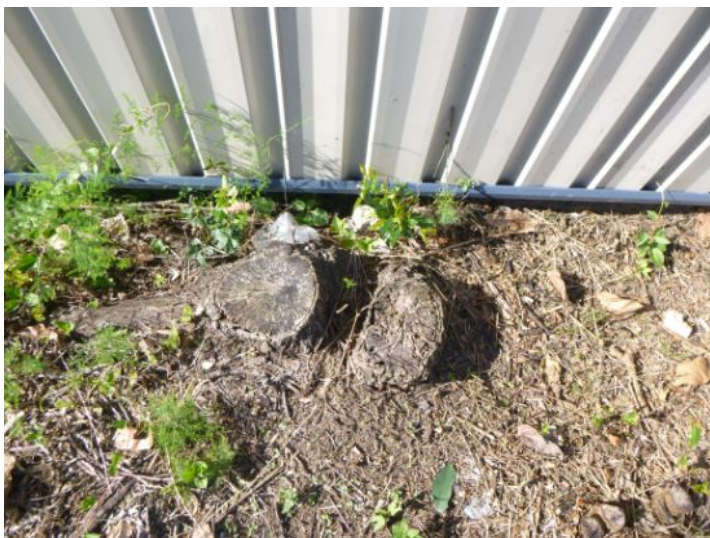
- There is landscaping/stored timber, or old tree stumps in contact with the ground that provides possible breeding grounds for subterranean termites. These should be removed.
- There is timber landscaping materials used on the property or against the edge of the home, which could attract termites or provide possible entry points for termites into the home. These should be removed or replaced with a material less susceptible to termite attack.

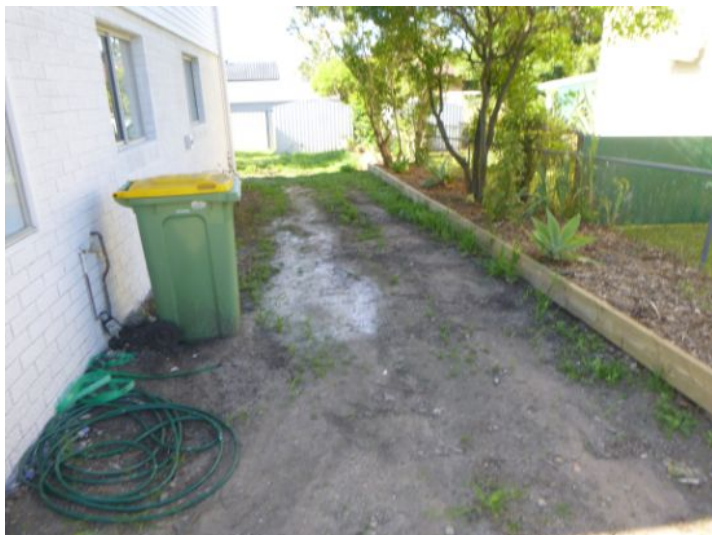
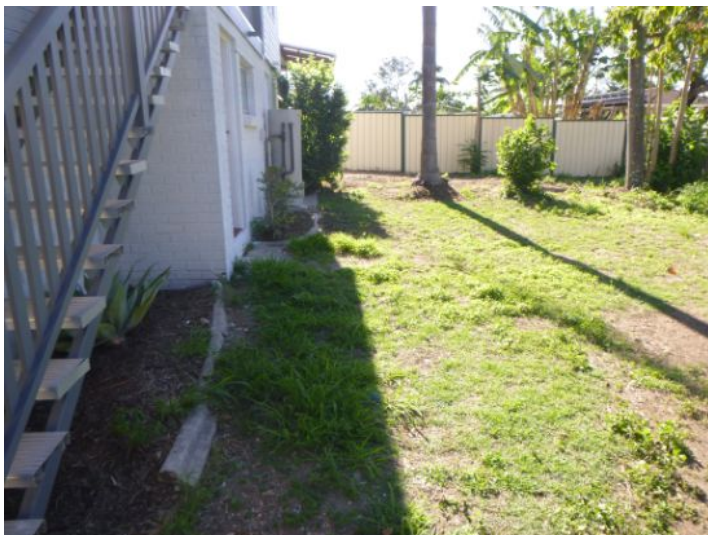
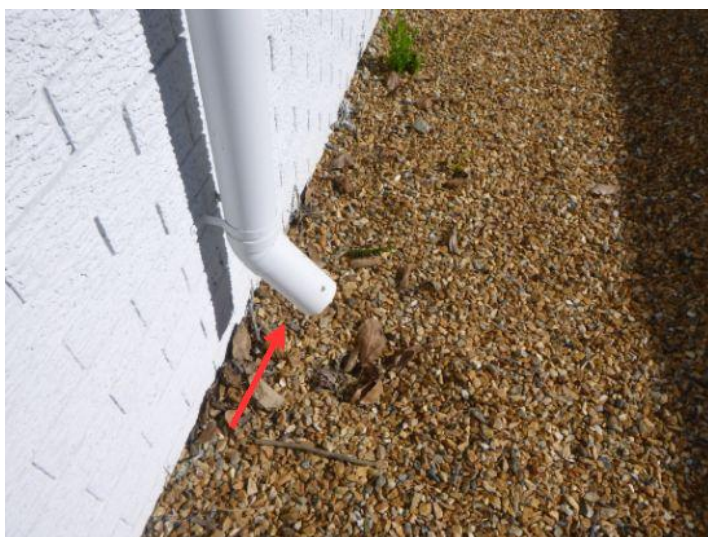
- It is important to redirect moisture away from the property to limit areas of excess moisture. Faulty gutters and downpipes in poor condition can cause water to seep into the foundations, causing conditions conducive to termites and fungal decay.
- Surface drainage conditions within 3 metres of the inspected structure appeared satisfactory.
- Some of the down pipes are not plumbed into the storm water. This allows water discharged to possibly pool beside the external foundation walls and soak in adjacent to the structure. This can cause foundation settlement, dampness in external walls and can create an ideal environment for termites. It is recommended that all down pipes should be plumbed into the storm water.

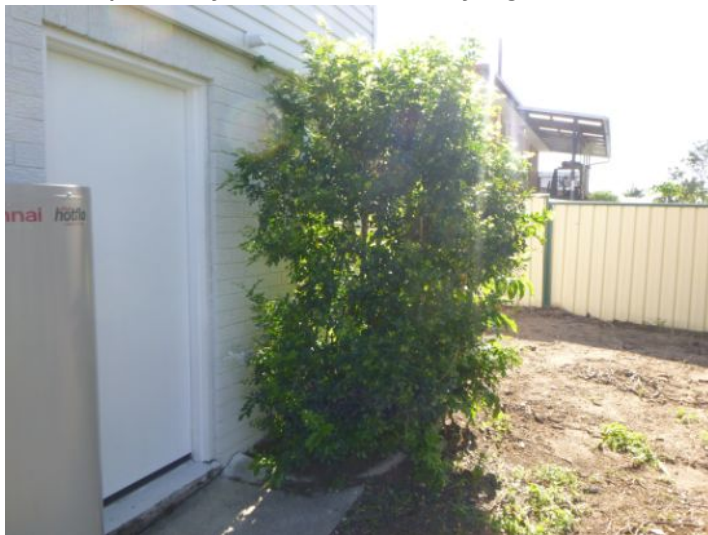
- Prune or remove any plants that are in contact or proximity to home to eliminate pathways of wood destroying insects.
