# Visual Timber Pest Inspection and Report in Accordance with AS 4349.3-2010

143 Bush Tucker Road, Berrinba

| Type of inspection: | Timber Pest Inspection AS 4349.3-2010 |

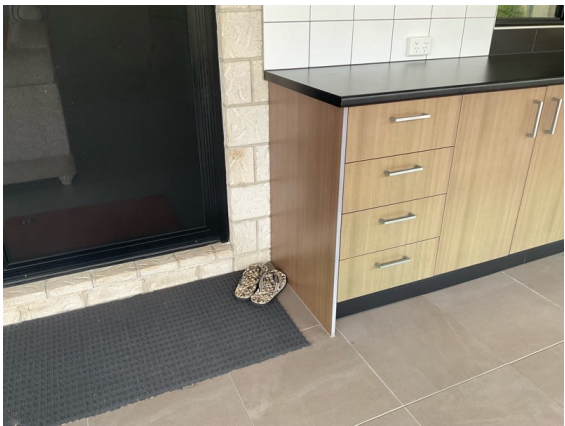
Outdoor kitchen conceals the physical termite management system in the rear patio. Recommend consulting the installers for information on what system they have installed in this area.

External kitchen conceals the physical termite management system in the rear patio

No. External kitchen

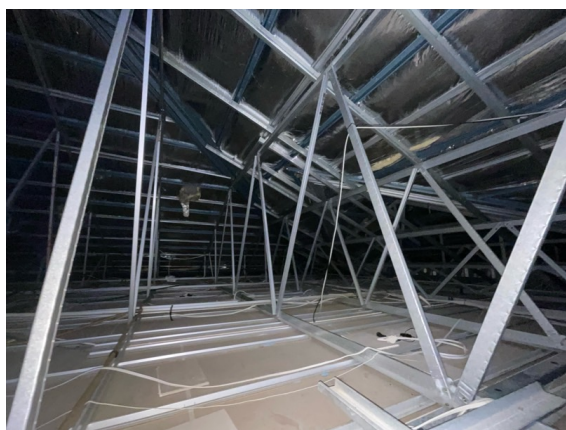
Insulation blanket in the roof void which restricts the inspection process in this area. Steel frame home

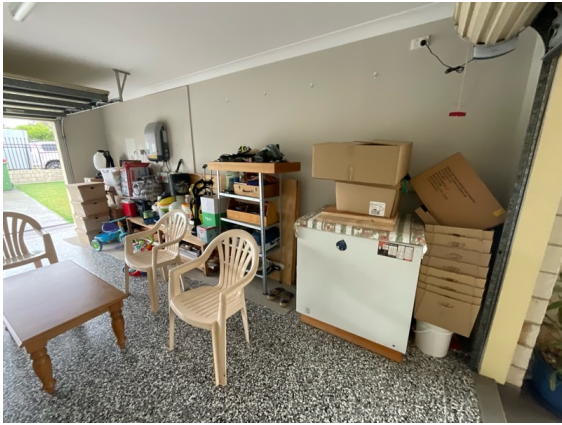
Stored items in the garage which restricts the inspection process in this area.

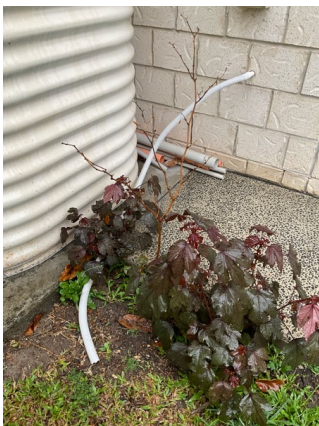
A/C runoff not to drain, recommend repairs.

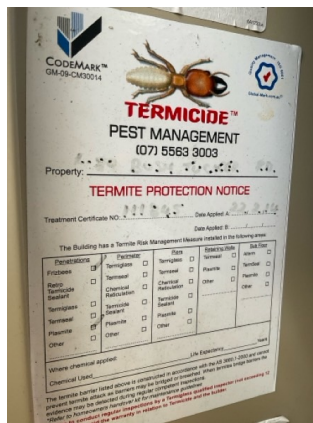
**Image of Termite Management Sticker**

Pre-Construction

A termite management system has been installed by another company. It is recommended you consult that company for full details of the system installed.
