## **Pre-Purchase Standard Property Inspection Report**

**143 BUSH TUCKER ROAD  
BERRINBA 4117**

| Report number: | 23915 |
| Date of inspection: | 28 Oct 2025 |

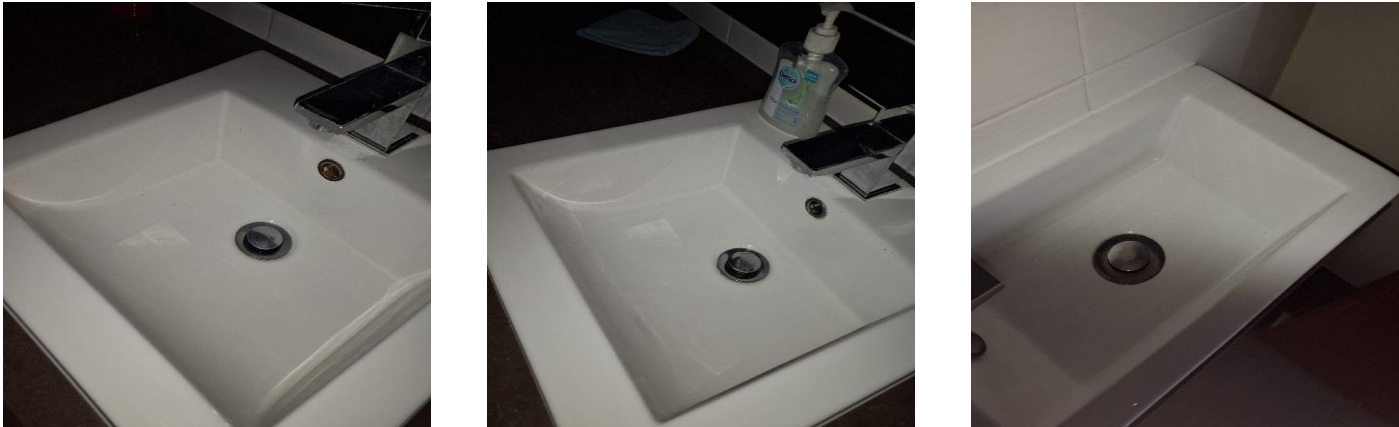
| D7 Bathroom fittings: | <p>No evidence of Major Defects was found.</p> <p>The pop-up waste plugs in the vanity bowls are quite sticky, very common. .</p> <p><b>I recommend that they be removed / cleaned and reinserted.</b></p> |

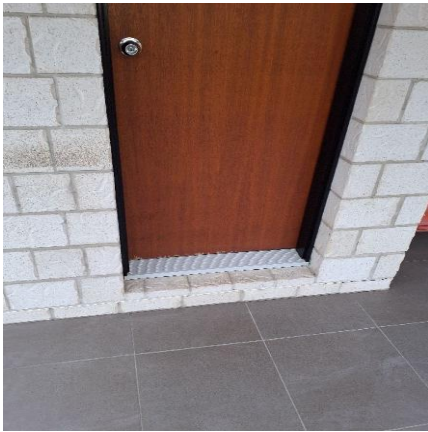
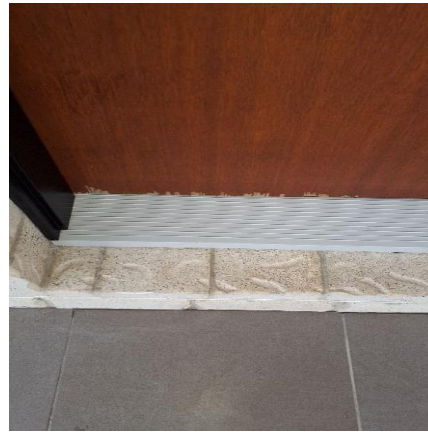
| D13 External doors:<br>(including patio doors) | <p>No evidence of Major Defects was found.</p> <p>I noted minor damage on the bottom edge of the external toilet door.</p> <p><b>I recommend some general patching and repainting.</b></p> |

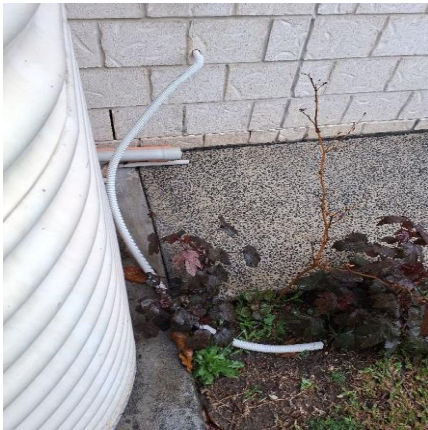
| D15 Other external primary elements | <p>No evidence of Major Defects was found.</p> <p>The air conditioners condensation pipe discharges under the ground .</p> <p><b>I recommend that it'd be diverted to the nearest drain because wet areas May attract termites.</b></p> |
