## BUILDING AND TIMBER PEST REPORT

2 Pipit Cl  
Mango Hill, QLD 4509

BYB  
12/08/2025

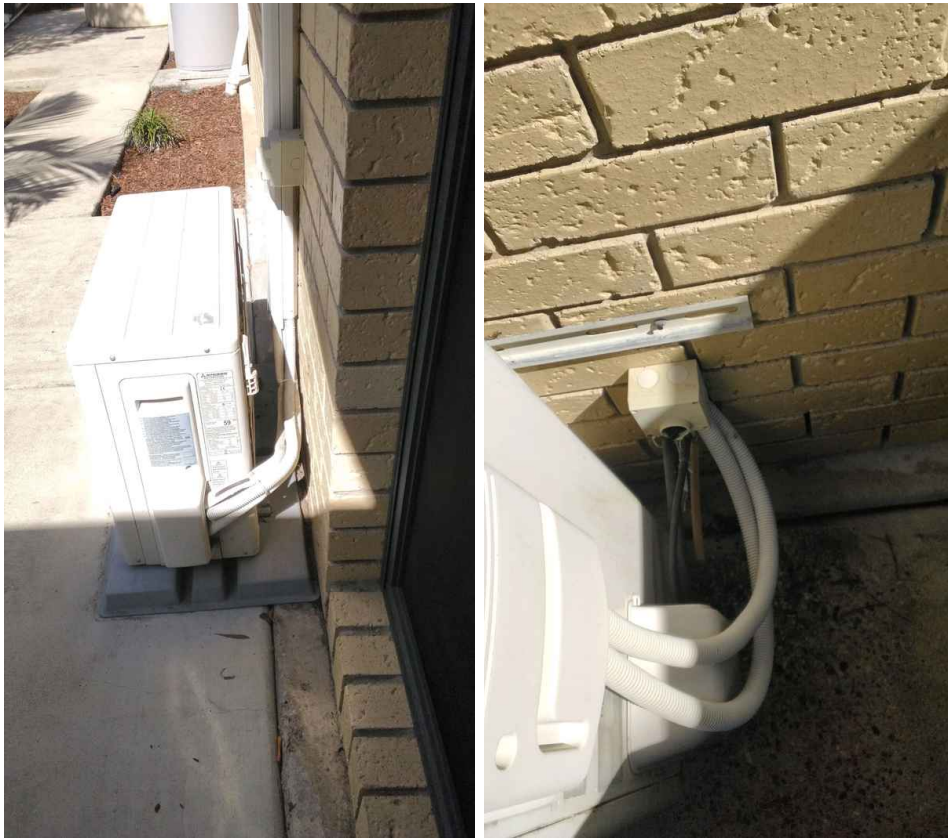
## 6.3.1 Air Conditioning

**PIPE INSULATION DETERIORATED/DAMAGED**

Further evaluation and corrections recommended

Minor-Moderate Attention Recommended

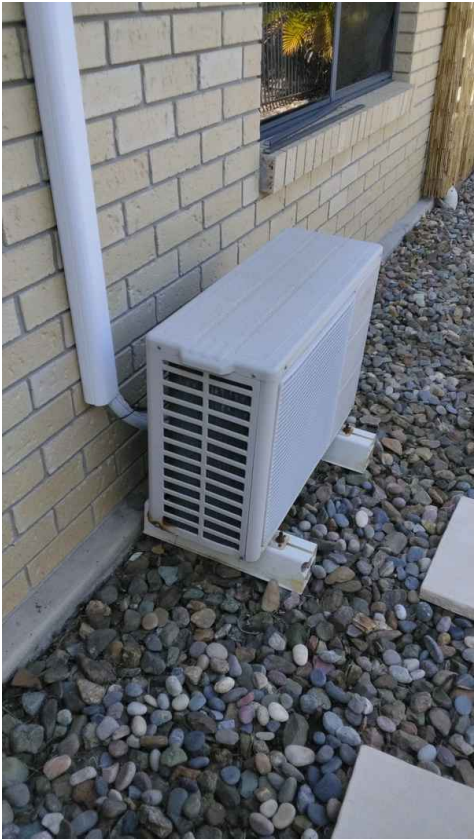
6.3.2 Air Conditioning

MINOR CORROSION

Monitoring and maintenance recommended

Contact a qualified HVAC professional.

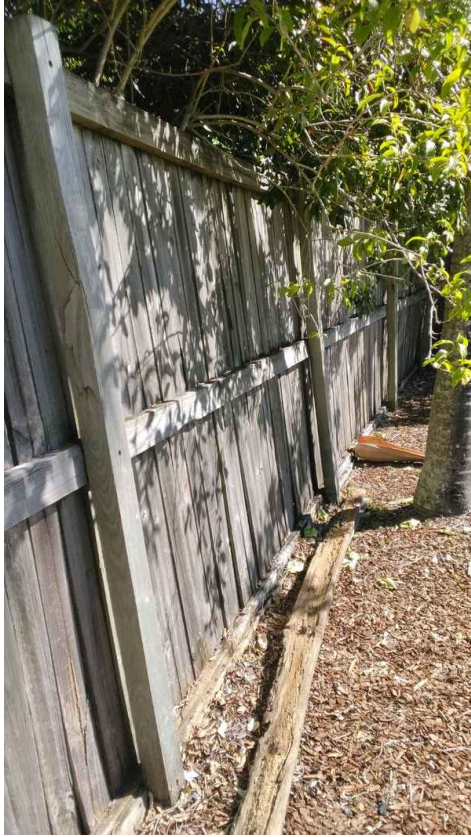
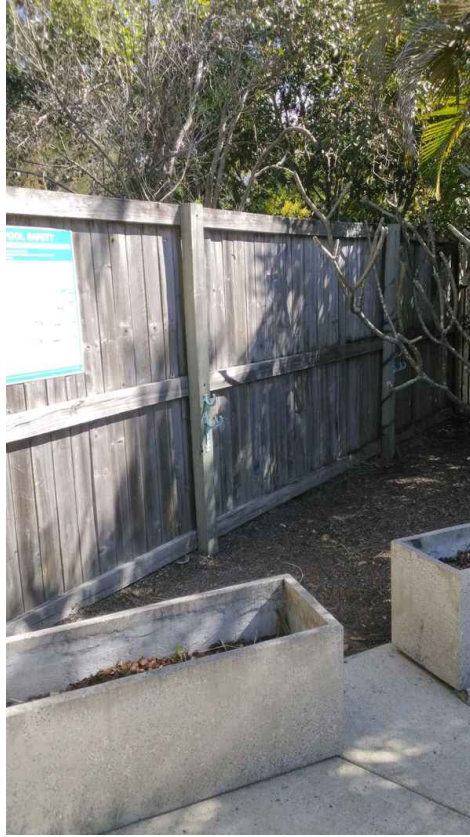
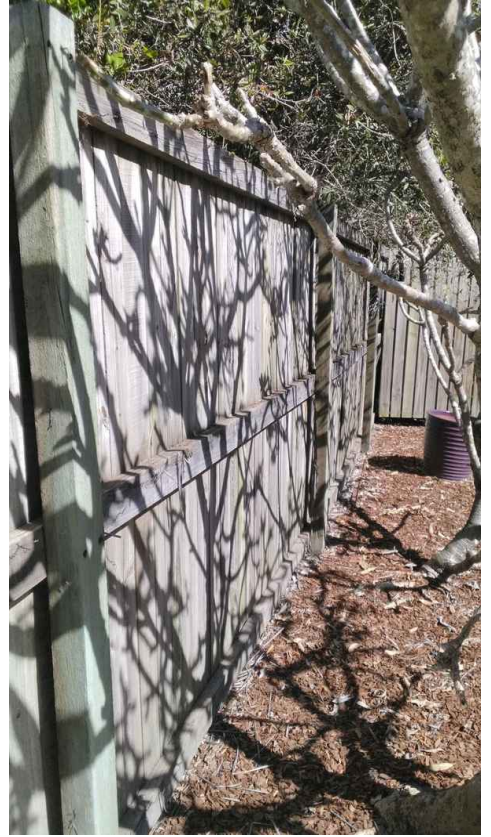
Fence leaning in areas. A qualified contractor should evaluate and make repairs or replace sections as necessary.

Minor-Moderate Attention Recommended

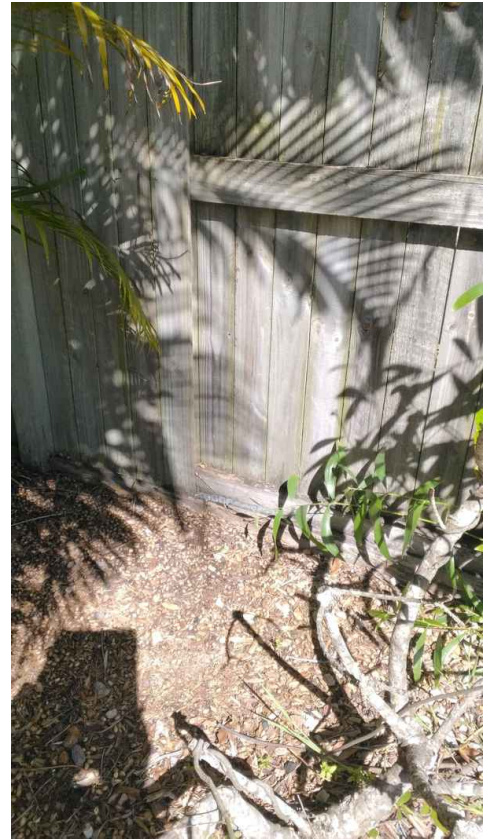
**TERMITE DAMAGE**

There is damage consistent with termite attack to visible accessible timbers. Replacement of damaged timbers is recommended. Refer to the Timber Pest report.

Contact a qualified professional.

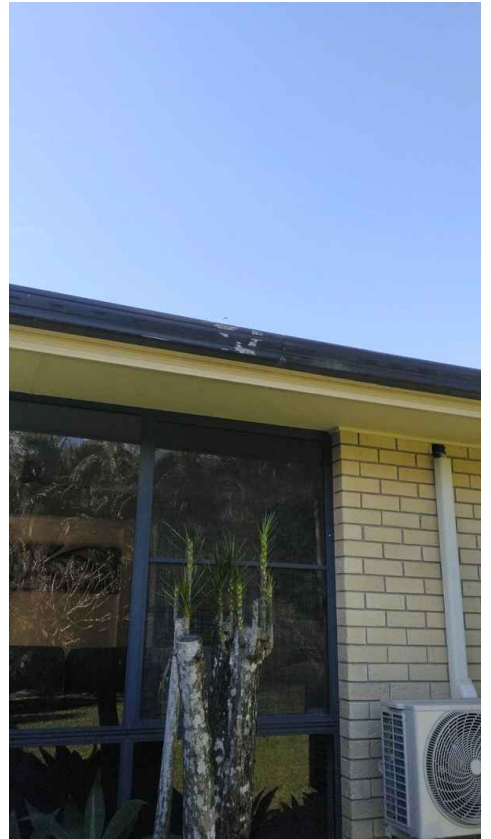
Blockages to stormwater flow can lead to overflow and water ingress. Further evaluation and correction recommended

Contact a handyman or DIY project

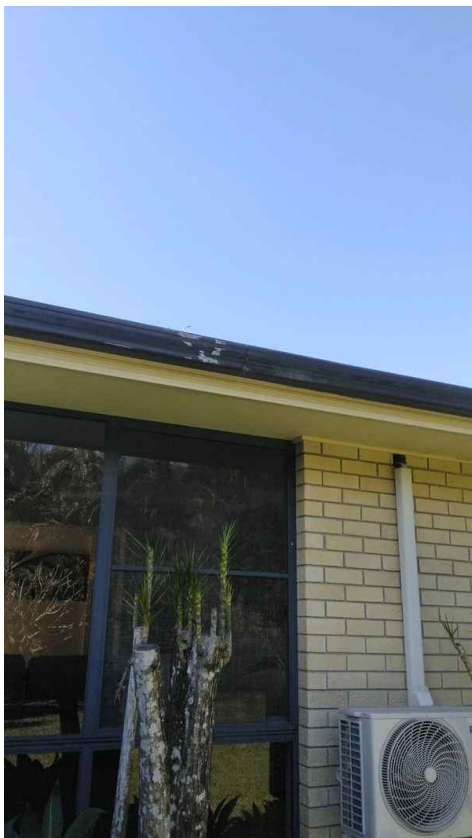
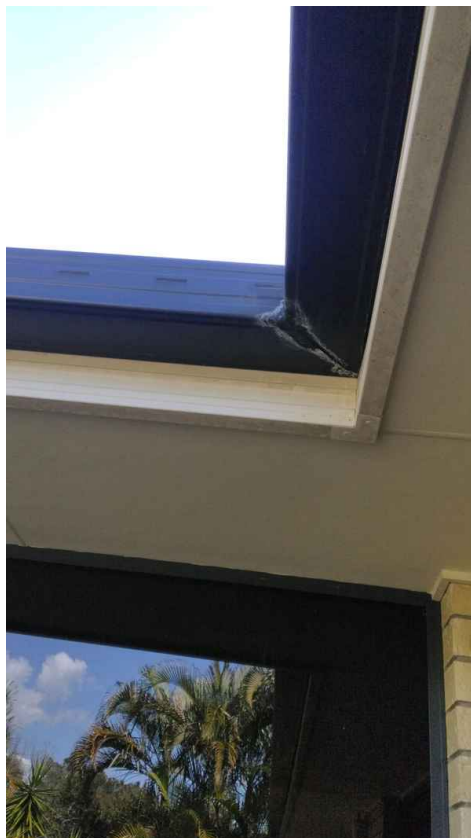
## 11.3.2 Roof Drainage Systems

**LEAKING AT JOINTS**

Maintenance recommended.

Minor-Moderate Attention Recommended

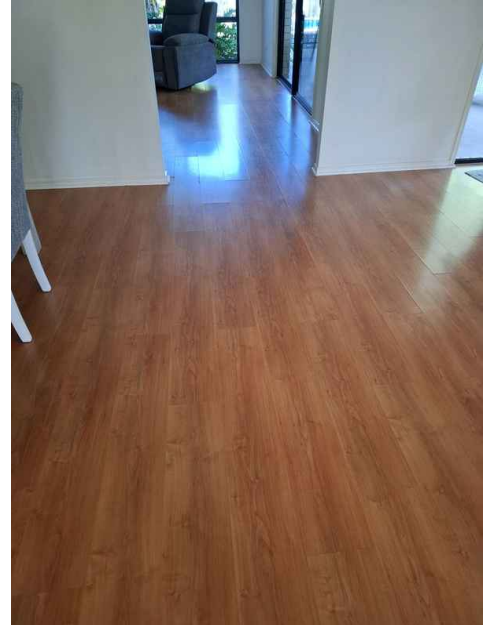
#### **MINOR FLOOR TILE DAMAGE - APPEARANCE**

The tiles had minor floor tile damage/cracks visible at the time of the inspection. This is an appearance defect. Further evaluation and correction recommended.

Contact a qualified professional.

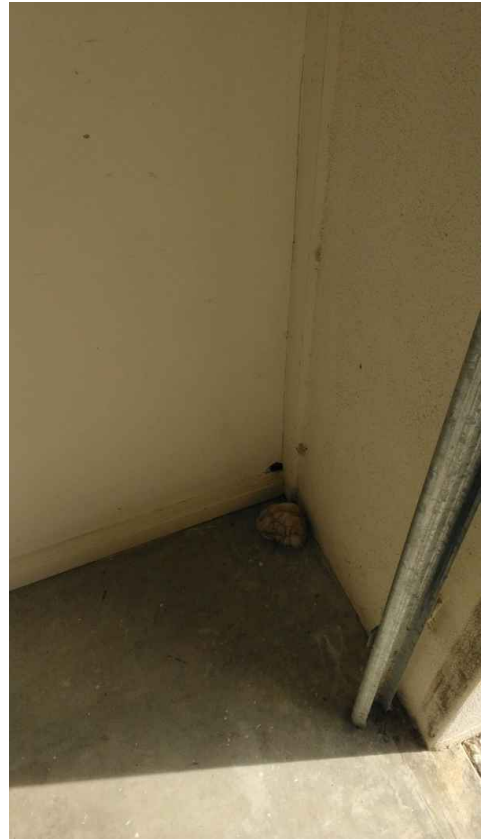
**IMPACT DAMAGE**

Minor-Moderate Attention Recommended

Further evaluation and correction recommended

Contact a qualified professional.

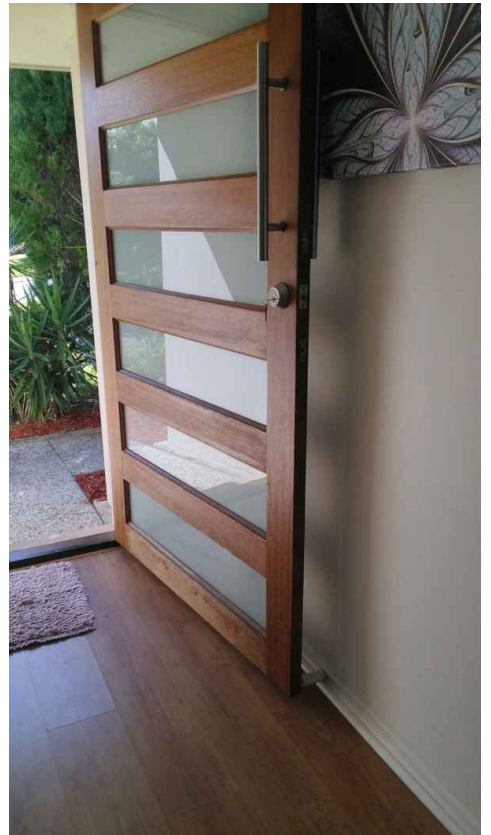
## 14.6.1 Doors

**BINDING/RUBBING**

Minor-Moderate Attention Recommended

Further evaluation and correction recommended.

Contact a qualified professional.

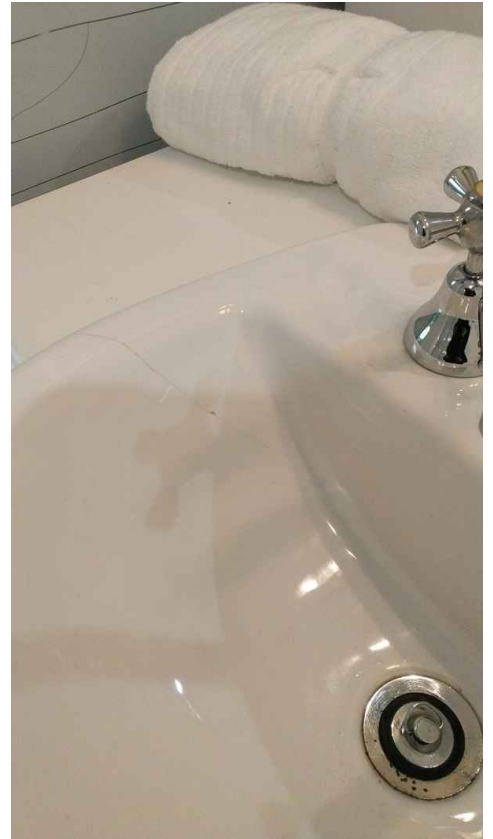
## 16.1.1 General

**DAMAGED  
FIXTURES AND FITTINGS**

Further evaluation and correction recommended

Minor-Moderate Attention Recommended

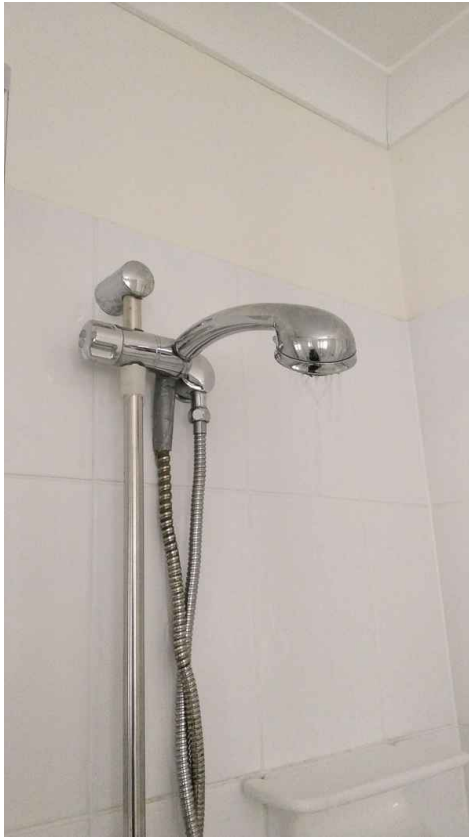
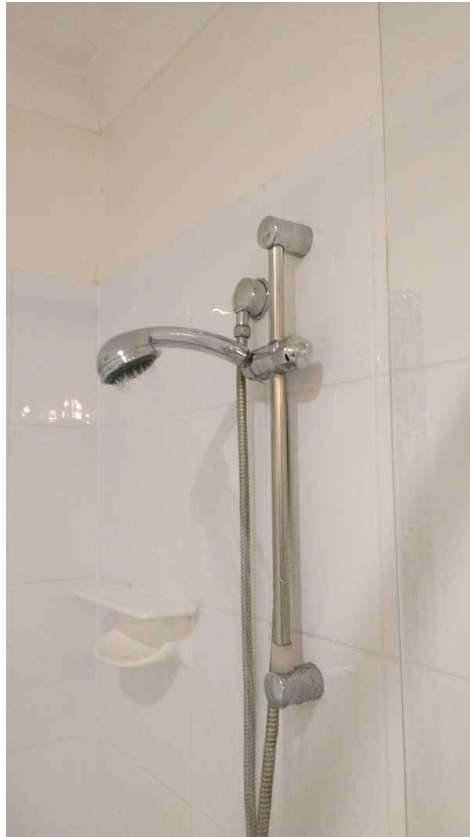
## 16.2.1 Shower

**SHOWER HEAD/HOSE LEAKING**

The shower head/ hose is leaking. This is may due to deterioration. It may simply require a new seal or tightening. Replacement is relatively inexpensive.

Minor-Moderate Attention Recommended

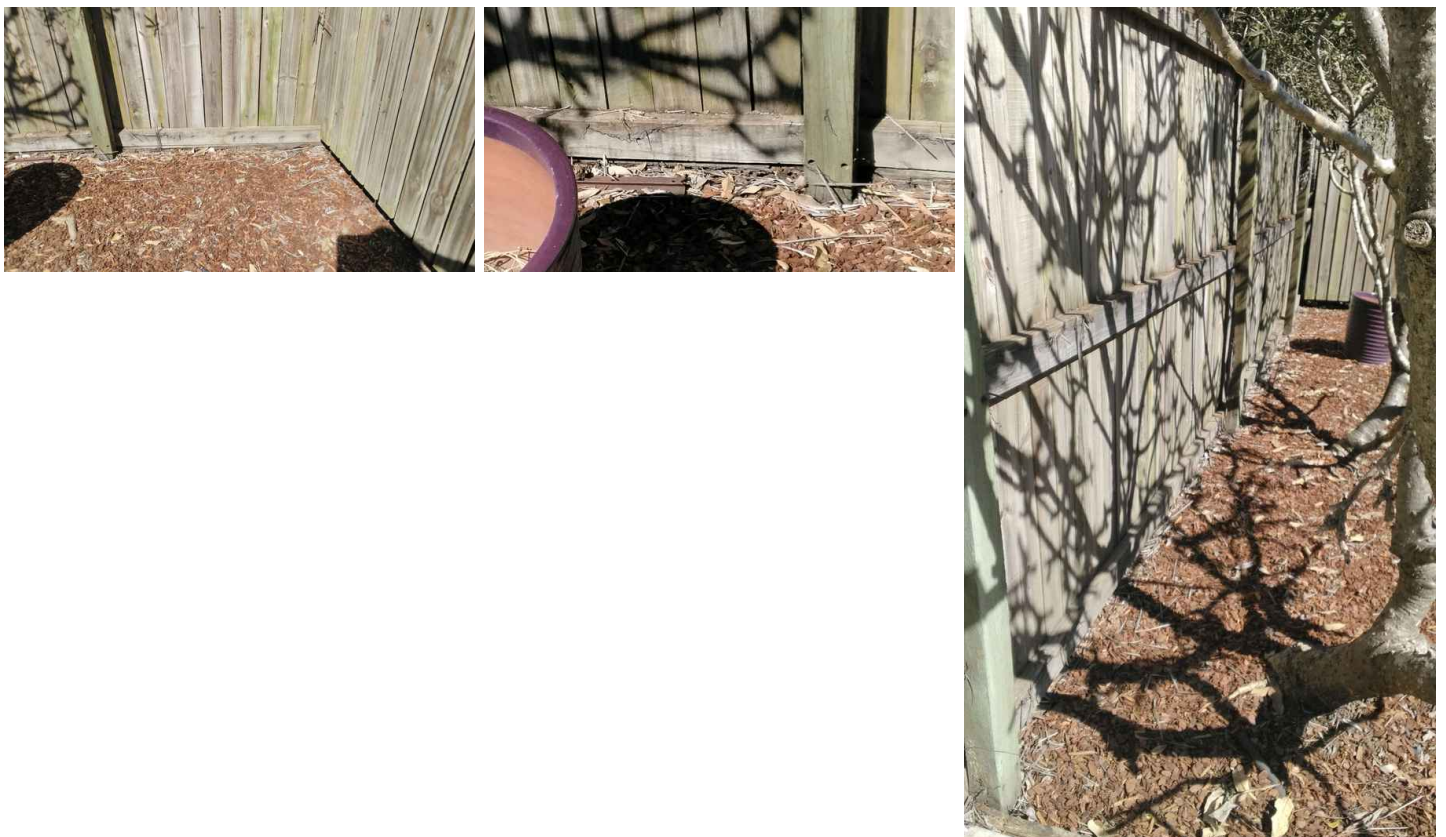
20.5.1 Termite Workings or Damage

### **TERMITE DAMAGE OR WORKINGS FOUND**

Observations consistent with subterranean termite workings such as mud packing and/or damage was found at the time of the inspection

Where visual evidence of termite workings and/or damage is reported above, but no live termites were present at the time of inspection, it is possible that termites are still active in the immediate vicinity and the termites may continue to cause further damage. It is not possible, without the benefit of further investigation and a number of inspections over a period of time, to ascertain whether any infestation is active or inactive. Active termites may simply have not been present at the time of the inspection due to a prior disturbance, climatic conditions, or they may have been utilising an alternative feeding source. Invasive inspections are recommended to determine the full extent of damage. Continued, regular, inspections are essential. Unless written evidence of a termite protection program in accord with "Australian Standard 3660" with ongoing inspections is provided, arrange for a treatment in accord with "Australian Standard 3660" to be carried out to reduce the risk of further attack

Contact a qualified pest control specialist.

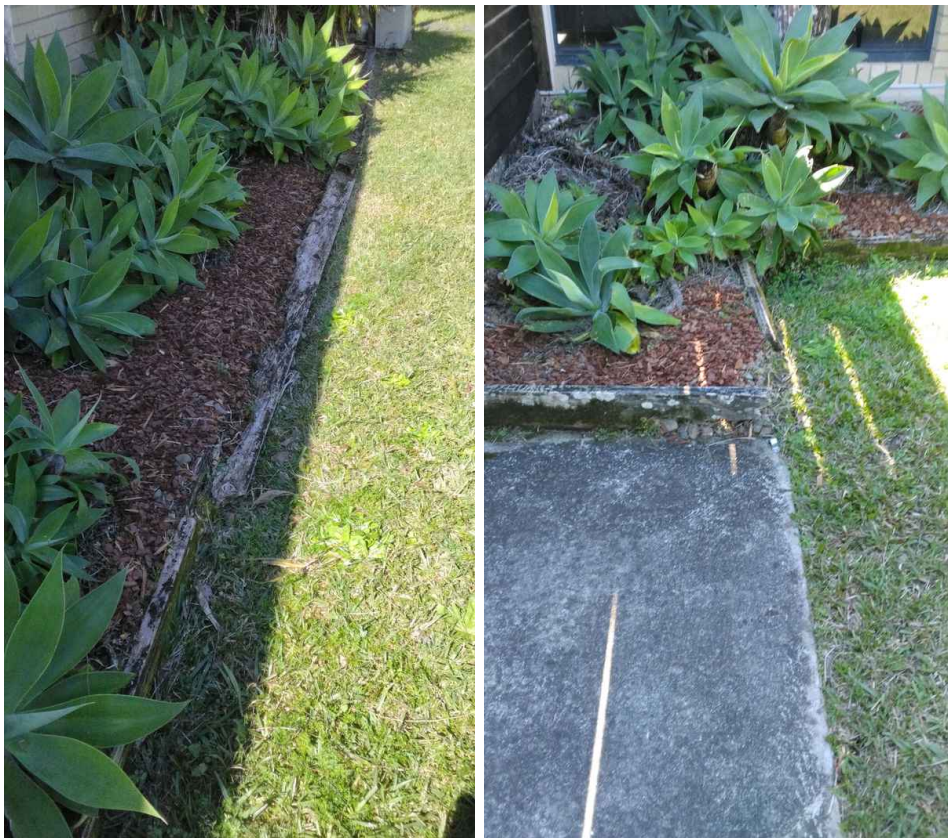
## 20.8.1 Fungal Decay (Wood Rot)

**ADVANCED DECAY**

Further evaluation and correction recommended

Contact your builder.

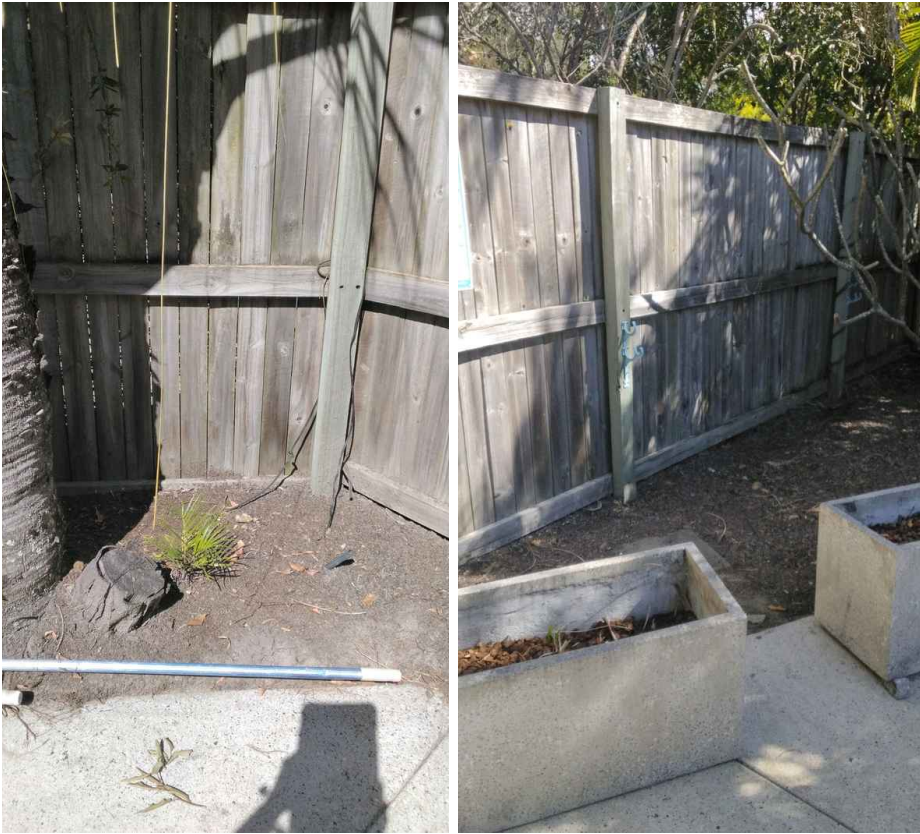
Timber in contact with the ground and or soil will shorten the life of a fence

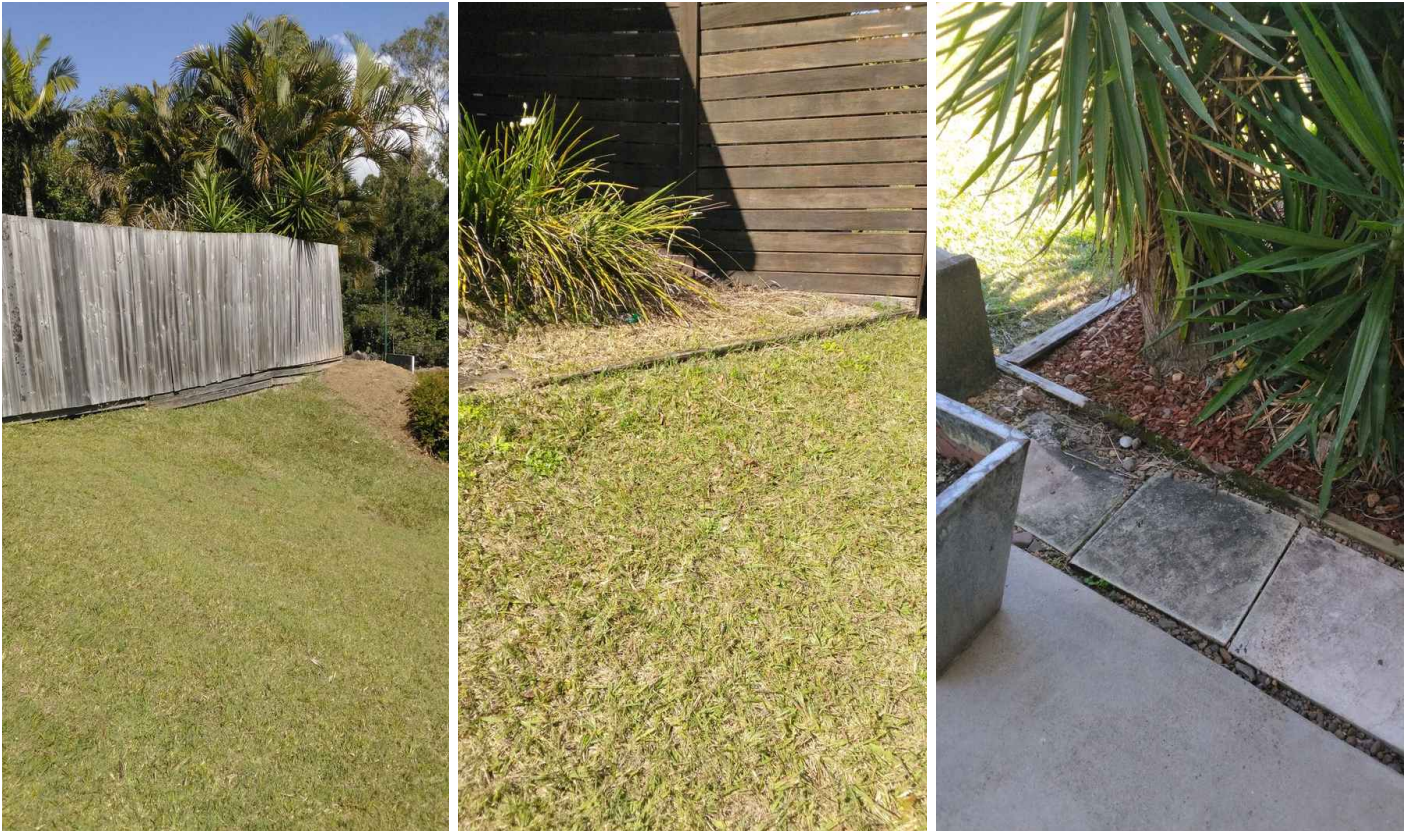
### Site and Exterior: Landscaping Timbers

Timber in direct contact with the ground and or soil produces are ready food source for termites. Susceptible Timbers used in a hazardous environment are prone to fungal decay. It is recommended that you remove this condition order to prevent timber pest activity.

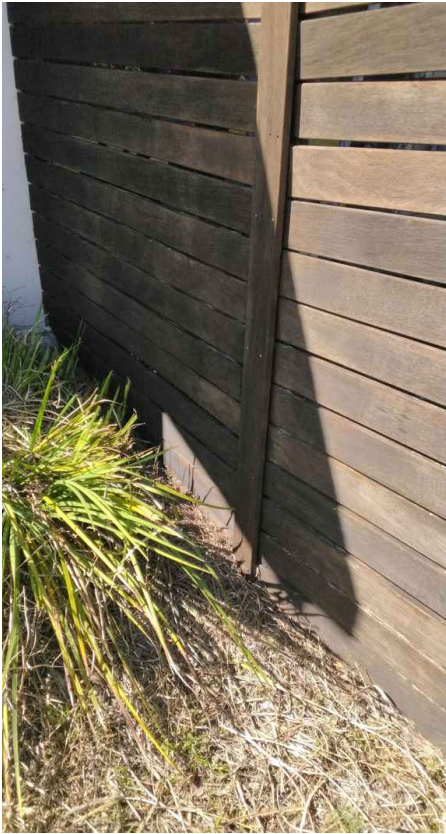
### Site and Exterior: Timber in ground contact

Timber in contact with the ground will raise the moisture content of timber creating conditions conducive to fungal decay. Action is required to remove this condition in order to prevent timber pest activity and structural damage occurring.

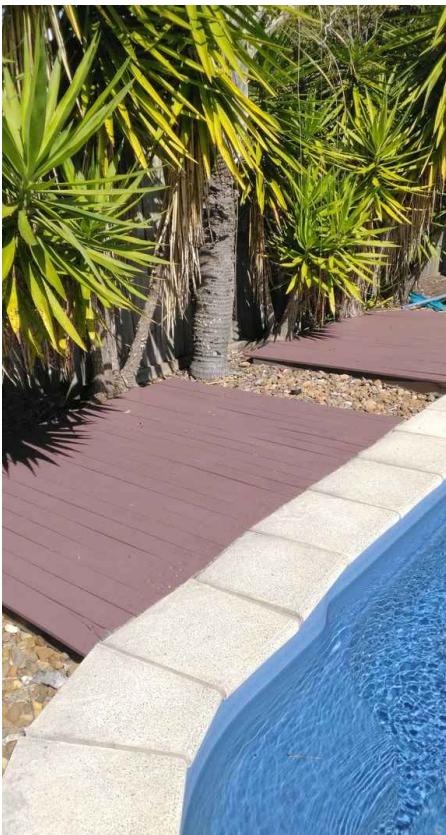
### Site and Exterior: Deck in contact with the ground

Timber deck close to ground The long term performance of timber decking in weather exposed situations is dependant on regular and effective maintenance. The frequency of maintenance will depend on the type of finish and the degree of exposure to the weather.
