# Inspection Report

**Inspectrite Australia Pty Ltd**

**4/7 Justine Parade, Rutherford, NSW, 2320**

### Pest And Building Inspection

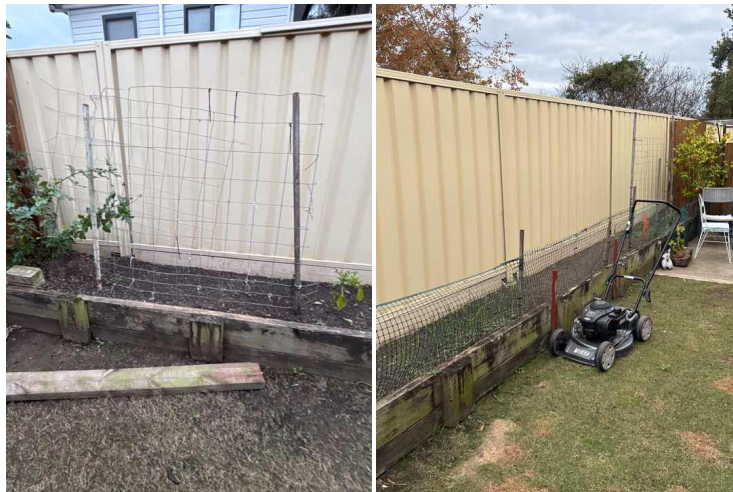
Deterioration was observed in retaining walls. Recommend a suitably qualified landscaping contractor or tradesperson is engaged for repairs and recommendations. Note: Retaining walls 1m higher or higher, or within a zone of influence should be engineered.

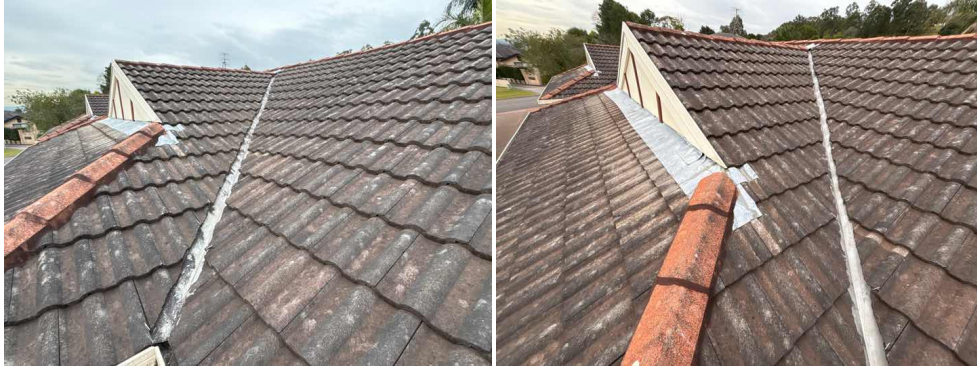
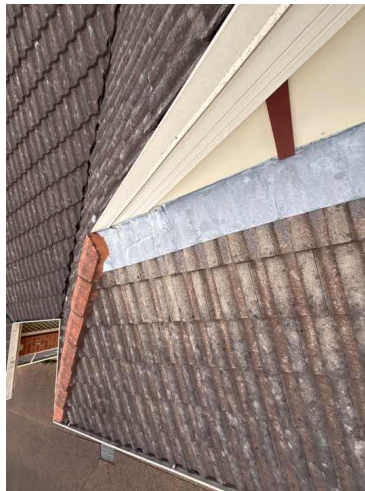
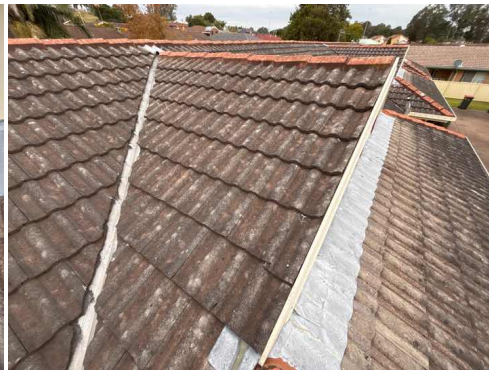
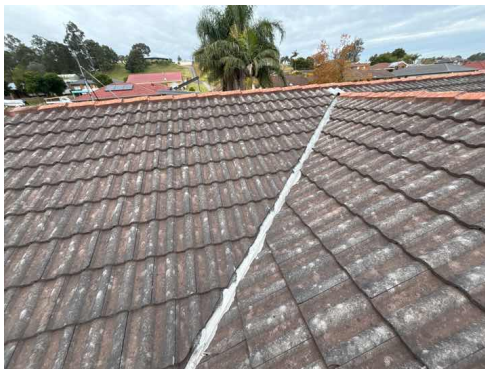
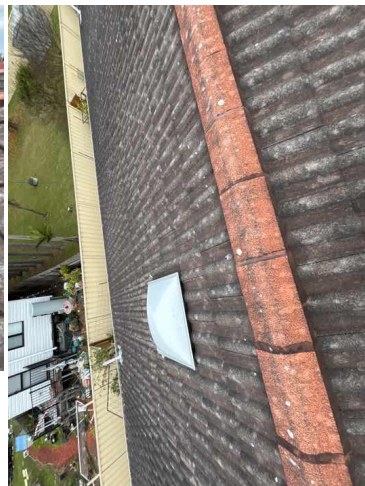
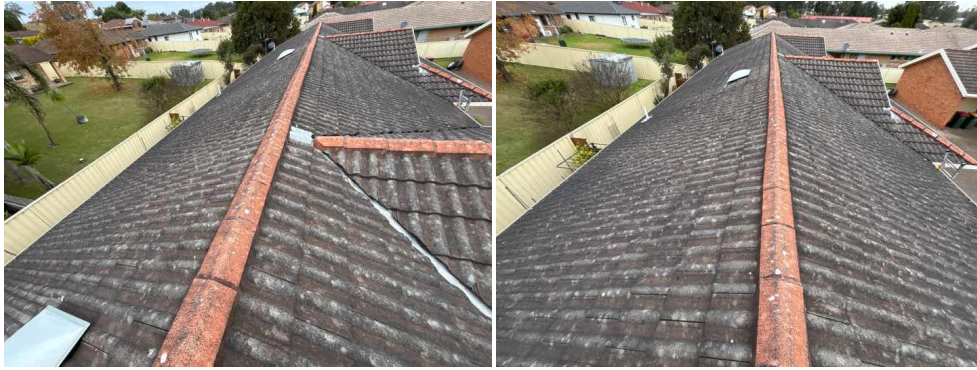
The roof cladding was in generally fair condition, however there were some observations.

General deterioration & ageing observed (e.g. cracked & spalling pointing, cracked tiles, tile deterioration). Recommend a licensed roofer or suitably qualified specialist contractor is engaged to further evaluate the roof for replacement or restoration(clean, replace damaged tiles, seal, and repoint the mortar).

There was evidence of leaking from flashings (e.g. apron flashing to the Dutch gables / gablets). Recommend repair as necessary by a licensed roofer or plumber.

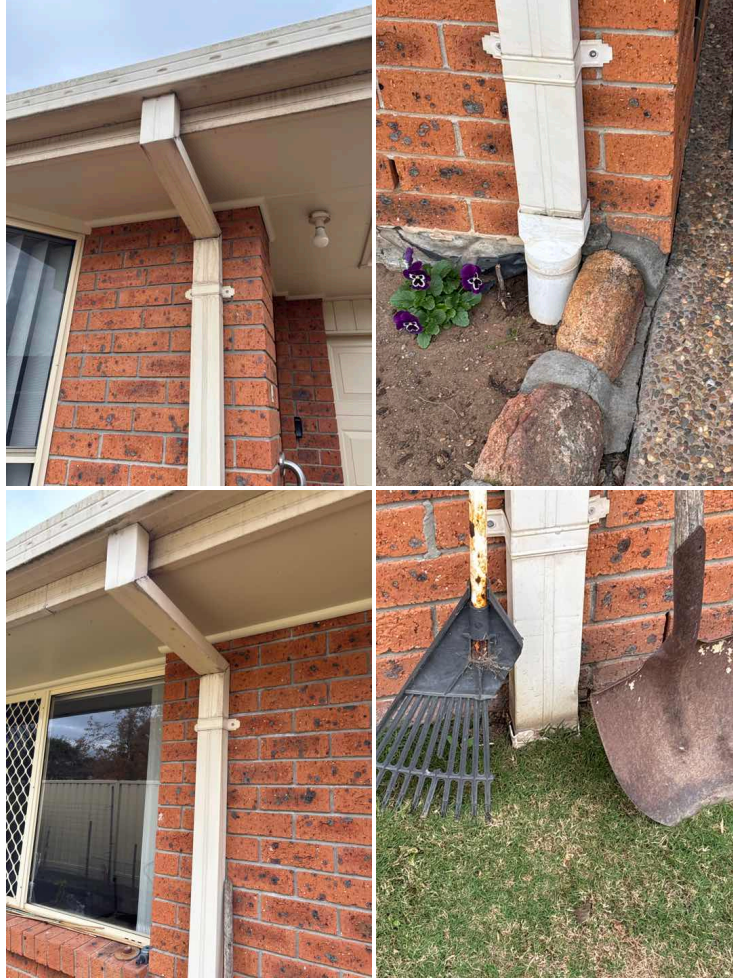
Some down pipe adapters were damaged. Recommend repair as necessary by a licensed plumber.

Evidence of leaking from down pipe joints observed. This can be conducive to termite infestation and cause water damage to cladding over time. A licensed plumber should be engaged to repair.

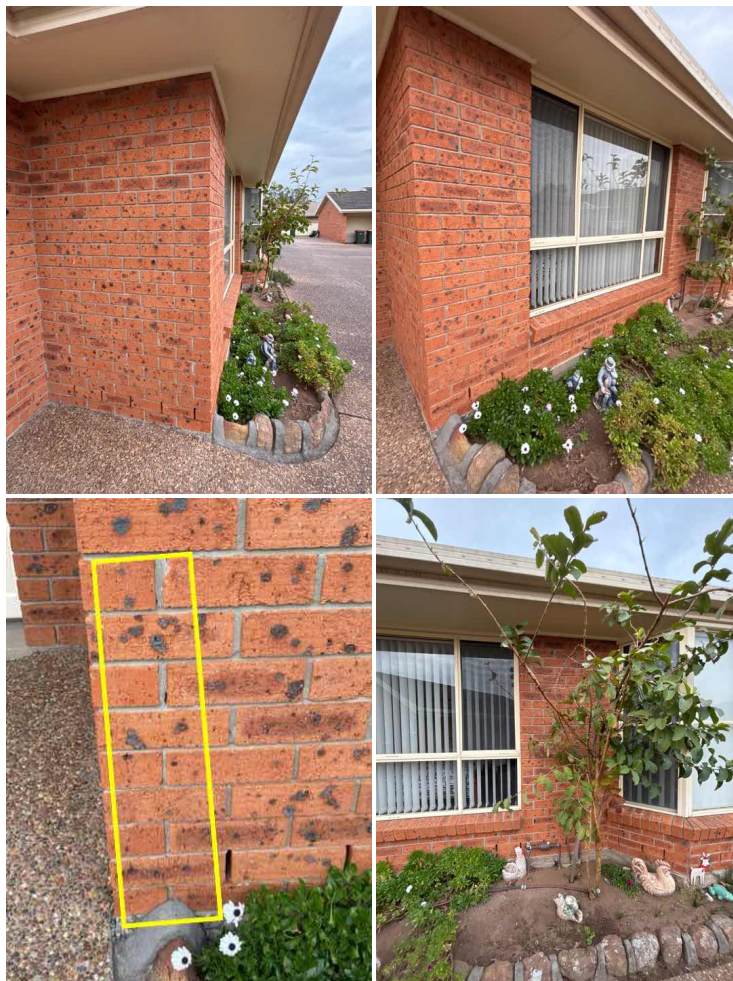
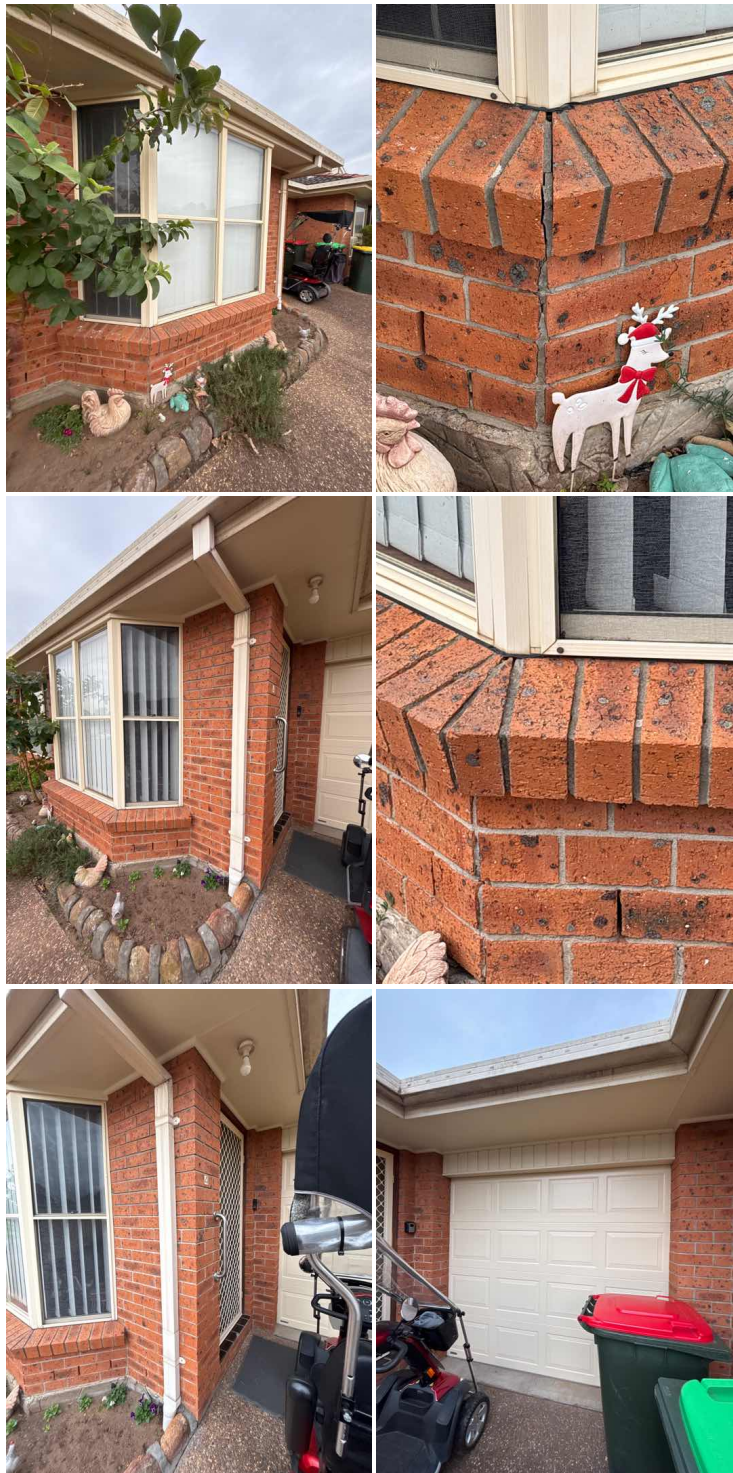
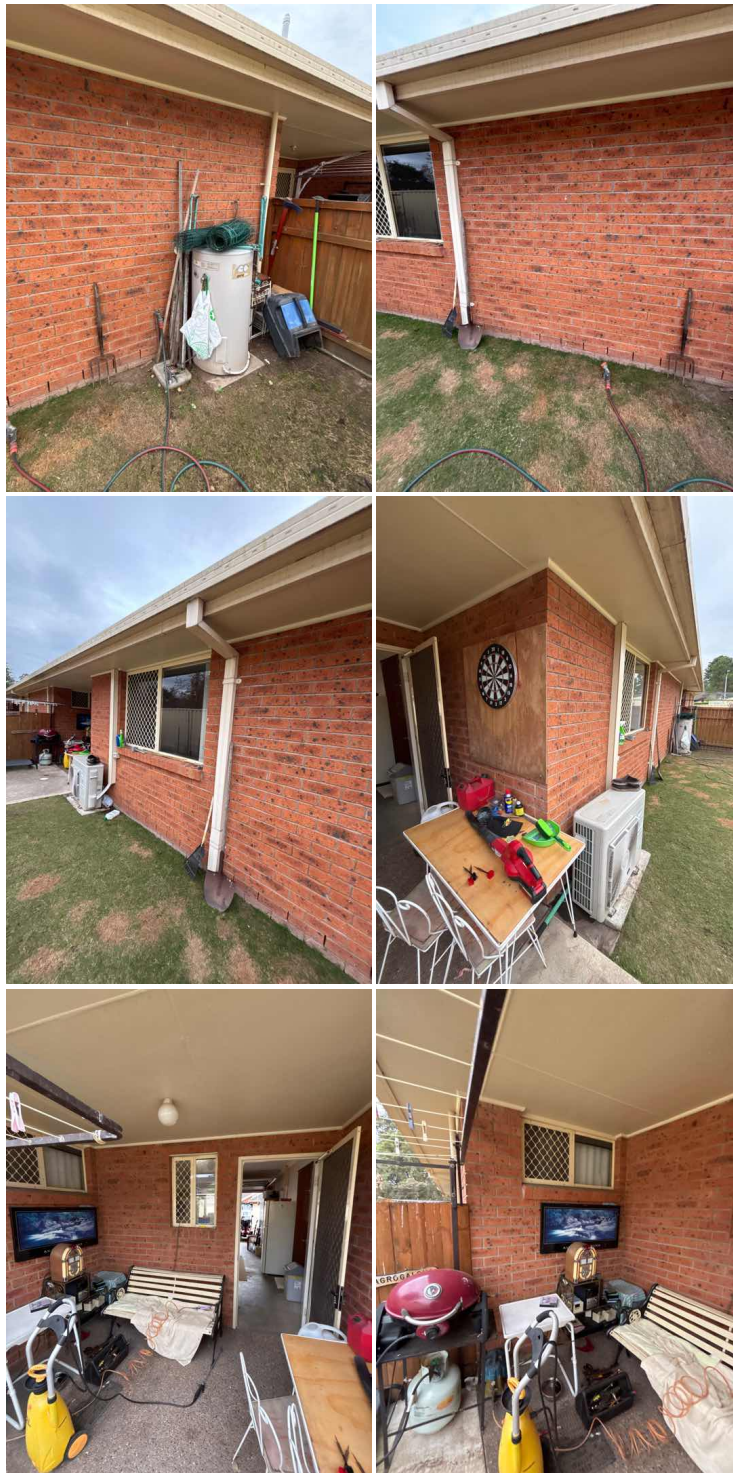
There appears to have been some settlement in the building which has caused some cracking to the walls. These cracks are categorized as 0 to 2. This can also cause some doors to bind or be out of square. In the inspector's opinion, these cracks are due to settlement, usually due to ground movement and subsequent movement to building materials can be expected. Any cracks should be monitored and if cracks increase in size, further investigation should be carried out by a structural engineer.

Sill bricks require repair (e.g. loose bricks, mortar voids). Recommend repair as necessary by a suitably qualified tradesperson. If left unrepaired the issue could further deteriorate.

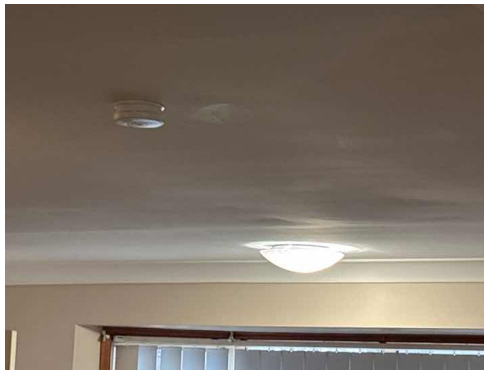
Ceiling linings had evidence of patching and minor repairs.

Minor to moderate ceiling sagging / pillowing. Recommend repair as necessary by a qualified plasterer.

There was evidence of leaking from the roof. The areas were tested with electronic impedance moisture testing equipment and / or thermal imaging and found to be dry (consistent with other areas / linings) at the time of inspection. Recommend repair as necessary to deteriorated damaged materials by a suitably qualified tradesperson and monitoring for further issues.

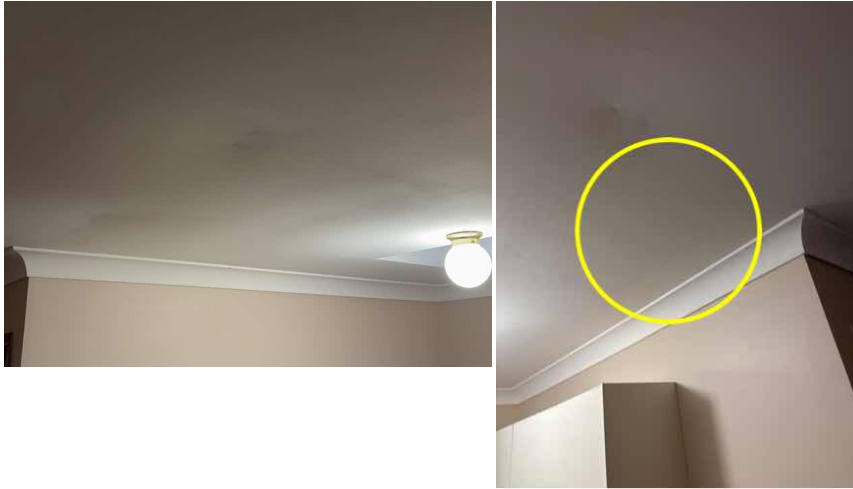
There was evidence of leaking from the roof. The area was dry at the time of inspection. Reviled repair as necessary by a suitably qualified tradesperson.

Pillowing / minor sagging was observed to the ceiling linings in areas. Recommend repair as necessary by a suitably qualified tradesperson.

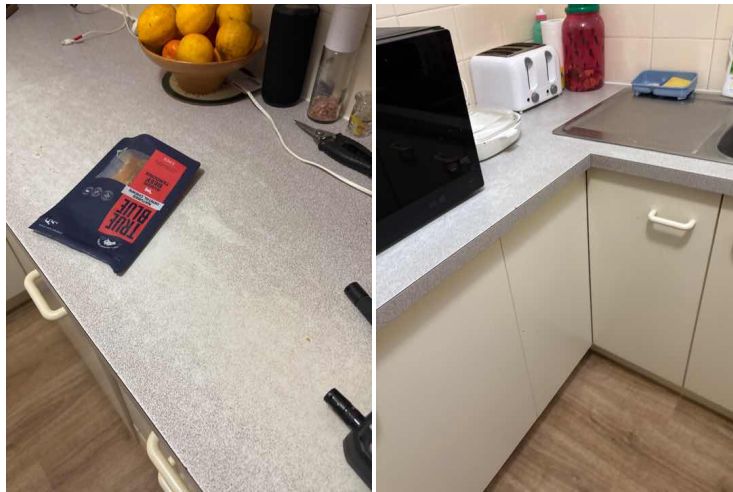
There was age and wear deterioration with the cabinetry and bench tops. Recommend repair or replacement as necessary by a suitably qualified tradesperson.

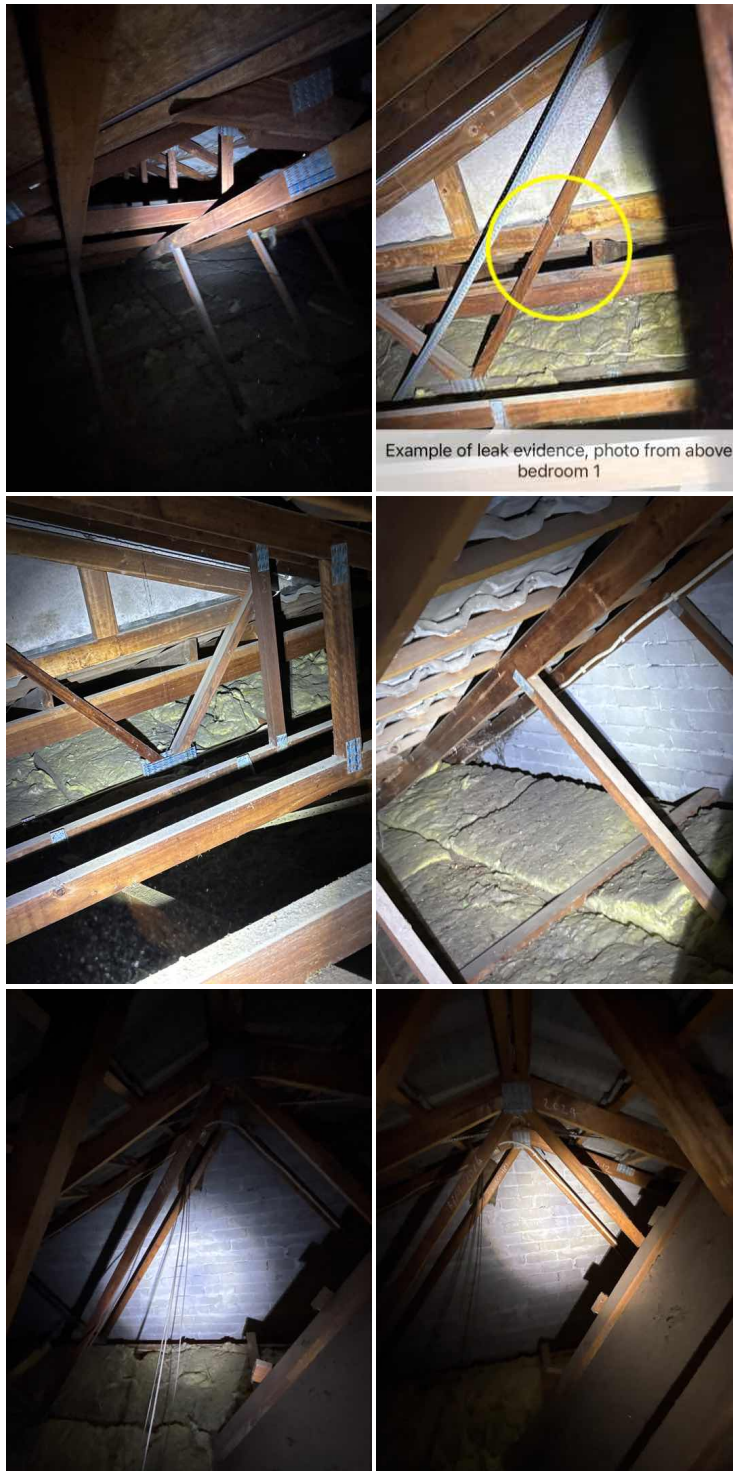
Example of leak evidence, photo from above bedroom 1

There is evidence to suggest that there is some leakage into the roof void. In the absence of rain it is difficult to determine if this is an old leak or it's active. Monitoring during periods of rain should reveal and leaks, if leaks are active contact a qualified roofing contractor for repairs.

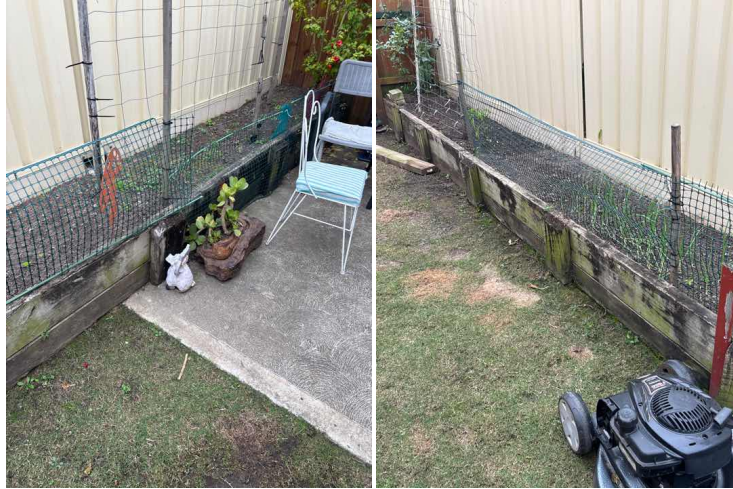
Retaining wall / garden edging (e.g. less than 700mm high).

The extent of rot damage is considered to be moderate.

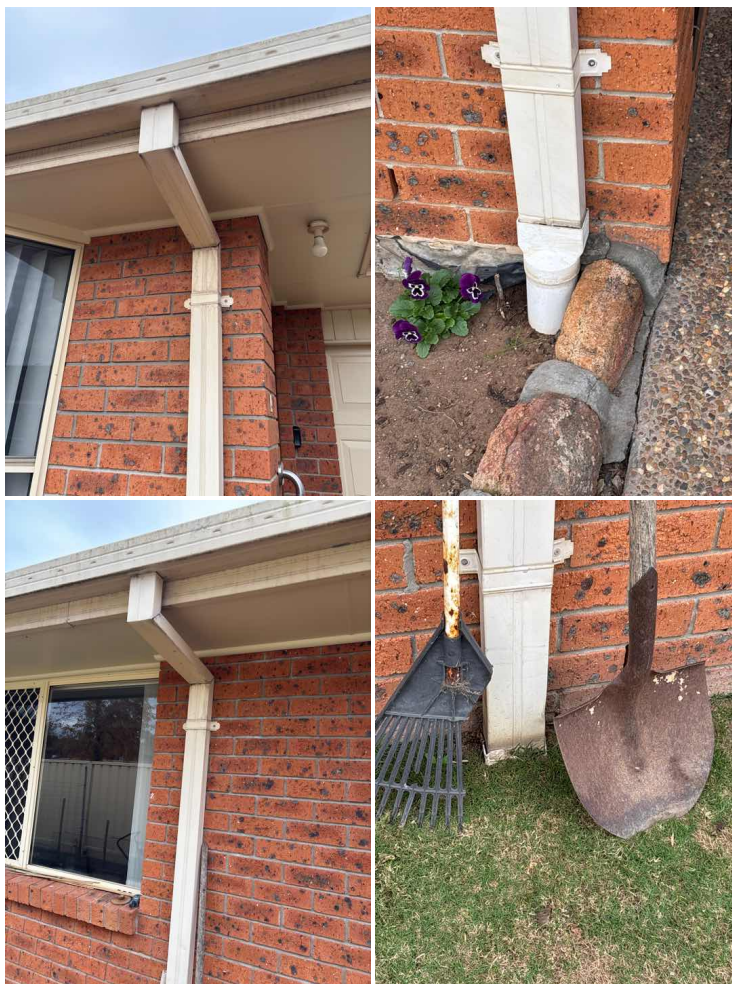
Some downpipe adapters were damaged.

There was water leakage detected during the inspection from some downpipe joints. Consult a roof plumber for a scope of works and cost of repairs for the issue prior to contracts becoming binding.

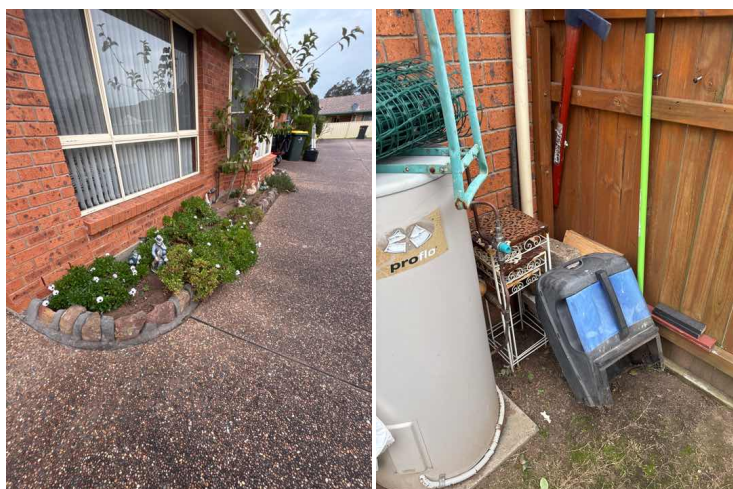
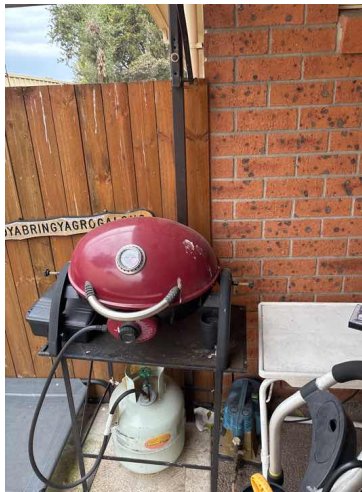
Garden beds located close to or against the building. These should be removed or relocated away from the building.

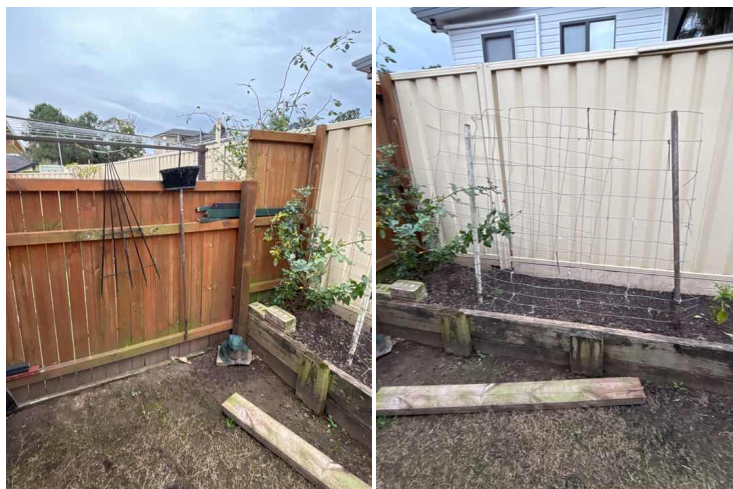
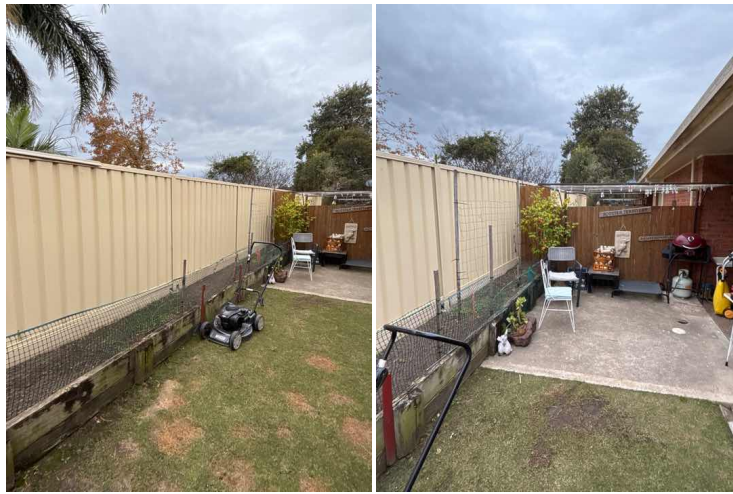
There are timber sleepers in the garden. Termites love nesting below timber sleepers as it provides a good food source while also providing protection for the nest. It is recommended that all timber sleepers be removed or replaced with a non-susceptible product as they are conducive conditions for termites.
