Affordable Inspections

B-1 Samoa Close Ashtonfield

15th July 2025

Building Report

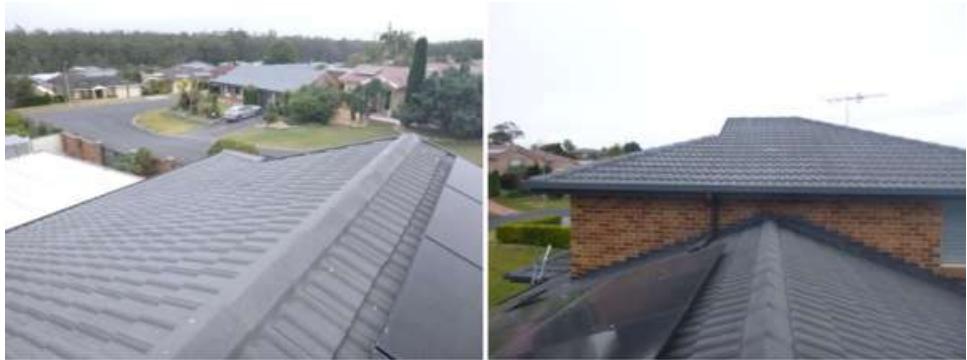
The overall condition of the roof coverings is good. Roof tiles have been repainted.

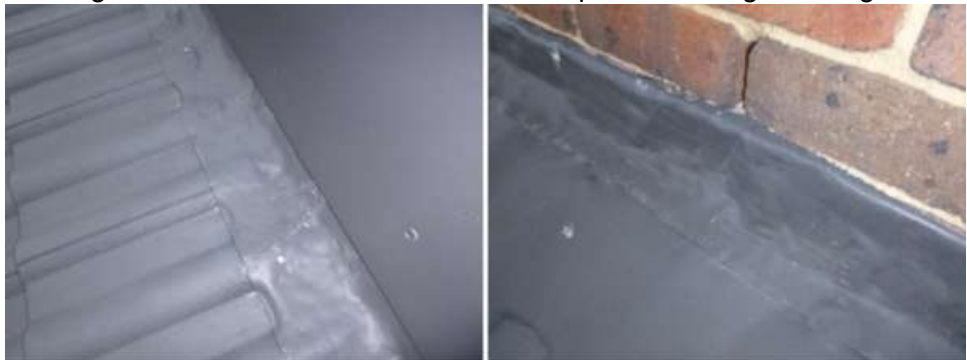
Flashing material is of lead. Flashings appear to be in serviceable condition. It should be noted that flashings are only viewed from a distance in some areas and sometimes defects are very small and not clearly visible. Cracked lead flashings have been resealed. These will require checking on a regular basis.

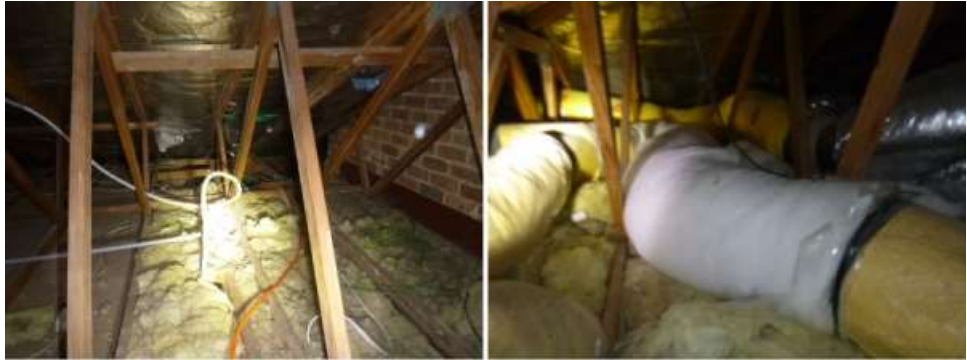
- Roof Supports - Type and Condition:** The timber truss roof system is adequate for the roof covering.

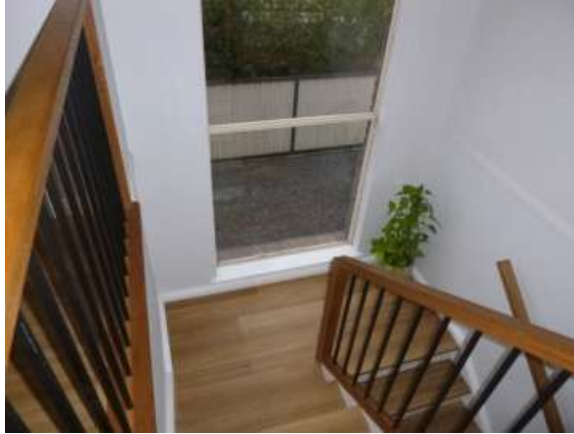
The stairs are constructed primarily from timber. The stairs are constructed primarily from steel. The overall condition of the stairs is good. safety glass is recommended in window in stair well.

**The following action is recommended:**

A glazier should be called to make a further evaluation and repairs or rectification as needed.

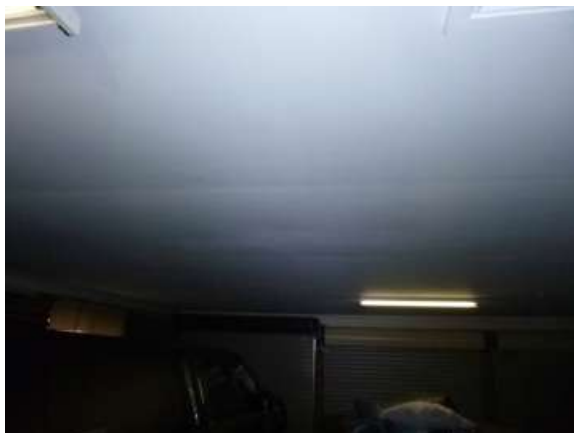
Garage Location:	Adjacent to the main building.
Restrictions to inspection	Stored items restricted inspection to the interior. Stored items should be removed to enable a more complete report to be submitted.
Roof Construction:	The roof is of pitched style construction.
Roof Access	Solar panels on roof restricted inspection.
Limitations:	
Roof Covering:	Concrete tiles:
Roof Covering Condition in Detail:	The overall condition of the roof coverings is good. Roof tiles have been repainted.
External walls constructed from:	A combination of double and single brick:
External Wall General Condition:	The condition of the walls is generally good.
Front Doors - Type & Condition	The main garage door is a roller shutter style door and is in good condition.
Ceiling Condition:	Moderate undulations were noted to the ceiling lining. This is to be expected in a house of this age. Periodic maintenance will be required. Evidence of past water penetration through the ceiling. No evidence of any current leaks. Visible from inside the roof.

The following action is recommended: A plasterer should be called to make a further evaluation and repairs or rectification as needed. A Licensed painter should be called to make a further evaluation and repairs or rectification as needed.

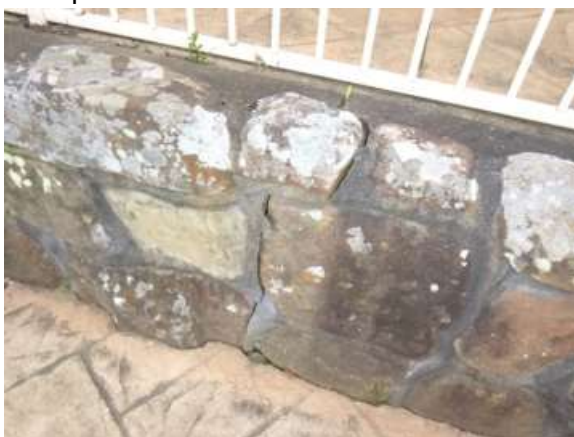
Type & General Condition: The masonry retaining walls show normal deterioration, cracks etc, and should be repaired.

The following action is recommended: A licensed builder should be called to make a further evaluation and repairs or rectification as needed.
