## PRE-PURCHASE PROPERTY REPORT

Report number: 3007242

**Inspection date:** 30 July 2024

Property address: 16 Vaocluse Pl, Mansfield QLD 4122

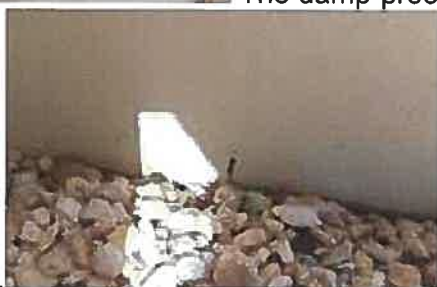
The damp-proof course and weepholes are at and below ground level in

sections. However, tests on the internal walls, with a moisture meter, indicate no moisture present, so the assumption is that the DPC has not failed. Care should be taken not to hose into these weepholes. Building codes require 75mm clearance from weepholes/DPC to ground level. A further detailed investigation (by a competent person e.g., a licensed building contractor) is recommended to determine the method and extent of any remedial work required, and associated costs. The above recommendation should be implemented without delay.

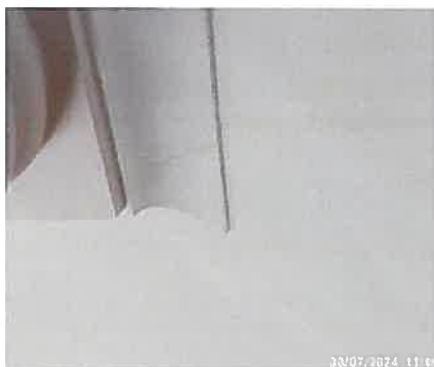
**Thermal fractures on cornice.**

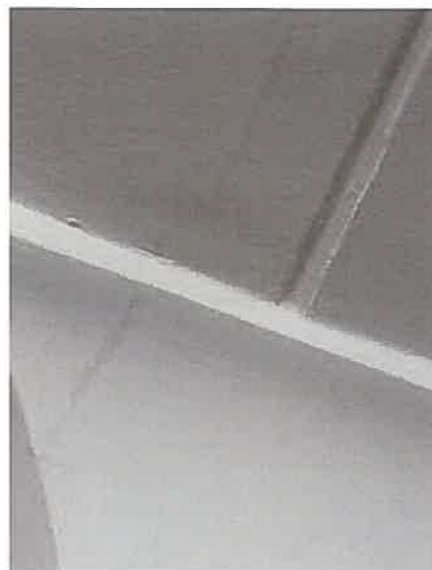
Ensuite spa bath deck tile s cracked.

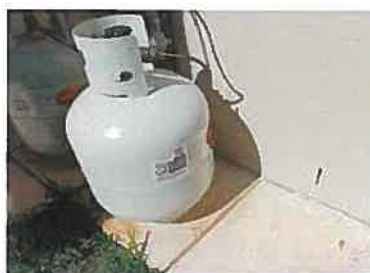
The following evidence was found: The LPG gas bottle station against the building is an inappropriate storage of dangerous materials. The weepholes are too close to the cylinders. The opening window should also be accessed This condition is considered potentially dangerous. A further investigation by a competent person e.g., a licensed plumber/gas fitter contractor or gas supply company is strongly recommended to determine the extent of remedial work required. The above recommendation should be implemented as a matter of urgency. The client has been verbalised on site. Please read attached document
