# Pre-Inspection Building And Timber Best Report

Inspection Date: 17 Sep 2025

Property Address: 9 & 9A Refalo Place Quakers Hill 2763

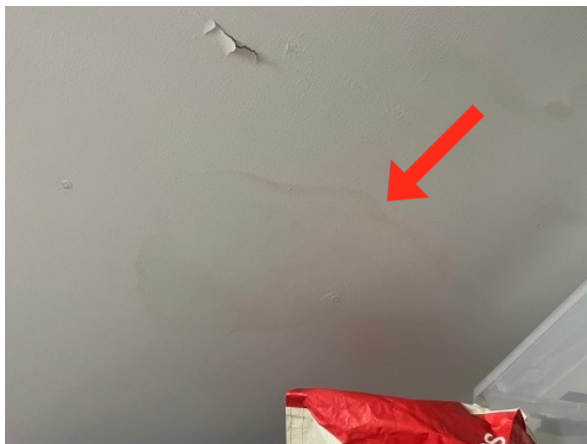
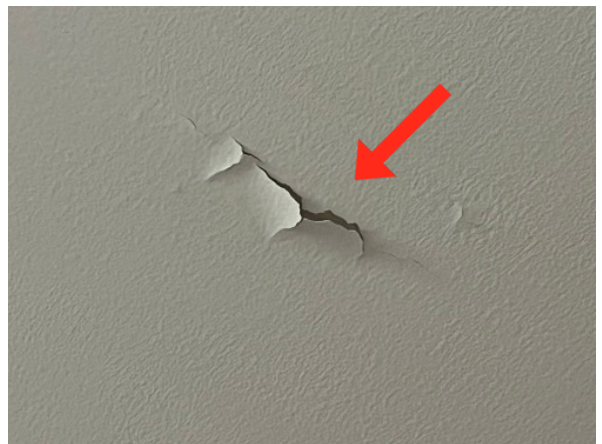
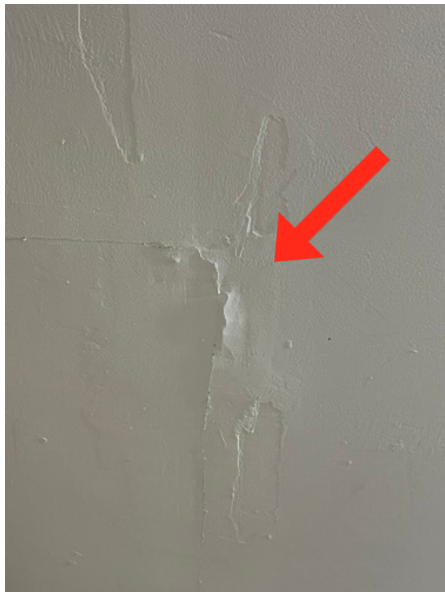
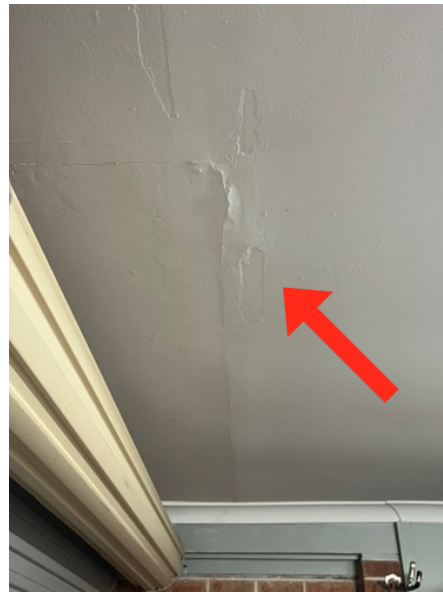
**Finding:** Water Stains and Water Damage

During the inspection, several water stains and areas of water damage were observed on the ceiling of the garage. The current status of any repairs to address potential leaks remains unknown, necessitating further investigation to determine their cause and extent. It is recommended to engage a licensed building professional to conduct a thorough assessment and implement necessary remedial actions to prevent further water intrusion and associated damage.

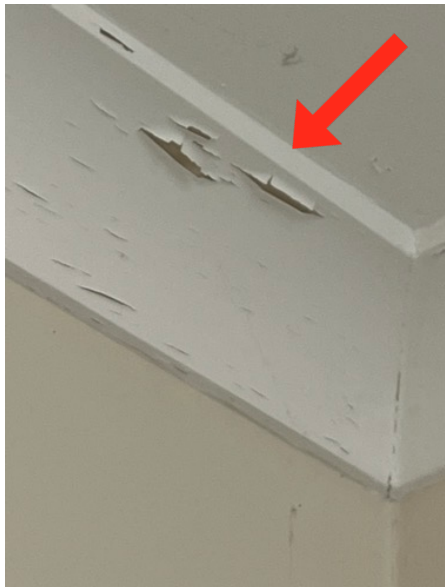
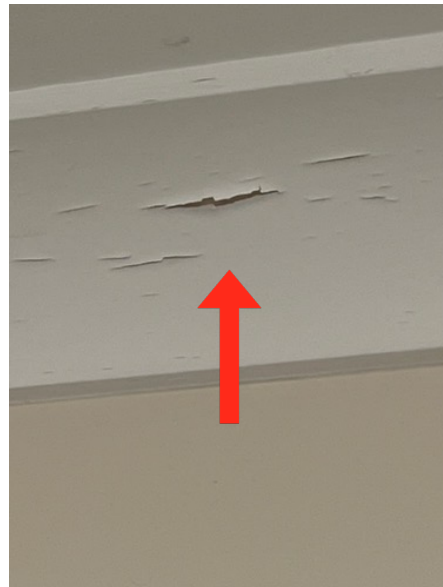
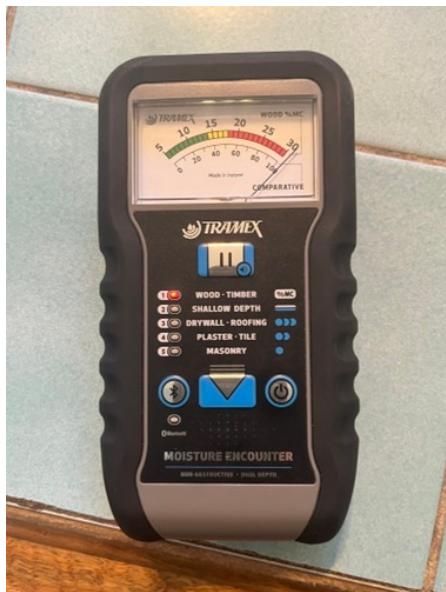
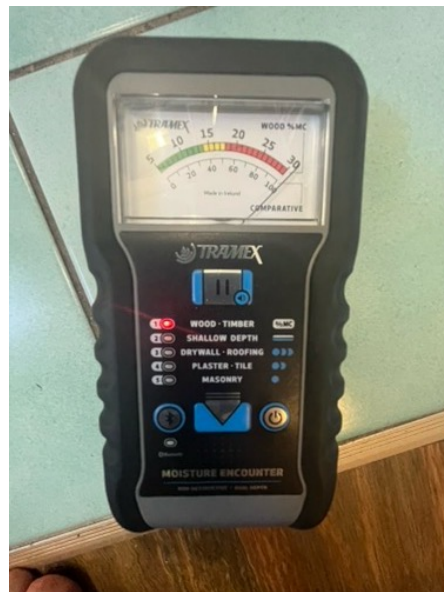
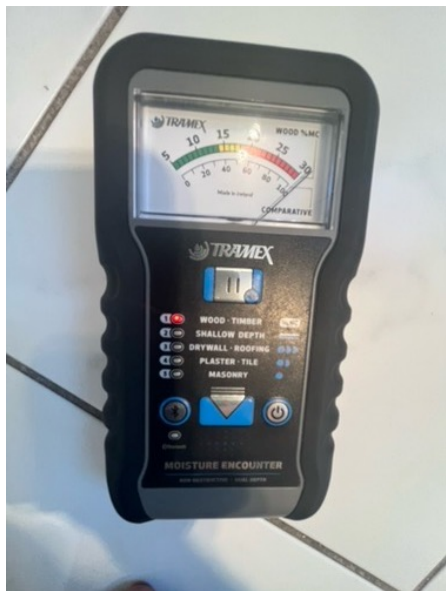
**Location:** Bathrooms

**Finding:** High Moisture Readings and Peeling paint

High moisture readings were recorded outside the shower recesses in both the main house bathroom and the granny flat bathroom, necessitating further investigation to determine if immediate remedial action is required. Additionally, there is peeling paint on the ceiling and cornice in the main bathroom, likely due to insufficient ventilation. It is recommended to assess and improve ventilation in the affected areas and conduct a thorough investigation to identify and rectify any underlying sources of moisture intrusion. Implementing these measures will help mitigate potential damage and maintain the integrity of the affected spaces.

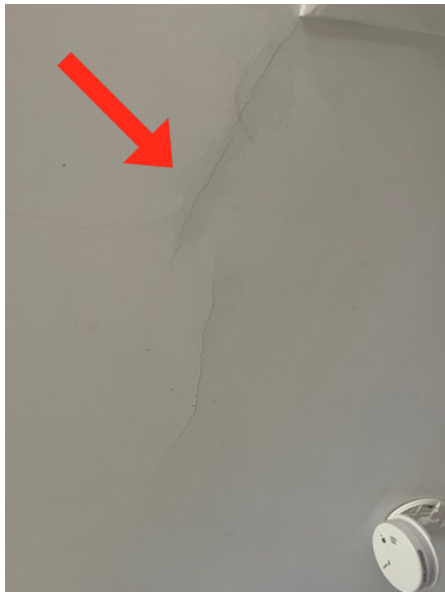
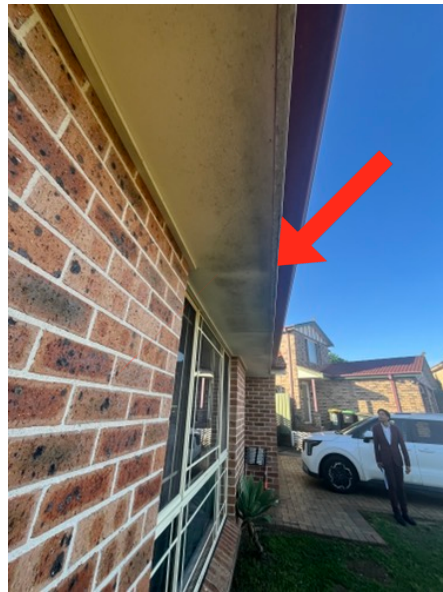
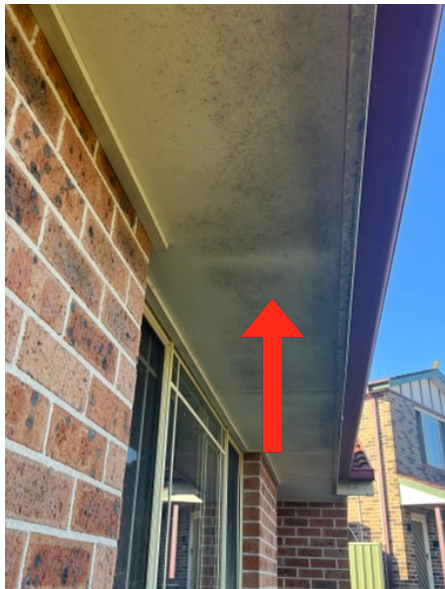
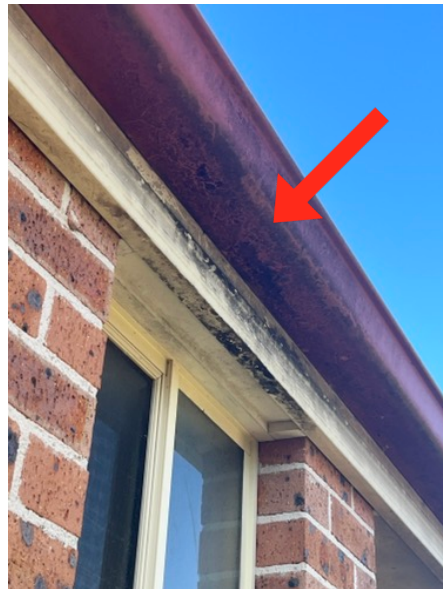
**Location:** Main House Living Area And Guttering

**Finding:** Minor Crack and Blocked Gutters

During the inspection of the main house's living area, a minor ceiling crack was observed, which is deemed to be non-structural in nature. Additionally, the gutters appear to be blocked, as indicated by significant water stains and mould on the eaves lining. It is recommended to clear and maintain the gutters regularly to prevent water overflow and further damage. Additionally, monitoring the ceiling crack for any changes is advised, with repairs carried out if necessary to ensure the integrity and aesthetic of the living space.

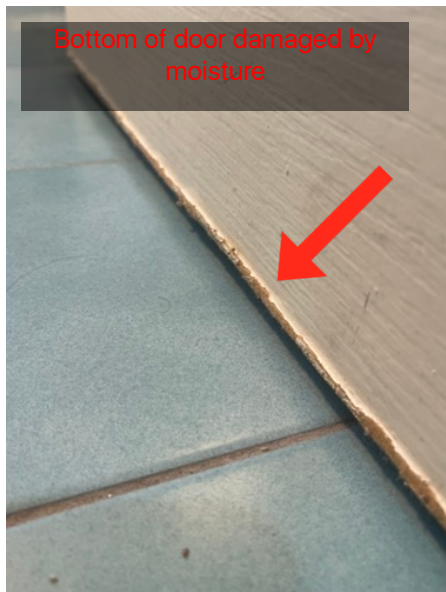
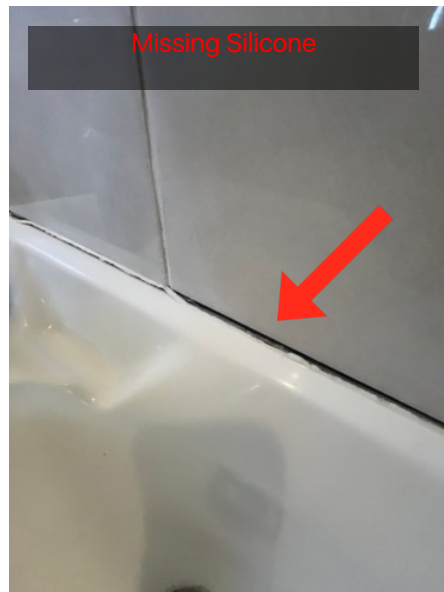
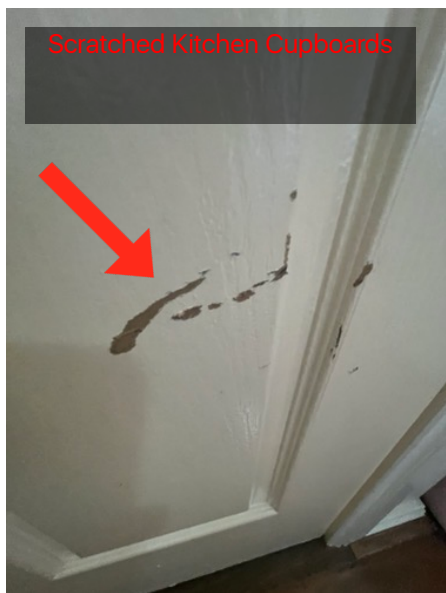
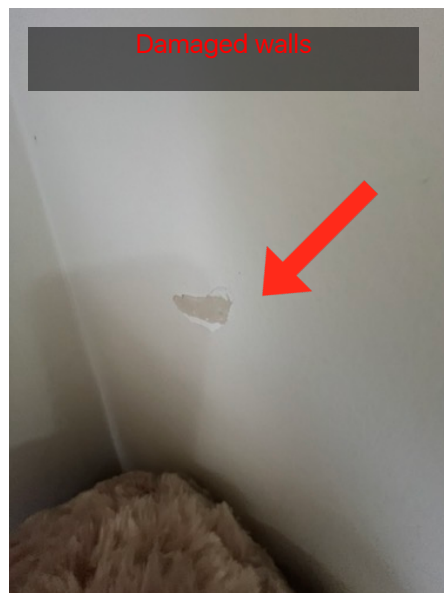
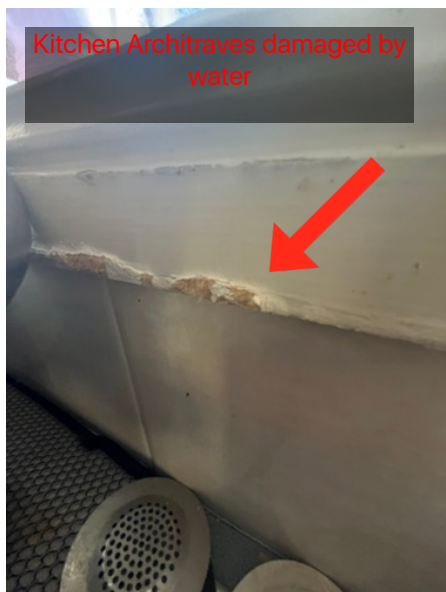
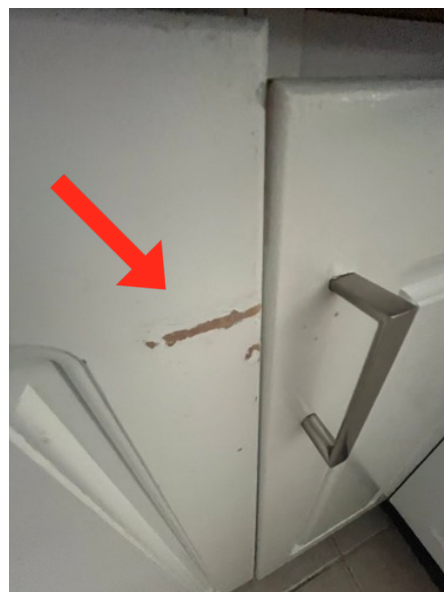
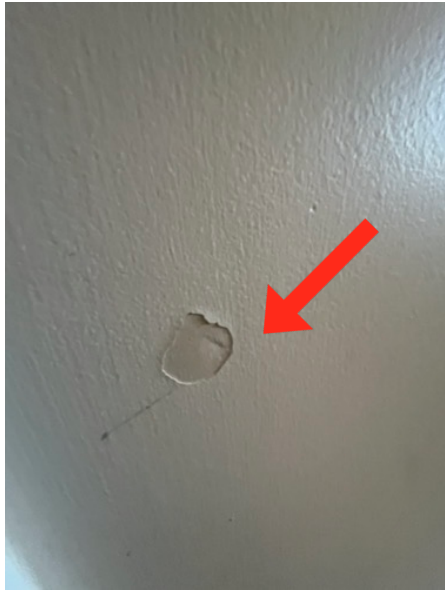
**Location:** All Internal Areas

**Finding:** Wear and Tear

Upon inspection, general wear and tear consistent with the property's age was observed both internally and externally. These elements are typical of a property of this vintage and do not pose significant concerns. However, routine maintenance is recommended to preserve the overall condition.

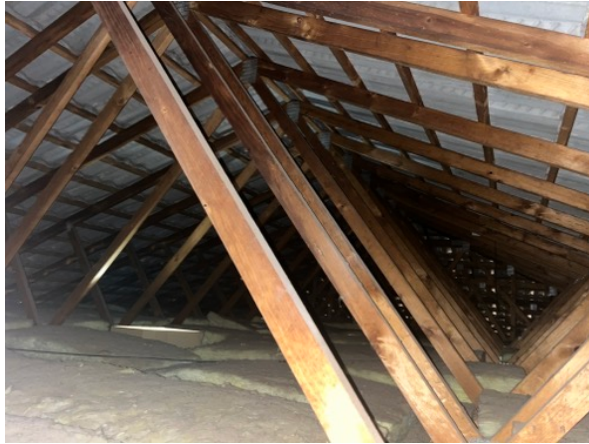
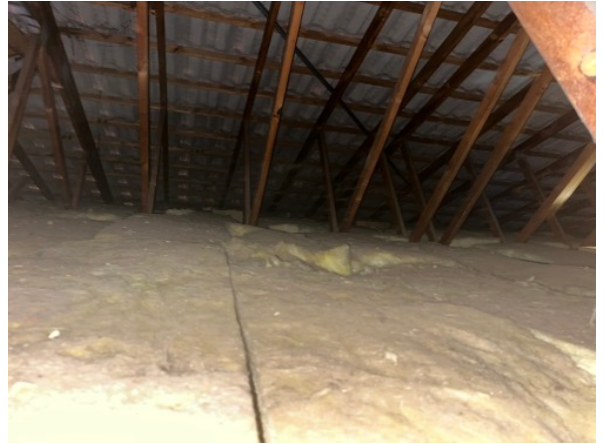
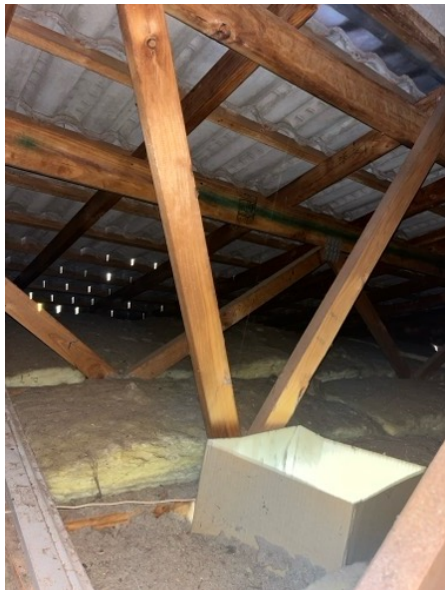
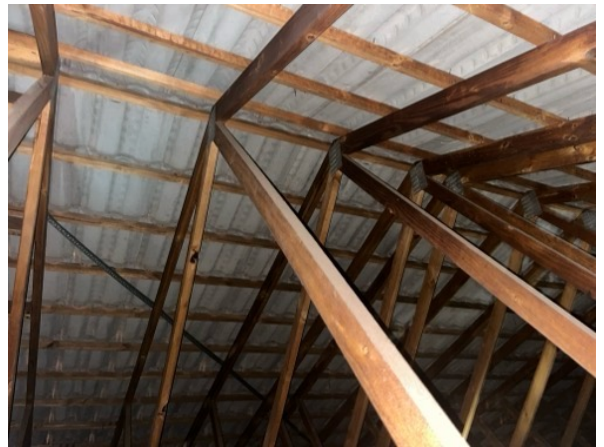
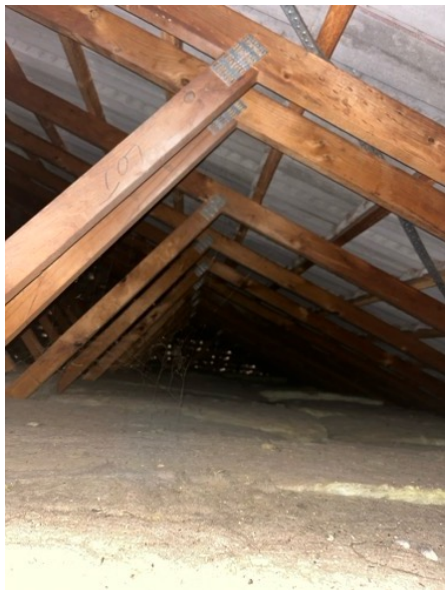
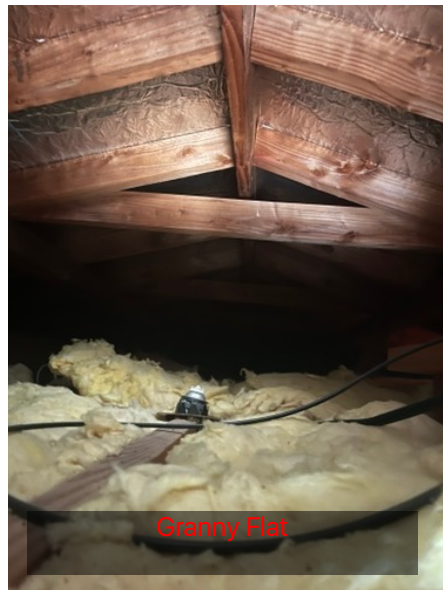
**Location:** Roofspace  
**Finding:** Roofspace Overview

Note/Description: Roof sarking is a crucial layer of protection that is typically installed under the roof tiles or metal sheets. Its absence may lead to potential issues such as reduced thermal insulation, increased risk of water leaks during heavy rain, and decreased protection against dust and debris.

Possible risks: Without roof sarking, the dwelling may experience higher heating and cooling costs due to reduced insulation properties. In heavy rain or severe weather conditions, water leaks may occur, potentially leading to water damage and deterioration of building materials.

Recommendations: It is recommended to consider installing roof sarking to enhance the dwelling's thermal efficiency and protect against water infiltration. A qualified roofing specialist should be contacted to assess the roof's current condition and provide suitable options for the installation of roof sarking only at the owners discretion.

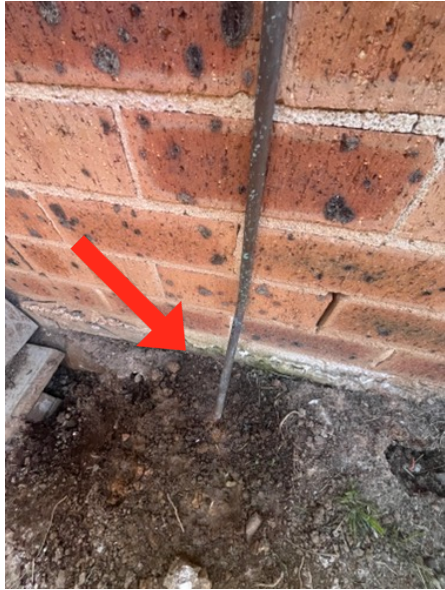
The hot water unit is not properly connected to the stormwater system, creating a potential termite attraction. This defect poses a significant risk as termites are drawn to moisture, and the absence of proper drainage may lead to water accumulation near the property's foundation. To rectify this issue, it is recommended to engage a qualified plumber to connect

the outlet to the stormwater system, ensuring proper drainage and minimizing the risk of termite infestation.

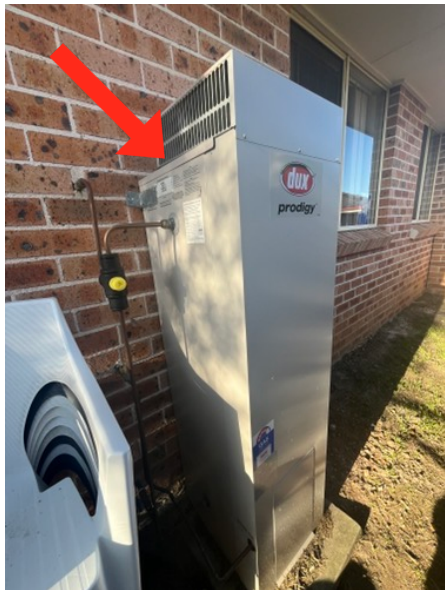
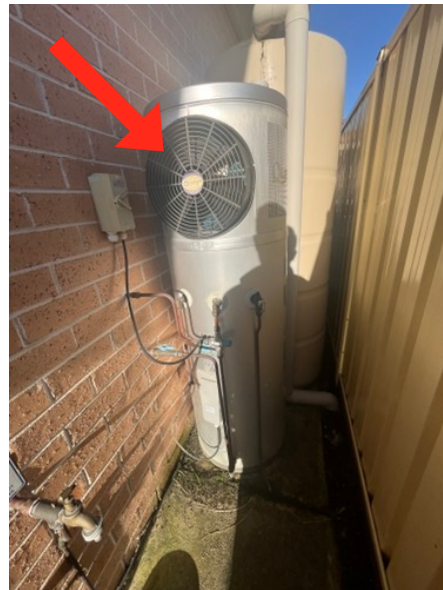
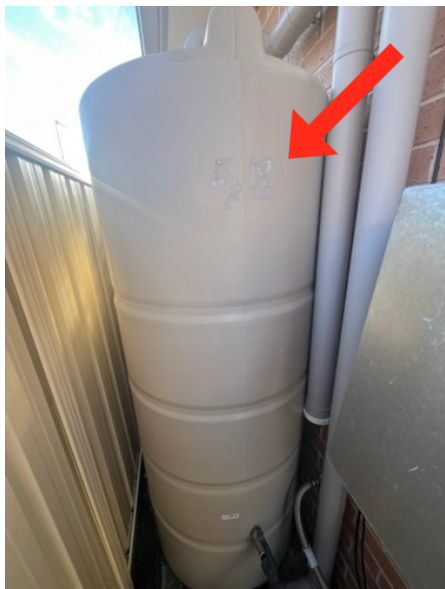
**Finding:** Bridging or Obstruction - Air Conditioner, Hot Water, Vegetation & Storage

Where bridging has occurred full inspection is prevented and termites may enter a property in a concealed or undetectable manner.

Recommend moving obstructions away from the external walls for further and future inspections.

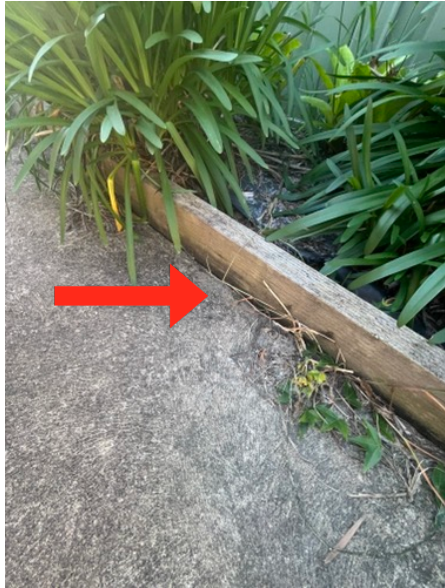
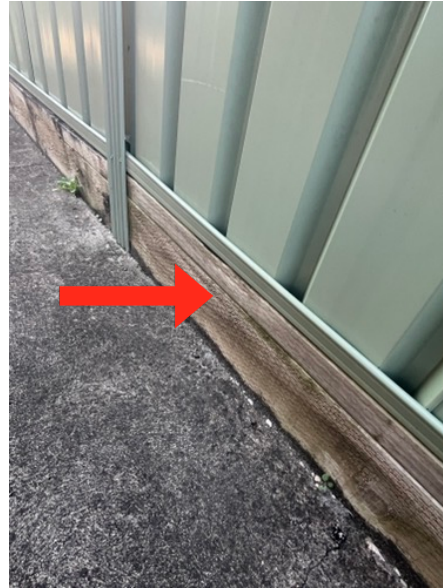
Timbers at the property were found to be in contact with the ground. Where timber elements are in direct contact with the ground and consequently there is moisture or dampness they become conducive to termite activity. Whether timber is used as a building element part of a fencing structure or stored as an unused item they can provide an environment that is attractive to termite infestation. When met with excessive moisture timber begins to decay and develop wood decay. Any timbers that are in direct contact with external grounds especially if left untreated or non-durable also provide ingress for subterranean termites into that particular element. Any such materials that may be conducive to termite activity should be monitored

frequently for any changes to minimise the risk of termite attack.

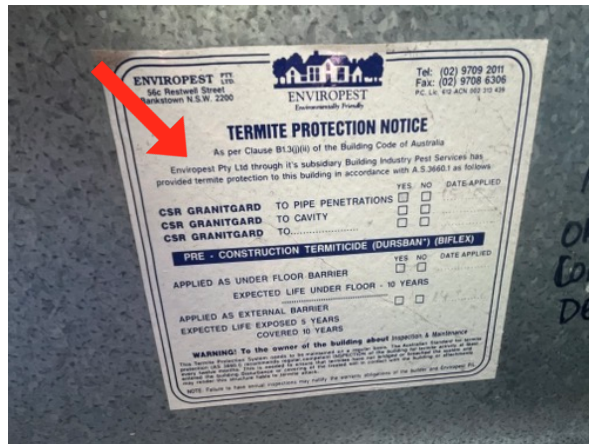
**Finding:** Durable notice found but not maintained

A durable notice was found to the external switchboard but has not maintained its annual inspections. The installation date is unknown and no inspections have been made since. A re-inspection must be evaluated within the next 30 days by a professional Pest Management Technician to ensure termites have not bridged or breached the system.
