# Pre Inspection Building And Timber Pest Report

**Inspection Date: 4 Sep 2025**

Property Address: 5 Tulip Place Quakers Hill 2763

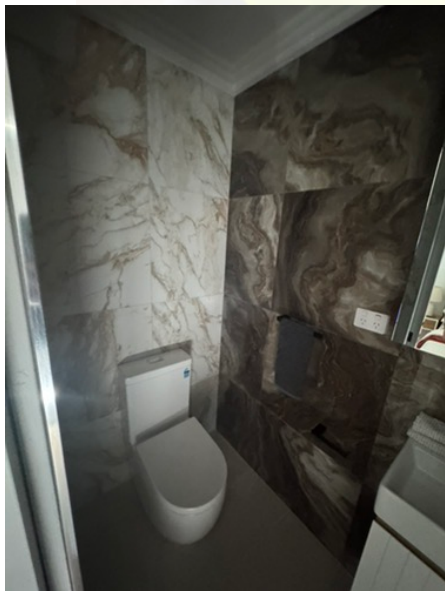
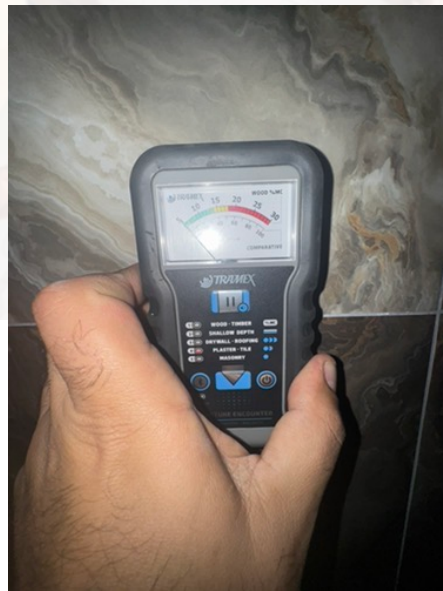
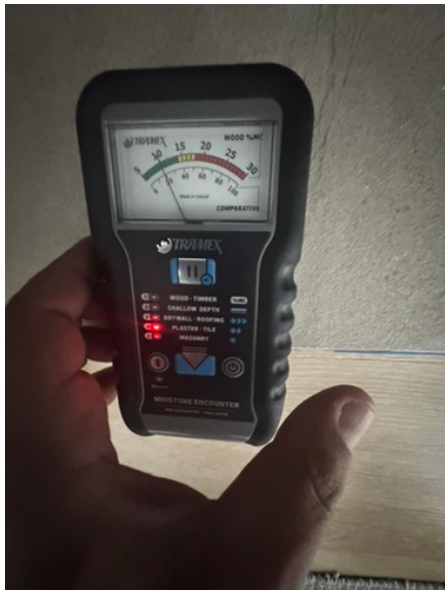
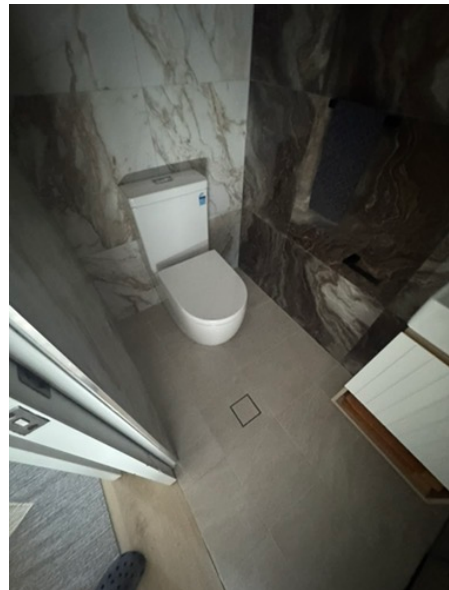
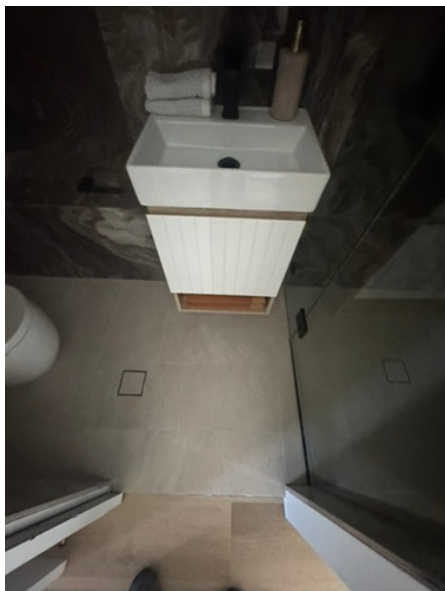
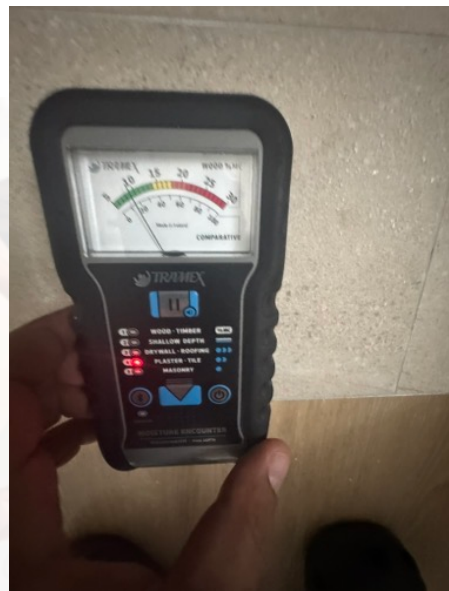
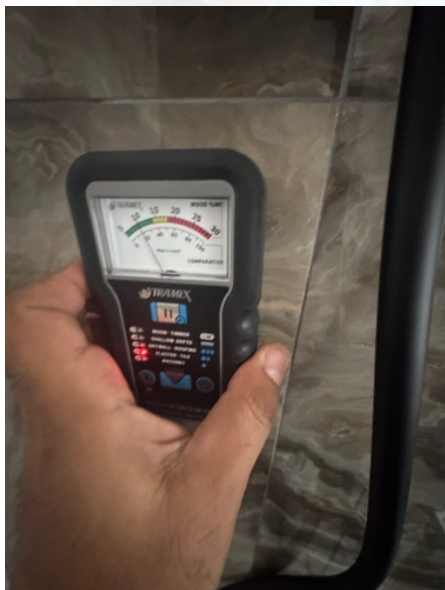
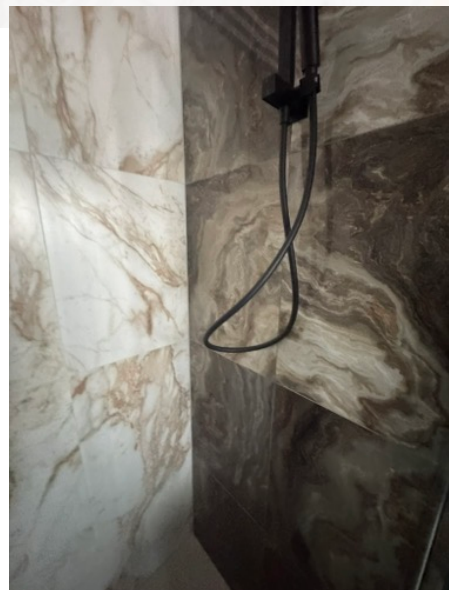
## For your information 1.01

**Location:** Bathrooms

**Finding:** Additional Photos-low moisture readings

- Moisture Reading: A moisture meter reading was taken in the master bathroom, and it indicated a low level of dampness.
- Note/Description: The master bathroom showed no visible signs of water leaks or water-related issues. The low moisture reading suggests that the bathroom area is adequately dry, and no immediate concerns are identified.

- Moisture Reading: Moisture meter readings were also taken in any additional bathrooms within the property, and all readings indicated low levels of dampness.
- Note/Description: The other bathrooms inspected did not show any visible signs of water leaks or moisture issues. The low moisture readings suggest that these bathroom areas are in satisfactory condition.

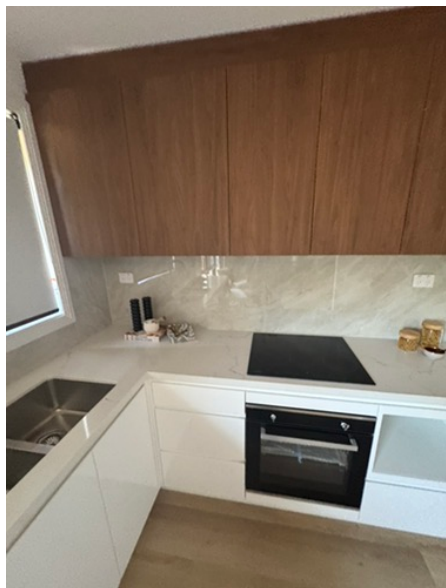
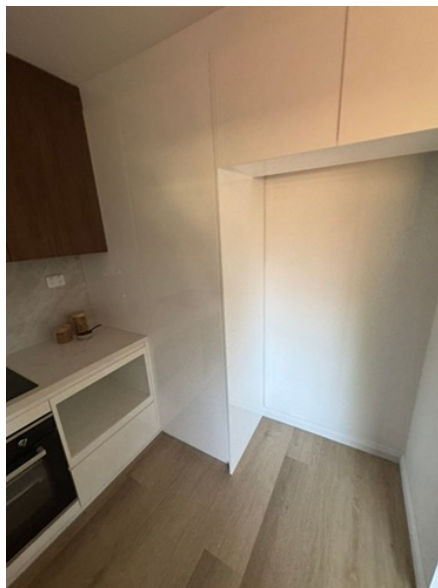
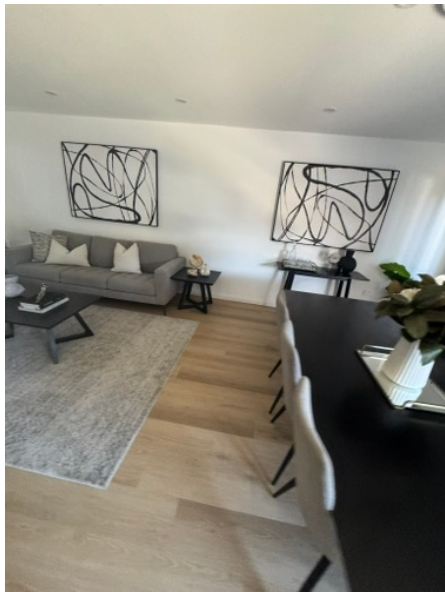
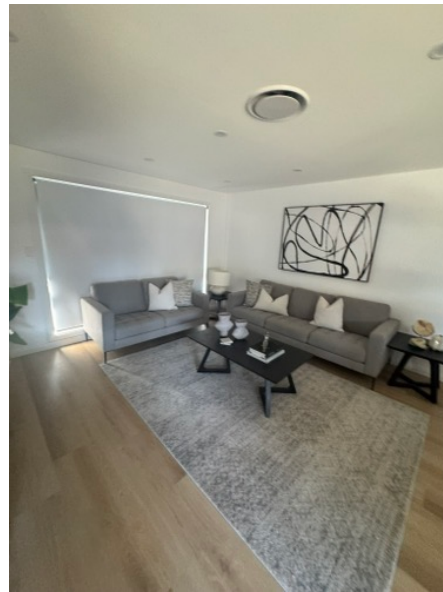
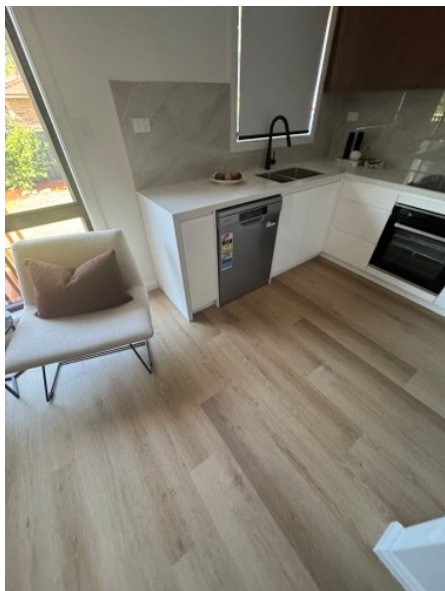
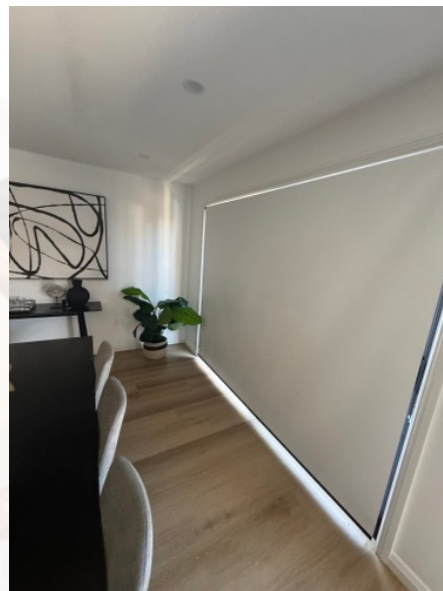
## For your information 1.02

**Location:** All Internal Areas

Upon inspection, the internal areas of the property were assessed for any visible defects or issues. The following areas were thoroughly inspected, and no significant defects or concerns were identified:

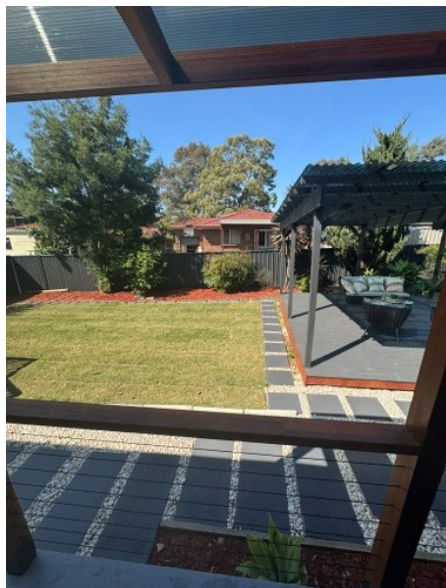
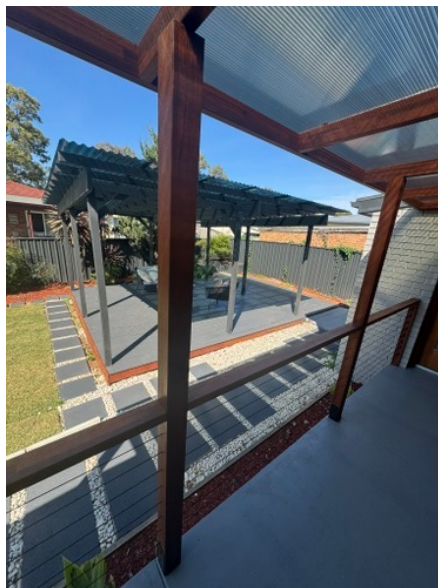
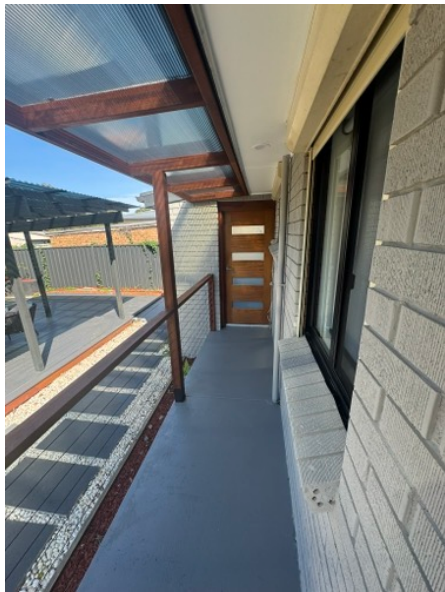
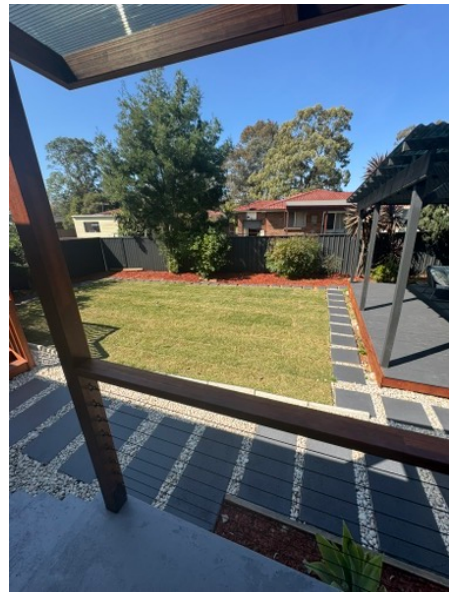
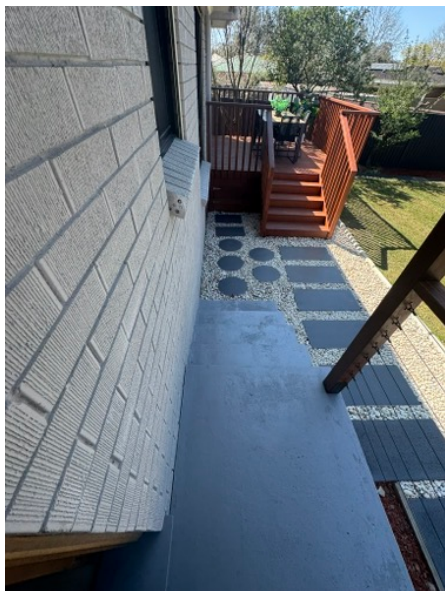
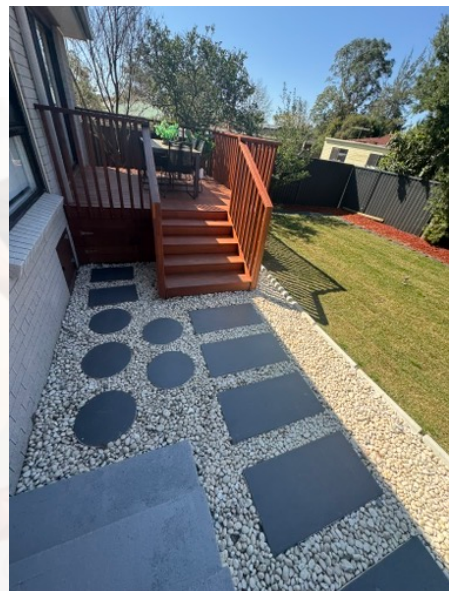
## For your information 1.03

The external areas of the property were thoroughly inspected for any visible defects or issues. The following external components and features were assessed, and the observations are as follows:

1. **Roofing:**The roof was examined for signs of damage, missing tiles, or leaks. No significant roofing issues were detected during the inspection.
2. **Exterior Walls:**The exterior walls were inspected for cracks, dampness, or structural concerns. No major defects were found, and the walls appeared to be in satisfactory condition.

5. **Driveway and Pathways:**The driveway and pathways were inspected for cracks or uneven surfaces. Minor wear and tear were observed, but no significant defects were noted.

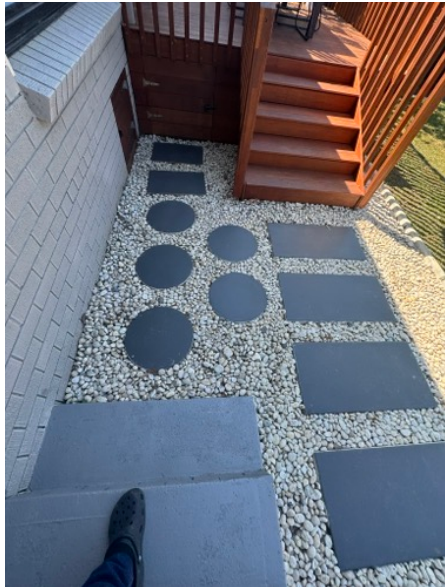
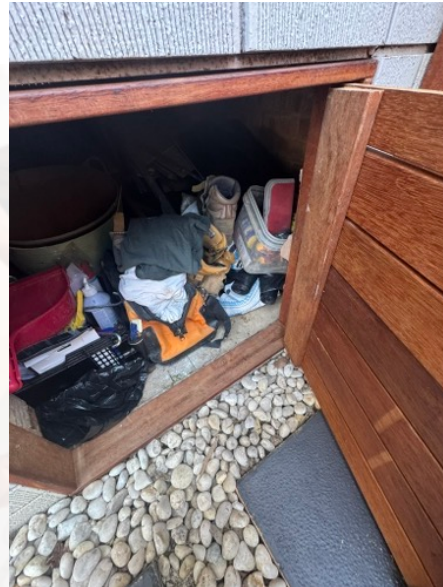
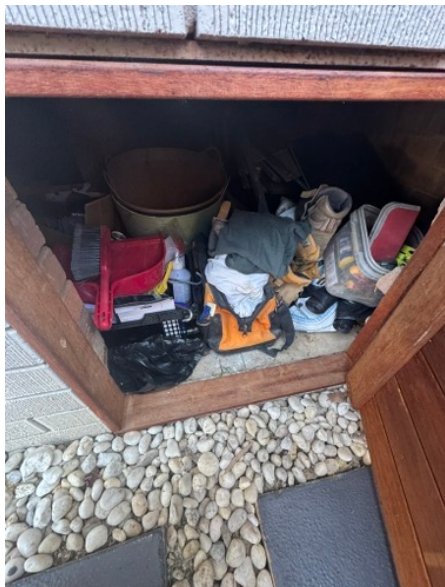
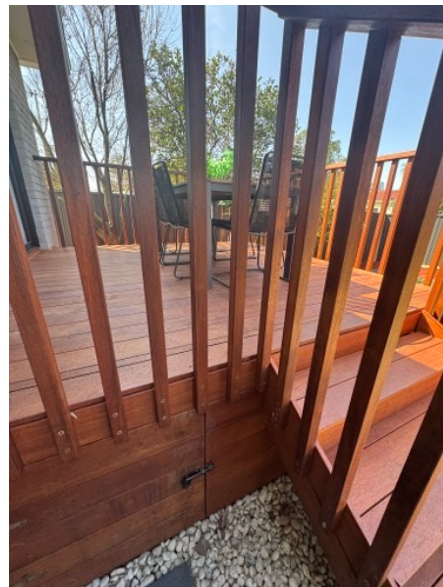
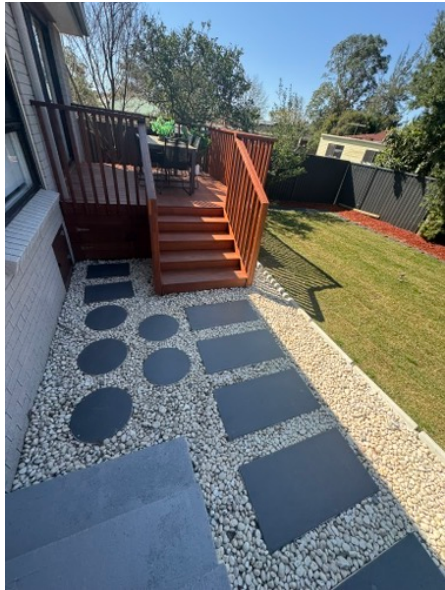
### Conditions conducive to timber pest attack 2.01

**Finding:** Timbers in contact with ground

Timbers throughout the property were found to be in contact with the ground. Where timber elements are in direct contact with the ground and consequently there is moisture or dampness they become conducive to termite activity. Whether timber is used as a building element part of a fencing structure or stored as an unused item they can provide an environment that is attractive to termite infestation. When met with excessive moisture timber begins to decay and develop wood decay. Any timbers that are in direct contact with external grounds especially if left untreated or non-durable also provide ingress for subterranean termites into that particular element. Any such materials that may be conducive to termite activity should be monitored frequently for any changes to minimise the risk of termite attack.

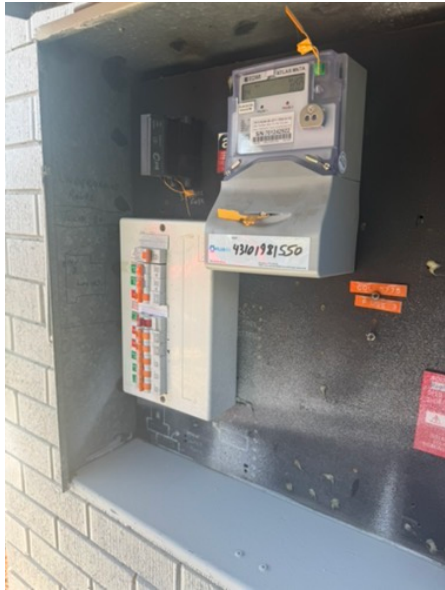
**Finding:** Durable Notice - Missing

A durable notice is missing from the meterbox. The application of a post-construction chemical termite barrier is highly recommended for all properties with timber building elements. Such barriers are highly effective in preventing termite attack on any timber building elements throughout the property. A durable notice should be placed in the meter board to indicate current termite barriers. At the time of inspection, it appeared as though no termite management system has been installed, with no evidence to suggest preventative works taking place which puts this property at very high risk. The client should consider gaining further advice from a licensed termite/timber pest technician as to the costs and procedures involved with implementing and maintaining a pest management system for this

Recommendations: Engage a qualified pest control expert with experience in termite management for older properties. They can assess the specific risk factors of the property, recommend appropriate treatments, and provide ongoing guidance to ensure effective termite prevention. Additionally, refer to local regulations and guidelines related to termite management for your area.
