# Pre-Inspection Building And Timber Pest Report

Inspection Date: 16 Sep 2025

Property Address: 8 Jacaranda Place Doonside 2767

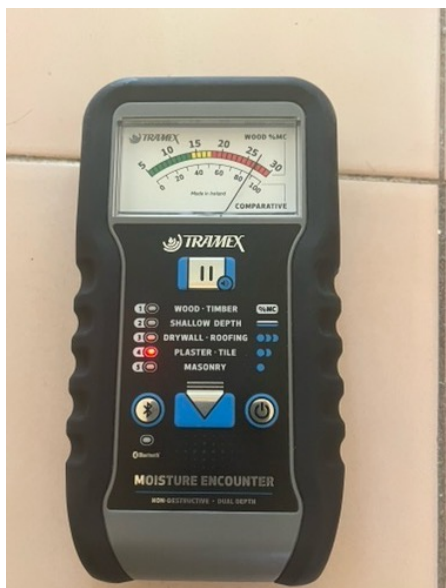
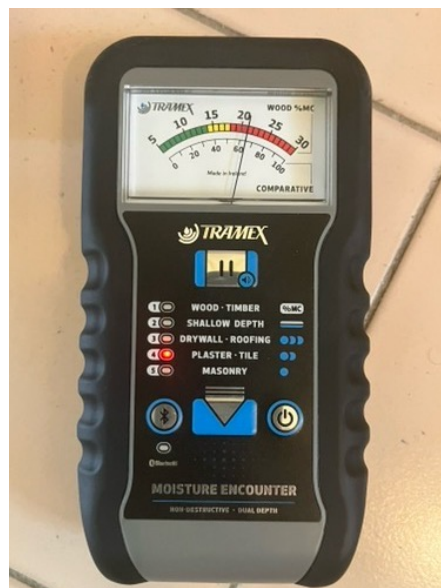
### Minor Defect 1.01

**Finding:** High moisture readings

During the inspection, elevated moisture readings were recorded outside the shower area in the bathroom. This condition may indicate potential water ingress or inadequate sealing, which can lead to further structural issues or mold growth if left unaddressed. It is recommended that a qualified professional conduct a more detailed assessment to determine the source and extent of the moisture intrusion. Remedial action may include re-sealing the shower area or repairing damaged waterproofing to prevent future moisture problems and ensure the long-term integrity of the bathroom structure.

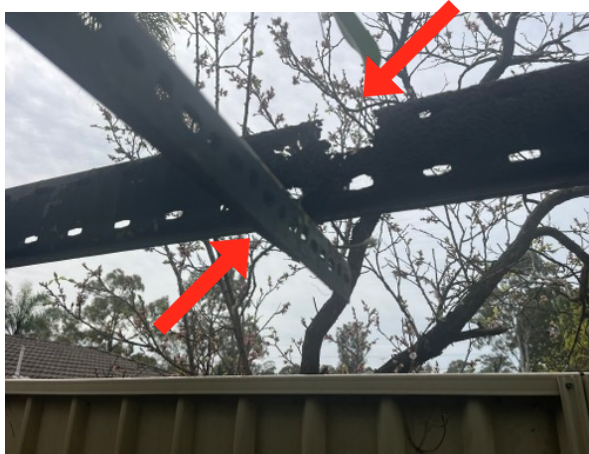
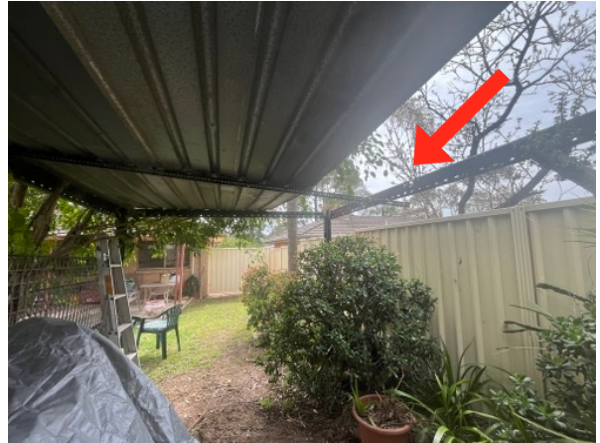
## Minor Defect 1.02

**Location:** Backyard

**Finding:** Corroding Metal pergola

In the backyard, significant corrosion has been identified on the metal pergola, particularly affecting its structural integrity. Notably, one of the crossbars has dislodged due to the extent of the deterioration. This defect poses potential safety risks and requires prompt attention. It is recommended to engage a qualified contractor to assess the full extent of the damage and undertake necessary repairs or replacements. It may be prudent to consider using corrosion-resistant materials to prevent recurrence, thus ensuring the pergola's longevity and safety.

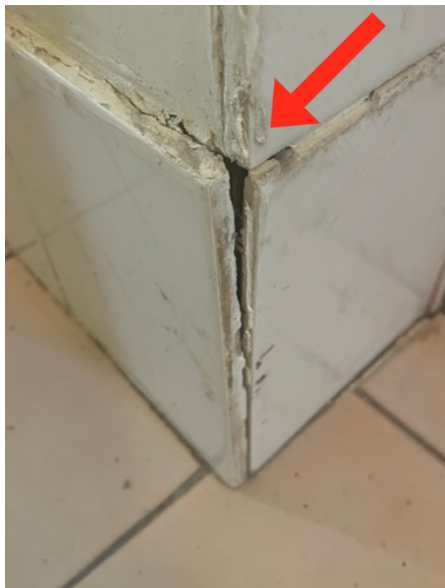
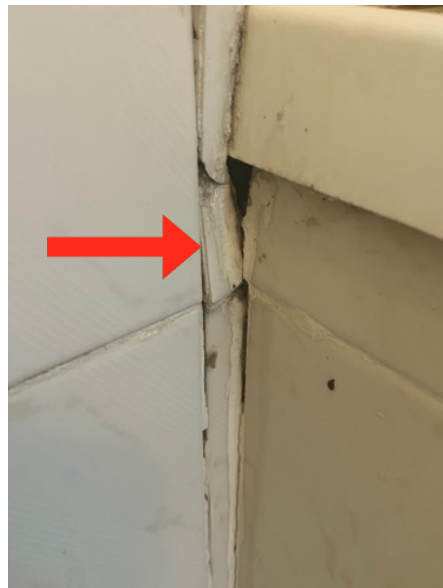
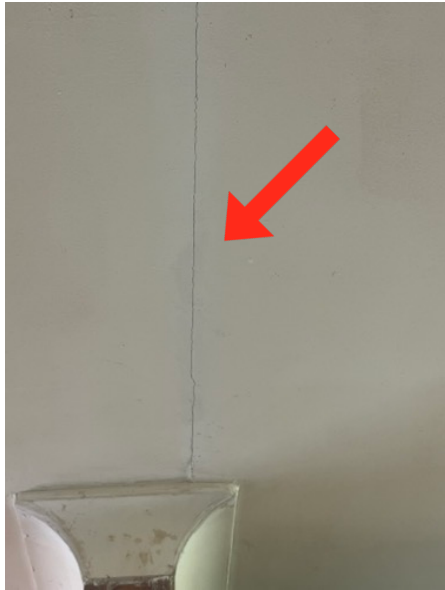
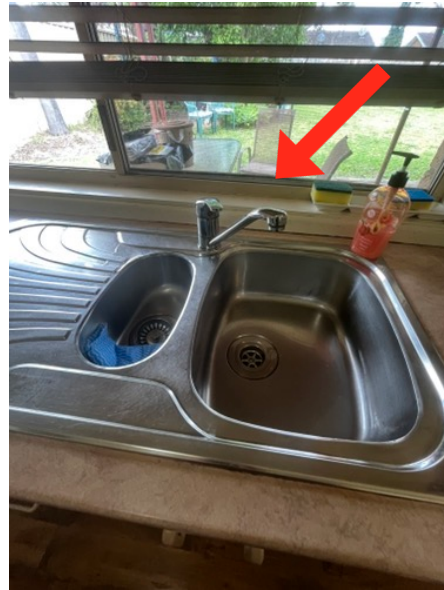
## Minor Defect 1.03

**Location:** Kitchen, bathroom, dining area

**Finding:** Water Hammer/ Minor crack/ Disengaged Tiles

The property exhibits several minor defects requiring attention. There is a slight water hammer present at the kitchen sink flick mixer, which may be resolved by securing loose pipes or installing a water hammer arrestor. Additionally, the bathroom features disengaged wall tiles, likely due to age; re-adhesion or replacement of the tiles is recommended. Furthermore, a minor, non-structural ceiling crack is noted in the dining area, best addressed by monitoring for any progression and patching if necessary. Prompt remedial action will help maintain the property's condition and prevent further issues.

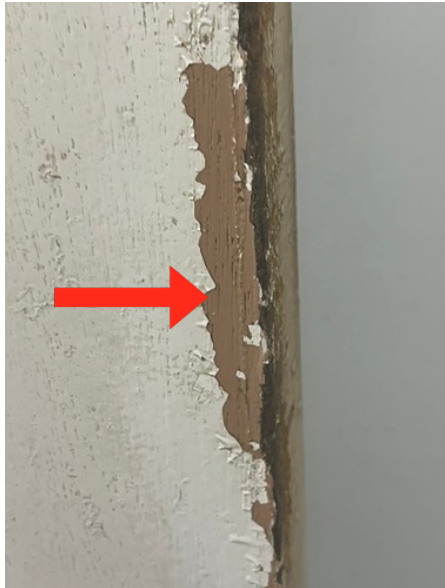
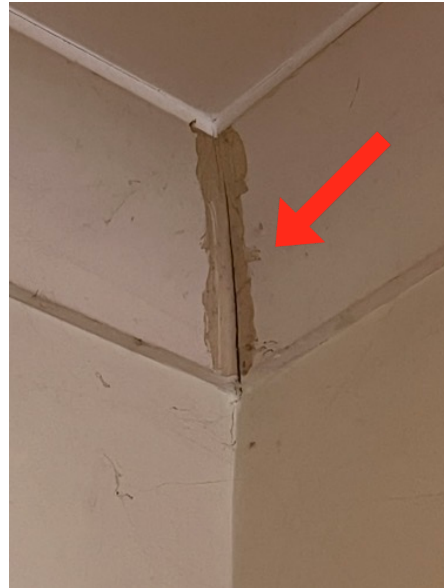
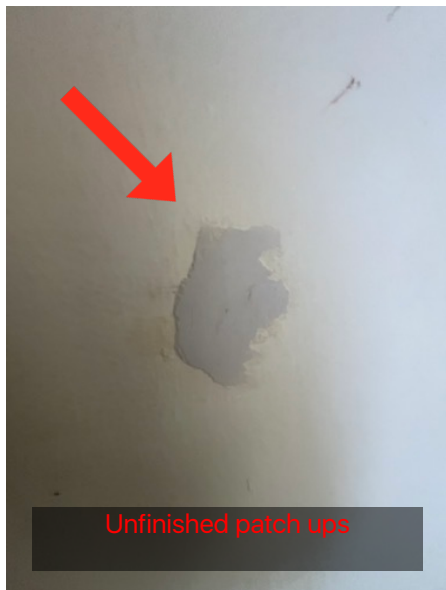
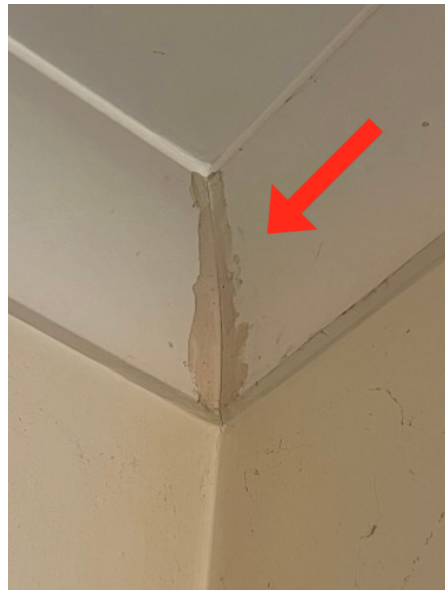
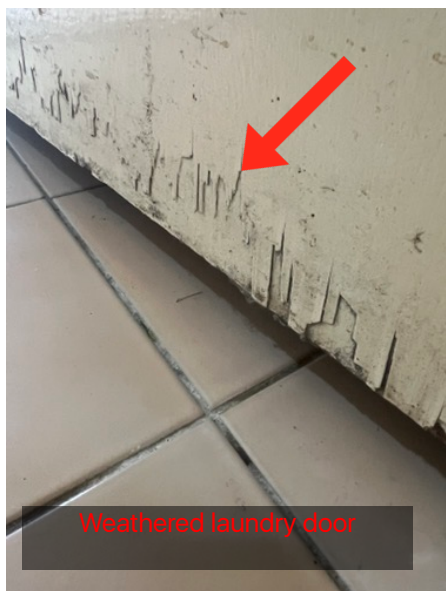
## Minor Defect 1.04

**Location:** Internally and externally

**Finding:** Wear and tear

General wear and tear is observed throughout the property, manifesting internally and externally. Notable defects include scratches on the timberwork, weathered external doors, and areas with unfinished patchwork and painting. To maintain the property's aesthetic and structural integrity, it is recommended to undertake remedial action. This should involve sanding and refinishing the scratched timber surfaces, replacing or refurbishing weathered doors, and completing necessary patchwork along with a fresh coat of paint. Such measures will not only enhance the property's appearance but also prevent further deterioration.

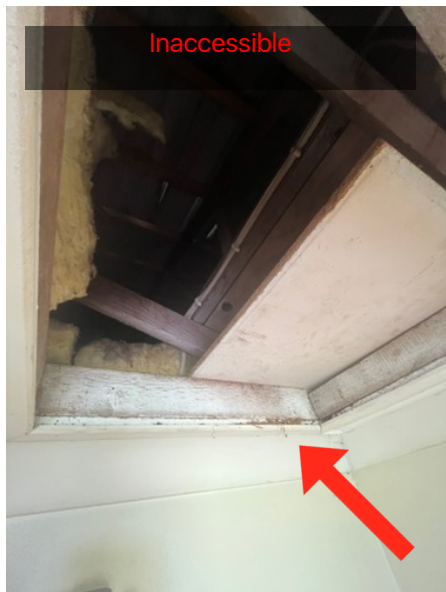
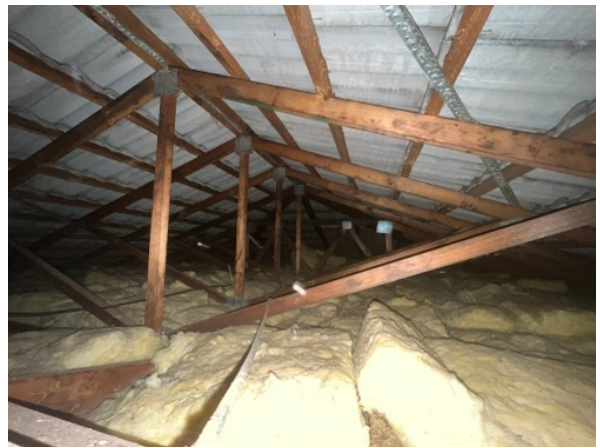
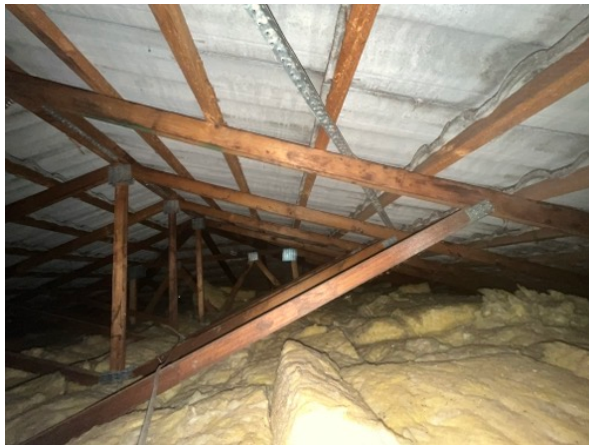
## For your information 2.03

**Location:** Roofspace  
**Finding:** Roofspace Overview - Truss Roof with Insulation only present

Note/Description: Roof sarking is a crucial layer of protection that is typically installed under the roof tiles or metal sheets. Its absence may lead to potential issues such as reduced thermal insulation, increased risk of water leaks during heavy rain, and decreased protection against dust and debris.

Possible risks: Without roof sarking, the dwelling may experience higher heating and cooling costs due to reduced insulation properties. In heavy rain or severe weather conditions, water leaks may occur, potentially leading to water damage and deterioration of building materials.

Recommendations: It is recommended to consider installing roof sarking to enhance the dwelling's thermal efficiency and protect against water infiltration. A qualified roofing specialist should be contacted to assess the roof's current condition and provide suitable options for the installation of roof sarking only at the owners discretion.

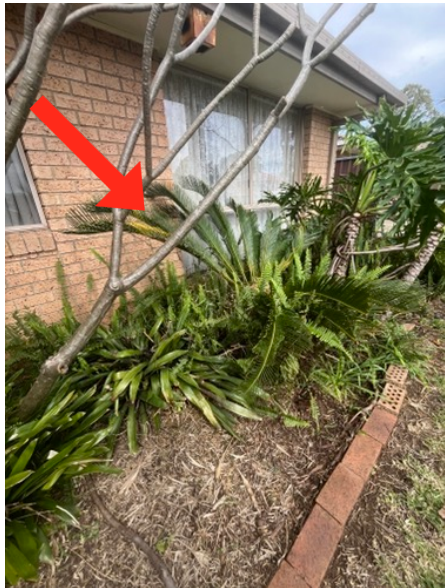
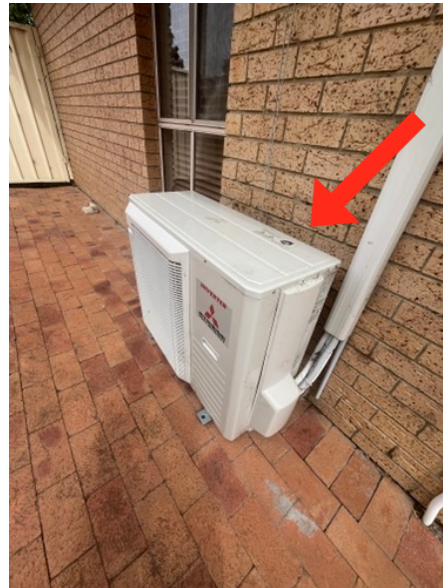
## Conditions conducive to timber pest attack 3.01

**Finding:** Bridging or Obstruction - Air Conditioner, Hot Water, Vegetation & Storage

Where bridging has occurred full inspection is prevented and termites may enter a property in a concealed or undetectable manner.

Recommend moving obstructions away from the external walls for further and future inspections.

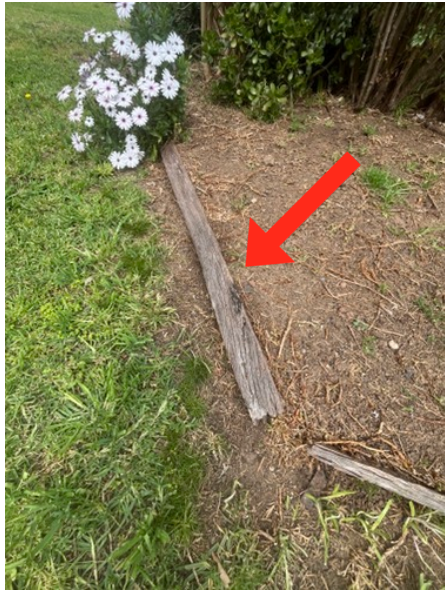
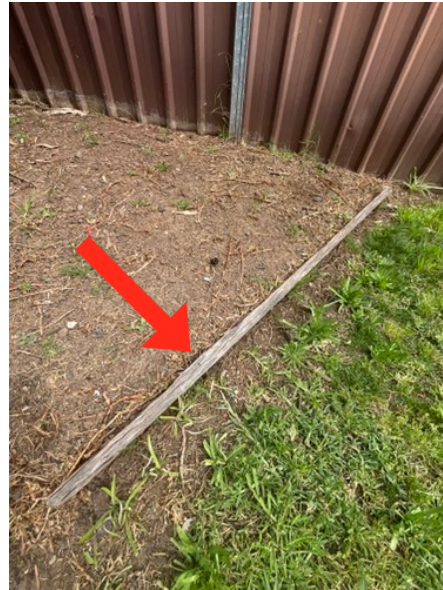
## Conditions conducive to timber pest attack 3.02

**Finding:** Timbers on Ground

Timbers at the property were found to be in contact with the ground. Where timber elements are in direct contact with the ground and consequently there is moisture or dampness they become conducive to termite activity. Whether timber is used as a building element part of a fencing structure or stored as an unused item they can provide an environment that is attractive to termite infestation. When met with excessive moisture timber begins to decay and develop wood decay. Any timbers that are in direct contact with external grounds especially if left untreated or non-durable also provide ingress for subterranean termites into that particular element. Any such materials that may be conducive to termite activity should be monitored frequently for any changes to minimise the risk of termite attack.

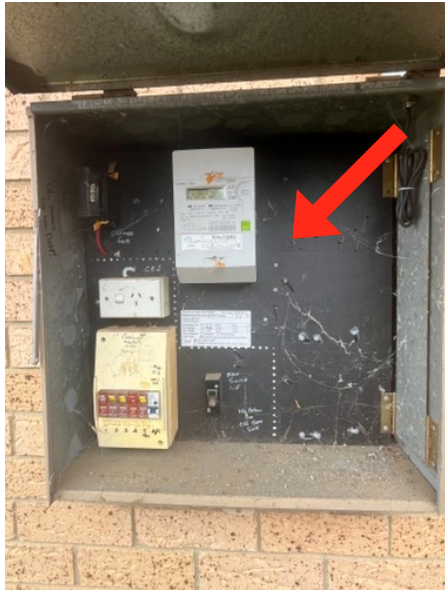
**Finding:** Durable Notice - Missing

A durable notice is missing from the meterbox. The application of a post-construction chemical termite barrier is highly recommended for all properties with timber building elements. Such barriers are highly effective in preventing termite attack on any timber building elements throughout the property. A durable notice should be placed in the meter board to indicate current termite barriers. At the time of inspection, it appeared as though no termite management system has been installed, with no evidence to suggest preventative works taking place which puts this property at very high risk. The client should consider gaining further advice from a licensed termite/timber pest technician as to the costs and procedures involved with implementing and maintaining a pest management system for this

Recommendations: Engage a qualified pest control expert with experience in termite management for older properties. They can assess the specific risk factors of the property, recommend appropriate treatments, and provide ongoing guidance to ensure effective termite prevention. Additionally, refer to local regulations and guidelines related to termite management for your area.
