Pre-Inspection Building And Timber Pest Report

Inspection Date: 16 Sep 2025

Property Address: 21/45 Bungarribee Road Blacktown 2148

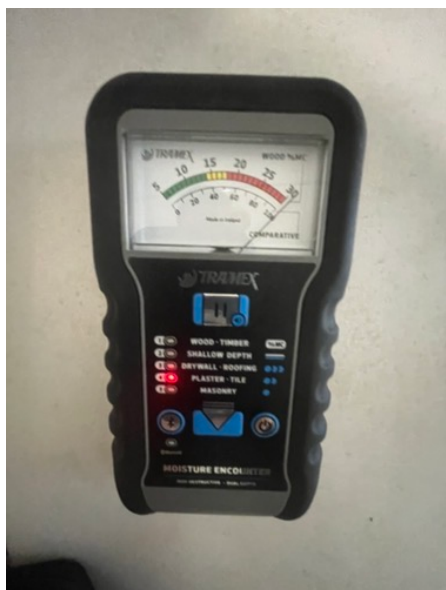
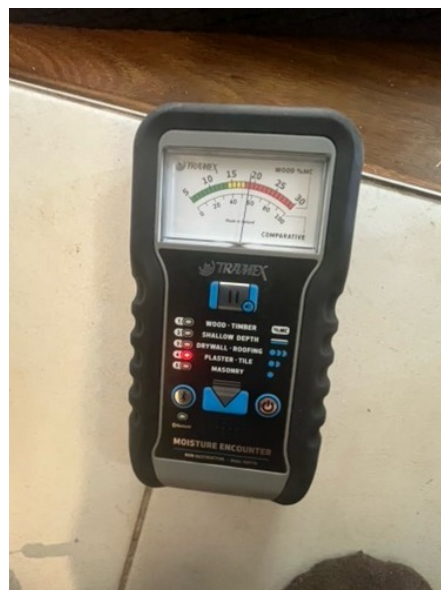
Minor Defect 1.01

Finding: High moisture readings

During the inspection, elevated moisture readings were detected outside the shower recess in the bathroom, indicating a potential moisture intrusion issue. This anomaly necessitates further investigation to determine its cause and scope and to assess whether remedial action is required. It is recommended to engage a qualified specialist to conduct a thorough examination of the area to identify any underlying problems, such as plumbing leaks or inadequate waterproofing. Depending on the findings, appropriate repairs, including resealing or replacing damaged components, may be necessary to prevent potential structural damage.

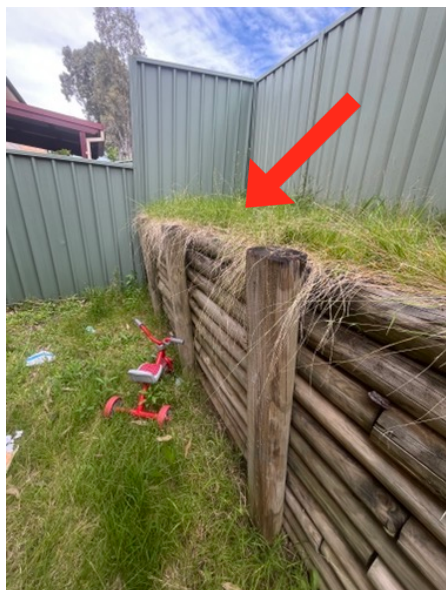
Minor Defect 1.02

Location: Backyard

Finding: Leaning Retaining Wall

The log retaining wall located in the backyard exhibits a slight lean, which, although not presently a cause for immediate concern, should be monitored for any changes over time. This could indicate potential future instability, possibly affecting the integrity of the structure. Homeowners are advised to conduct periodic inspections and consider consulting a structural engineer to evaluate the condition of the retaining wall. Proactive measures, such as reinforcing the existing structure or implementing a drainage system to manage water flow, may be recommended to prevent further leaning and ensure long-term stability.

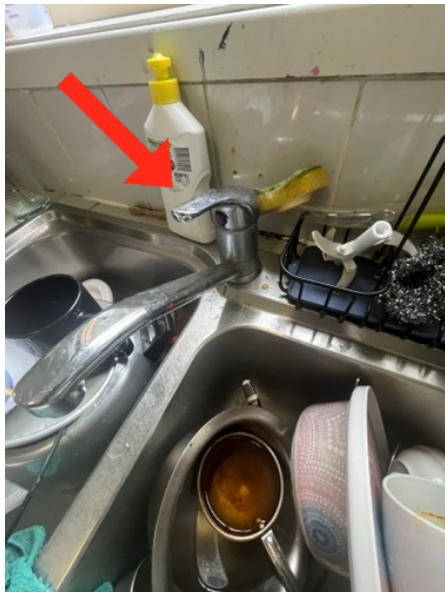
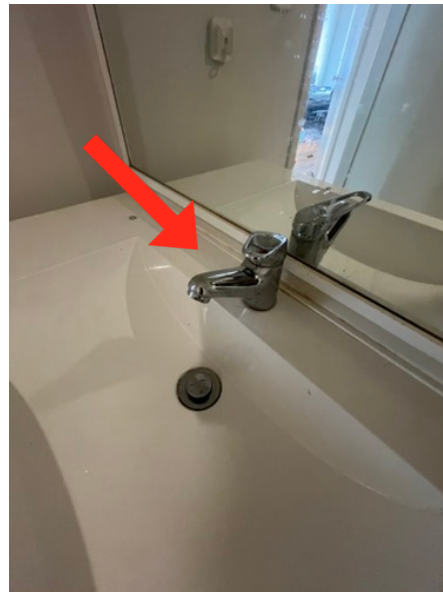
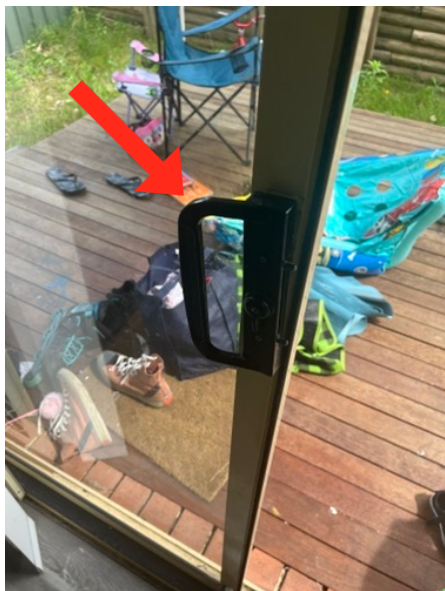
Minor Defect 1.03

Location: Bathroom, Kitchen and dining area

Finding: Water Hammer and Loose Fittings

During the inspection, water hammer was observed in the kitchen flick mixer and the bathroom vanity flick mixer, indicating potential pressure issues within the plumbing system. Additionally, the kitchen mixer was identified as being loose, which may lead to further instability or leakage. Furthermore, the door handle on the sliding door leading to the backyard was found to be loose, potentially compromising security and functionality. It is recommended to engage a qualified plumber to address the water hammer and secure the fixtures, and a skilled handyman to repair the sliding door handle to prevent further deterioration.

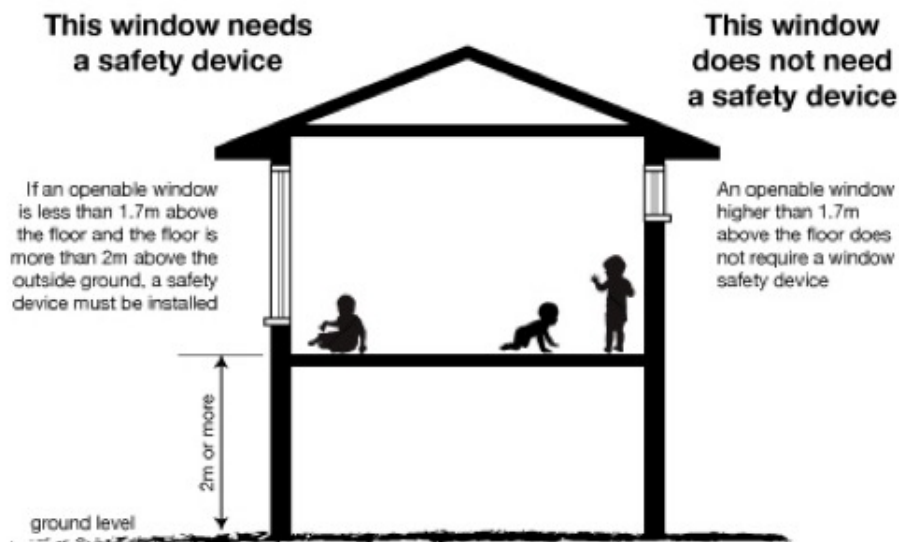
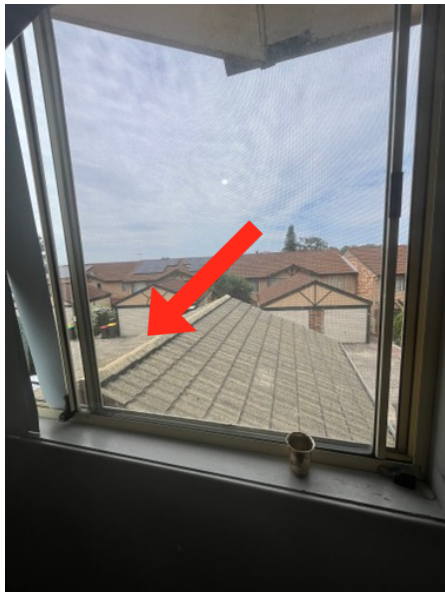
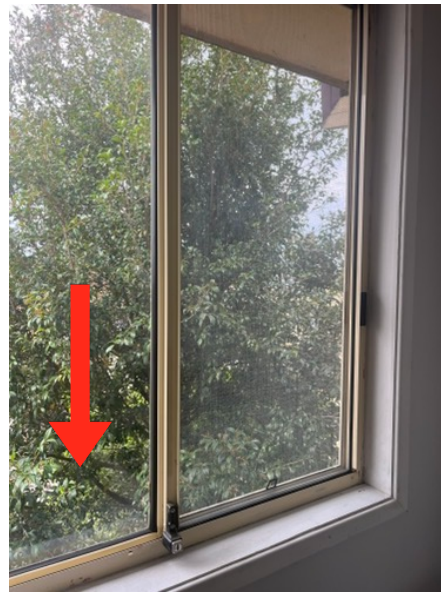
Minor Defect 1.04

Location: First floor Windows

Window restrictors were missing from upstairs windows. Windows need to be locked at 12.5cm when the devices are engaged. The safety devices must be robust and child proof. The alternative is security screens, such as bars or grills on the windows so long as they have gaps no bigger than 12.5cm. Flyscreens do not comply unless they are the reinforced security type and capable of resisting the very strong outward pressure which would prevent a child falling through.

The laws apply to openable windows in a building within 1700mm of the internal floor and if the internal floor is more than 2m above the ground floor outside.

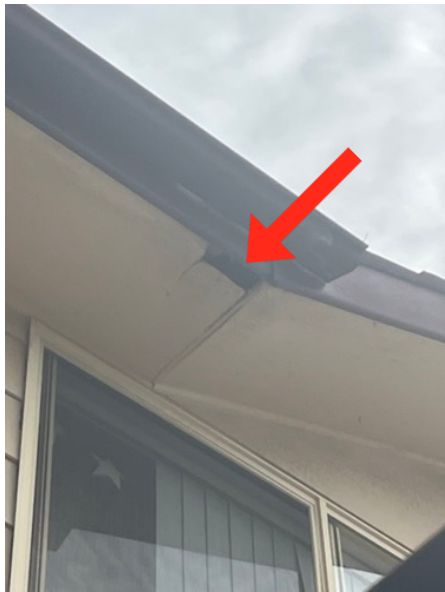
Minor Defect 1.05

Location: Front Facade

Finding: Hole in the Eaves

During the inspection, it was observed that there is a hole in the eaves located on the first-floor front facade of the property. The origin of this defect remains unknown but has potential implications for water intrusion and pest ingress, compromising structural integrity. It is advisable to engage a qualified builder to thoroughly assess the damaged area and implement necessary repairs. Sealing the hole and ensuring the eaves are structurally sound will prevent further deterioration and protect against potential environmental damage.

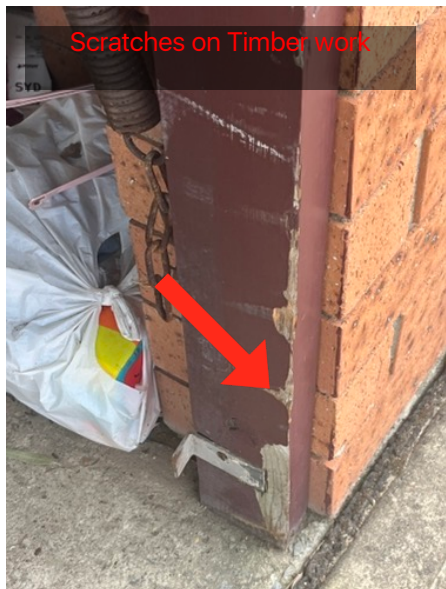
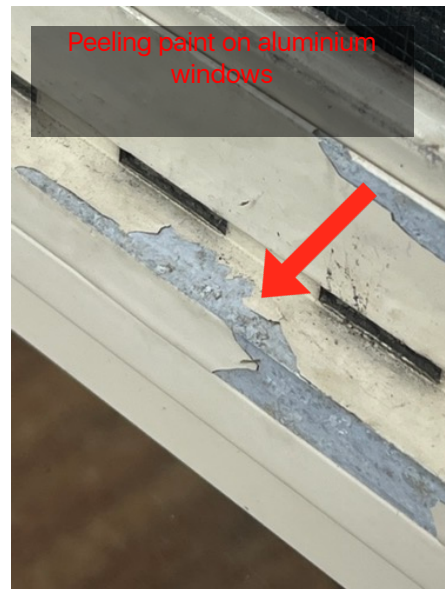
Minor Defect 1.06

Location: Internal and external areas

Finding: Wear and Tear

The property exhibits wear and tear consistent with its age, notably evident in the condition of the paintwork. The surface treatments have deteriorated over time, diminishing the overall aesthetic appeal and potentially compromising protective functionality. It is recommended that a comprehensive repainting of the affected areas be undertaken to restore the property's visual appeal and safeguard the underlying materials from further degradation. Such remedial action would enhance not only the appearance but also the longevity and value of the property, ensuring its continued serviceability for the foreseeable future.

Scuff marks and dirty walls

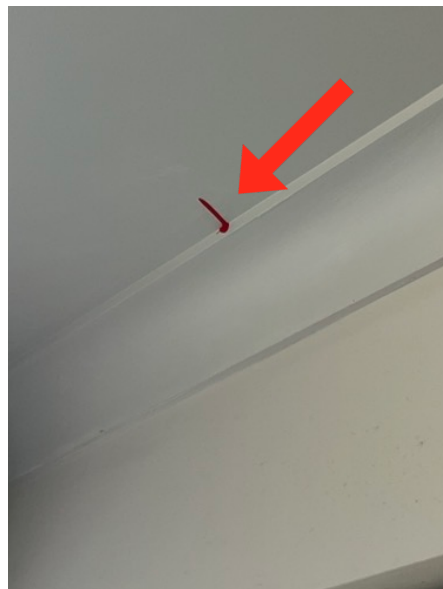
Minor crack on plasterboard

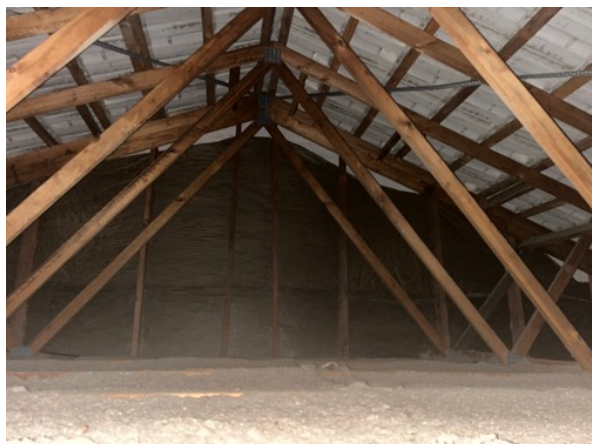
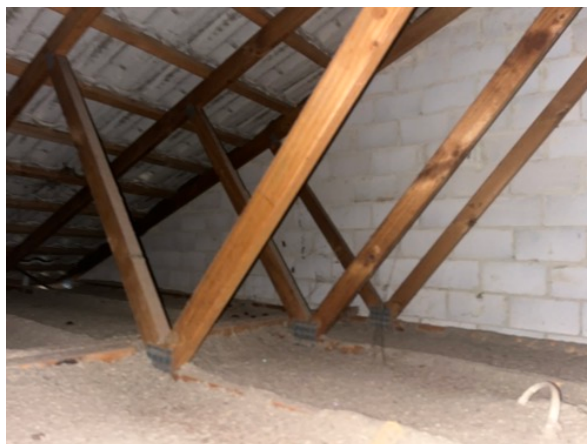
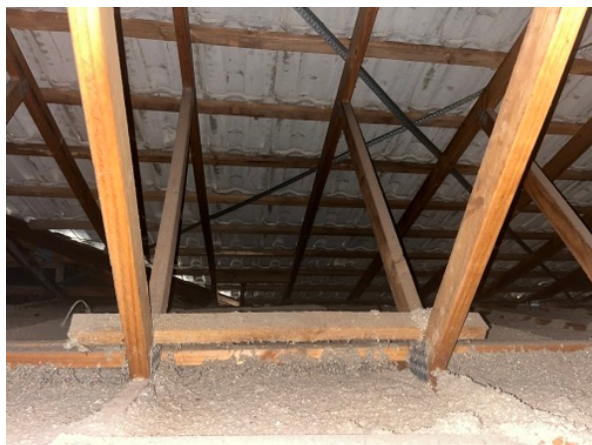
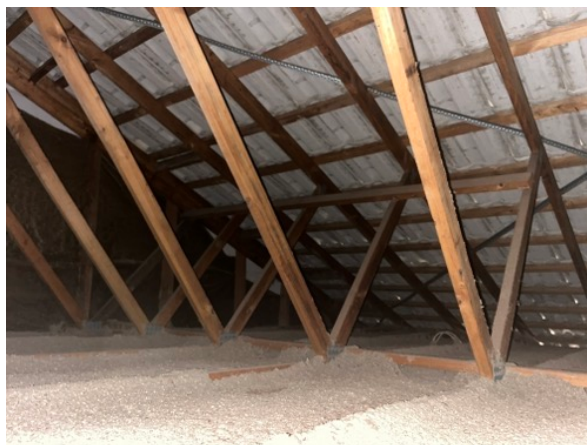
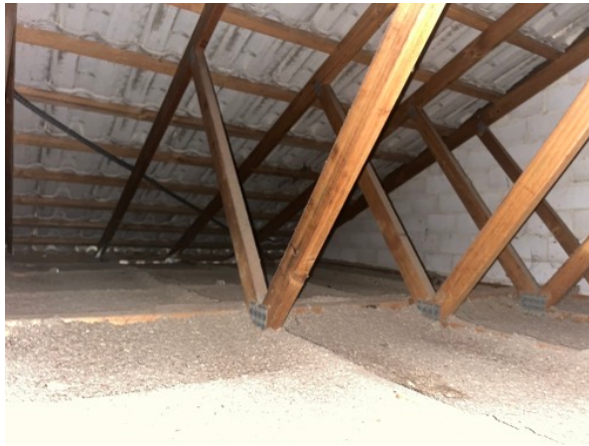
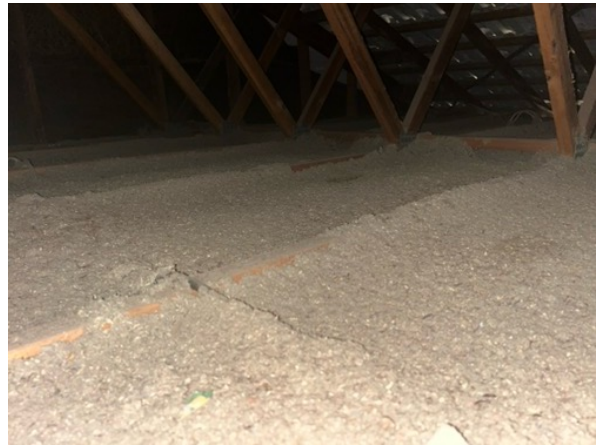
For your information 2.03

Location: Roofspace

Note/Description: Roof sarking is a crucial layer of protection that is typically installed under the roof tiles or metal sheets. Its absence may lead to potential issues such as reduced thermal insulation, increased risk of water leaks during heavy rain, and decreased protection against dust and debris.

Possible risks: Without roof sarking, the dwelling may experience higher heating and cooling costs due to reduced insulation properties. In heavy rain or severe weather conditions, water leaks may occur, potentially leading to water damage and deterioration of building materials.

Recommendations: It is recommended to consider installing roof sarking to enhance the dwelling's thermal efficiency and protect against water infiltration. A qualified roofing specialist should be contacted to assess the roof's current condition and provide suitable options for the installation of roof sarking only at the owners discretion.

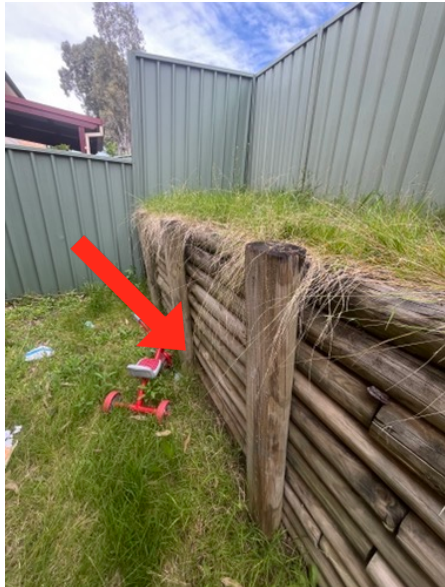
Conditions conducive to timber pest attack 3.01

Finding: Timbers on Ground

Timbers at the property were found to be in contact with the ground. Where timber elements are in direct contact with the ground and consequently there is moisture or dampness they become conducive to termite activity. Whether timber is used as a building element part of a fencing structure or stored as an unused item they can provide an environment that is attractive to termite infestation. When met with excessive moisture timber begins to decay and develop wood decay. Any timbers that are in direct contact with external grounds especially if left untreated or non-durable also provide ingress for subterranean termites into that particular element. Any such materials that may be conducive to termite activity should be monitored frequently for any changes to minimise the risk of termite attack.
