# Property Inspection Report

**65 Sherridon Crescent,  
Quakers Hill, 2763, NSW**

**Date of Inspection: 4/10/2025 | Time: 12:30PM**

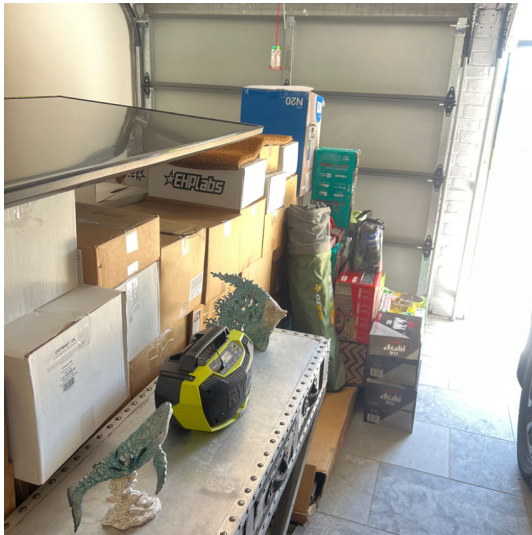
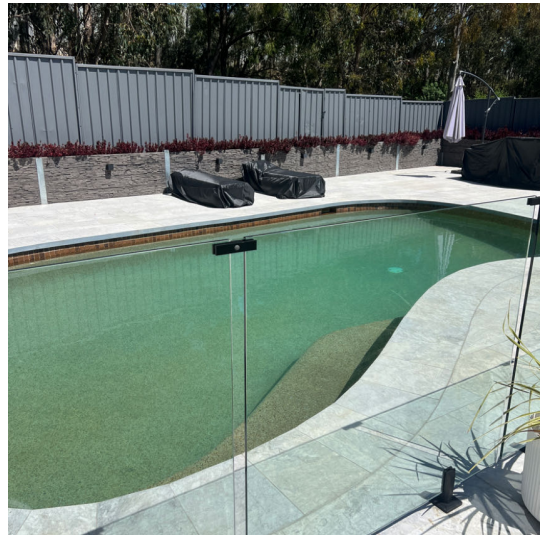
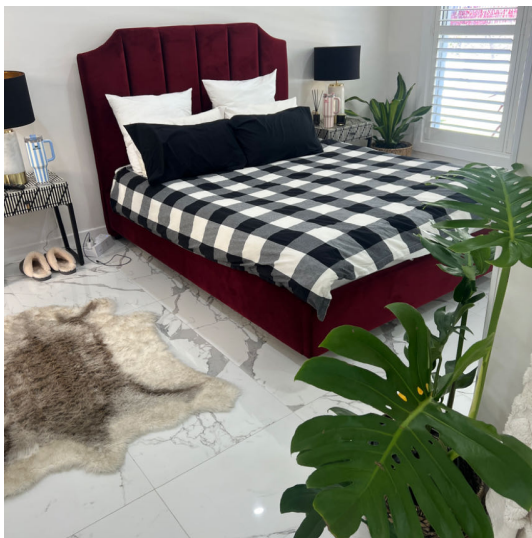
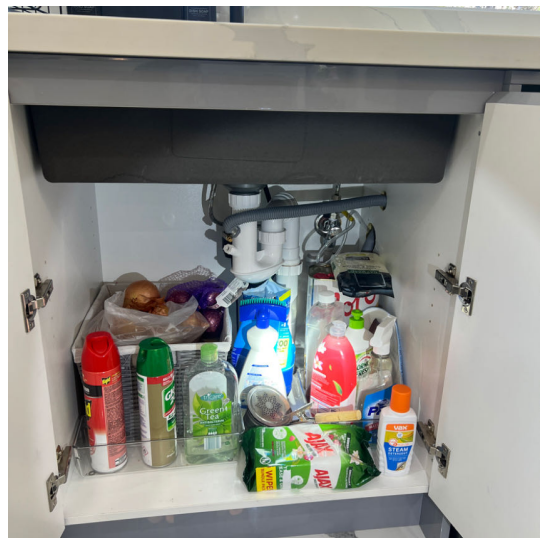
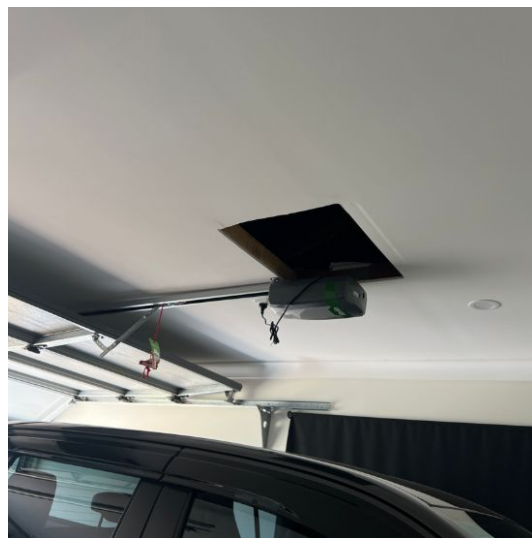
- The garage visual inspection was obstructed or restricted because stored items.
- A pool was noted. This was not tested as part of the inspection process and should be checked at the final pre-settlement inspection.
- The interior visual inspection was obstructed or restricted because stored items.
- We recommend all braided flexible water hoses in the property be checked regularly and replaced as required to prevent water damage.
- The internal roof space was not able to access the hatch due to vehicle parked.

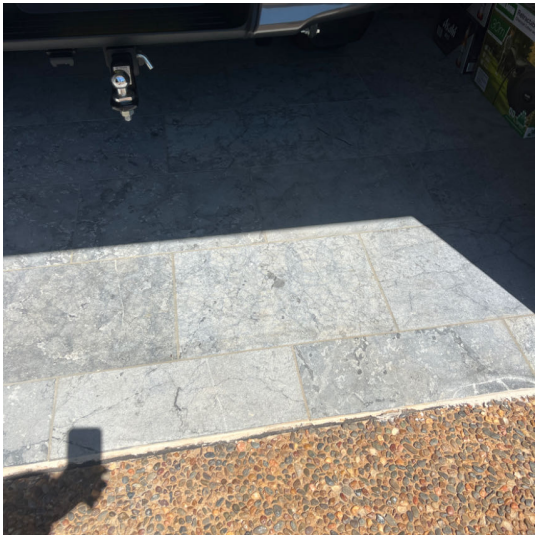
- Visible sections of the concrete slab appeared satisfactory.
  - Most areas of the concrete slab not visible due to floor coverings.
  - All concrete floor slabs experience some degree of cracking due to shrinkage in the drying process. In most instances floor coverings prevent recognition of cracks or settlement in all but the most severe cases. Where carpeting and other floor coverings are installed, the materials and condition of the flooring underneath cannot be determined.

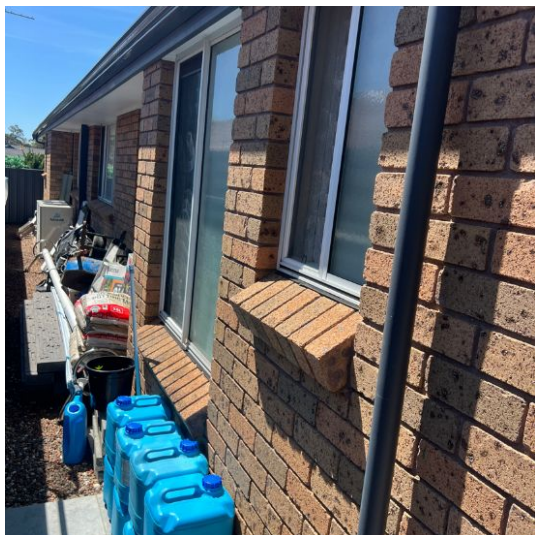
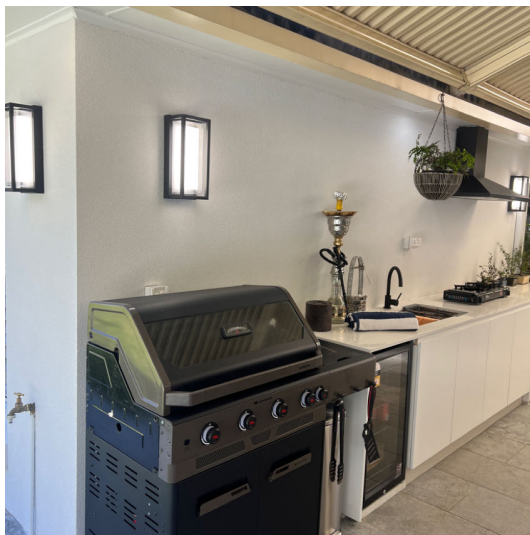
- The wall structure components appeared functional.
- Externals walls are of a timber frame and rendered brick veneer construction.

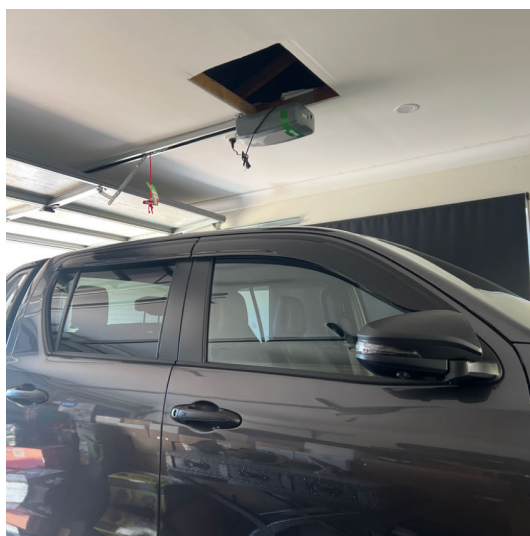
- The internal roof space did not have reasonable access available because parked vehicle.

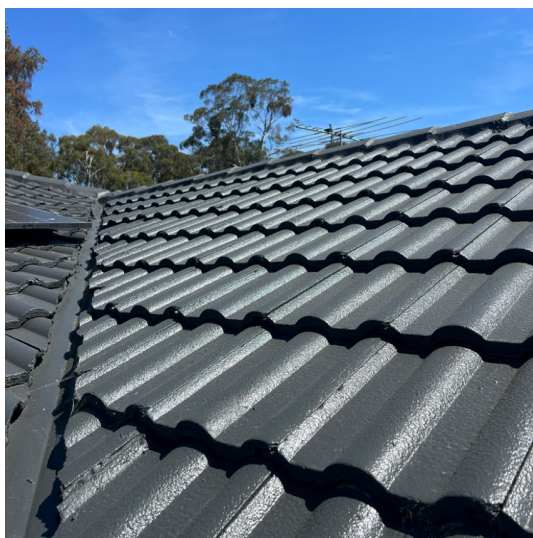
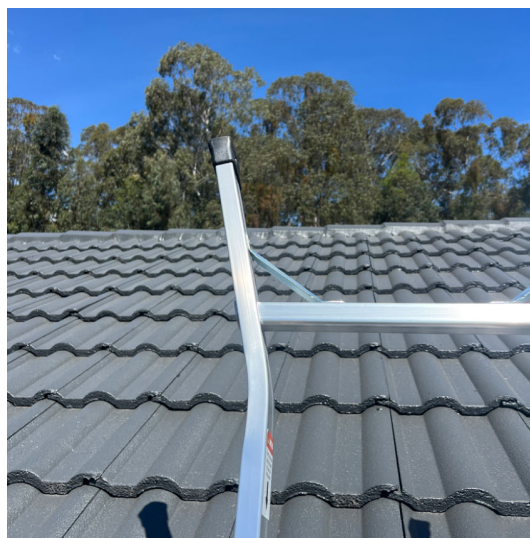
- The concrete tile roofing material appeared to be in satisfactory condition other than noted.

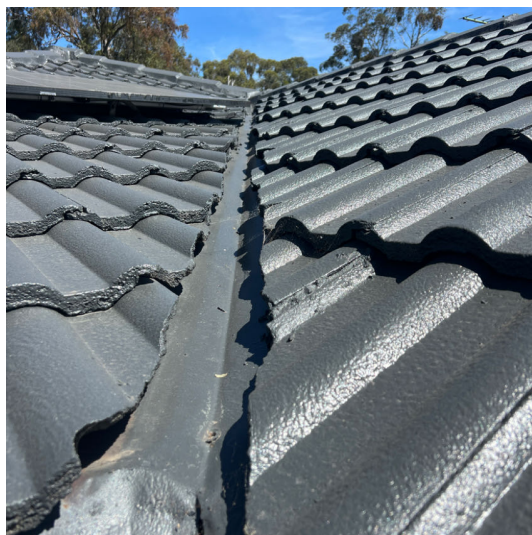
- Flashing is an impervious material (usually galvanized sheet metal) that comes in a variety of shapes and sizes and is used to cover, waterproof, and direct water away from roof penetrations and from valleys and intersections between the roof covering and other materials.
- The roof flashing, where visible, appears to be in satisfactory condition.

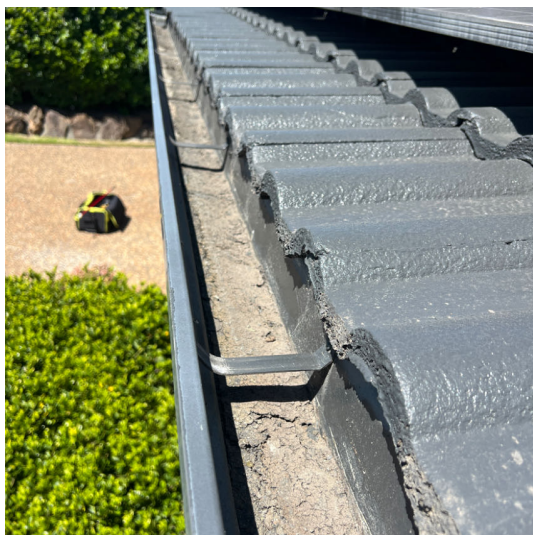
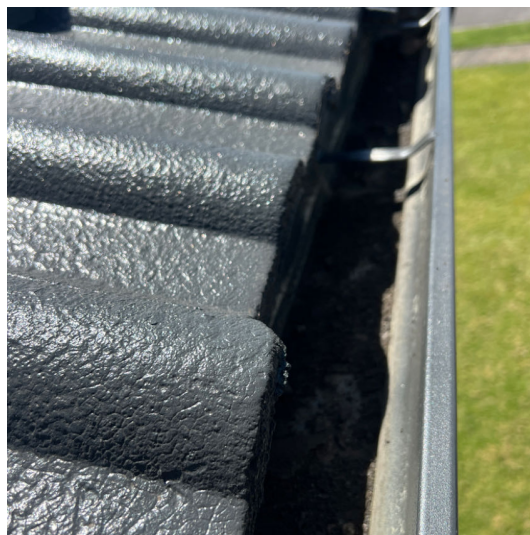
- No major function concerns noted at the time of inspection.
- The gutters should be regularly cleared of debris to ensure the proper flow of water from the roof.

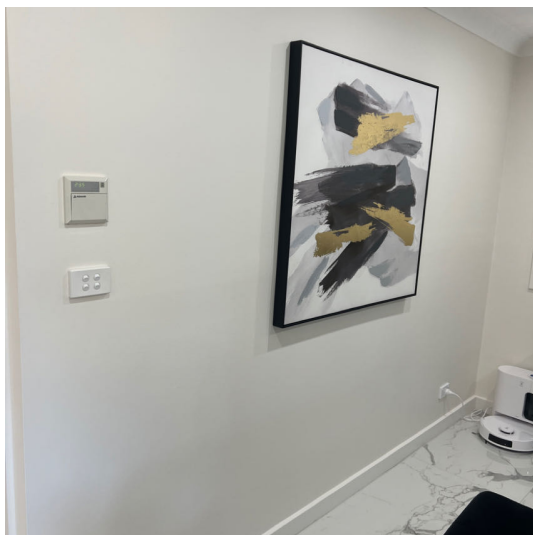
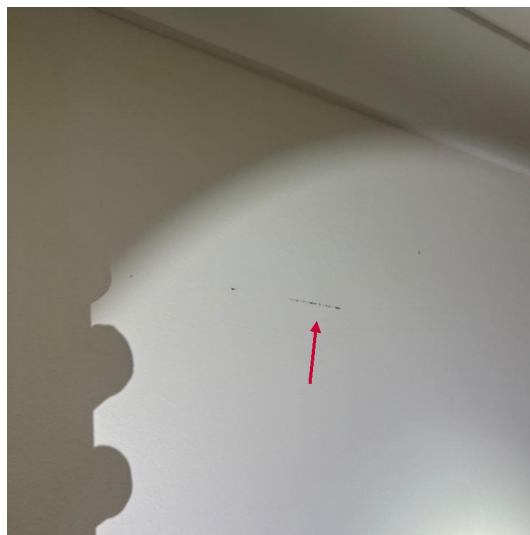
- There are marks and imperfections to the interior walls at bedroom 2. These can be repaired normally.

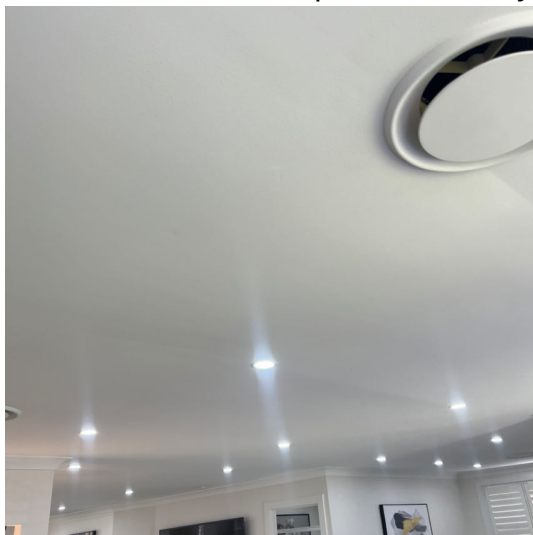
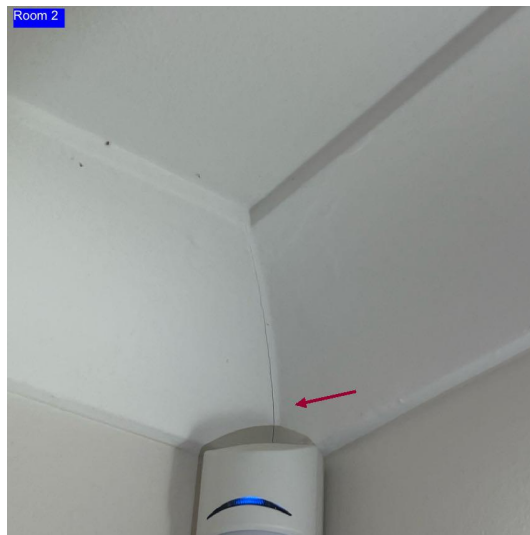
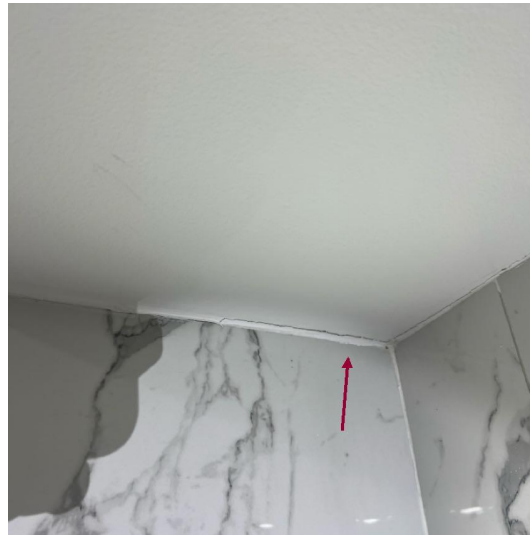
- There is minor cracking which has occurred at the interface between the ceiling cornice and the wall at bedroom 1 and main bathroom. This can be a result of foundation settlement and/or movement in the roof structure. This does not appear to have affected the structural integrity of the home and can be repaired normally.

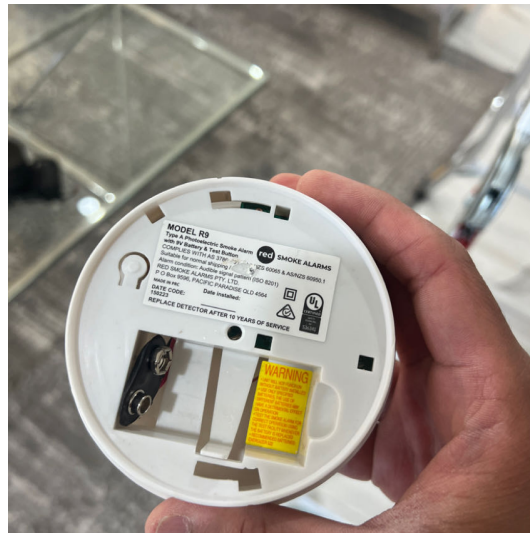
- Testing of smoke alarms is not included in this inspection. Pushing the "Test" button only verifies that there is power at the alarm--either a battery or hardwired to the house power--and not the operational workings of the alarm. The operational check is done by filling the sensor with smoke and is beyond the scope of this inspection. Battery operated smoke alarms should be checked routinely and the batteries changed frequently.
- There is a battery operated smoke alarm installed in the bedroom hallway area. Smoke alarm due for replacement in 2033.

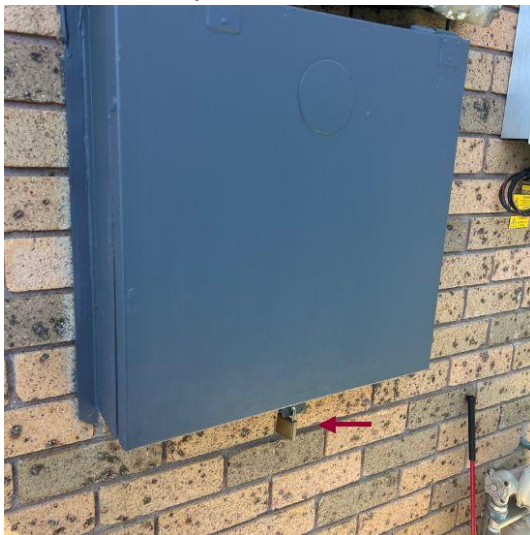
Observations: As the main panel was locked it was unable to be verified that two RCD's have been installed. This should be checked prior to settlement taking place and is required to be carried out by the vendors.

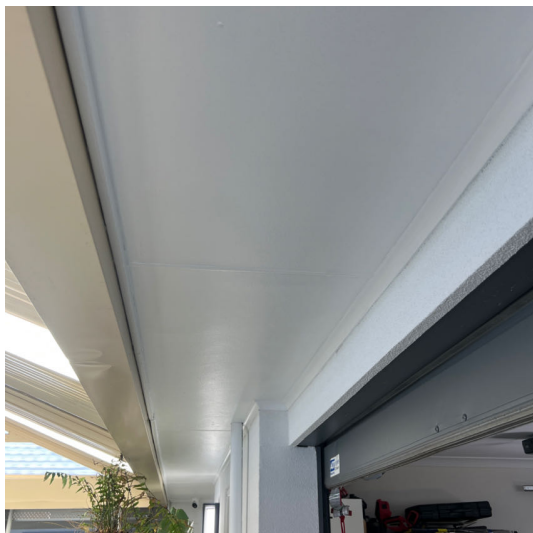
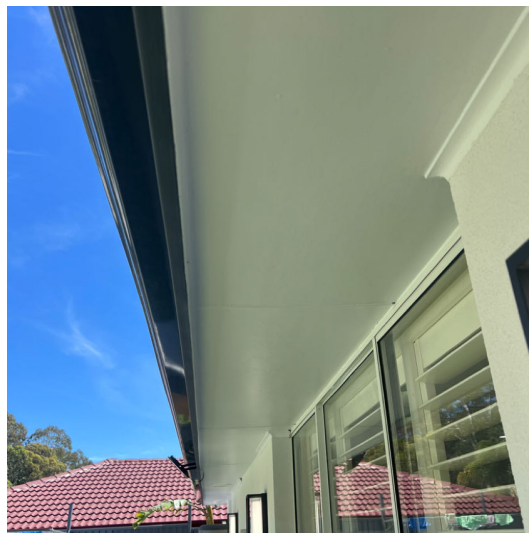
- The eaves are in satisfactory condition.

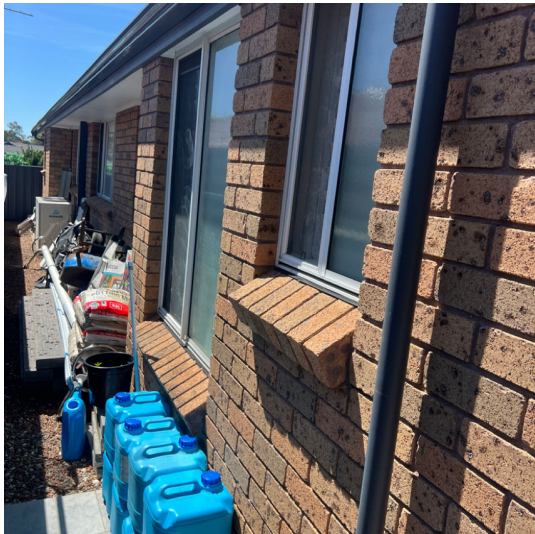
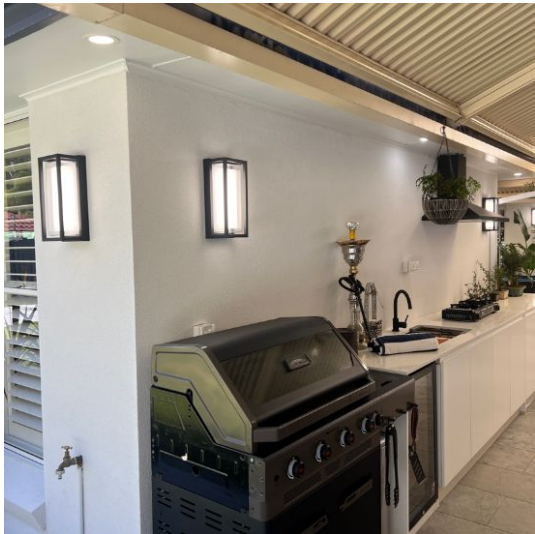
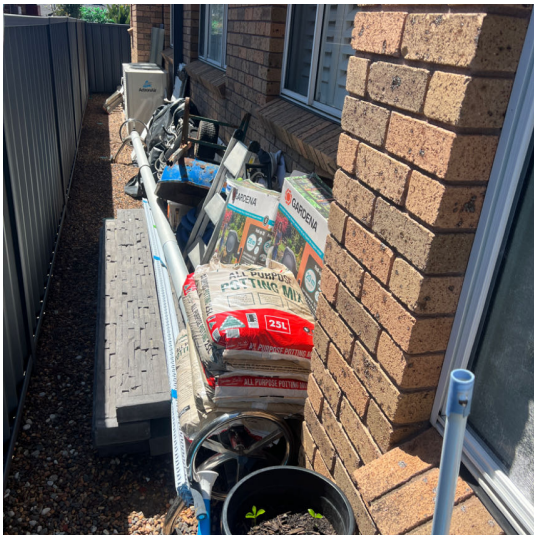
- Materials:
- The rendered brick wall covering is in a satisfactory condition.
- Observations:
- Stored materials was observed near the external wall. This could be potential safety hazards, obstruct access and contribute to moisture retention against walls.

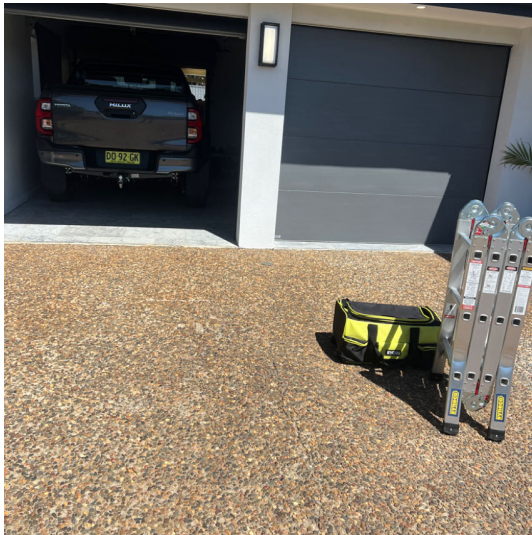
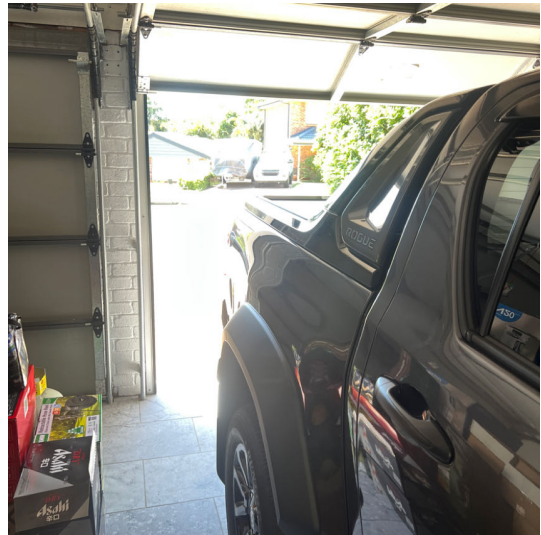
- Materials:
- The attached brick garage appears structurally sound.

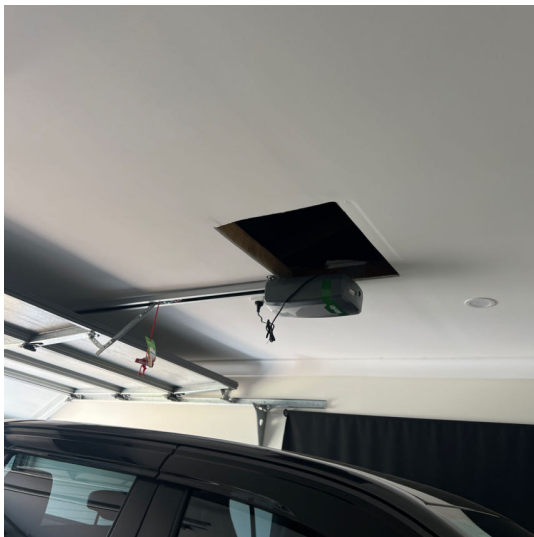
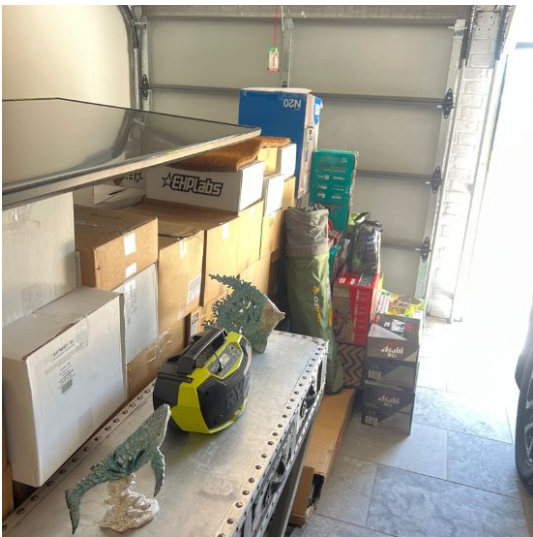
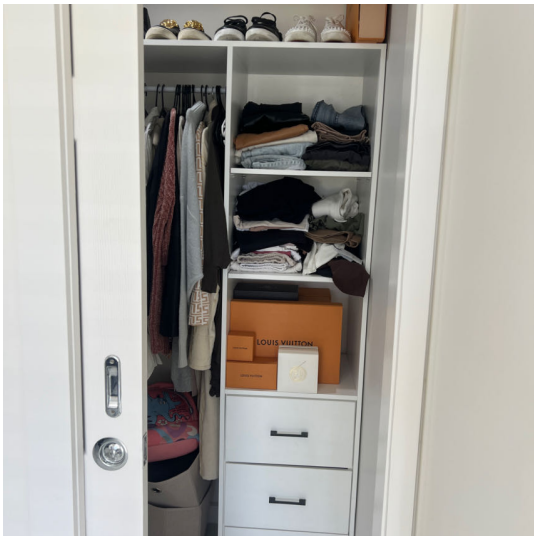
The garage visual inspection was obstructed or restricted because of stored materials.

The interior visual inspection was obstructed or restricted because stored materials.

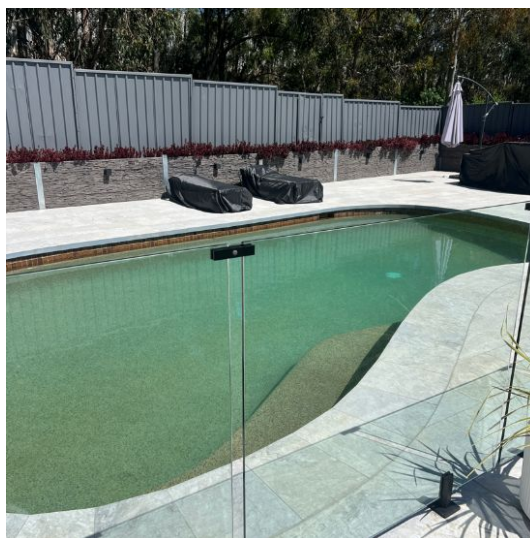
Observations: There did not appear to be any evidence of excessive moisture.

Ensure above and below ground pools/spas are free of leaks as this condition will create excessive moisture.

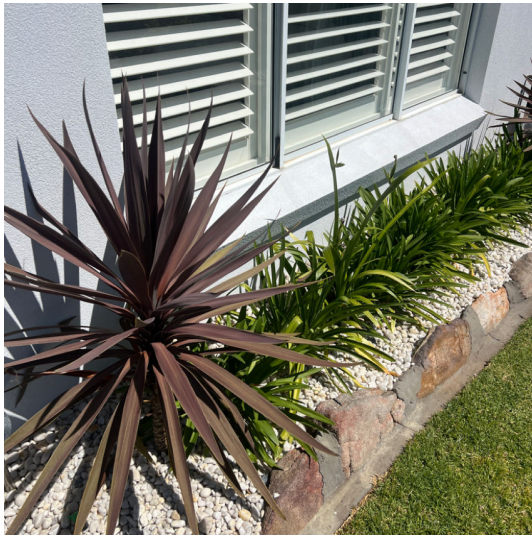
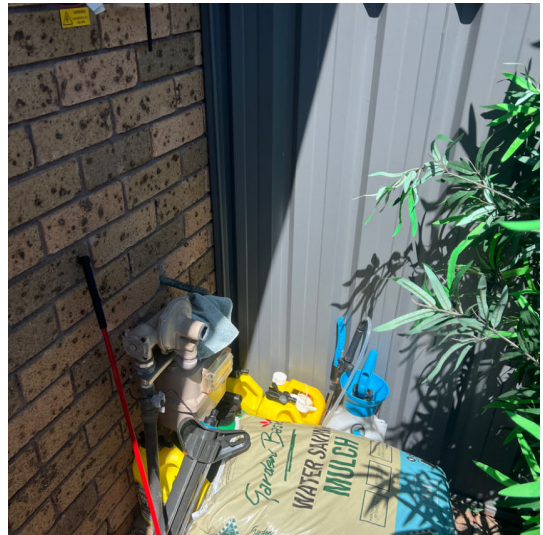
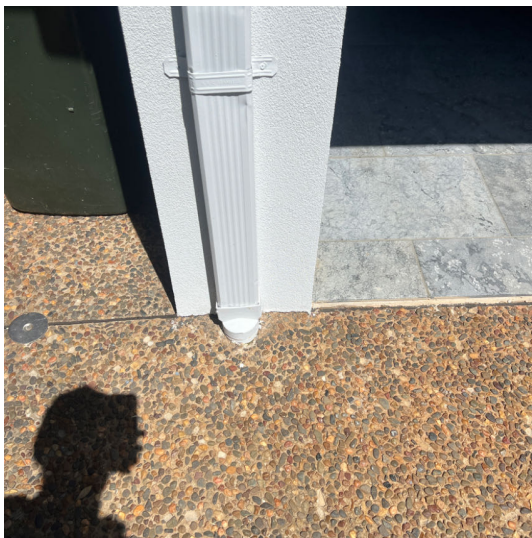
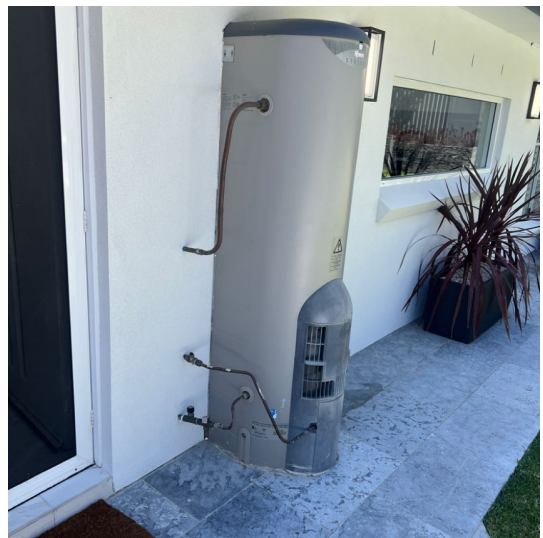
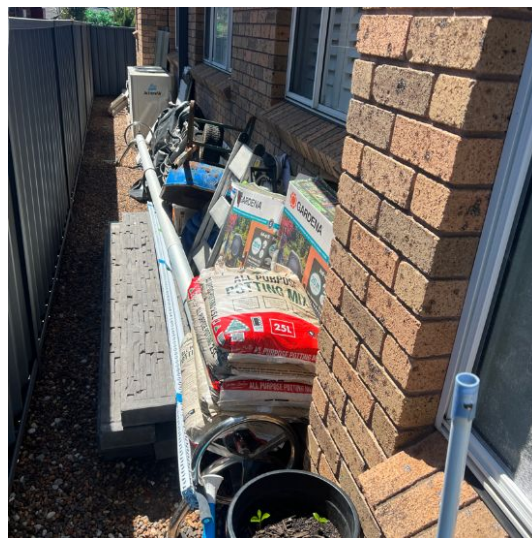
The support post for the front steps hand rail is in direct contact with the ground and the property, which may allow termites to breach any barrier and gain concealed access to the property structure.

The stored items against the exterior wall, which may allow termites to breach any barrier and gain concealed access to the property structure.

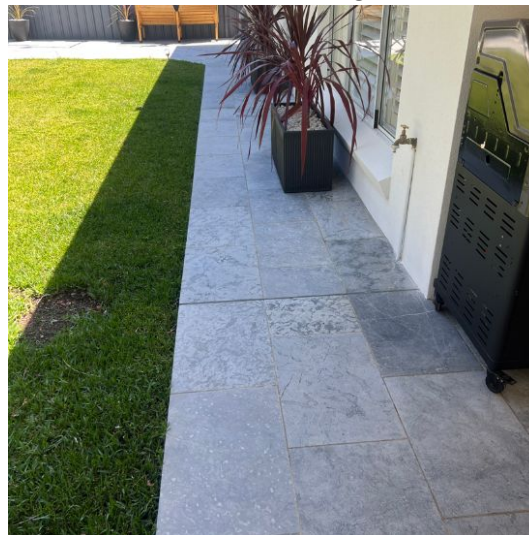
- Slab edges are covered by concrete. This may allow concealed termite entry into the wall frame. Slab edges should be cleared of concrete.

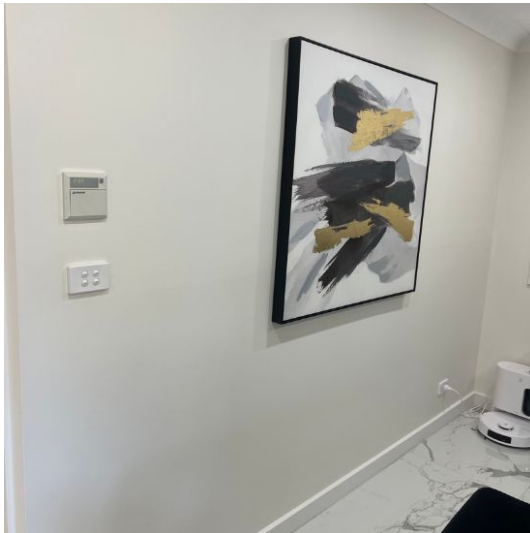
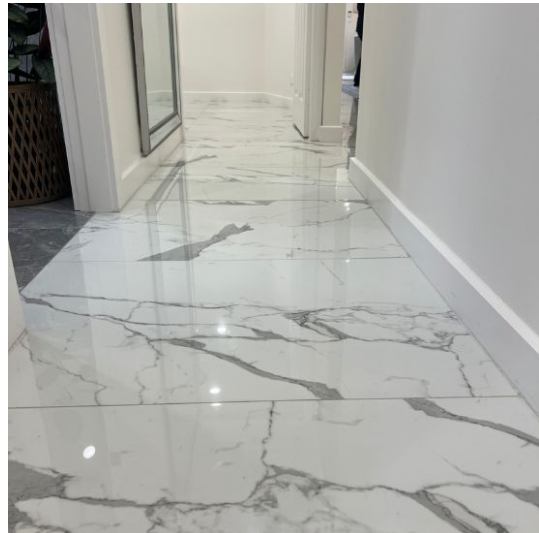
- Timber skirting and door frames appear functional.

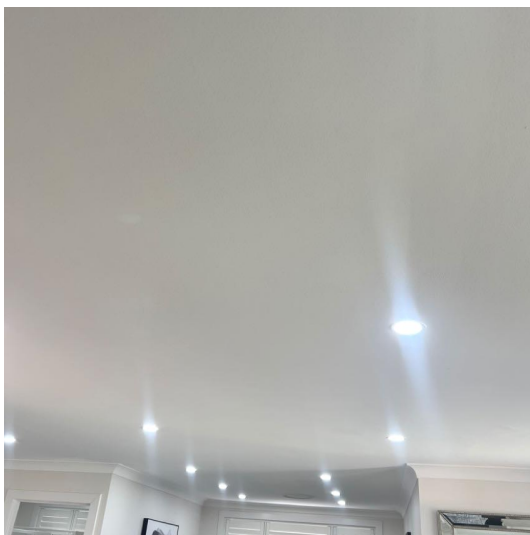
- There are plasterboard/gyprock ceilings in the property which appear functional.

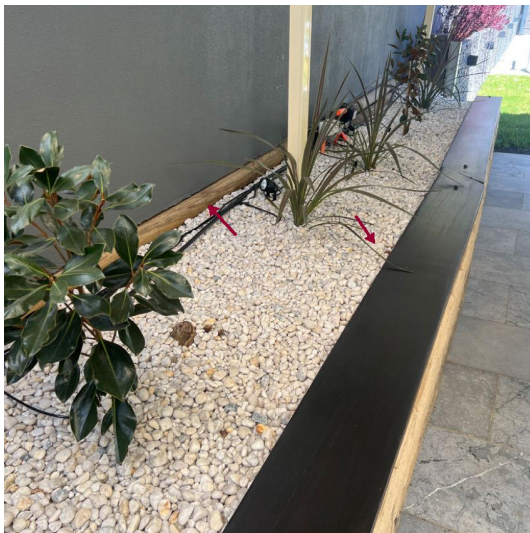
- There is landscaping/stored timber, or old tree stumps in contact with the ground that provides possible breeding grounds for subterranean termites. These should be removed.

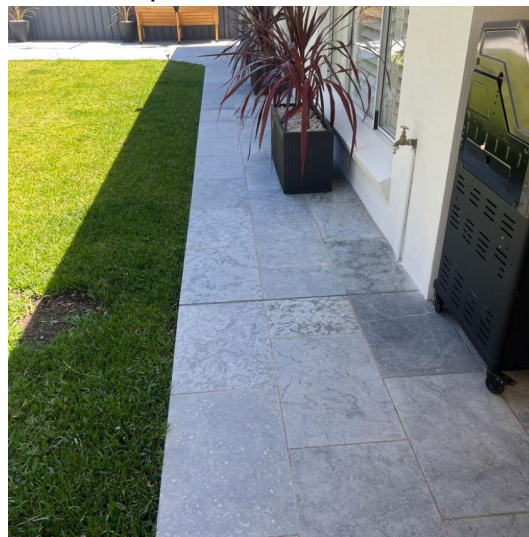
- It is important to redirect moisture away from the property to limit areas of excess moisture. Faulty gutters and downpipes in poor condition can cause water to seep into the foundations, causing conditions conducive to termites and fungal decay.
- Surface drainage conditions within 3 metres of the inspected structure appeared satisfactory given the prevailing weather conditions at the time of inspection. There was no evidence noted of water pooling at or around the building structure. These areas should be monitored during periods of heavy rainfall for a full representation of drainage conditions.
- There are no drains located beneath the outdoor taps. This can cause water pooling if the taps were to leak. Recommend drains be installed beneath the taps. Where this is not possible it is important to ensure taps are well maintained to prevent leaks.

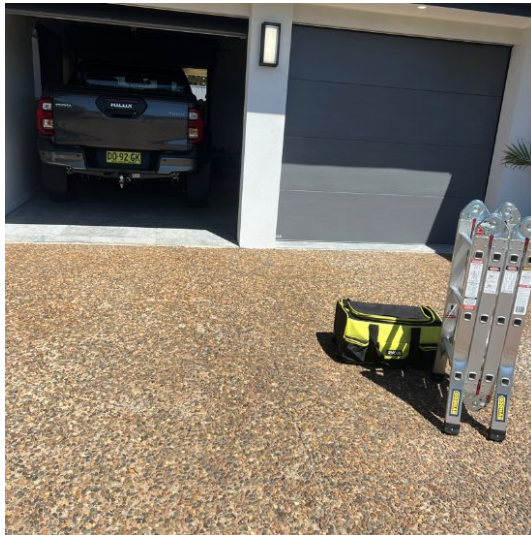
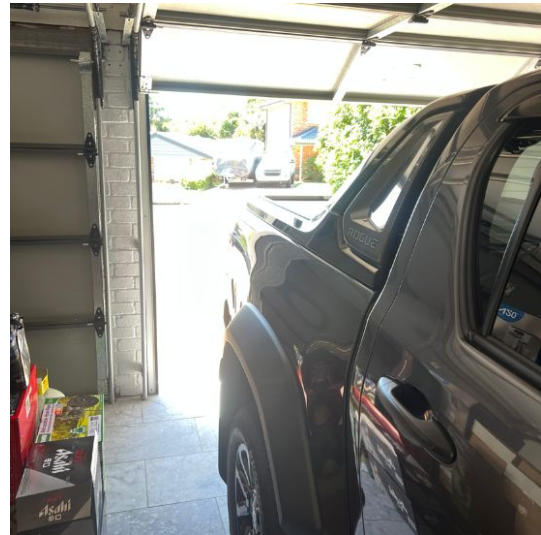
- Appeared satisfactory.

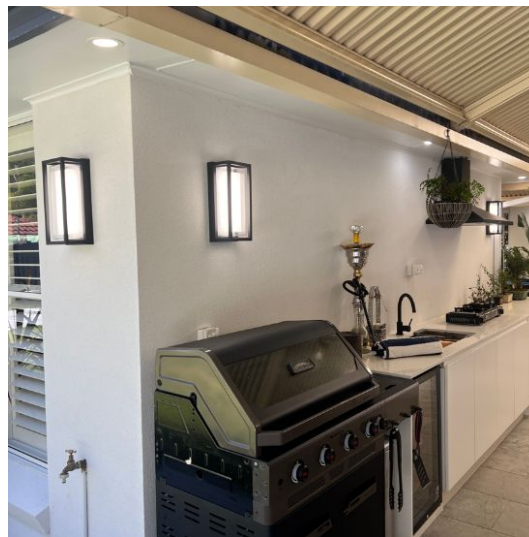
- Rendered brick noted.

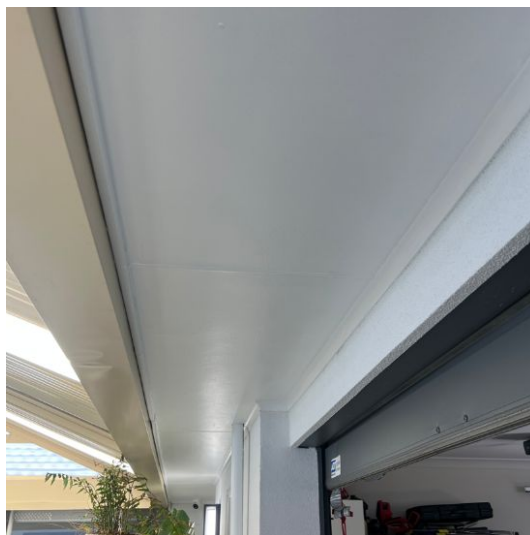
- The eaves are in satisfactory condition.
