# Pre Inspection Building And Timber Pest Report

**Inspection Date: 16 Oct 2025**

Property Address: 5 Yantara Place Woodcroft 2767

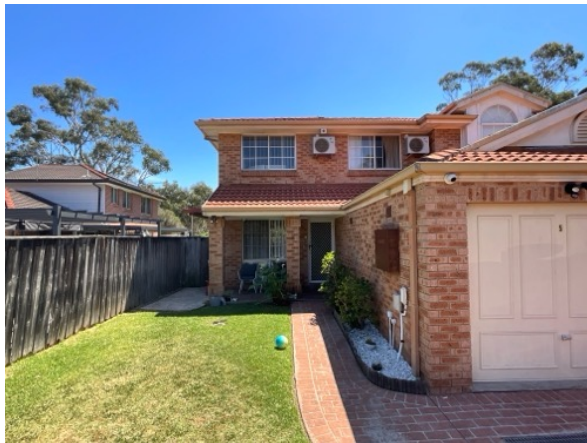
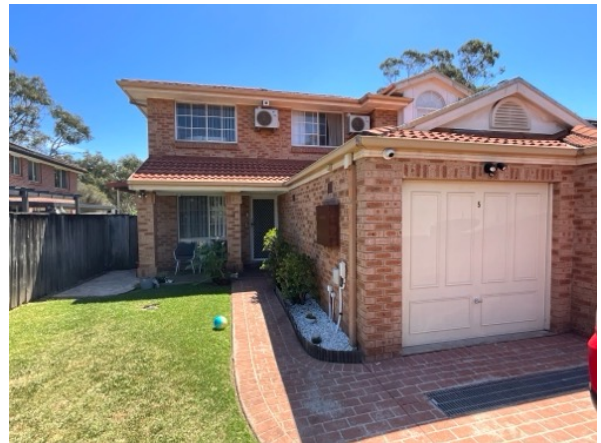
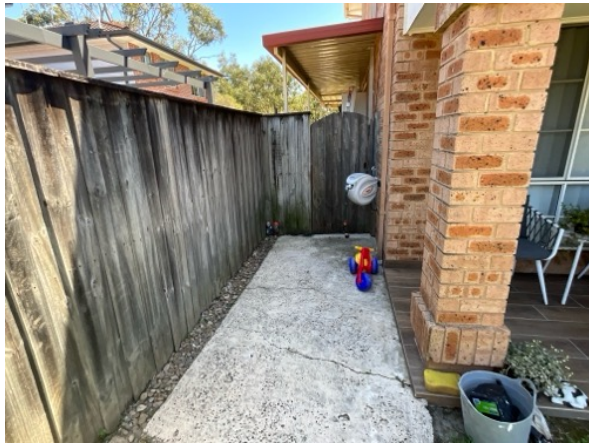
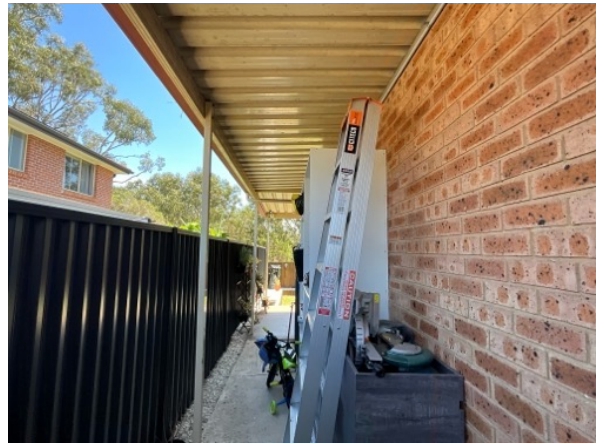
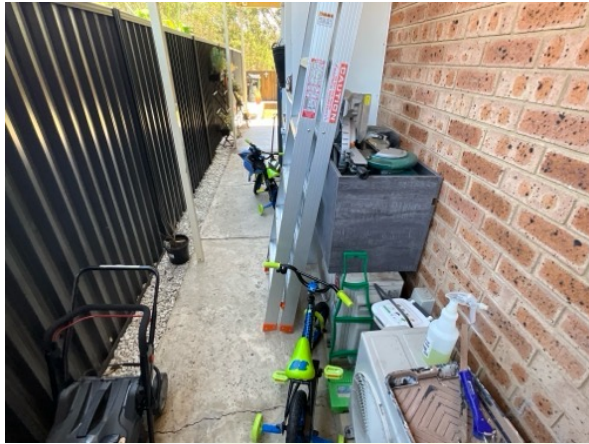
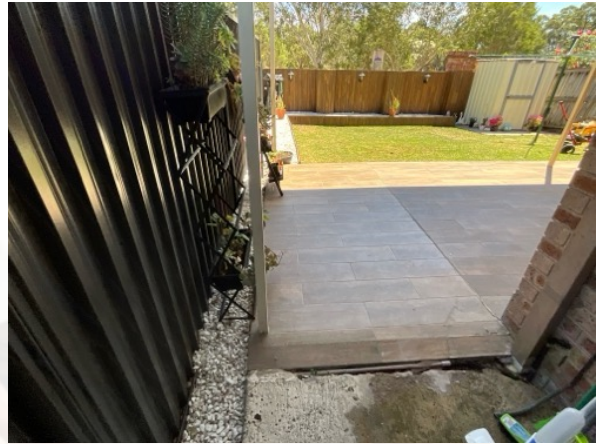
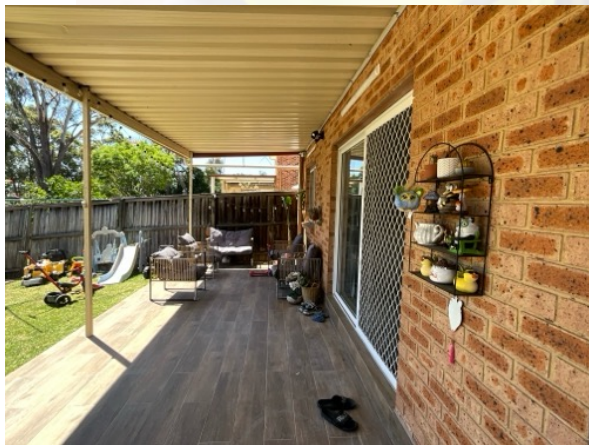
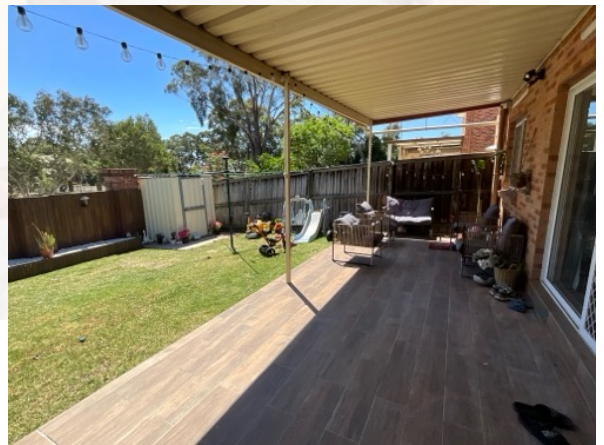
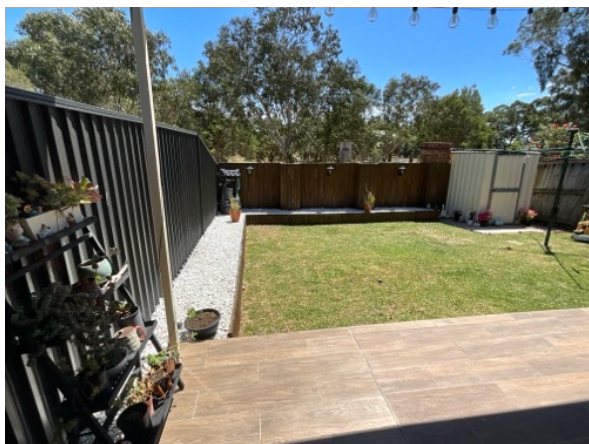
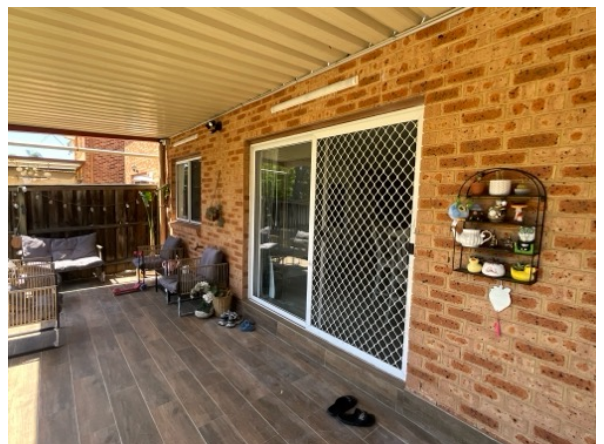
## For your information 1.01

**Location:** All External Areas

The external areas of the property were thoroughly inspected for any visible defects or issues. The following external components and features were assessed, and the observations are as follows:

1. **Roofing:**The roof was examined for signs of damage, missing tiles, or leaks. No significant roofing issues were detected during the inspection.
2. **Exterior Walls:**The exterior walls were inspected for cracks, dampness, or structural concerns. No major defects were found, and the walls appeared to be in satisfactory condition.

3. **Gutters and Downpipes:**Gutters and downpipes were checked for blockages or damage. It is noted that regular maintenance is essential to ensure proper water drainage and prevent potential water-related issues.

4. **Windows and Doors:**External windows and doors were examined for proper functionality, seals, and signs of wear. All windows and doors were found to be in good working condition.

5. **Driveway and Pathways:**The driveway and pathways were inspected for cracks or uneven surfaces. Minor wear and tear were observed, but no significant defects were noted.

6. **Fencing and Gates:**The property's fencing and gates were examined, and no major issues were identified. However, routine maintenance is recommended to ensure their longevity.

7. **Landscaping:**The landscaping around the property was reviewed, and no specific concerns were noted. However, routine landscaping maintenance is advised to keep the property's appearance appealing.

8. **Exterior Paint and Finishes:**The exterior paint and finishes were assessed for signs of peeling, cracking, or fading. The property's facade was generally well-maintained.

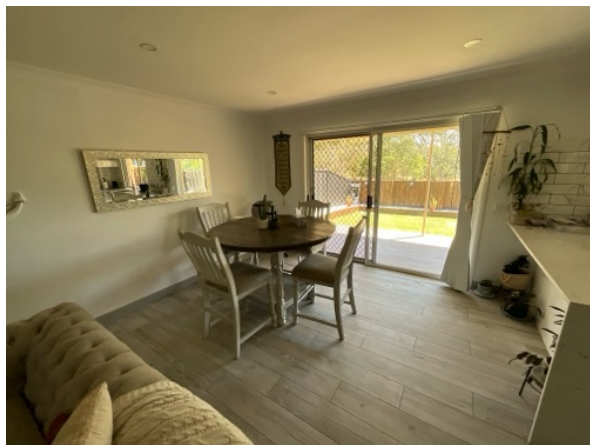
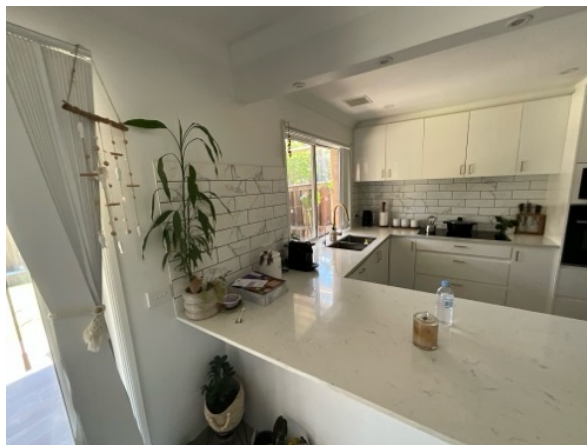
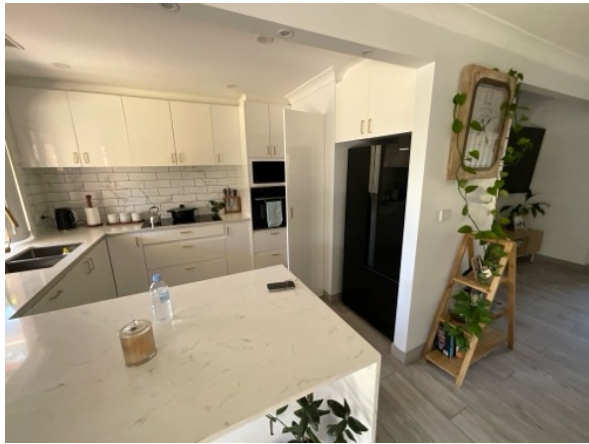
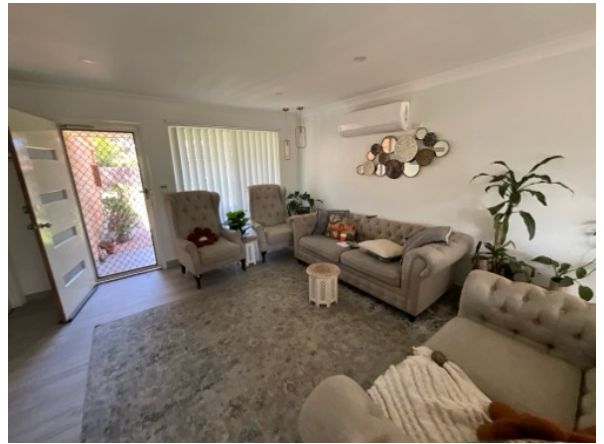
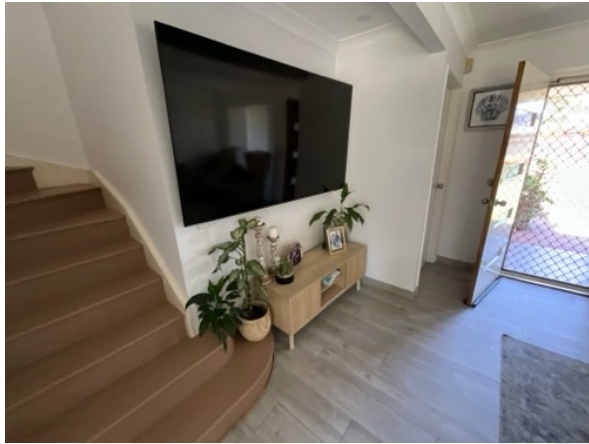
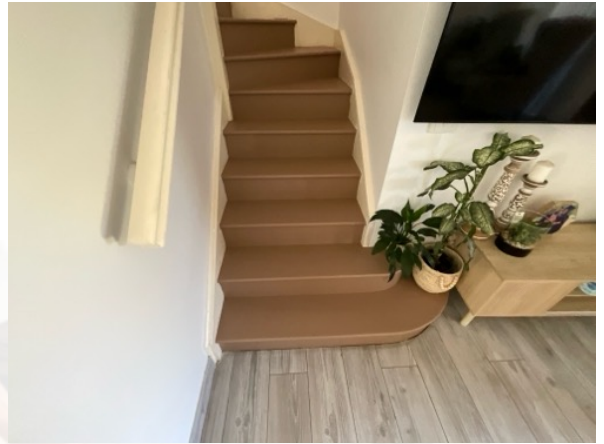
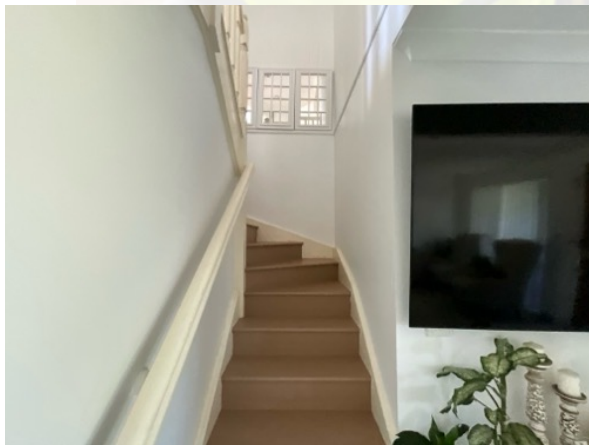
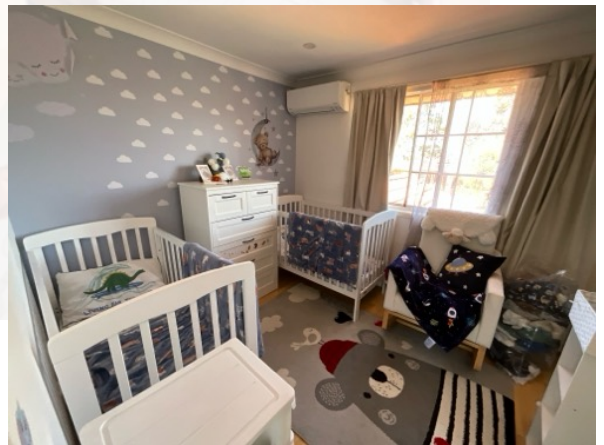
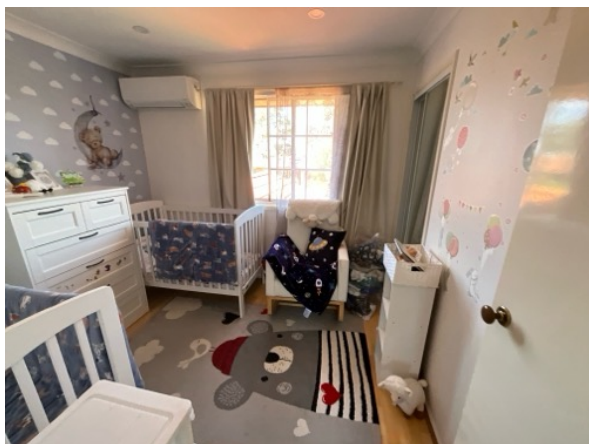
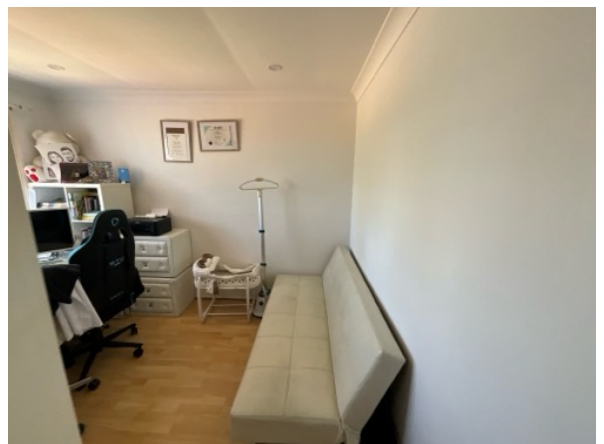
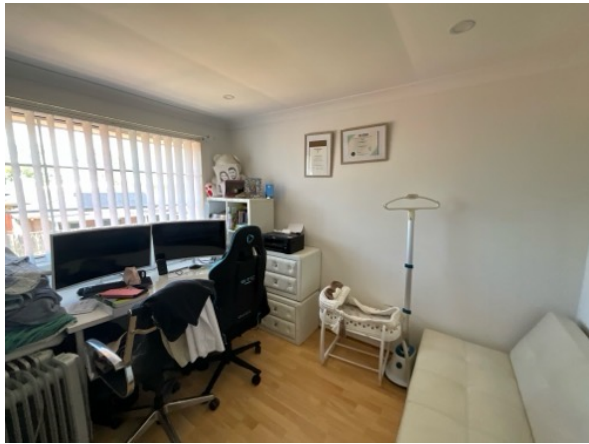
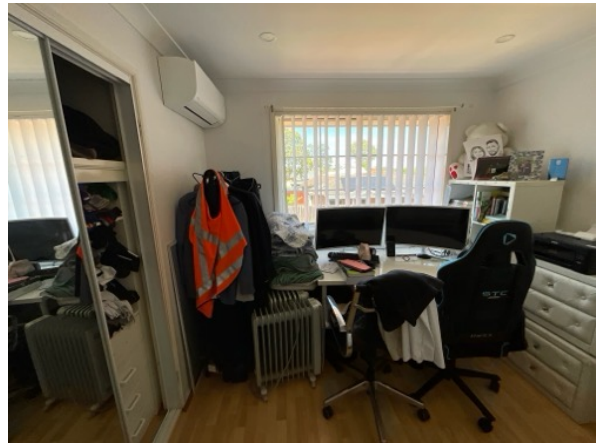
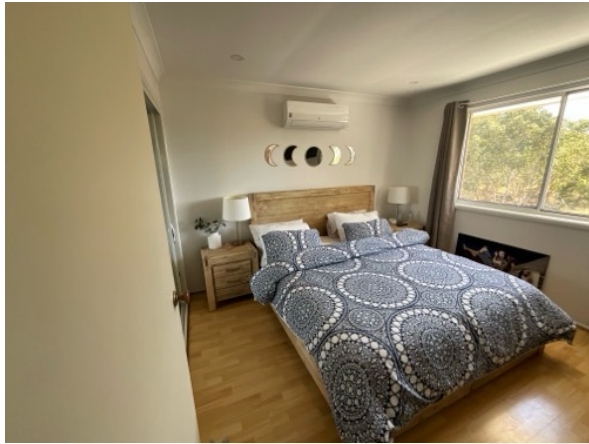
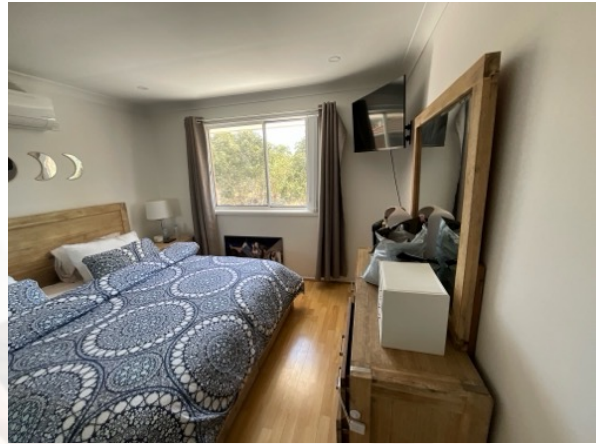
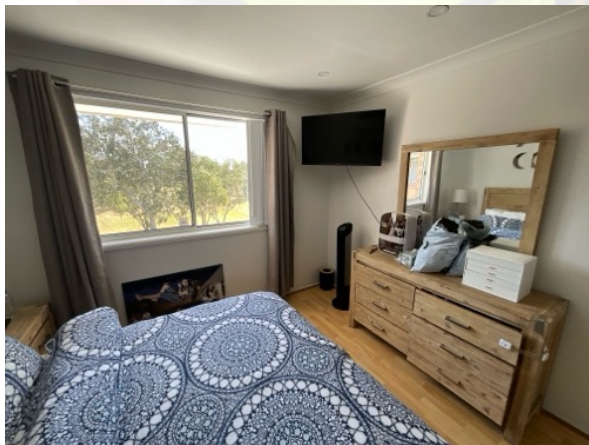
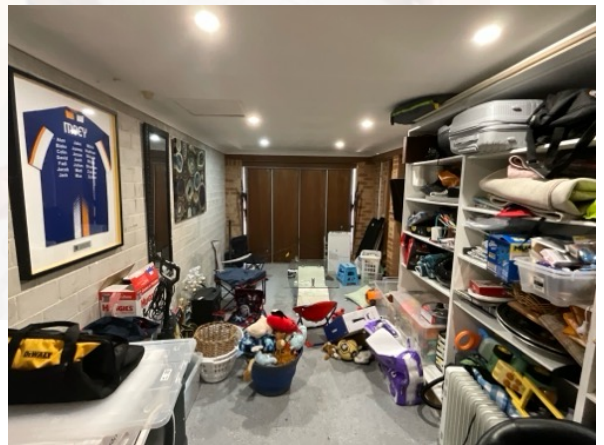
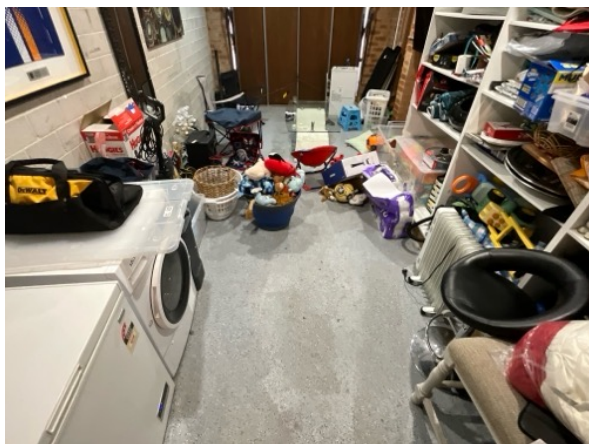
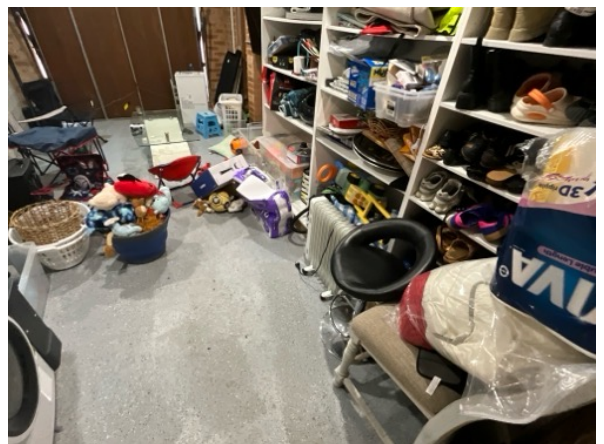
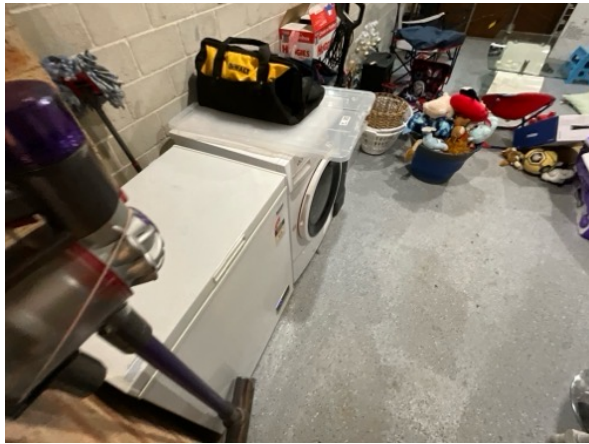
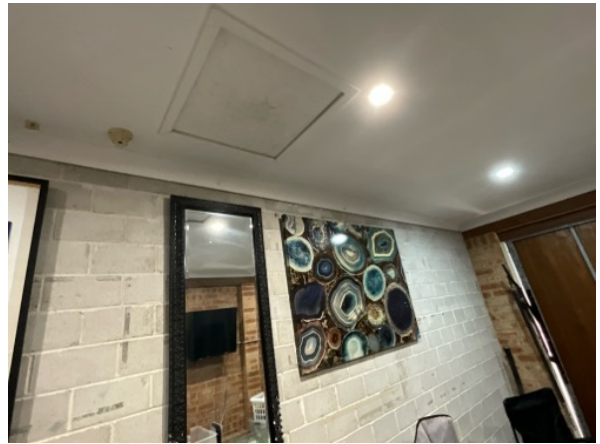
## For your information 1.02

**Location:** All Internal Areas

Upon inspection, the internal areas of the property were assessed for any visible defects or issues. The following areas were thoroughly inspected, and no significant defects or concerns were identified:

1. Living Room: The living room appeared to be in good condition, with no visible cracks, water damage, or structural issues observed.

2. Kitchen: The kitchen was in good condition, with all fixtures and appliances appearing to be functioning properly.

3. Bedrooms: Each bedroom was inspected, and no significant defects or structural problems were found. The flooring and walls were generally in good condition.

4. Hallways and Passageways: Hallways and passageways were checked, and no notable defects or safety concerns were identified.

6. Flooring : The flooring throughout the property were generally well-maintained and free from visible damages.

7. Ceilings and Walls: Ceilings and walls were examined for any signs of water damage, cracks, or structural concerns, and no major issues were found.

It is important to note that while no significant defects were identified during the inspection, regular maintenance and periodic checks are recommended to ensure the continued condition and safety of the property.

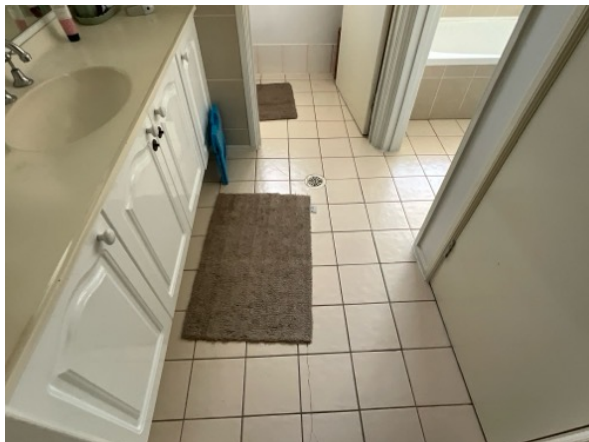
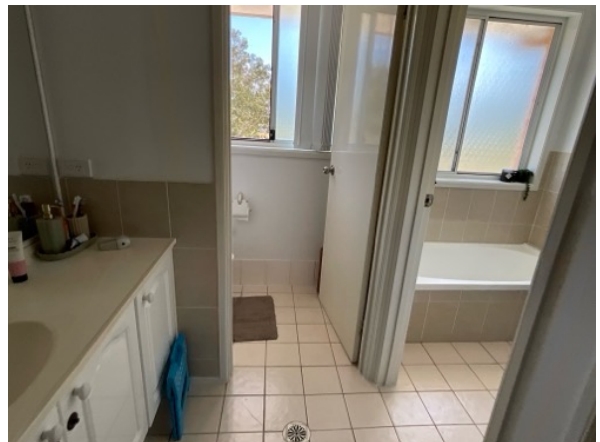
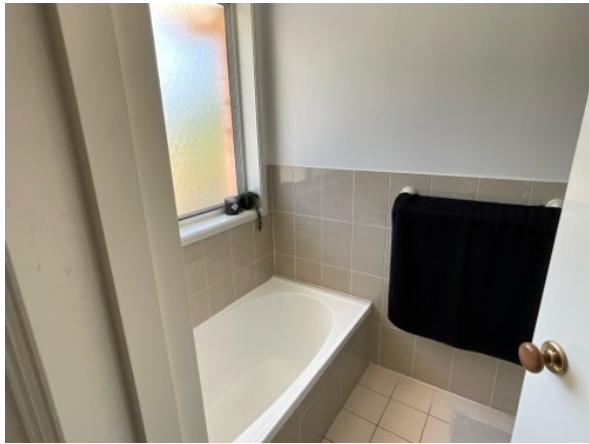
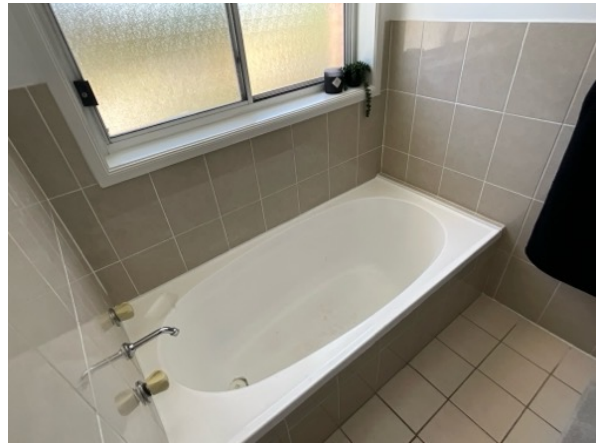
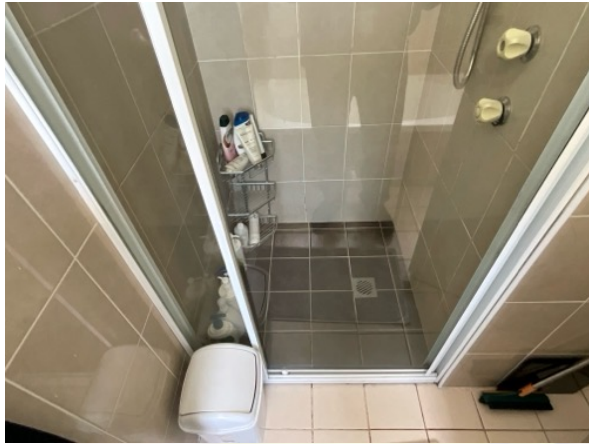
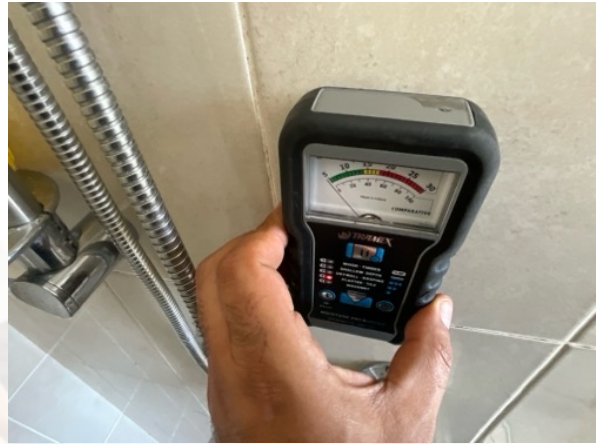
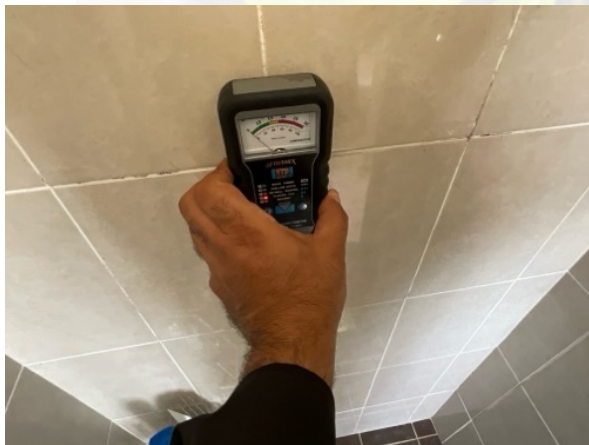
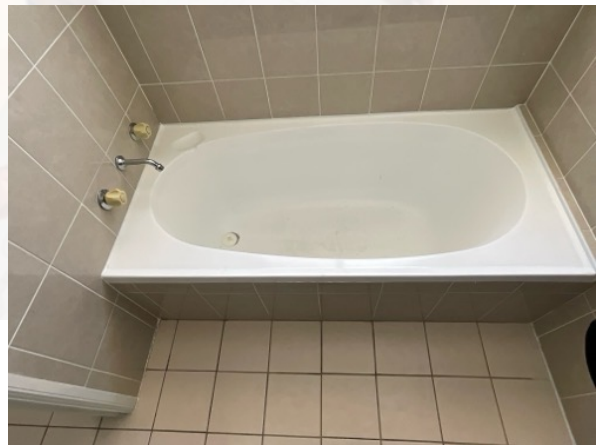
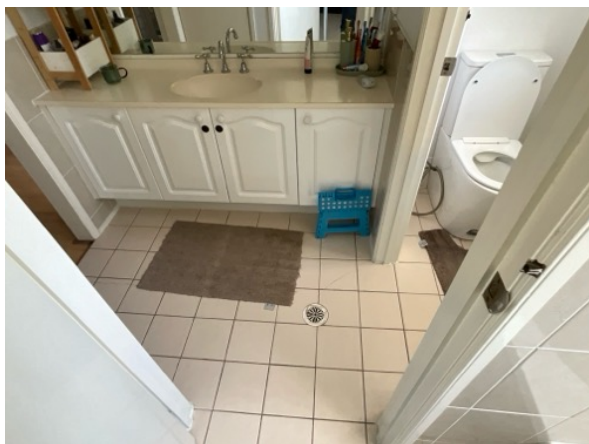
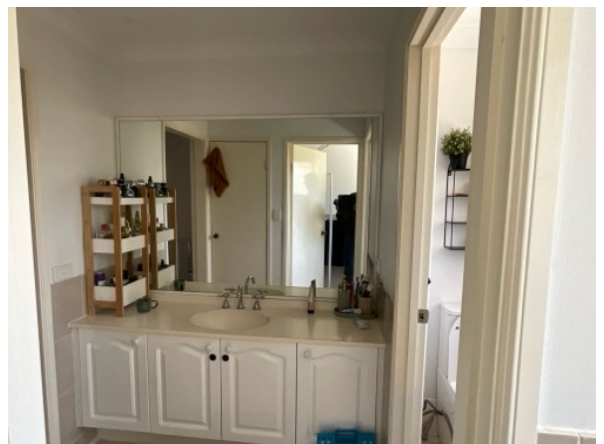
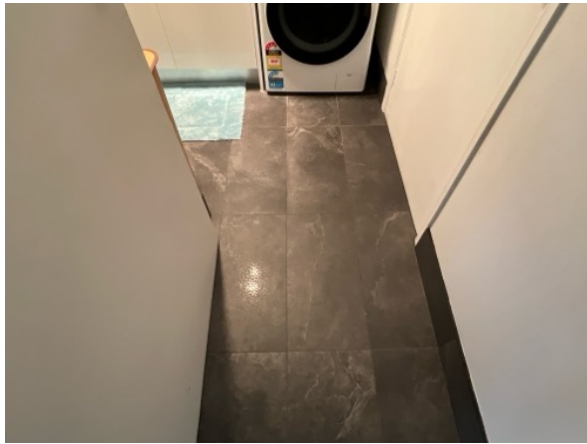
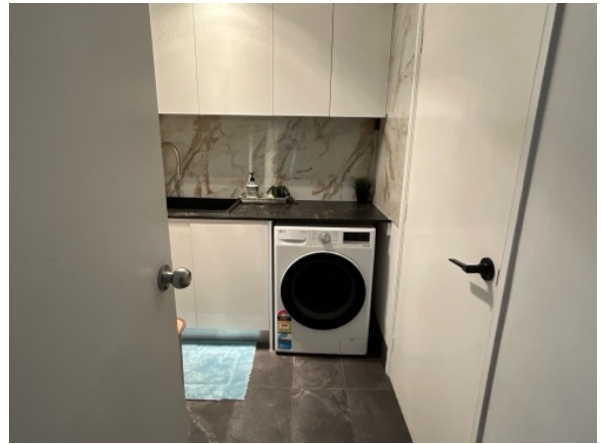
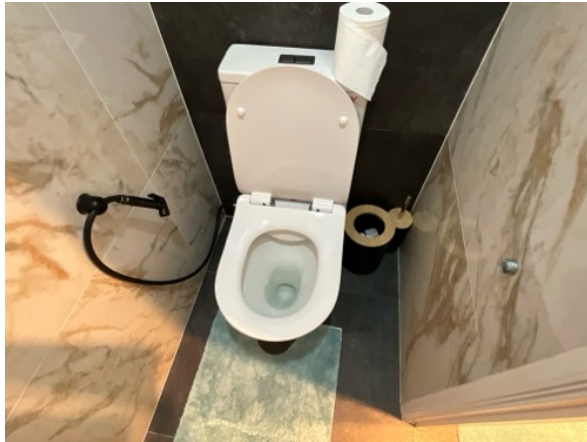
## For your information 1.03

**Location:** Bathrooms

**Finding:** Additional Photos-low moisture readings

During the inspection, moisture readings were taken in the bathrooms to assess the presence of dampness or water intrusion. The following observations were made:

- Moisture Reading: A moisture meter reading was taken in the master bathroom, and it indicated a low level of dampness.
- Note/Description: The master bathroom showed no visible signs of water leaks or water-related issues. The low moisture reading suggests that the bathroom area is adequately dry, and no immediate concerns are identified.

- Moisture Reading: Moisture meter readings were also taken in any additional bathrooms within the property, and all readings indicated low levels of dampness.
- Note/Description: The other bathrooms inspected did not show any visible signs of water leaks or moisture issues. The low moisture readings suggest that these bathroom areas are in satisfactory condition.

It is important to note that low moisture readings in bathrooms are positive indicators, suggesting that there are no immediate water-related problems. However, regular maintenance and monitoring of these areas are still recommended to prevent potential issues in the future.

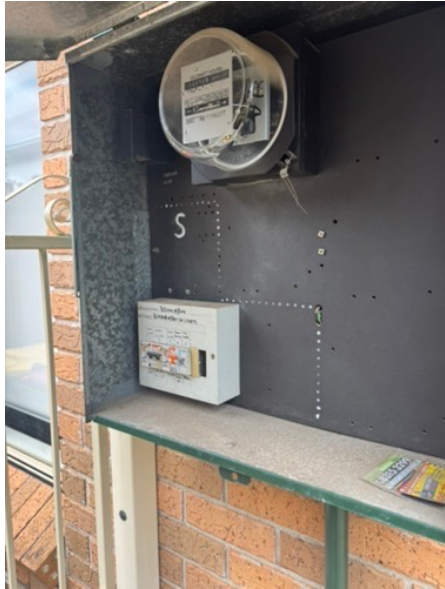
### Conditions conducive to timber pest attack 2.01

**Finding:** Durable Notice - Missing

A durable notice is missing from the meterbox. The application of a post-construction chemical termite barrier is highly recommended for all properties with timber building elements. Such barriers are highly effective in preventing termite attack on any timber building elements throughout the property. A durable notice should be placed in the meter board to indicate current termite barriers. At the time of inspection, it appeared as though no termite management system has been installed, with no evidence to suggest preventative works taking place which puts this property at very high risk. The client should consider gaining further advice from a licensed termite/timber pest technician as to the costs and procedures involved with implementing and maintaining a pest management system for this

Recommendations: Engage a qualified pest control expert with experience in termite management for older properties. They can assess the specific risk factors of the property, recommend appropriate treatments, and provide ongoing guidance to ensure effective termite prevention. Additionally, refer to local regulations and guidelines related to termite management for your area.

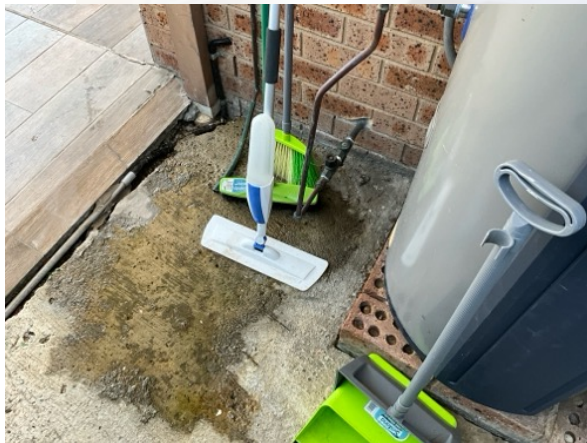
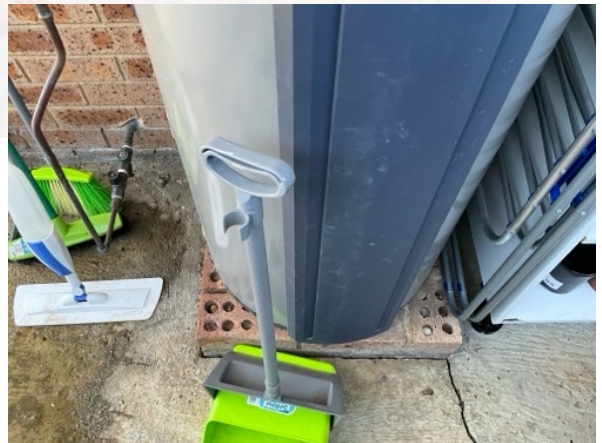
## Conditions conducive to timber pest attack 2.02

**Location:** Exterior Wall

The hot water pressure relief valve outlet pipe is not connected to the stormwater system as it should be.

Excessive moisture in an area can be conducive towards termite activity as well as potentially causing issues with foundations. An investigation (by a competent person e.g. a licensed plumbing contractor) is recommended as soon as possible to determine the method and extent of any remedial work required and associated costs.
