# Pre Inspection Building And Timber Pest Report

**Inspection Date: 13 Oct 2025**

Property Address: 20 Bandicoot Drive Woodcroft 2767

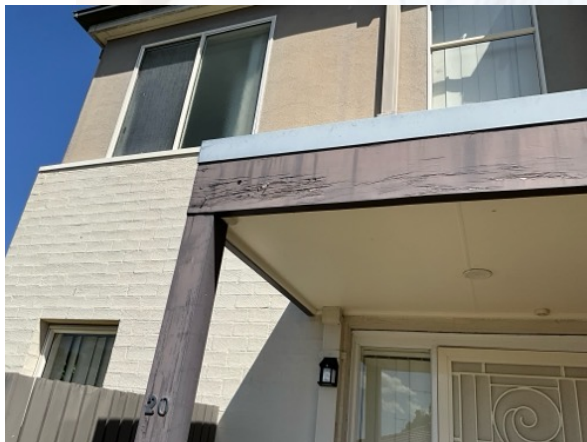
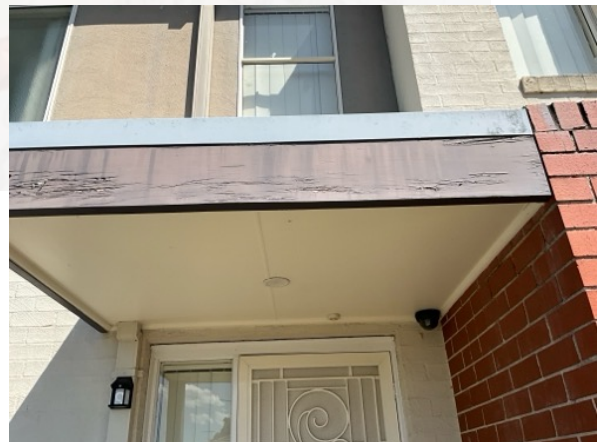
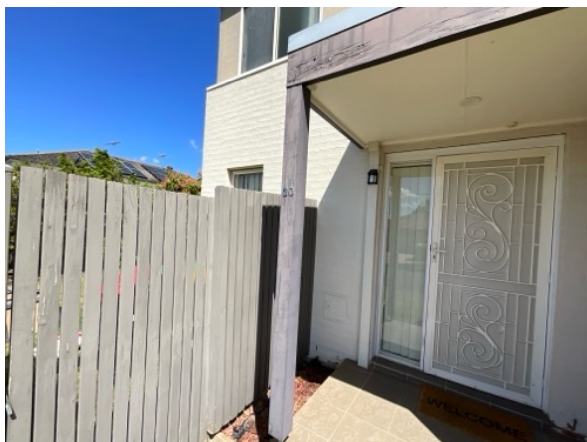
### Minor Defect 1.01

Water ingress deteriorated Timbers exposed to weather.

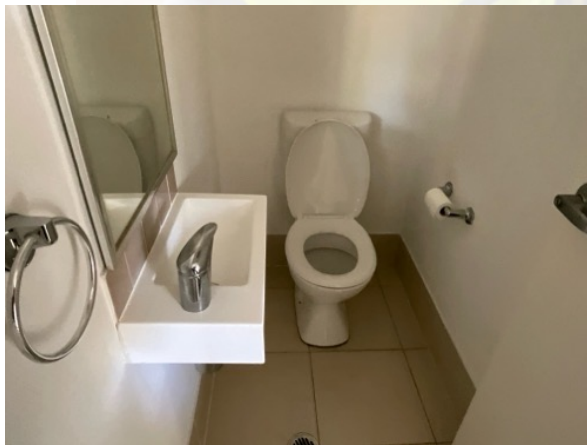
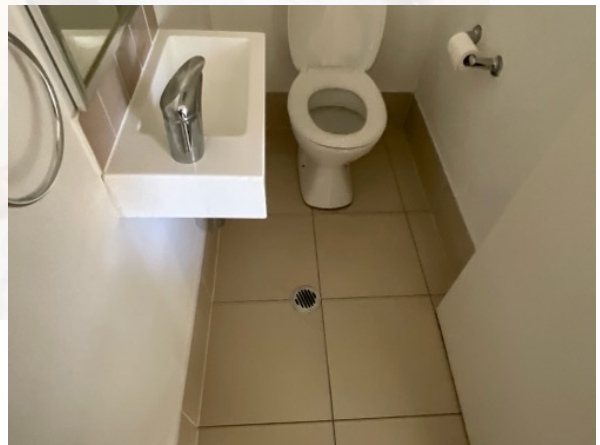
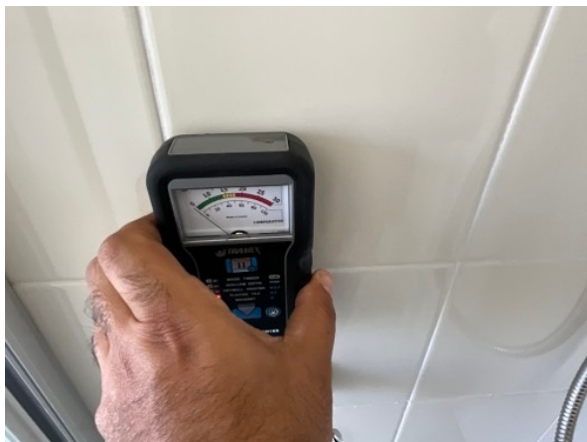
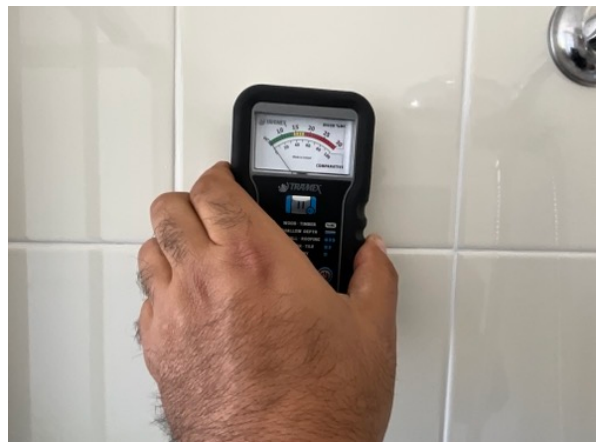
## For your information 2.03

**Finding:** Additional Photos-low moisture readings

- Moisture Reading: A moisture meter reading was taken in the master bathroom, and it indicated a low level of dampness.
- Note/Description: The master bathroom showed no visible signs of water leaks or water-related issues. The low moisture reading suggests that the bathroom area is adequately dry, and no immediate concerns are identified.

- Moisture Reading: Moisture meter readings were also taken in any additional bathrooms within the property, and all readings indicated low levels of dampness.
- Note/Description: The other bathrooms inspected did not show any visible signs of water leaks or moisture issues. The low moisture readings suggest that these bathroom areas are in satisfactory condition.

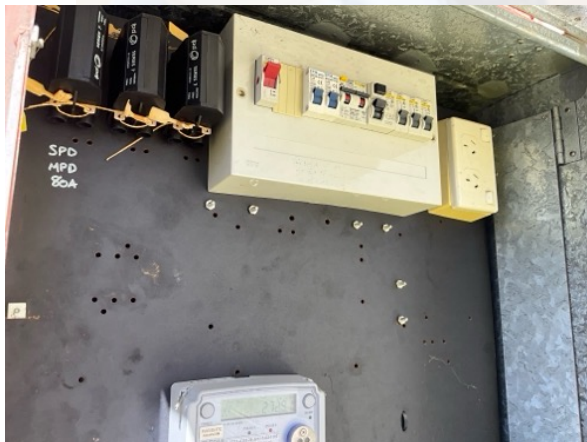
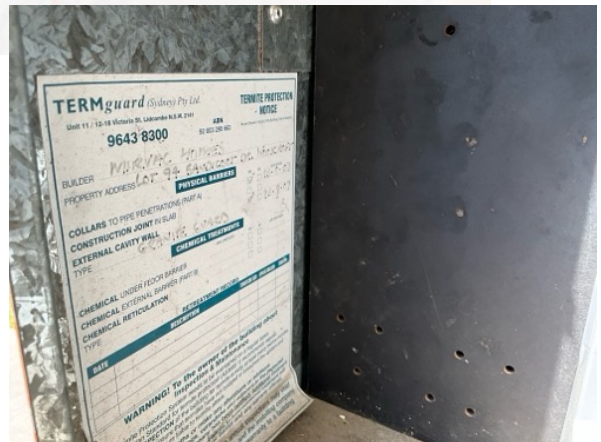
### For your information 3.01

**Location:** Main Switch Board  
**Finding:** Termite management system installed and not up to date.
