# Pre Inspection Building And Timber Pest Report

**Inspection Date: 10 Oct 2025**

Property Address: 4 Silvereye Circuit Woodcroft 2767

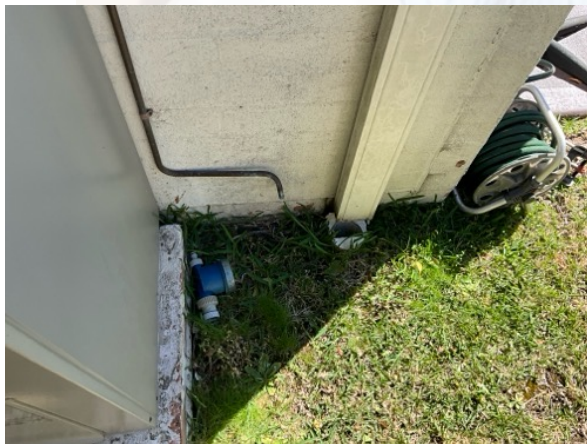
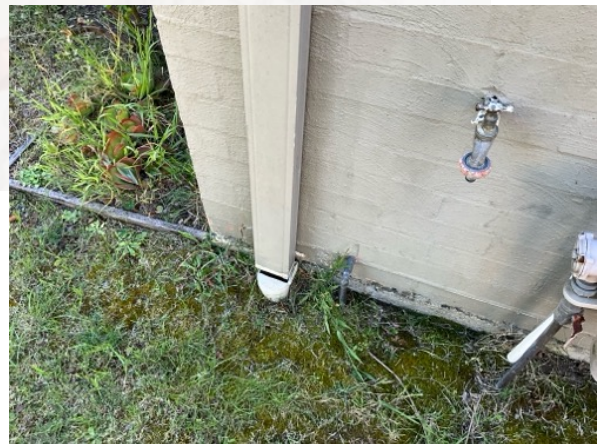
### Minor Defect 1.01

**Location:** All External Areas  
**Finding:** Drainage occ caps broken.

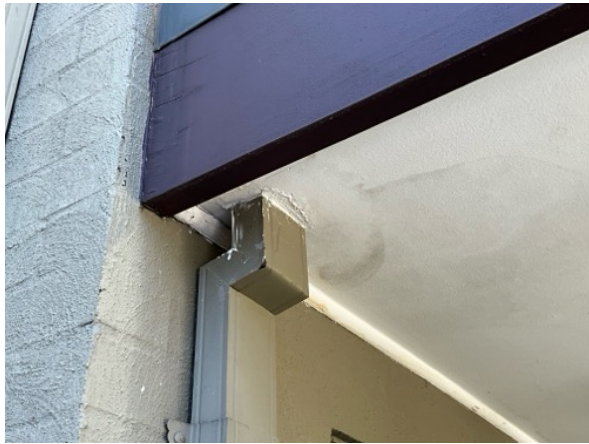
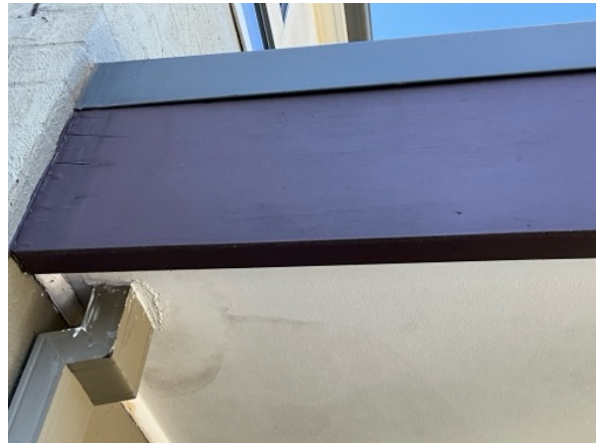
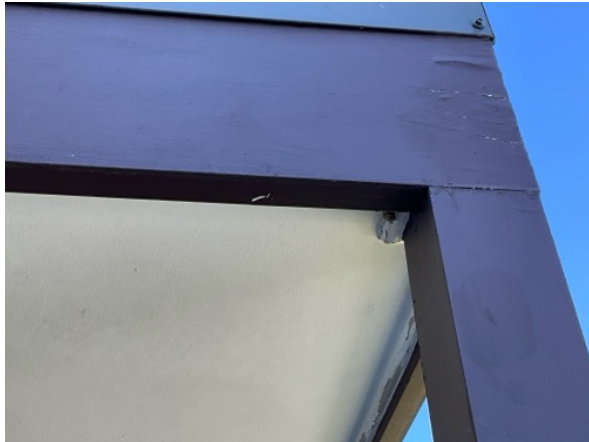
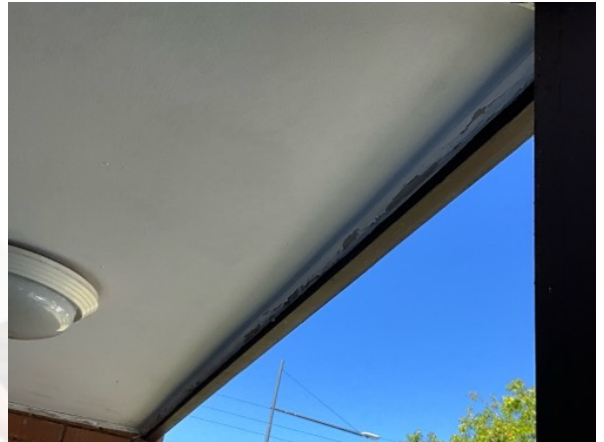
### Minor Defect 1.02

**Location:** Front Portico  
**Finding:** Water ingress deteriorated Timbers exposed to weather.

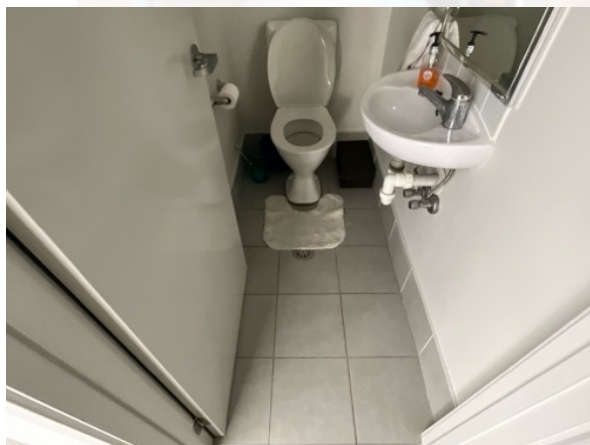
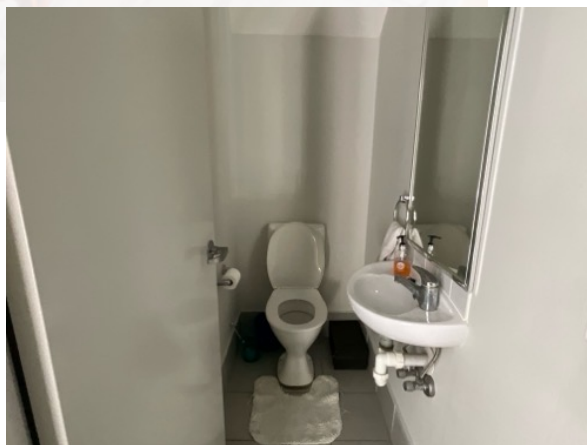
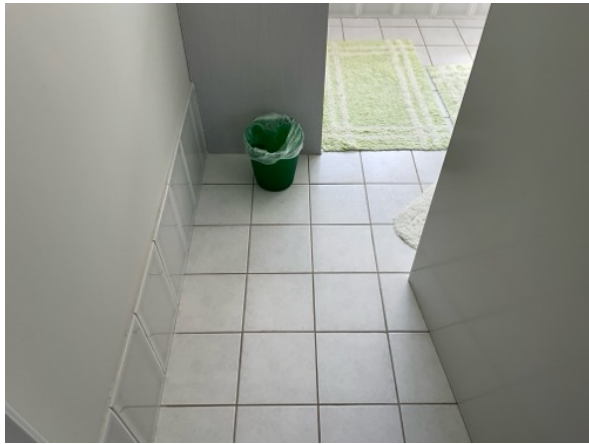
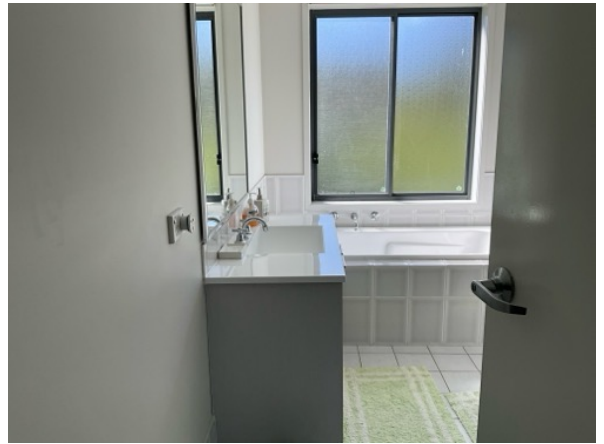
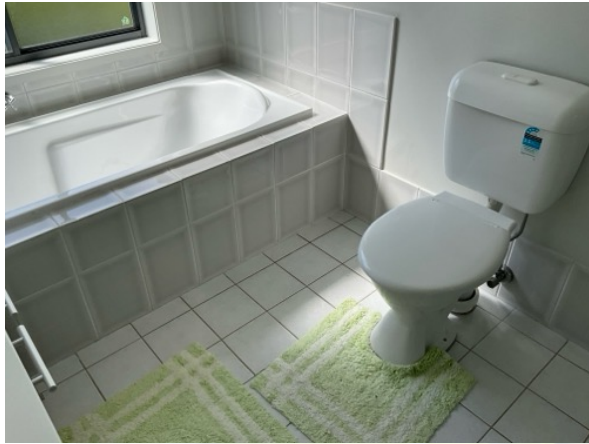
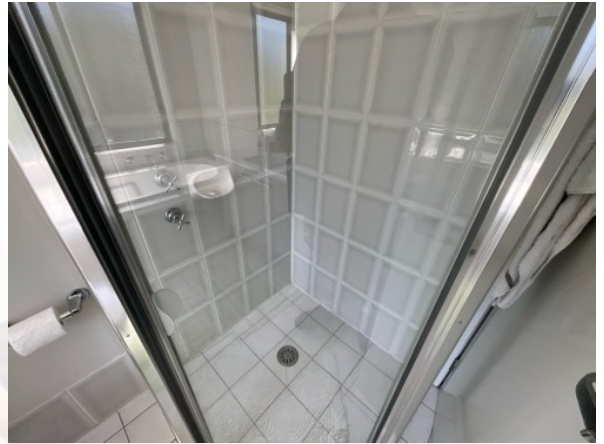
## For your information 2.03

**Finding:** Additional Photos-low moisture readings

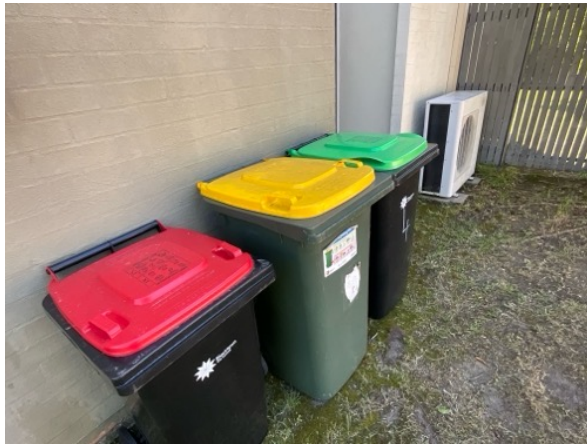
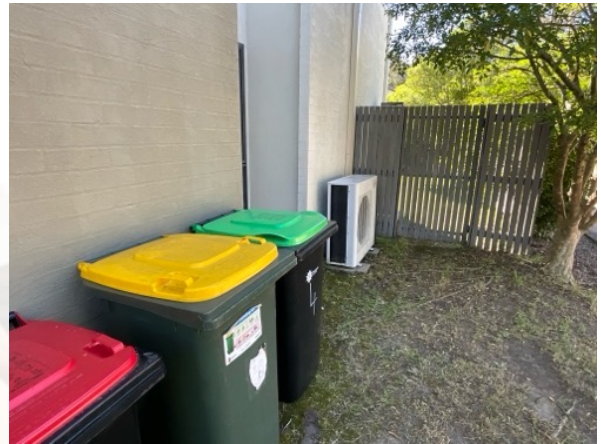
## Conditions conducive to timber pest attack 3.01

**Finding:** Bridging or Obstruction - Air Conditioner, Hot Water & Storage

Where bridging has occurred full inspection is prevented and termites may enter a property in a concealed or undetectable manner.

Recommend moving obstructions away from the external walls for further and future inspections.

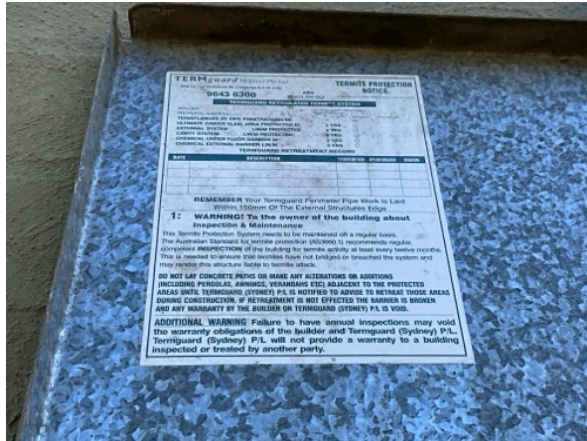
**Location:** Main Switch Board

**Finding:** Termite management system installed and up to date.
