# Pre Inspection Building And Timber Pest Report

**Inspection Date: 15 Oct 2025**

Property Address: 85 Alexander Street Bligh Park 2756

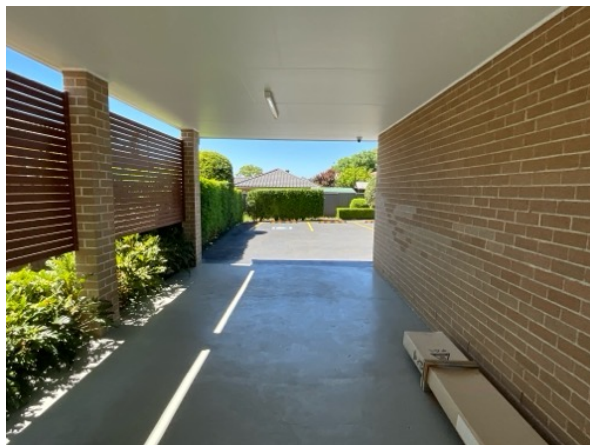
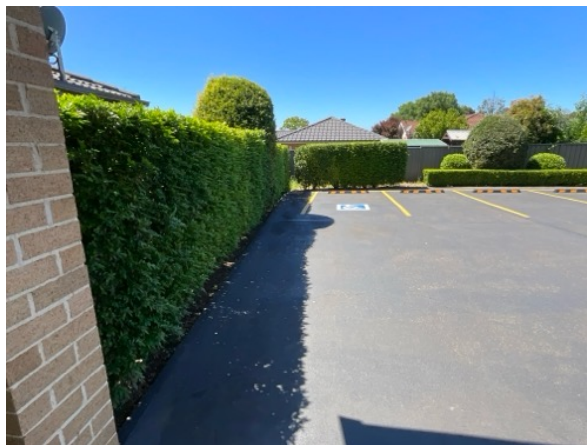
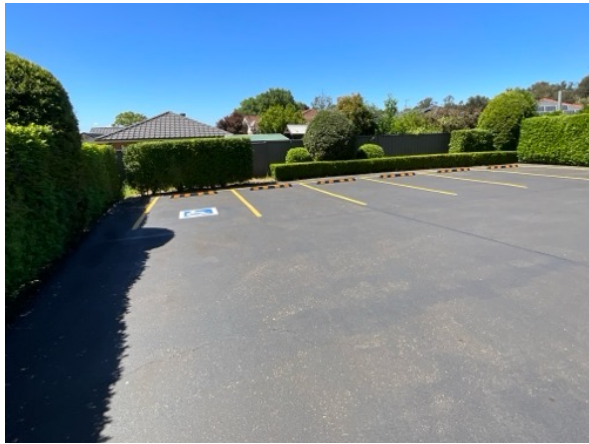
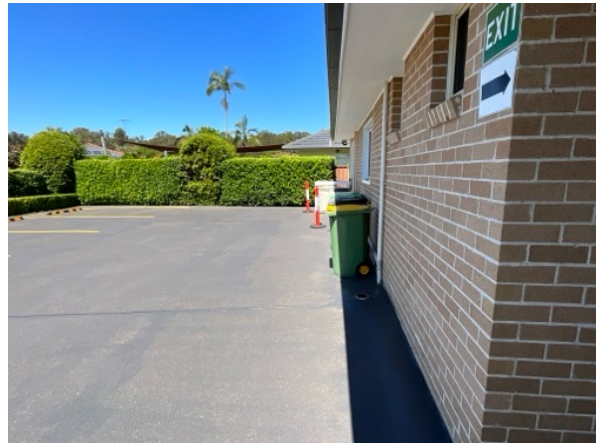
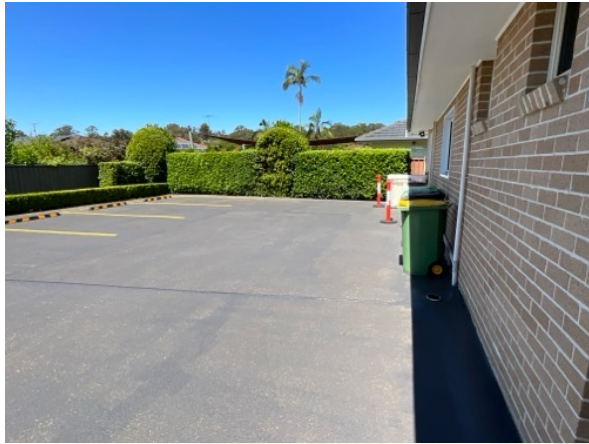
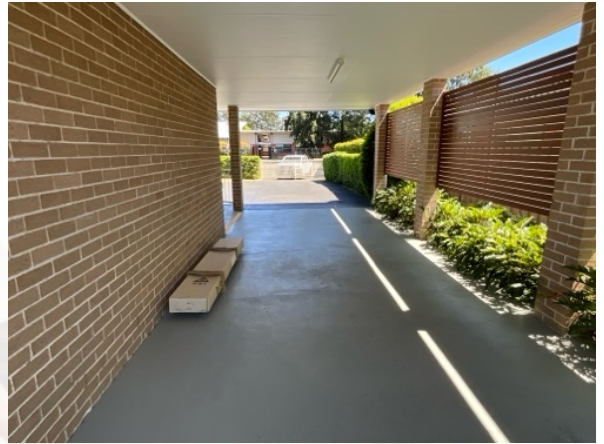
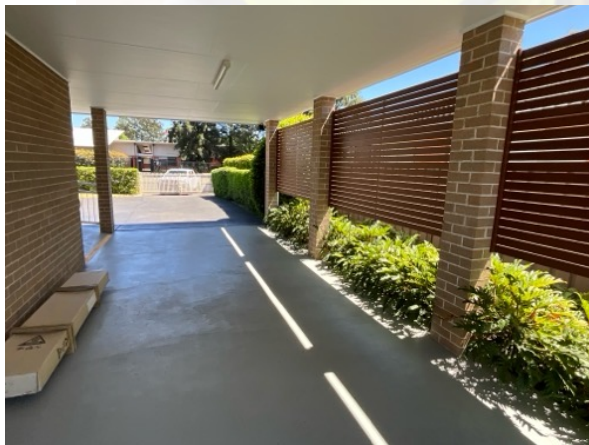
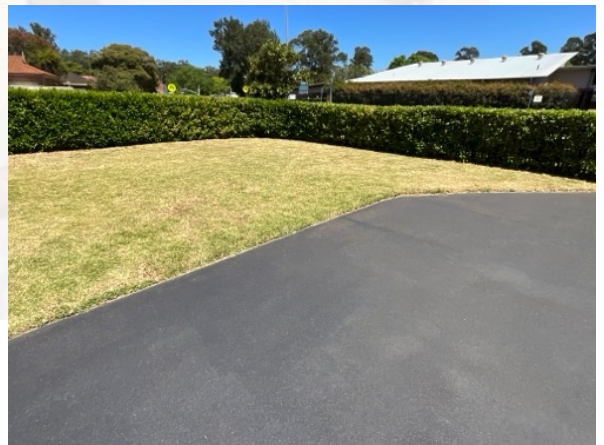
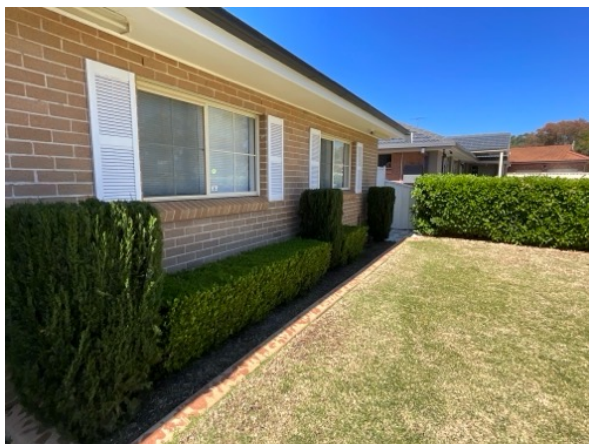
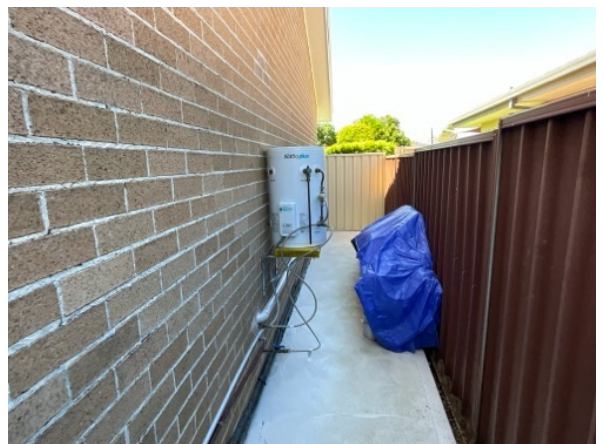
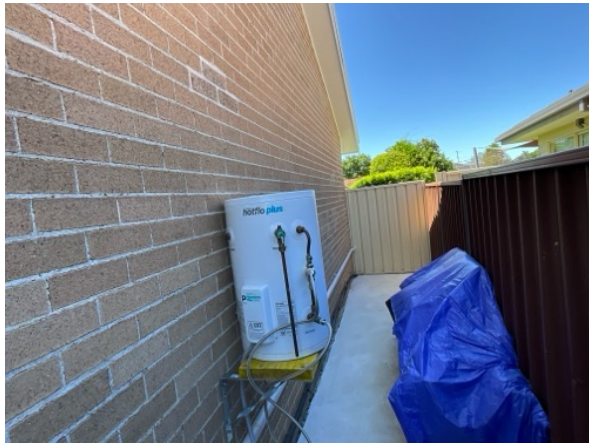
## For your information 1.01

The external areas of the property were thoroughly inspected for any visible defects or issues. The following external components and features were assessed, and the observations are as follows:

1. Roofing: The roof was examined for signs of damage, missing tiles, or leaks. No significant roofing issues were detected during the inspection.
2. Exterior Walls: The exterior walls were inspected for cracks, dampness, or structural concerns. No major defects were found, and the walls appeared to be in satisfactory condition.

3. Gutters and Downpipes: Gutters and downpipes were checked for blockages or damage. It is noted that regular maintenance is essential to ensure proper water drainage and prevent potential water-related issues.

4. Windows and Doors: External windows and doors were examined for proper functionality, seals, and signs of wear. All windows and doors were found to be in good working condition.

5. Driveway and Pathways: The driveway and pathways were inspected for cracks or uneven surfaces. Minor wear and tear were observed, but no significant defects were noted.

6. Fencing and Gates: The property's fencing and gates were examined, and no major issues were identified. However, routine maintenance is recommended to ensure their longevity.

7. Landscaping: The landscaping around the property was reviewed, and no specific concerns were noted. However, routine landscaping maintenance is advised to keep the property's appearance appealing.

8. Exterior Paint and Finishes: The exterior paint and finishes were assessed for signs of peeling, cracking, or fading. The property's facade was generally well-maintained.

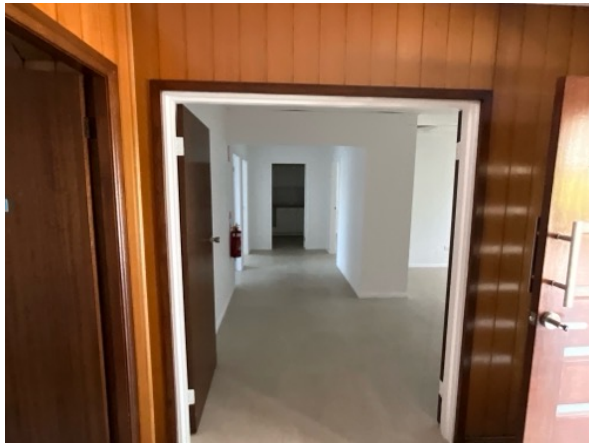
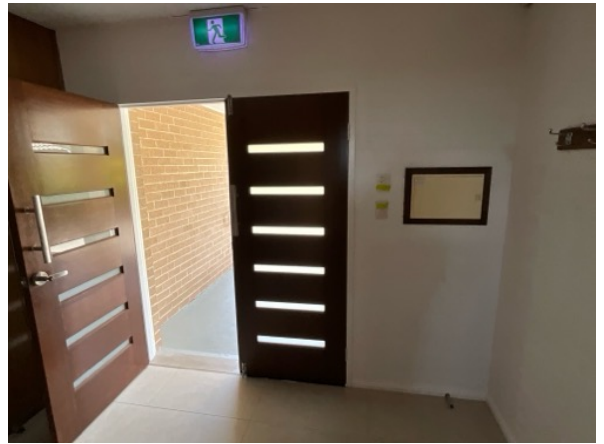
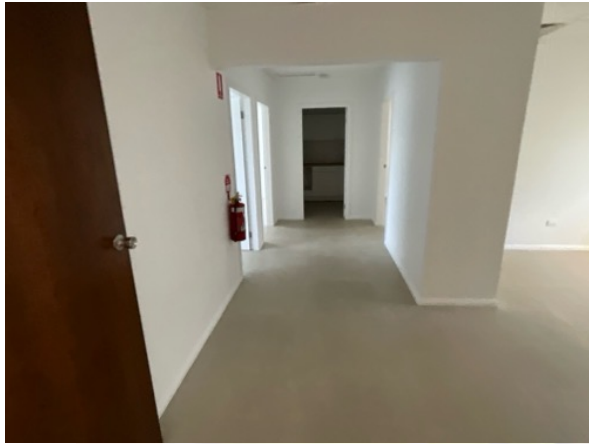
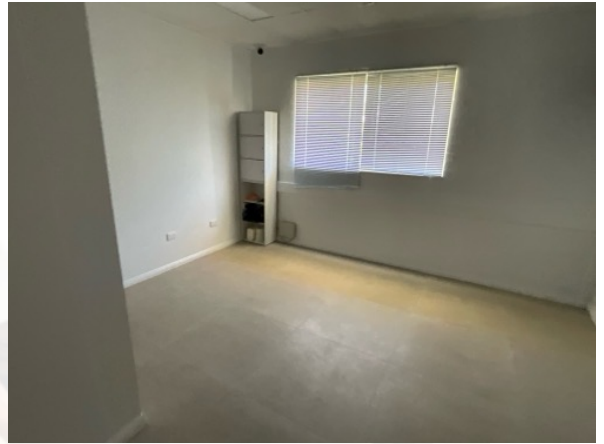
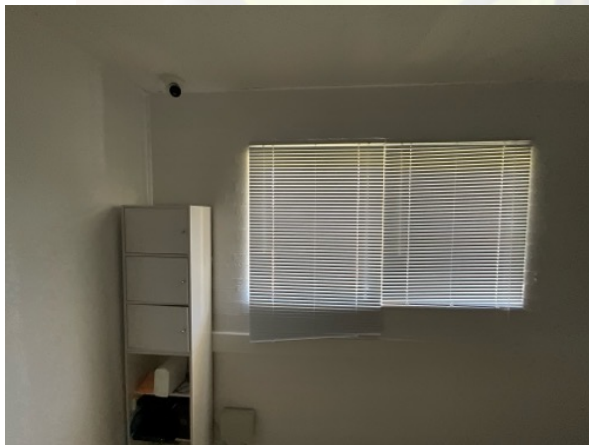
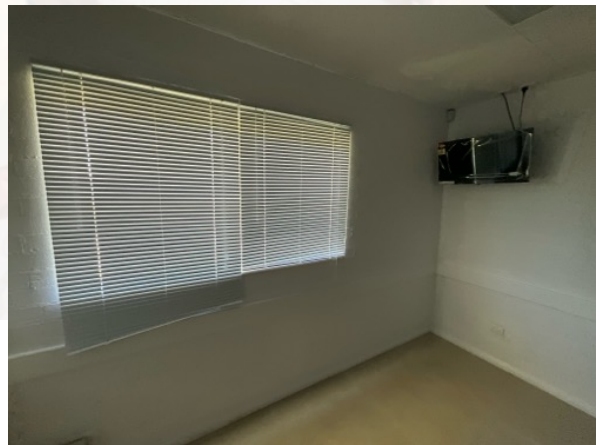
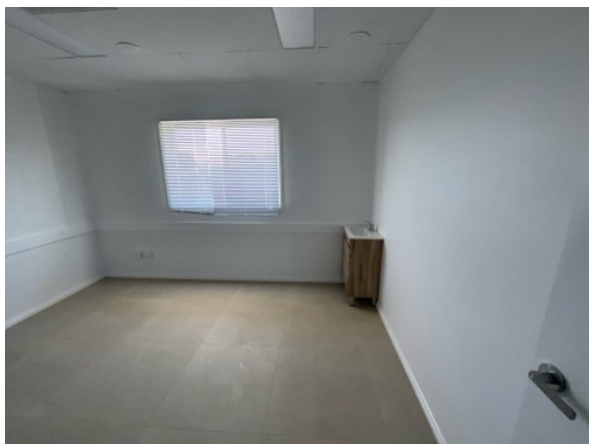
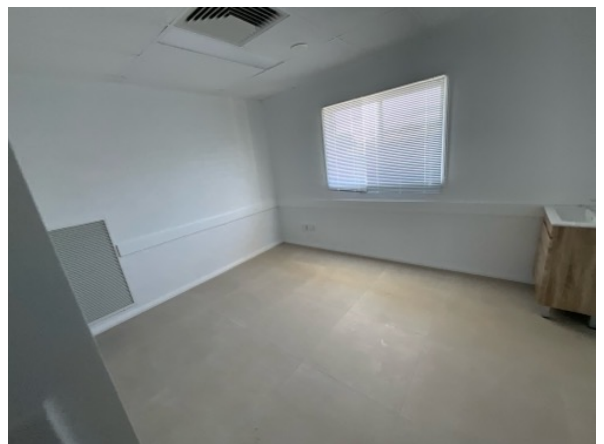
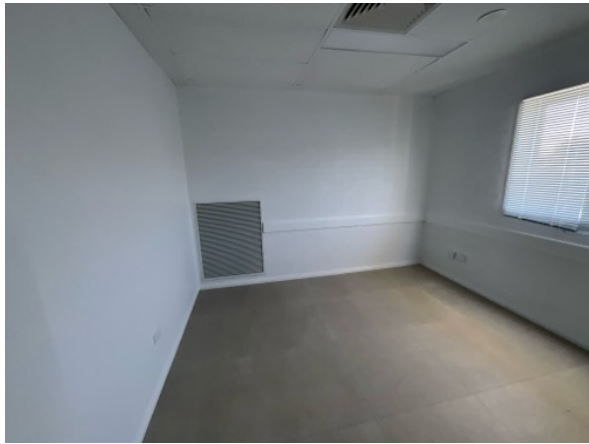
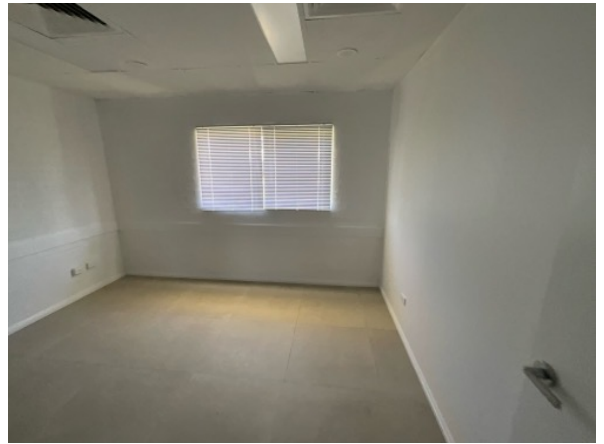
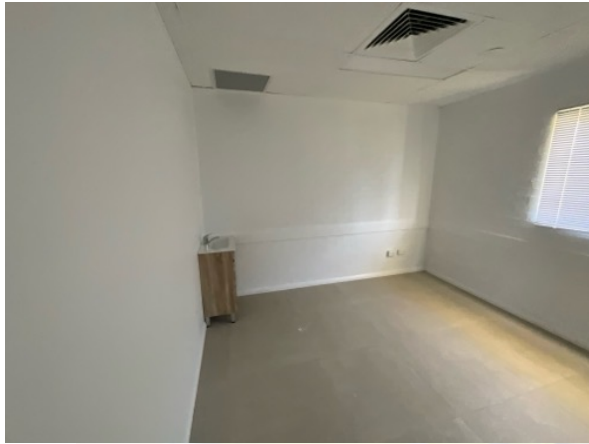
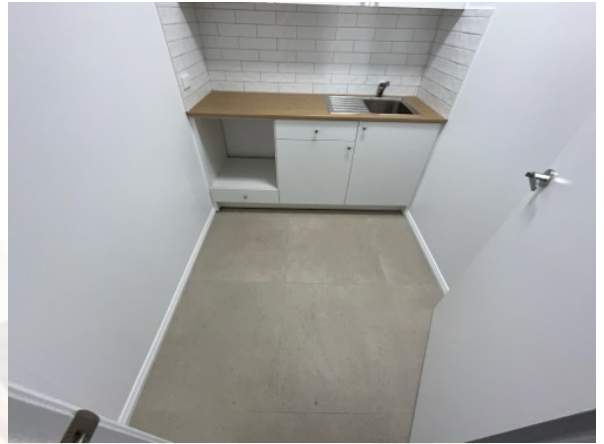
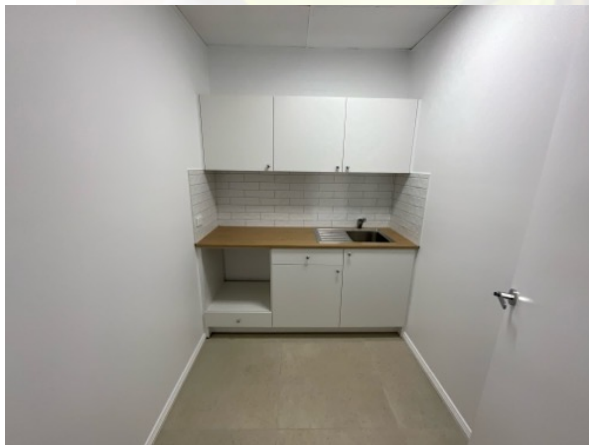
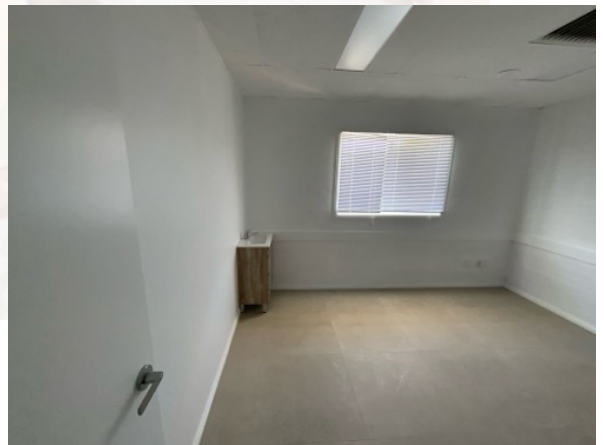
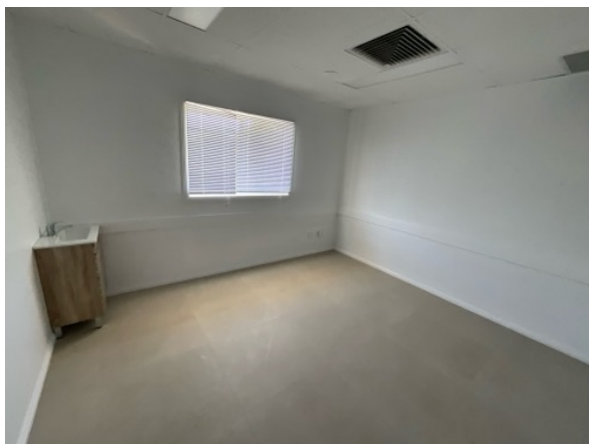
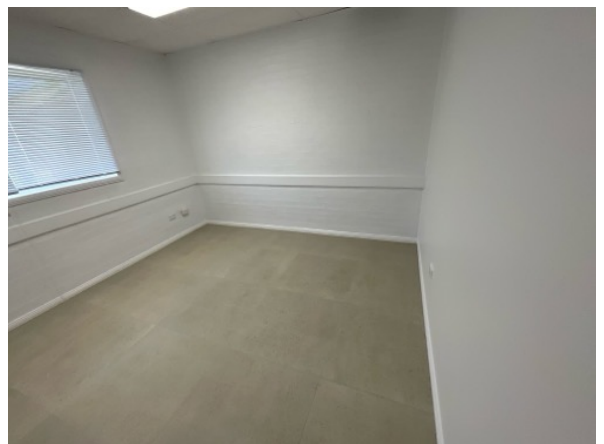
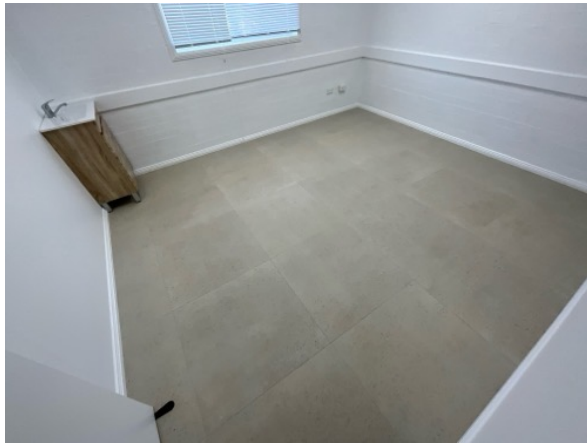
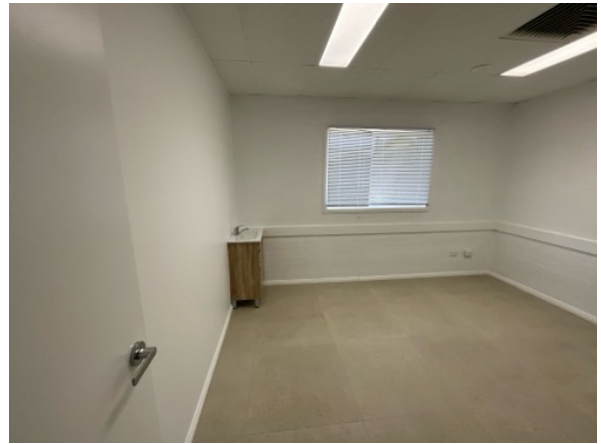
## For your information 1.02

Upon inspection, the internal areas of the property were assessed for any visible defects or issues. The following areas were thoroughly inspected, and no significant defects or concerns were identified:

1. Living Room: The living room appeared to be in good condition, with no visible cracks, water damage, or structural issues observed.
2. Kitchen: The kitchen was in good condition, with all fixtures and appliances appearing to be functioning properly.

3. Bedrooms: Each bedroom was inspected, and no significant defects or structural problems were found. The flooring and walls were generally in good condition.

4. Hallways and Passageways: Hallways and passageways were checked, and no notable defects or safety concerns were identified.
5. Doors and Windows: All doors and windows were examined, and they appeared to be in proper working order without any major issues.

6. Flooring : The flooring throughout the property were generally well-maintained and free from visible damages.
7. Ceilings and Walls: Ceilings and walls were examined for any signs of water damage, cracks, or structural concerns, and no major issues were found.

It is important to note that while no significant defects were identified during the inspection, regular maintenance and periodic checks are recommended to ensure the continued condition and safety of the property.

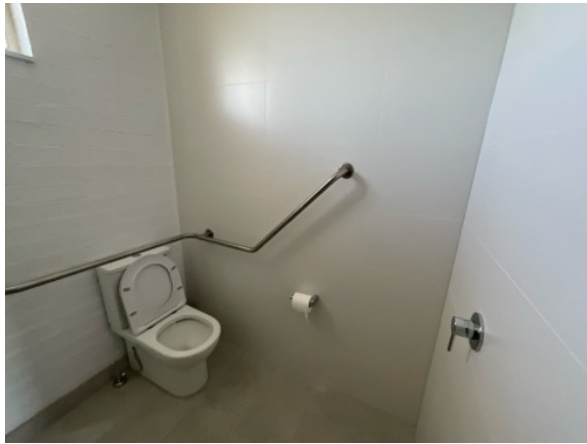
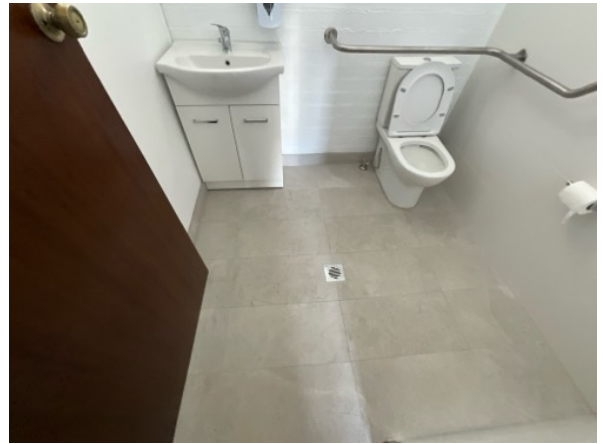
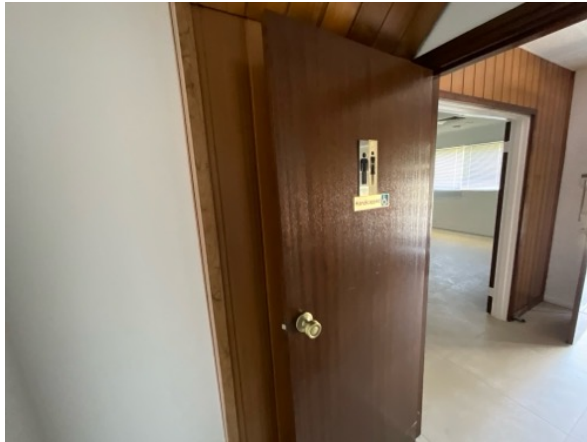
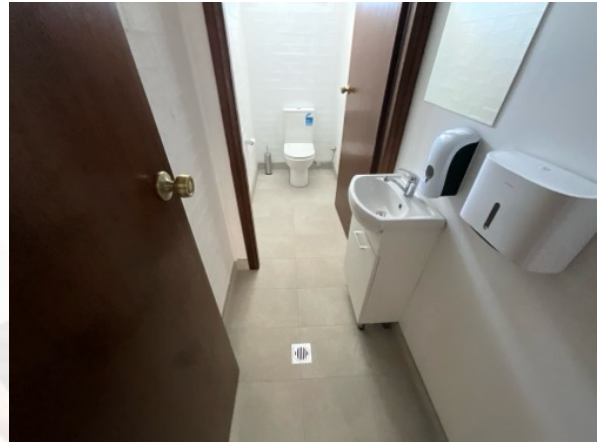
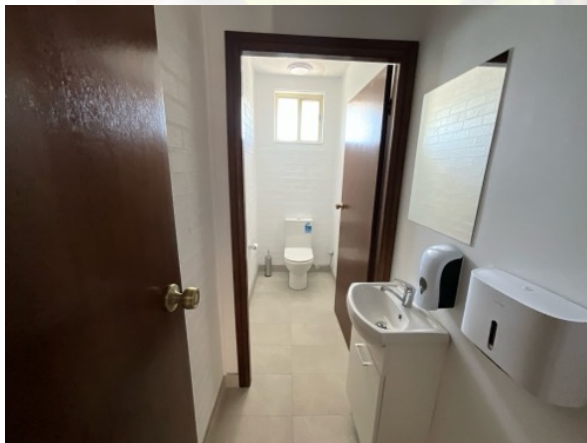
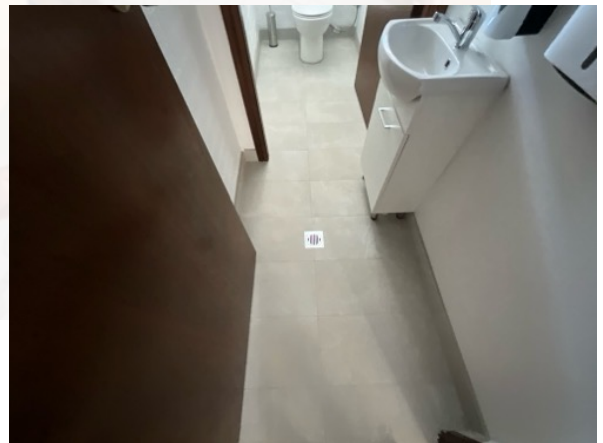
## For your information 1.03

**Finding:** Additional Photos-low moisture readings

- Moisture Reading: A moisture meter reading was taken in the master bathroom, and it indicated a low level of dampness.
- Note/Description: The master bathroom showed no visible signs of water leaks or water-related issues. The low moisture reading suggests that the bathroom area is adequately dry, and no immediate concerns are identified.

- Moisture Reading: A moisture meter reading was conducted in the guest bathroom, and it revealed a low level of moisture.
- Note/Description: The guest bathroom exhibited no visible damp spots or water damage. The low moisture reading indicates that the bathroom area is free from any significant water intrusion or moisture-related problems.

- Moisture Reading: Moisture meter readings were also taken in any additional bathrooms within the property, and all readings indicated low levels of dampness.
- Note/Description: The other bathrooms inspected did not show any visible signs of water leaks or moisture issues. The low moisture readings suggest that these bathroom areas are in satisfactory condition.

It is important to note that low moisture readings in bathrooms are positive indicators, suggesting that there are no immediate water-related problems. However, regular maintenance and monitoring of these areas are still recommended to prevent potential issues in the future.

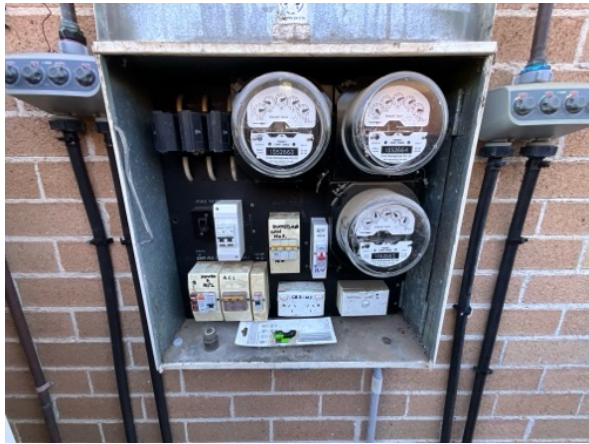
## For your information 2.01

**Location:** Main Switch Board

**Finding:** Durable Notice - Missing

A durable notice is missing from the meterbox. The application of a post-construction chemical termite barrier is highly recommended for all properties with timber building elements. Such barriers are highly effective in preventing termite attack on any timber building elements throughout the property. A durable notice should be placed in the meter board to indicate current termite barriers. At the time of inspection, it appeared as though no termite management system has been installed, with no evidence to suggest preventative works taking place which puts this property at very high risk. The client should consider gaining further advice from a licensed termite/timber pest technician as to the costs and procedures involved with implementing and maintaining a pest management system for this

Recommendations: Engage a qualified pest control expert with experience in termite management for older properties. They can assess the specific risk factors of the property, recommend appropriate treatments, and provide ongoing guidance to ensure effective termite prevention. Additionally, refer to local regulations and guidelines related to termite management for your area.
