# Pre Inspection Building And Timber Pest Report

**Inspection Date: 13 Oct 2025**

Property Address: 39 Camilleri Avenue Quakers Hill 2763

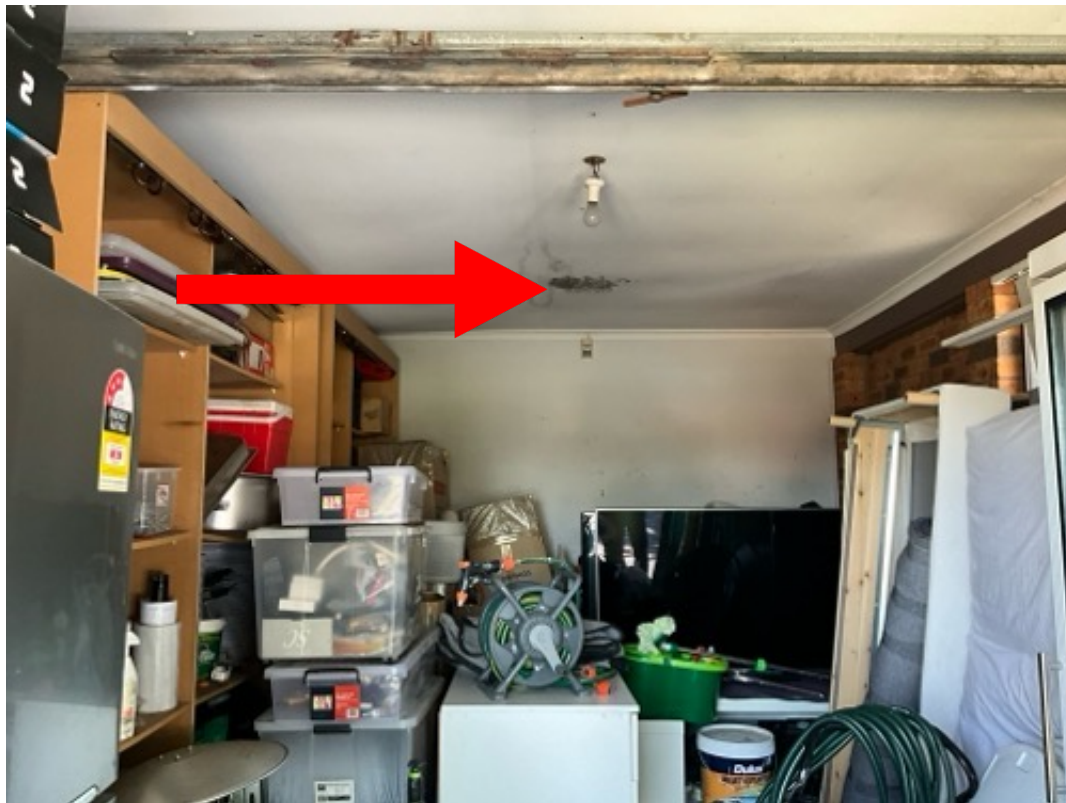
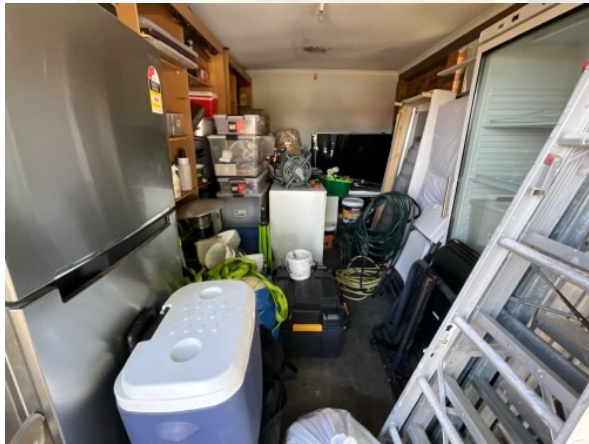
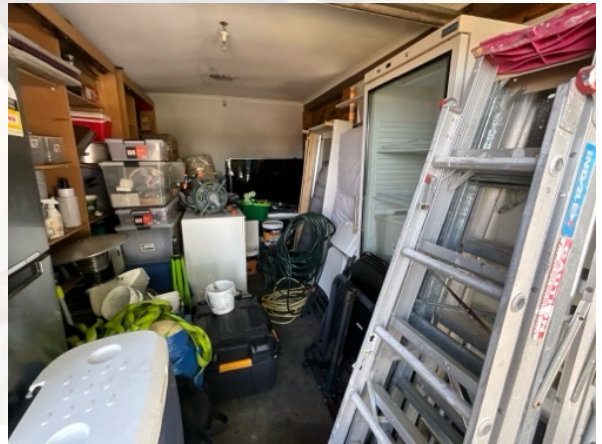
### Minor Defect 1.01

Stained ceiling

Water staining was observed to the ceiling plaster in the garage. Water staining is indicative of moisture ingress into the area. This should be repaired as soon as possible as excessive moisture can cause conditions conducive to timber pest activity as well as leading to the deterioration of internal elements.

An investigation (by a competent person e.g. a licensed roof plumber) is recommended as soon as possible to determine the method and extent of any remedial work required and associated costs.

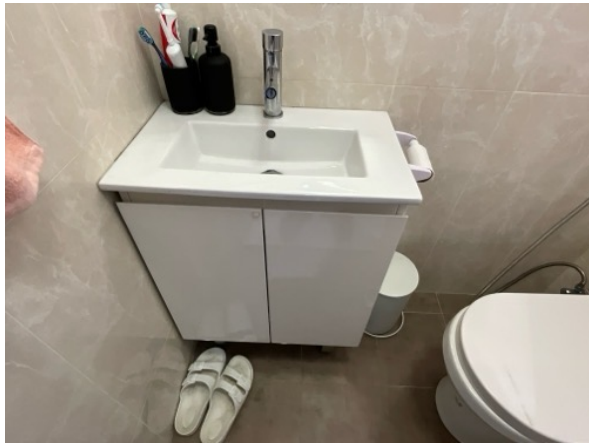
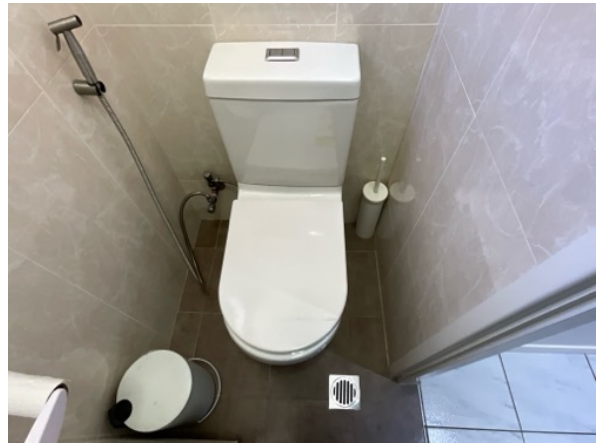
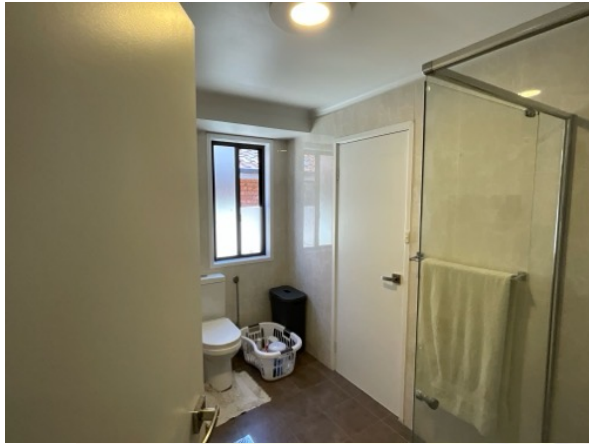
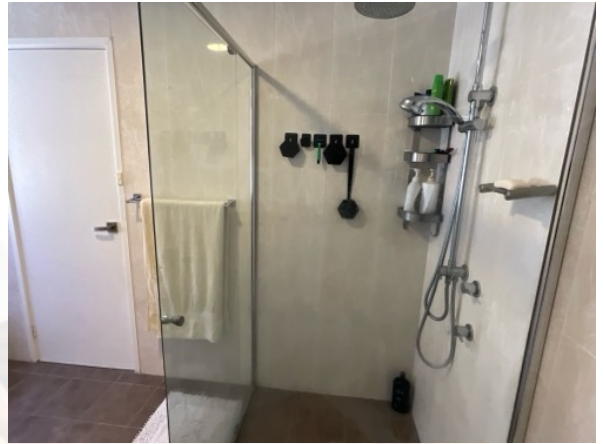
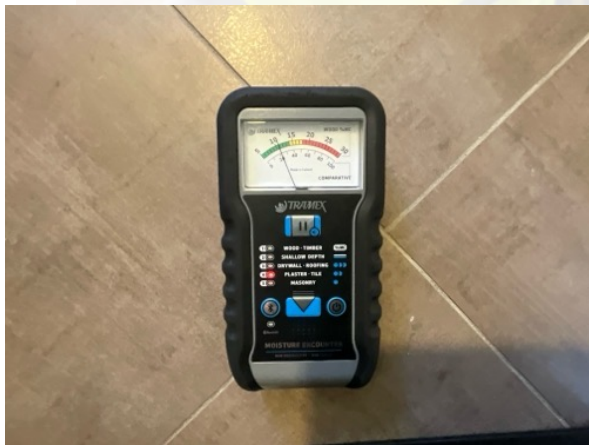
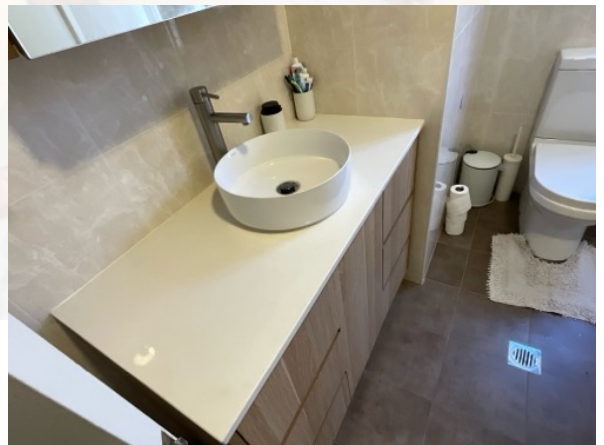
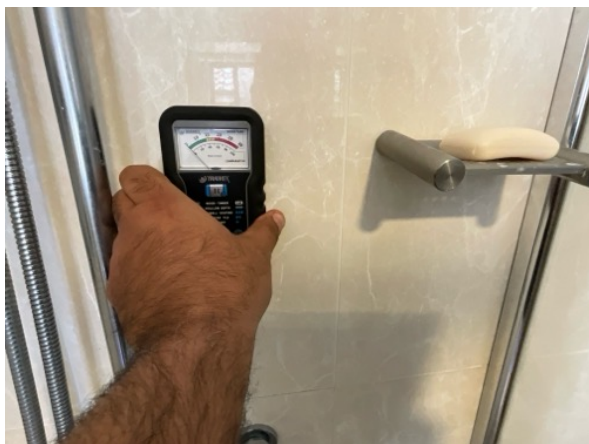
## For your information 2.02

**Location:** Bathrooms  
**Finding:** Additional Photos-low moisture readings

During the inspection, moisture readings were taken in the bathrooms to assess the presence of dampness or water intrusion. The following observations were made:

1. Master Bathroom:
  - Moisture Reading: A moisture meter reading was taken in the master bathroom, and it indicated a low level of dampness.
  - Note/Description: The master bathroom showed no visible signs of water leaks or water-related issues. The low moisture reading suggests that the bathroom area is adequately dry, and no immediate concerns are identified.
2. Ensuite.
  - Moisture Reading: Moisture meter readings were also taken in any additional bathrooms within the property, and all readings indicated low levels of dampness.
  - Note/Description: The other bathrooms inspected did not show any visible signs of water leaks or moisture issues. The low moisture readings suggest that these bathroom areas are in satisfactory condition.

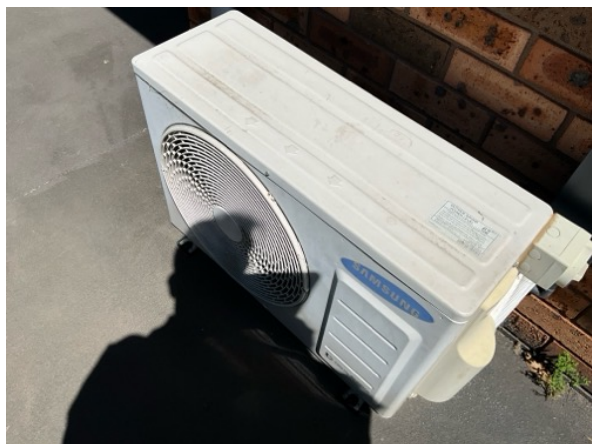
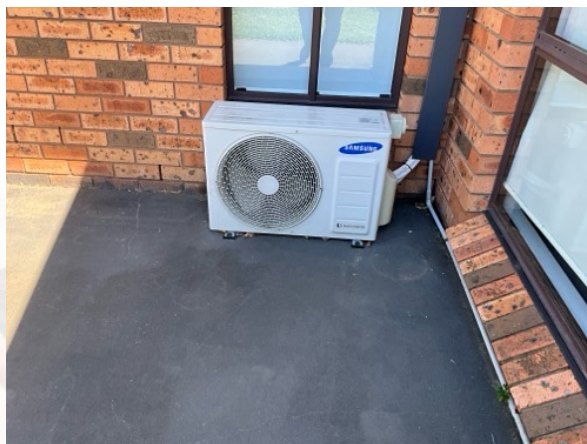
## Conditions conducive to timber pest attack 3.01

**Finding:** Bridging or Obstruction - Air Conditioner, Hot Water & stored items

Where bridging has occurred full inspection is prevented and termites may enter a property in a concealed or undetectable manner.

Recommend moving obstructions away from the external walls for further and future inspections.

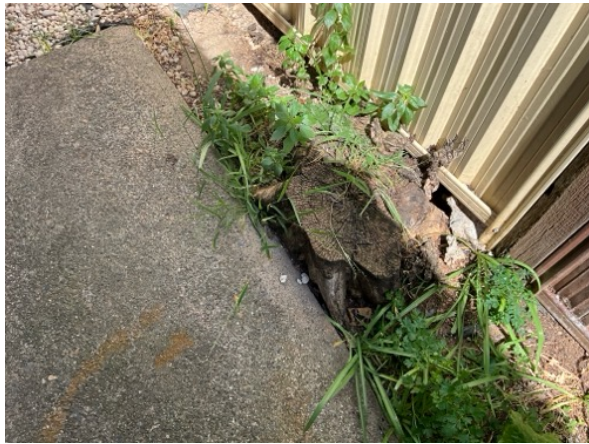
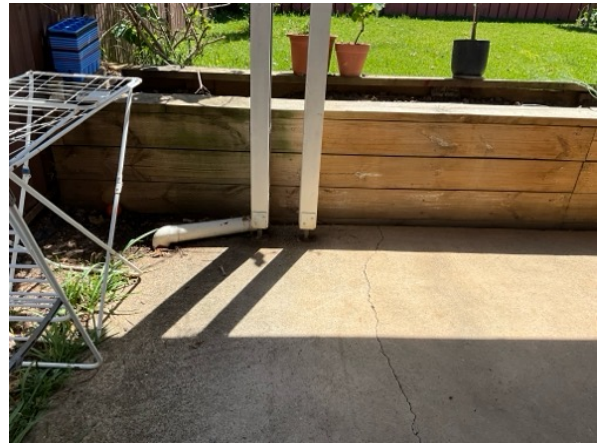
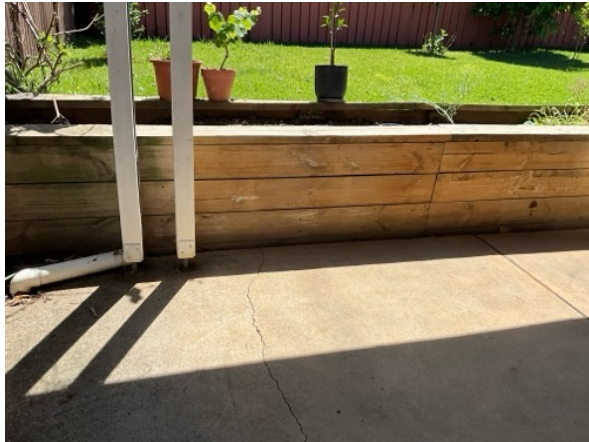
## Conditions conducive to timber pest attack 3.02

**Finding:** Timbers in contact with ground

Timbers throughout the property were found to be in contact with the ground. Where timber elements are in direct contact with the ground and consequently there is moisture or dampness they become conducive to termite activity. Whether timber is used as a building element part of a fencing structure or stored as an unused item they can provide an environment that is attractive to termite infestation. When met with excessive moisture timber begins to decay and develop wood decay. Any timbers that are in direct contact with external grounds especially if left untreated or non-durable also provide ingress for subterranean termites into that particular element. Any such materials that may be conducive to termite activity should be monitored frequently for any changes to minimise the risk of termite attack.

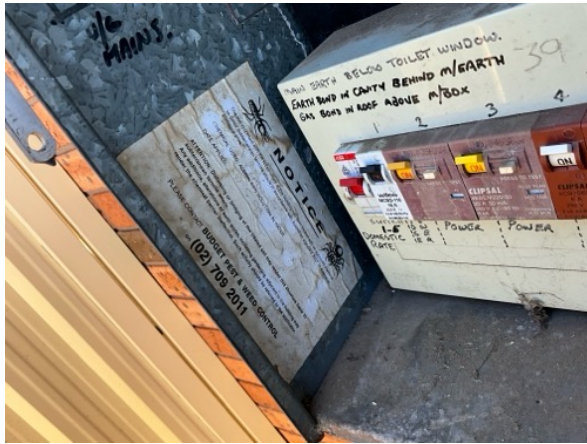
A durable notice is missing from the meterbox. The application of a post-construction chemical termite barrier is highly recommended for all properties with timber building elements. Such barriers are highly effective in preventing termite attack on any timber building elements throughout the property. A durable notice should be placed in the meter board to indicate current termite barriers. At the time of inspection, it appeared as though no termite management system has been installed, with no evidence to suggest preventative works taking place which puts this property at very high risk. The client should consider gaining further advice from a licensed termite/timber pest technician as to the costs and procedures involved with implementing and maintaining a pest management system for this

Recommendations: Engage a qualified pest control expert with experience in termite management for older properties. They can assess the specific risk factors of the property, recommend appropriate treatments, and provide ongoing guidance to ensure effective termite prevention. Additionally, refer to local regulations and guidelines related to termite management for your area.
