# Pre Inspection Building And Timber Pest Report

**Inspection Date: 5 Nov 2025**

Property Address: 38 Burragorang Street Woodcroft 2767

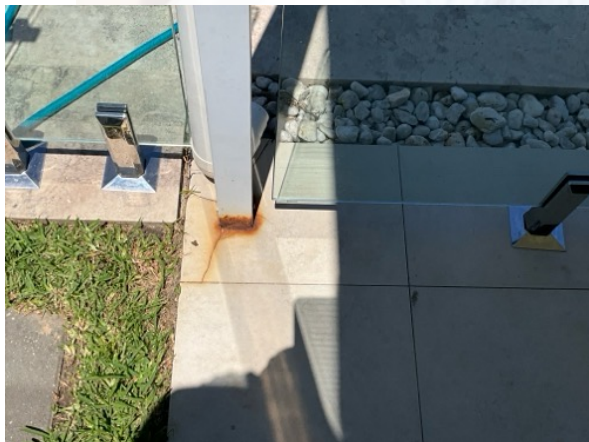
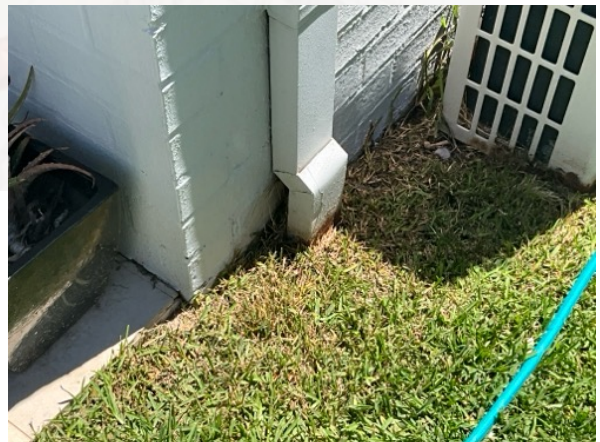
### Minor Defect 1.01

**Location:** Exterior Wall

**Finding:** Rusted Down-pipe and steel baluster, a suitably qualified Painter should assess and remediate.

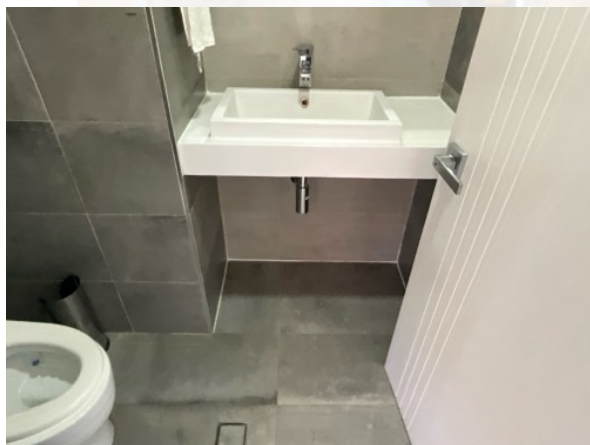
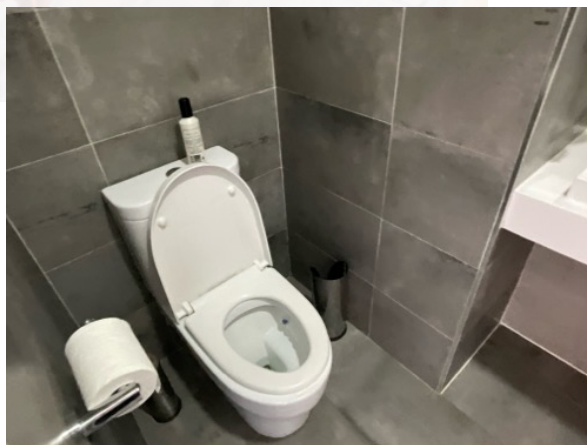
## For your information 2.03

**Location:** Bathrooms

**Finding:** Additional Photos-low moisture readings

- Moisture Reading: A moisture meter reading was taken in the master bathroom, and it indicated a low level of dampness.
- Note/Description: The master bathroom showed no visible signs of water leaks or water-related issues. The low moisture reading suggests that the bathroom area is adequately dry, and no immediate concerns are identified.

- Moisture Reading: A moisture meter reading was conducted in the guest bathroom, and it revealed a low level of moisture.
- Note/Description: The guest bathroom exhibited no visible damp spots or water damage. The low moisture reading indicates that the bathroom area is free from any significant water intrusion or moisture-related problems.

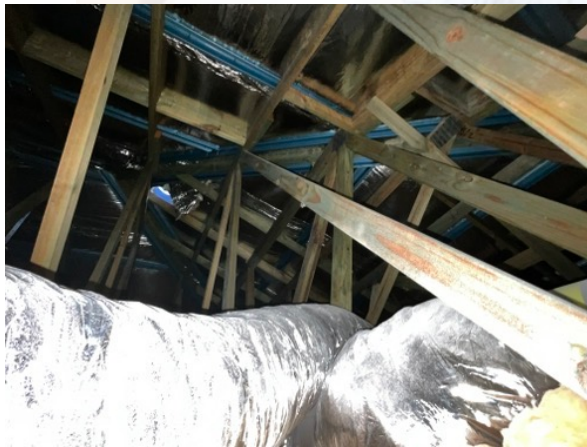
## For your information 2.04

**Location:** Roofspace

Note/Description: The installation of proper insulation and sarking is a positive aspect of the property. This helps in maintaining temperature control, reducing energy consumption, and preventing moisture penetration. Buyers should be aware that this installation contributes to the overall energy efficiency and comfort of the building.

Recommendations: No further actions are required in relation to this observation, as the correct installation of insulation and sarking aligns with recommended building practices. This contributes to the property's compliance with energy efficiency standards and enhances its overall value.

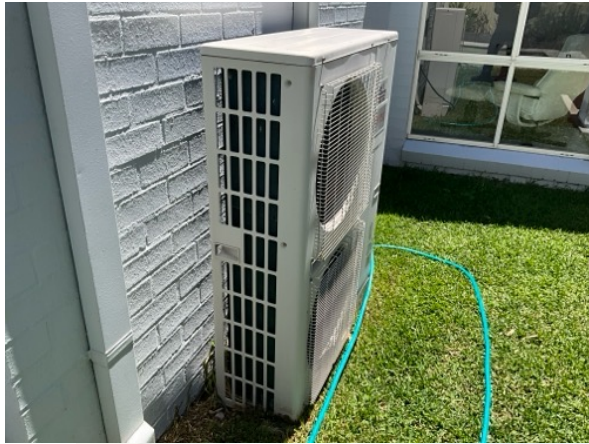
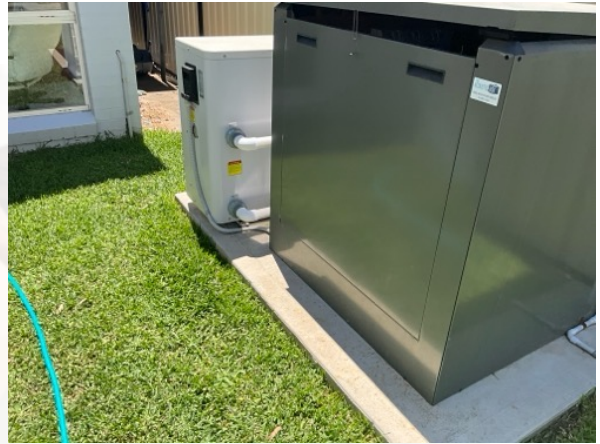
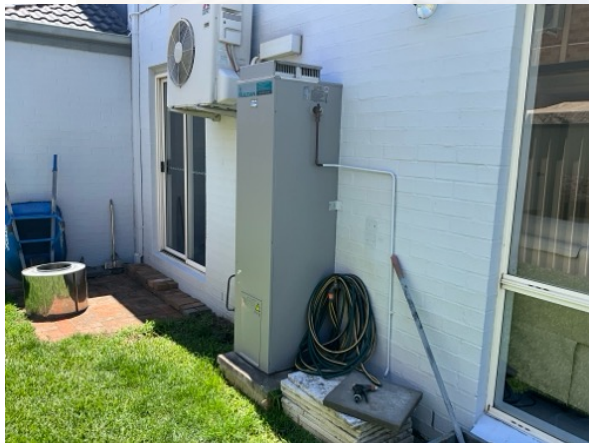
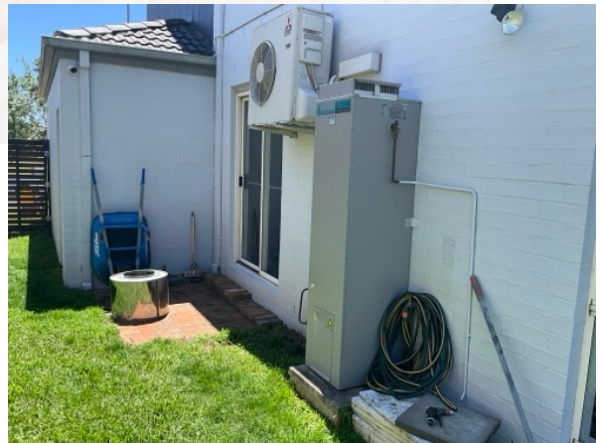
### Conditions conducive to timber pest attack 3.01

**Finding:** Bridging or Obstruction - Air Conditioner, Hot Water & stored items

Bridging of termite barriers occurs when termites bridge (usually by building a mud tunnel) a termite barrier or inspection zone or where termites have a passage allowing them to bridge the barrier. Either the A/C Unit, Hot Water unit, storage shed or stored goods obstructed a clear visual inspection to the wall(s) and weep holes in this area. Where bridging has occurred full inspection is prevented and termites may enter a property in a concealed or undetectable manner. Recommend moving obstructions away from the external walls for further and future inspections.

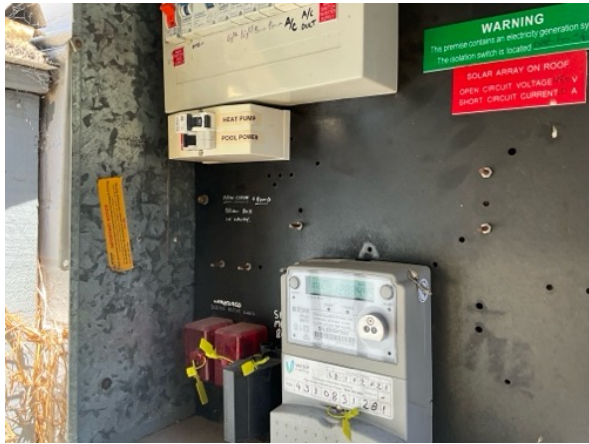
## For your information 3.02

**Location:** Main Switch Board

**Finding:** Durable Notice - Missing

A durable notice is missing from the meterbox. The application of a post-construction chemical termite barrier is highly recommended for all properties with timber building elements. Such barriers are highly effective in preventing termite attack on any timber building elements throughout the property. A durable notice should be placed in the meter board to indicate current termite barriers. At the time of inspection, it appeared as though no termite management system has been installed, with no evidence to suggest preventative works taking place which puts this property at very high risk. The client should consider gaining further advice from a licensed termite/timber pest technician as to the costs and procedures involved with implementing and maintaining a pest management system for this

Recommendations: Engage a qualified pest control expert with experience in termite management for older properties. They can assess the specific risk factors of the property, recommend appropriate treatments, and provide ongoing guidance to ensure effective termite prevention. Additionally, refer to local regulations and guidelines related to termite management for your area.
