BUILDING INSPECTION

Complies with Australian Standard AS 4349.1-2007
Inspection of Buildings Part 1: Pre-Purchase
Inspections of Residential Buildings - Appendix C

1/37 Andrew Street
Brighton, TAS
, Australia

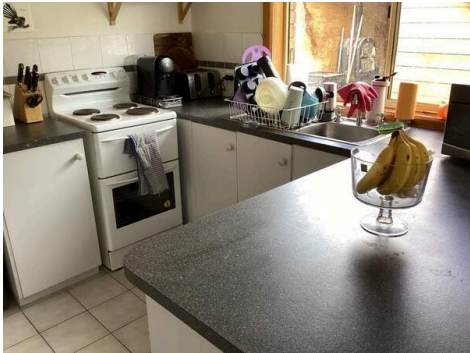
Photo Ref #1

Comments : Reasonable condition for the age with minor wear and tear

Defect Significance: Minor

Defect Type: A (Damage)

Comments:	Reasonable condition for the age with minor wear and tear
Defect Significance:	Minor
Defect Type:	A (Damage)

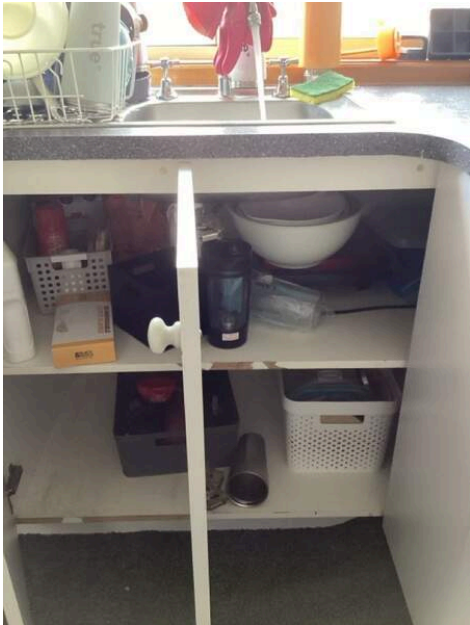
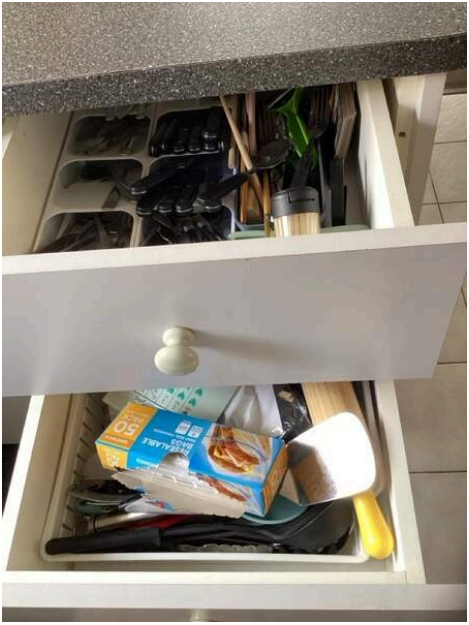
Photo Ref #2

Comments : Reasonable condition for the age with minor wear and tear evident

Defect Significance: Minor

Defect Type: A (Damage)

Comments:	Reasonable condition for the age with minor wear and tear evident
Defect Significance:	Minor
Defect Type:	A (Damage)

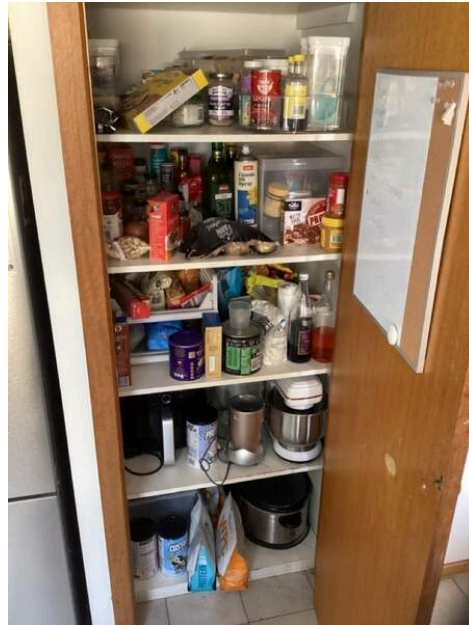
Photo Ref #4

Comments : Generally good condition for the age with typical minor wear and tear evident

Defect Significance: Minor

Defect Type: A (Damage)

Comments:	Generally good condition for the age with typical minor wear and tear evident
Defect Significance:	Minor
Defect Type:	A (Damage)

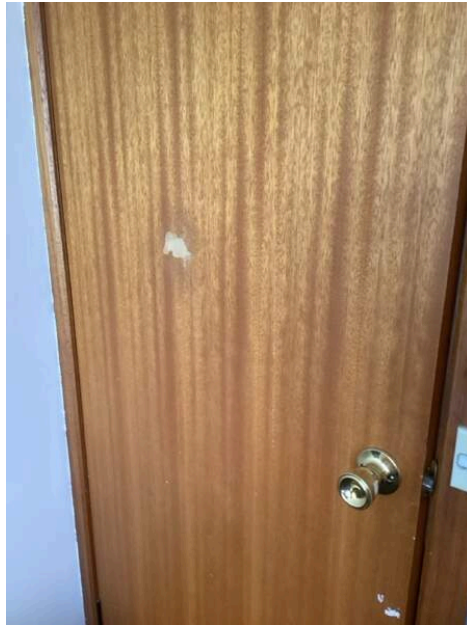
Photo Ref #5

Comments : Reasonable condition and functional. Minor damage repair evident.
Defect Significance: Minor
Defect Type: A (Damage)

Reasonable condition and functional. Minor damage repair evident.

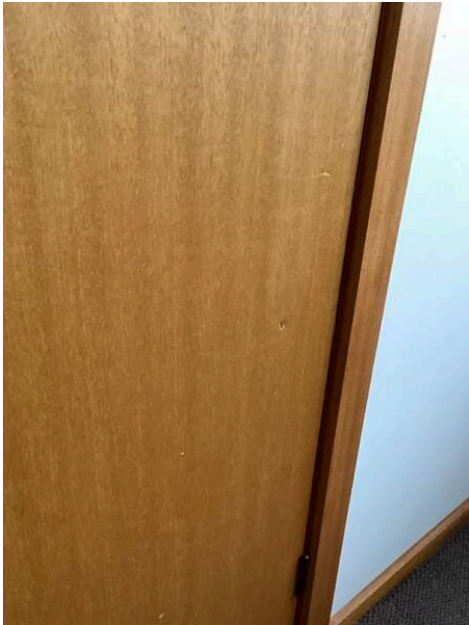
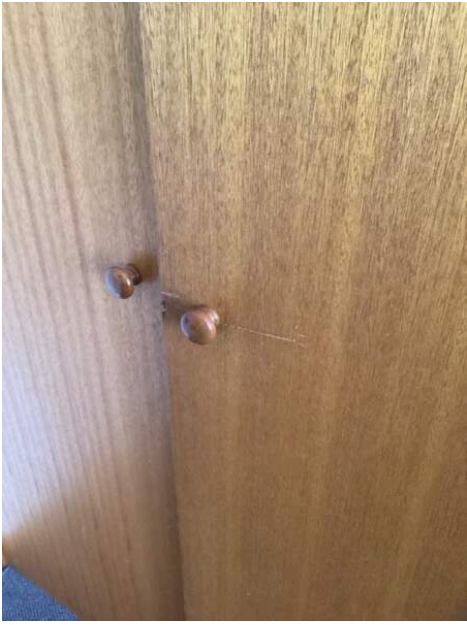
Photo Ref #6

Comments : Minor damage, typical wear and tear to door face
Defect Significance: Minor
Defect Type: A (Damage)

Minor damage, typical wear and tear to door face

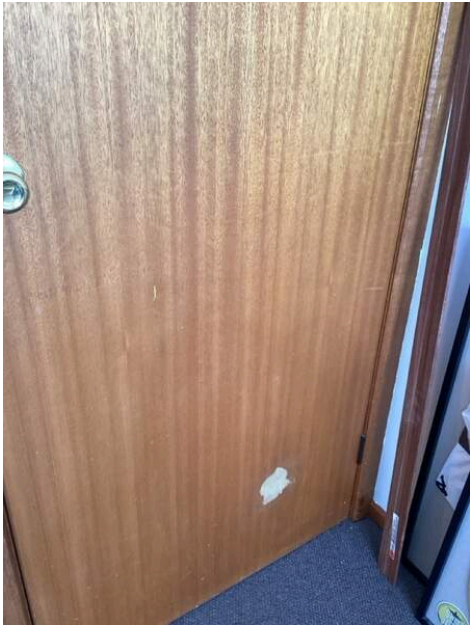
Photo Ref #8

Comments : Reasonable condition. Minor damage repair evident
Defect Significance: Minor
Defect Type: A (Damage)

Reasonable condition. Minor damage repair evident

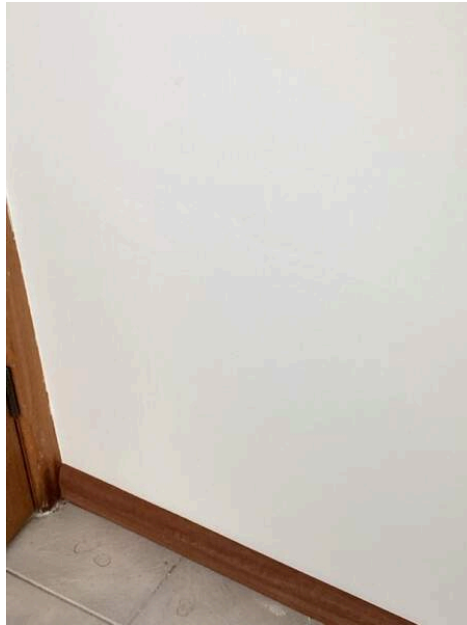
Photo Ref #9

Comments : Minor cosmetic defect/repair evident
Defect Significance: Minor
Defect Type: A (Damage)

Minor cosmetic defect/repair evident

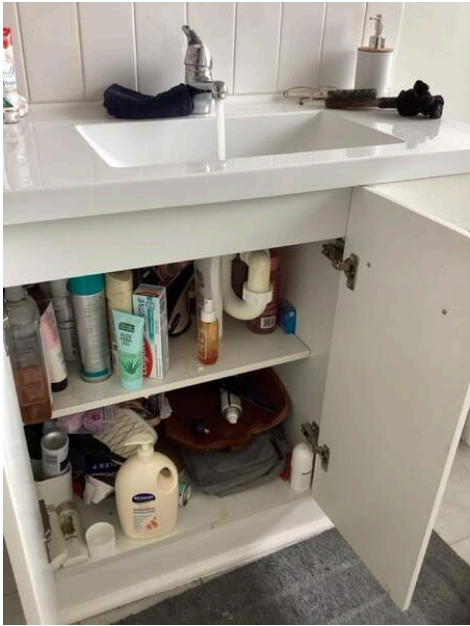
Photo Ref #10

Comments : Reasonable condition with typical wear and tear evident.

Defect Significance: Minor

Defect Type: A (Damage)

Reasonable condition with typical wear and tear evident.

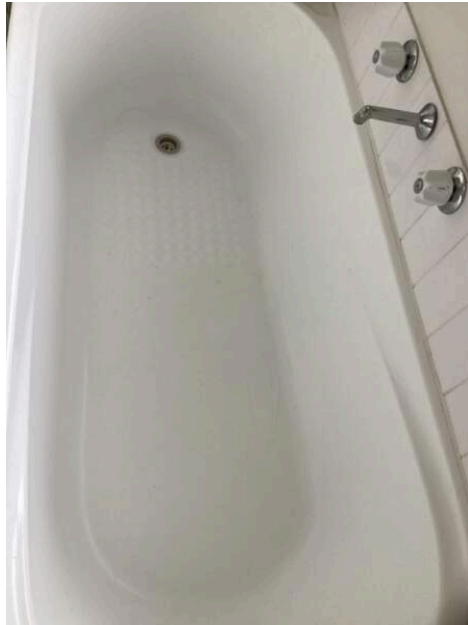
Photo Ref #11

Comments : Generally good condition with minor scuff marks/ wear and tear evident

Defect Significance: Minor

Defect Type: A (Damage)

Generally good condition with minor scuff marks/wear and tear evident

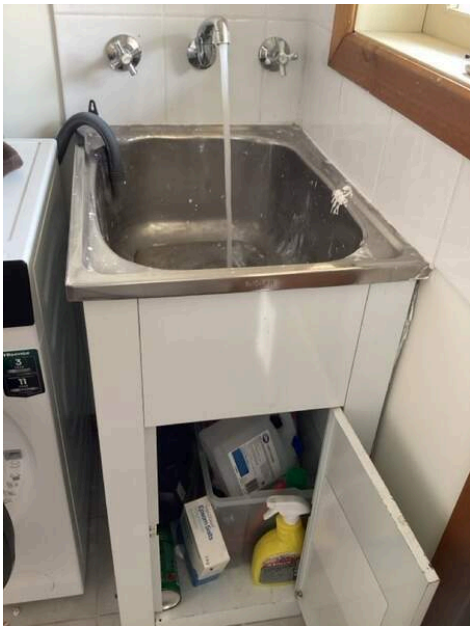
Photo Ref #12

Comments : Functional with wear and tear evident
Defect Significance: Minor
Defect Type: A (Damage)

Functional with wear and tear evident

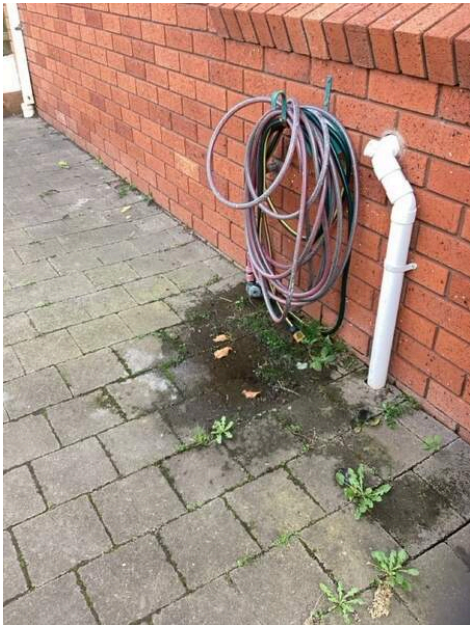
Photo Ref #13

Comments : Rear garden tap has slight weep evident.
 Recommend typical maintenance/tap washer
 replacement.
Defect Significance: Minor
Defect Type: E (Operational)

Rear garden tap has slight weep evident. Recommend typical maintenance/tap washer replacement.

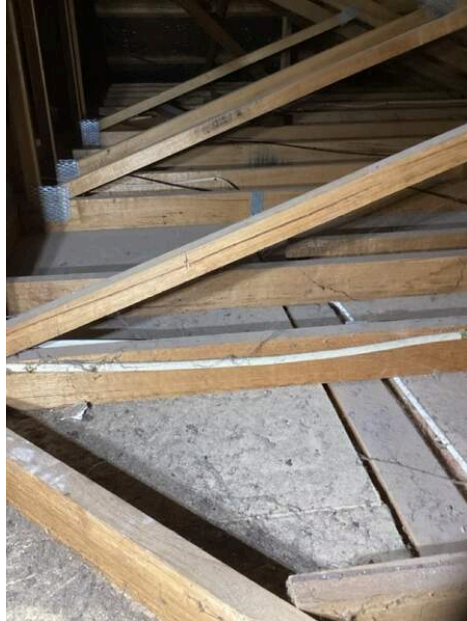
Photo Ref #14

Comments : No insulation installed
Defect Significance: Minor
Defect Type: E (Operational)

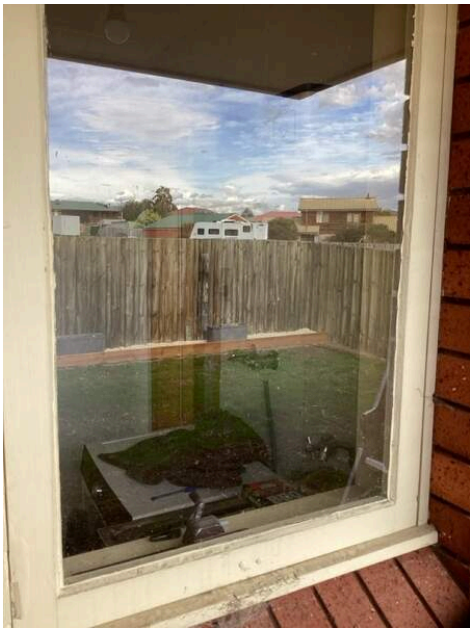
Photo Ref #15

Comments : Generally good condition for the age with typical element weathering

Defect Significance: Minor

Defect Type: D (Material Deterioration: rusting, rotting, corrosion, decay)

Generally good condition for the age with typical element weathering

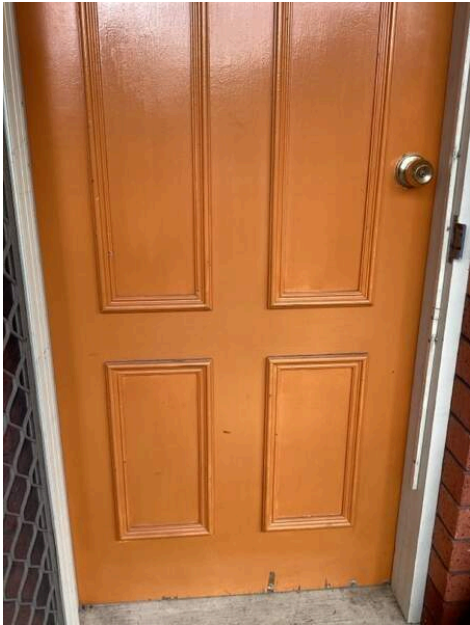
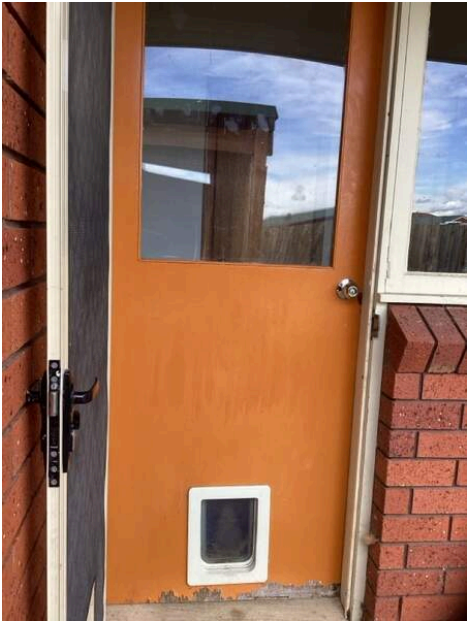
Photo Ref #16

Comments : Generally reasonable condition with minor element weathering and minor defect to lower sections of door faces.

Defect Significance: Minor

Defect Type: D (Material Deterioration: rusting, rotting, corrosion, decay)

Generally reasonable condition with minor element weathering and minor defect to lower sections of door faces.

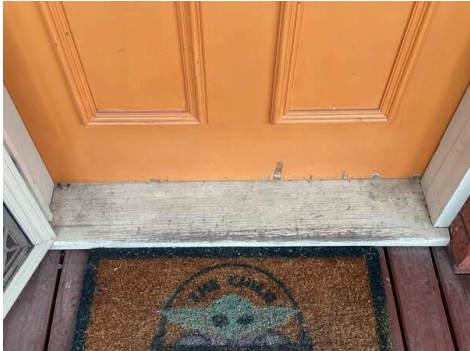
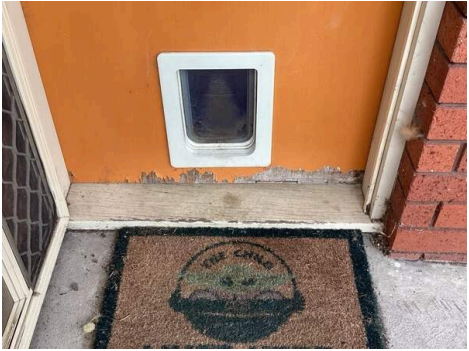
Photo Ref #18

Comments : Reasonable condition with typical element, weathering wear and tear evident

Defect Significance: Minor

Defect Type: A (Damage)

Reasonable condition with typical element, weathering wear and tear evident

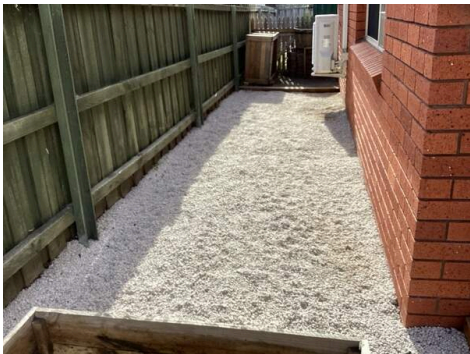
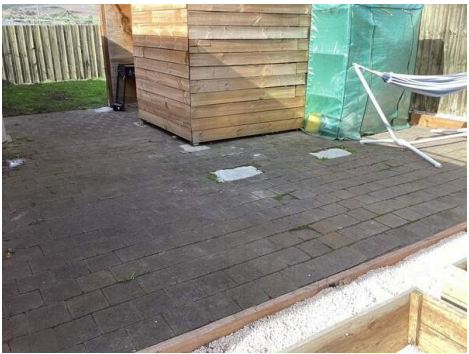
Photo Ref #20

Comments : At the time of inspection the site was dry and no drainage defects were evident.
Drainage monitoring is always recommended as a matter of course as drainage conditions have potential to change, particularly overtime
If drainage conditions or moisture become problematic, remedial measures may be required

Defect Significance: Further Investigation
Defect Type: E (Operational)

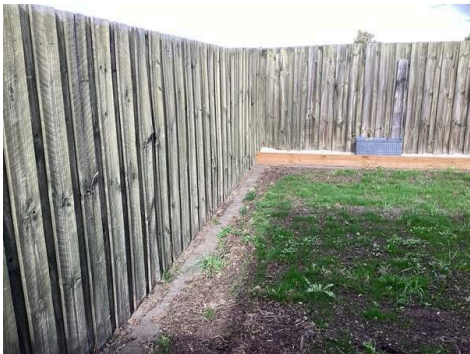
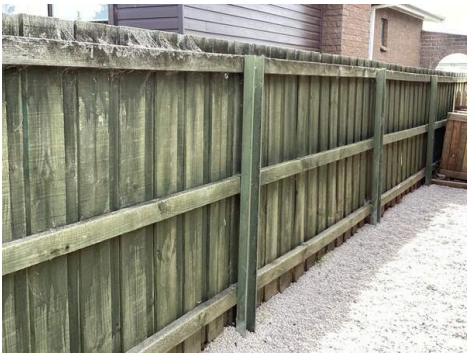
Photo Ref #22

Comments : Reasonable condition for the age with areas of typical element, weathering and minor defects evident

Defect Significance: Minor
Defect Type: D (Material Deterioration: rusting, rotting, corrosion, decay)

Reasonable condition for the age with areas of typical element, weathering and minor defects evident

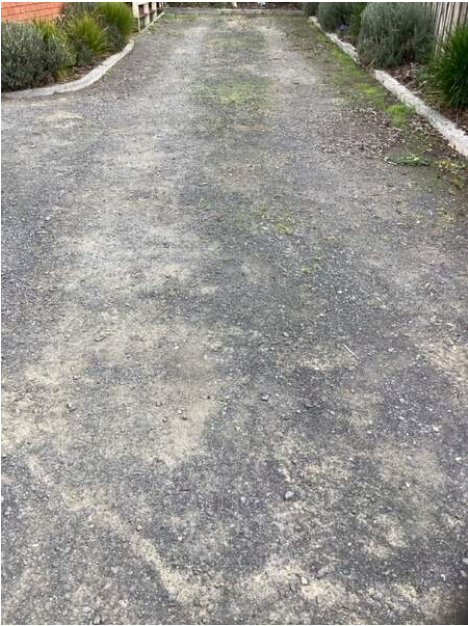
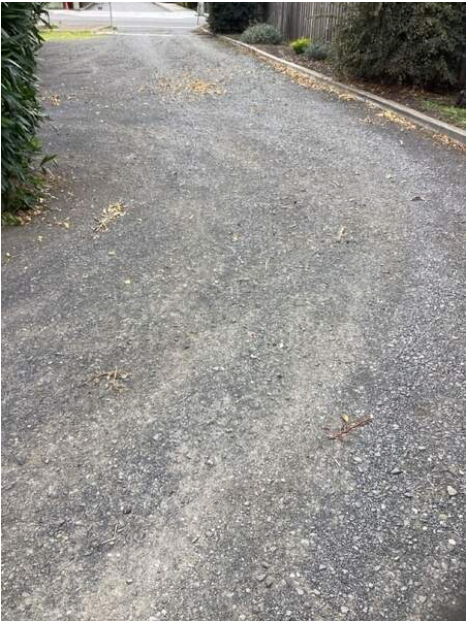
Photo Ref #26

Comments :	Reasonable condition. Gravel area subject to wash and erosion
Defect Significance:	Minor
Defect Type:	E (Operational)

Reasonable condition. Gravel area subject to wash and erosion

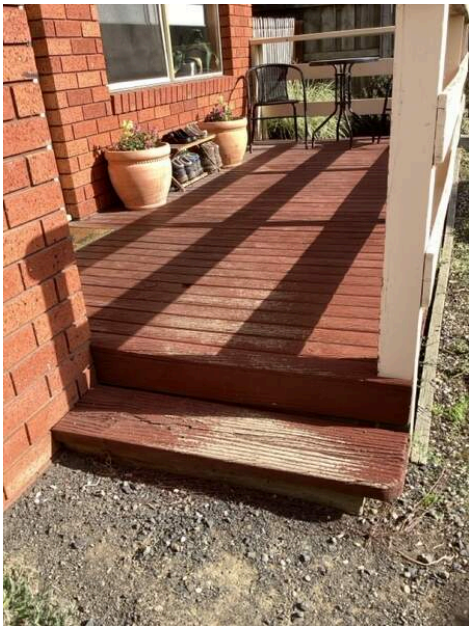
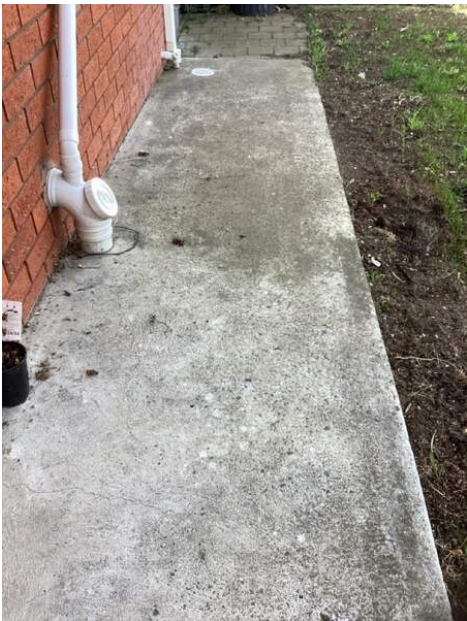
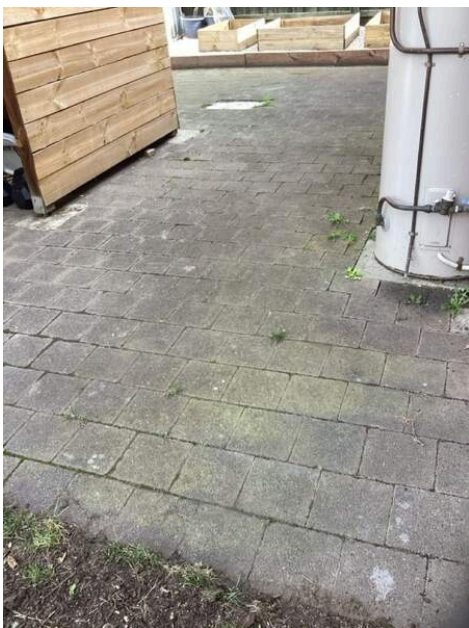
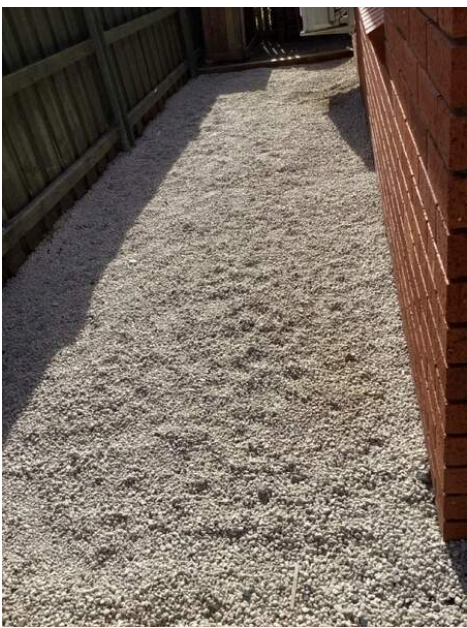
Photo Ref #28

Reasonable condition for the age with typical timber and paint element weathering evident to front deck area.
Gravel areas, subject to wash and erosion and mild deflection to paved areas evident

Defect Significance: Minor

Defect Type: D (Material Deterioration: rusting, rotting, corrosion, decay)

Reasonable condition for the age with typical timber and paint element weathering evident to front deck area. Gravel areas, subject to wash and erosion and mild deflection to paved areas evident

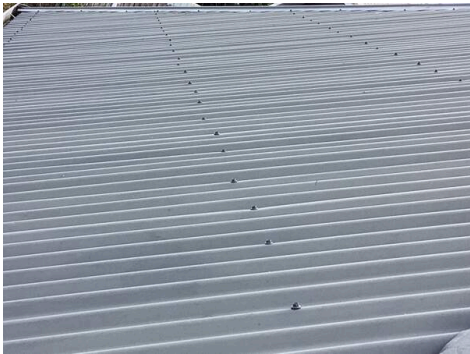
Photo Ref #32

Comments : Reasonable condition for the age with typical paint surface weathering evident

Defect Significance: Minor

Defect Type: D (Material Deterioration: rusting, rotting, corrosion, decay)

Reasonable condition for the age with typical paint surface weathering evident

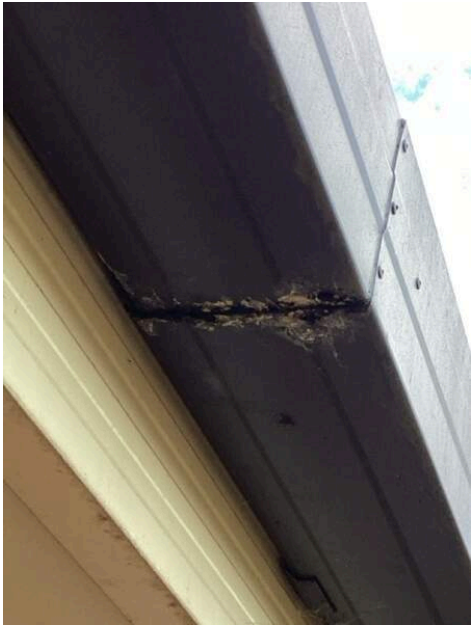
Photo Ref #33

Comments : Generally reasonable condition. Potential weeping at one or more junctions.

Defect Significance: Minor

Defect Type: E (Operational)

Generally reasonable condition. Potential weeping at one or more junctions.

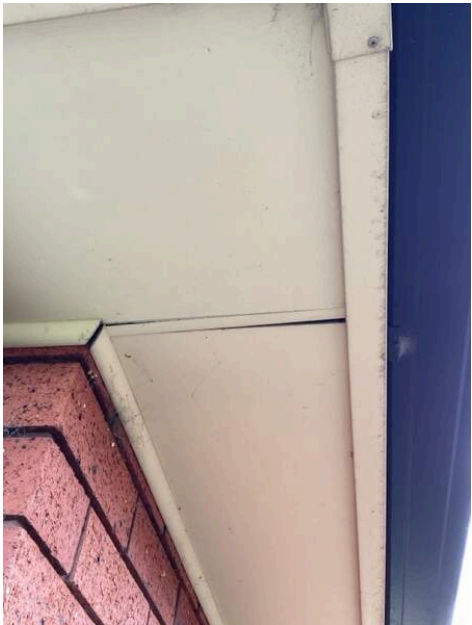
Photo Ref #34

Comments : Small gap at one suite sheet lining junction
Defect Significance: Minor
Defect Type: A (Damage)
