BUILDING INSPECTION

Complies with Australian Standard AS 4349.1-2007
Inspection of Buildings Part 1: Pre-Purchase
Inspections of Residential Buildings - Appendix C

617 Mount Llyod Road
Mount Lloyd, TAS
, Australia

Inspection Date: 29 Jul 2025
T: 0418 125 624

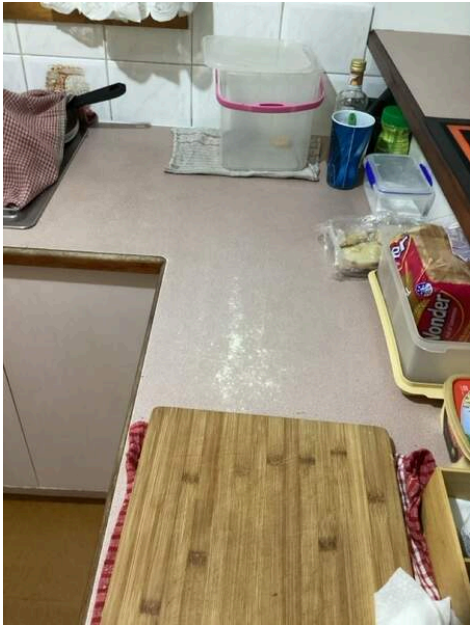
Photo Ref #1

Comments : Generally good condition for the age with typical minor wear and tear

Defect Significance: Minor

Defect Type: A (Damage)

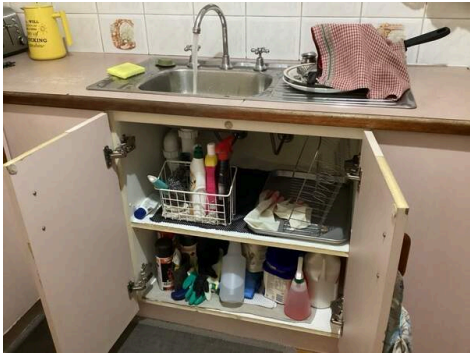
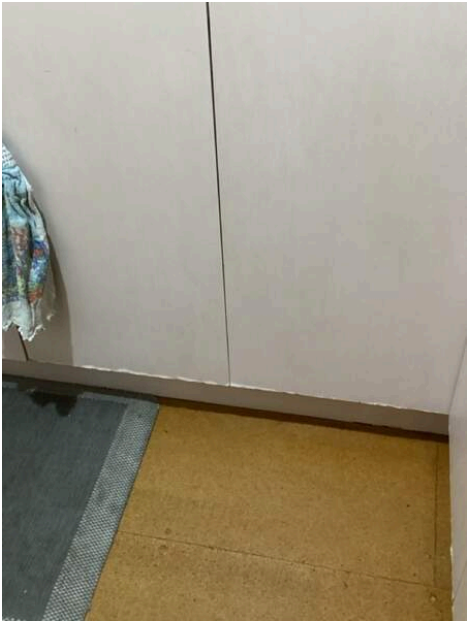
Photo Ref #4

Comments : Reasonable condition for the age with minor wear and tear.
Slight moisture damage to the bottom of one or more cabinet doors

Defect Significance: Minor

Defect Type: A (Damage)

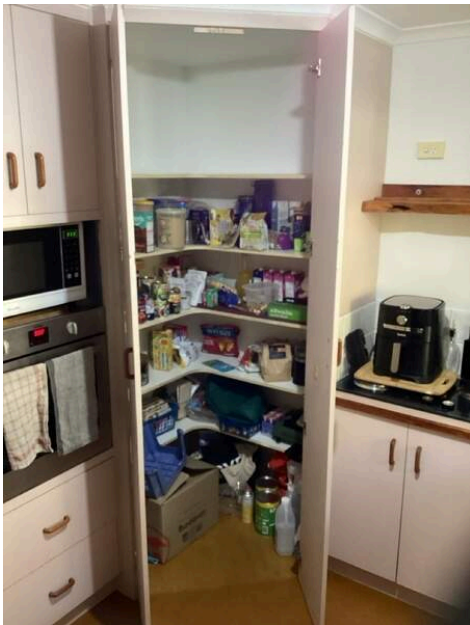
Photo Ref #6

Comments : Generally good condition with minor wear evident
Defect Significance: Minor
Defect Type: A (Damage)

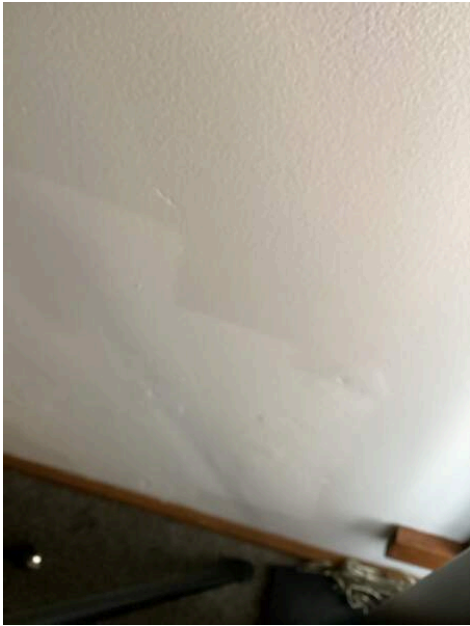
Photo Ref #7

Comments : Generally good condition with minor cosmetic defects in one or more areas

Defect Significance: Minor

Defect Type: A (Damage)

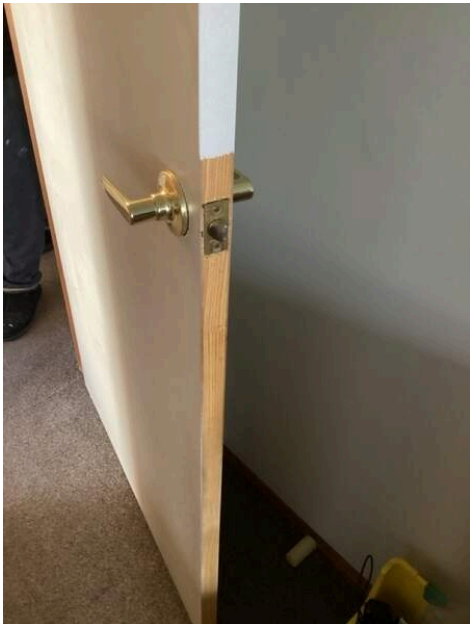
Photo Ref #8

Comments : Door edge not painted
Defect Significance: Minor
Defect Type: F (Installation, including omissions)

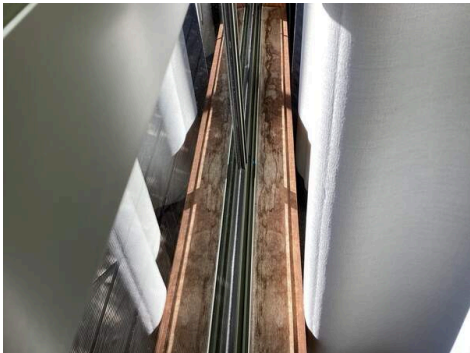
Photo Ref #9

Comments : Reasonable condition with typical windowsill reveal staining evident. Evident to some windows throughout the dwelling.

Defect Significance: Minor

Defect Type: A (Damage)

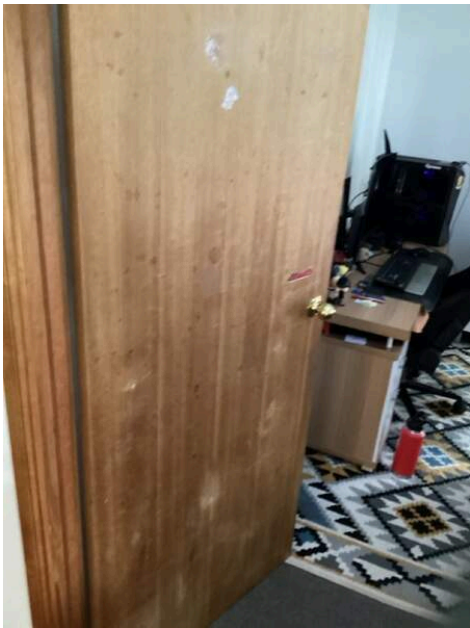
Photo Ref #10

Comments : Reasonable condition with typical minor wear and tear.
Evident to doors throughout dwelling

Defect Significance: Minor

Defect Type: A (Damage)

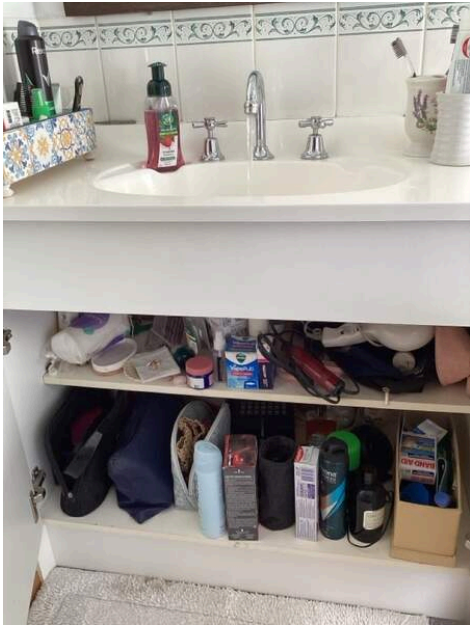
Photo Ref #12

Comments : Generally good condition with minor wear and tear
Defect Significance: Minor
Defect Type: A (Damage)

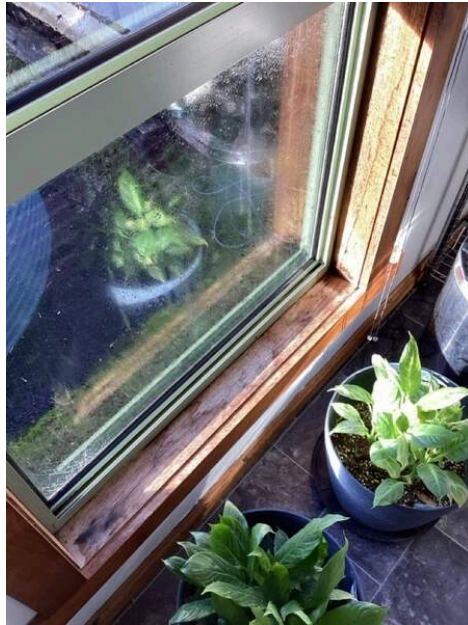
Photo Ref #14

Comments : Staining to windowsill reveal evident
Defect Significance: Minor
Defect Type: A (Damage)

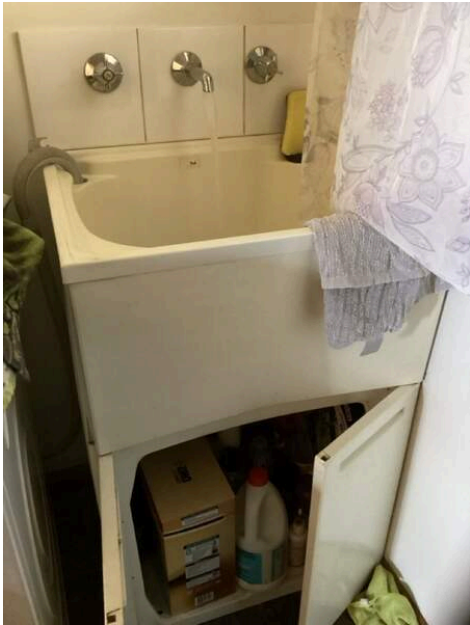
Photo Ref #15

Comments : Reasonable condition with typical minor wear and tear
Defect Significance: Minor
Defect Type: A (Damage)

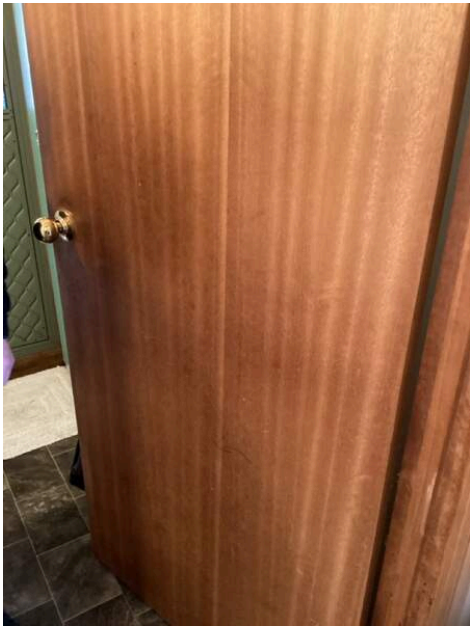
Photo Ref #16

Comments : Generally good condition with minor wear and tear
Defect Significance: Minor
Defect Type: A (Damage)

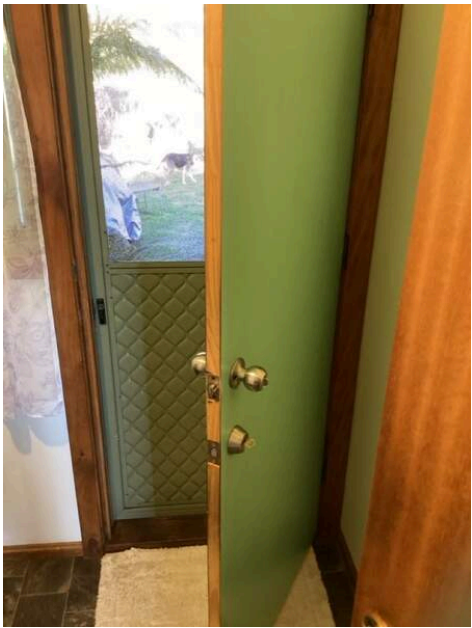
Photo Ref #17

EXPLANATIONS	Comments : Defect Significance: Defect Type:	Good condition. Door not painted. Minor F (Installation, including omissions)
--------------	--	---

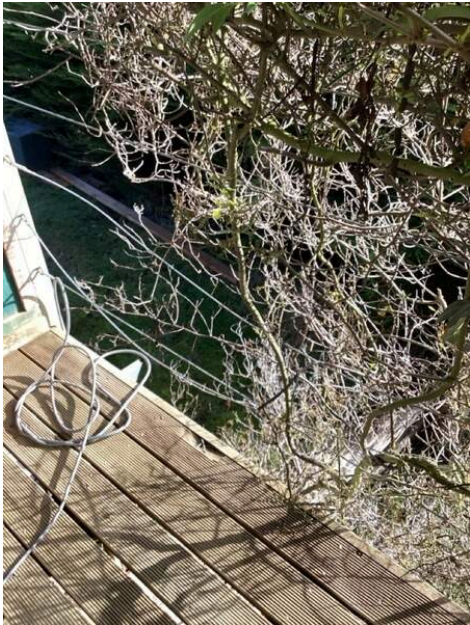
Photo Ref #21

Comments :	Wire balustrade loose in some sections
Defect Significance:	Minor
Defect Type:	F (Installation, including omissions)

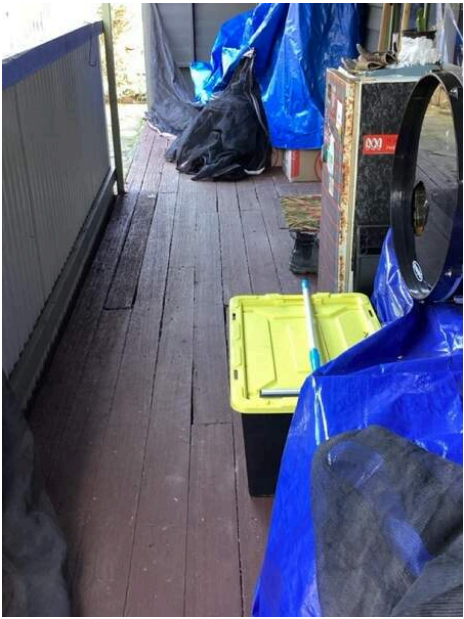
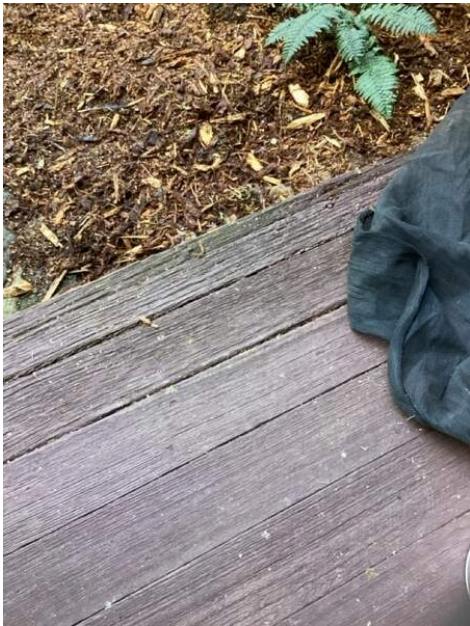
Photo Ref #22

Comments : Front deck has mild element weathering and is in good condition.
Rear deck flooring has typical element weathering with some sections of deterioration evident

Defect Significance: Minor

Defect Type: D (Material Deterioration: rusting, rotting, corrosion, decay)

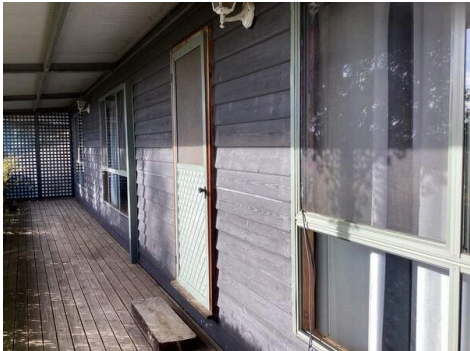
Photo Ref #25

Timber exterior cladding appears to be in reasonable condition for the age. Some areas of minor defects are evident. Some dents and minor defects are evident to corrugated iron cladding below floor level

Defect Significance: Minor

Defect Type: D (Material Deterioration: rusting, rotting, corrosion, decay)

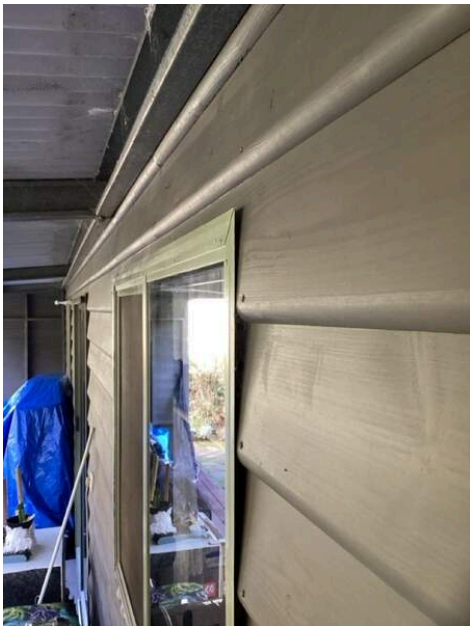
Photo Ref #33

Comments : Aluminium windows appear to be in good condition for the age.
Unable to determine or locate mechanical flashing. There was no evidence of moisture ingress at the time of inspection

Defect Significance: Further Investigation

Defect Type: F (Installation, including omissions)

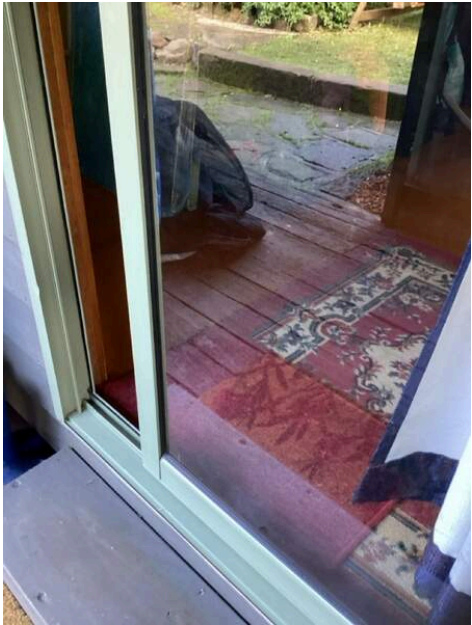
Photo Ref #34

Comments : Good condition for the age with typical weathering, minor track and roller wear

Defect Significance: Minor

Defect Type: A (Damage)

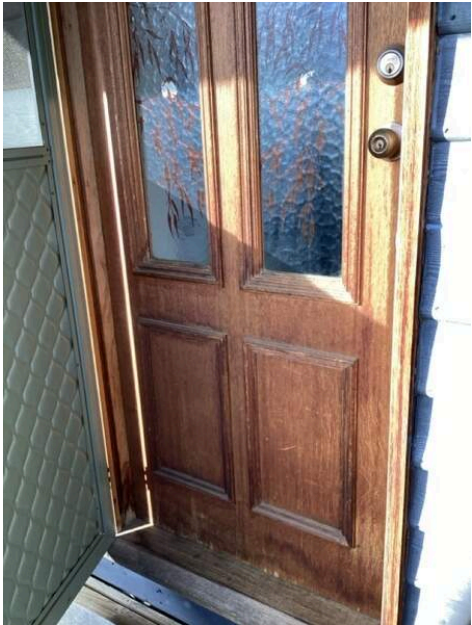
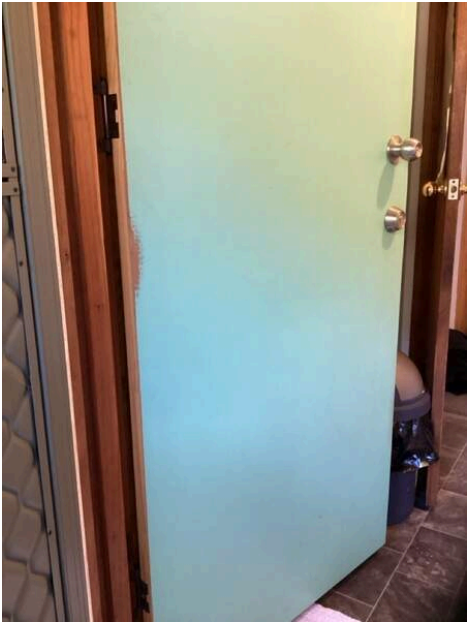
Photo Ref #35

Comments : Generally good condition with mild element weathering

Defect Significance: Minor

Defect Type: D (Material Deterioration: rusting, rotting, corrosion, decay)

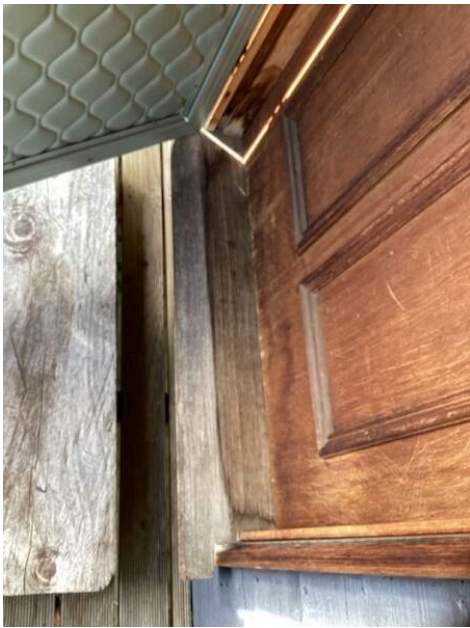
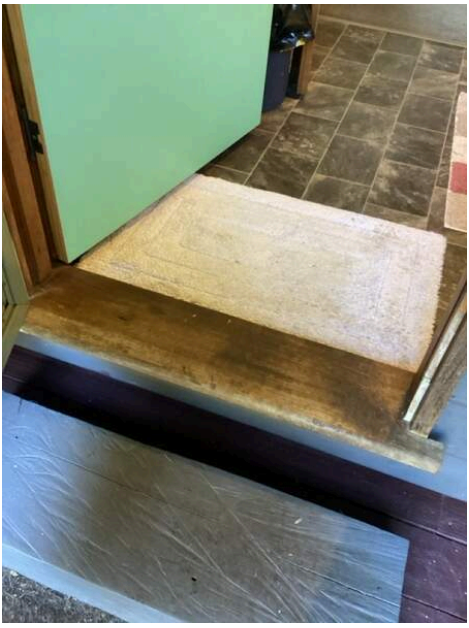
Photo Ref #37

Comments : Reasonable condition with typical weathering wear and tear evident

Defect Significance: Minor

Defect Type: A (Damage)

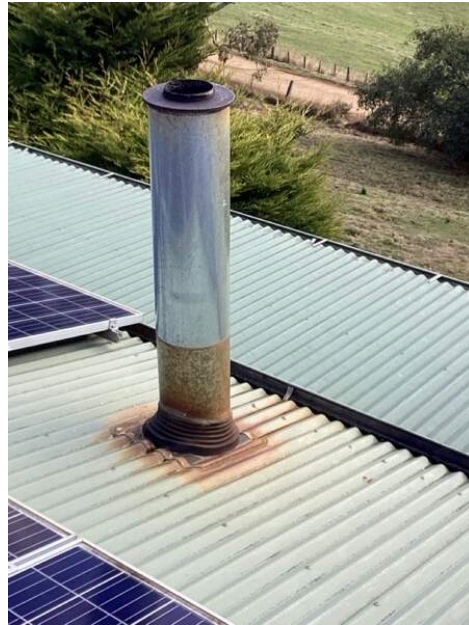
Photo Ref #39

Comments : Functional. Flu cap Missing.

Defect Significance: Minor

Defect Type: A (Damage)

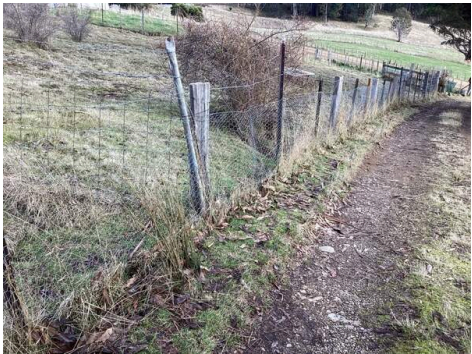
Photo Ref #42

Comments : Element weathering evident in some areas and areas of defects are evident
Gates may require adjustment to improve function

Defect Significance: Minor

Defect Type: D (Material Deterioration: rusting, rotting, corrosion, decay)

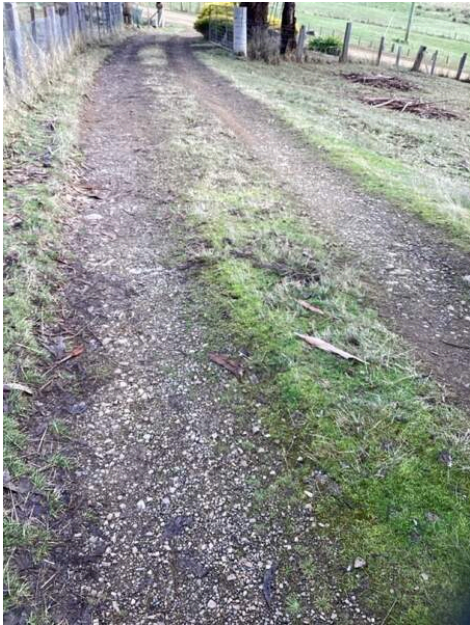
Photo Ref #47

Comments :	Gravel driveway is in reasonable condition for the age with some areas of wash and erosion evident
Defect Significance:	Minor
Defect Type:	A (Damage)

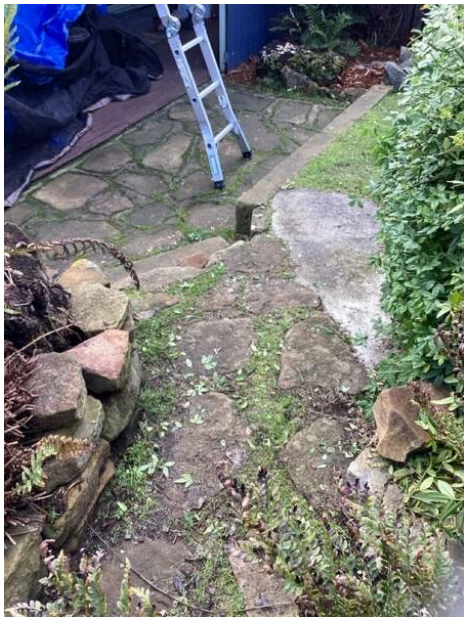
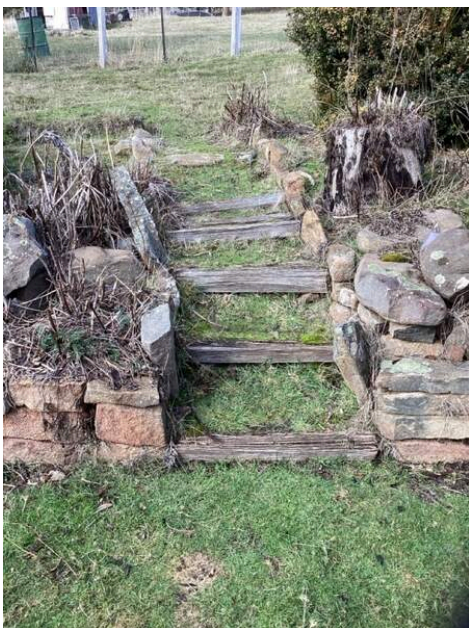
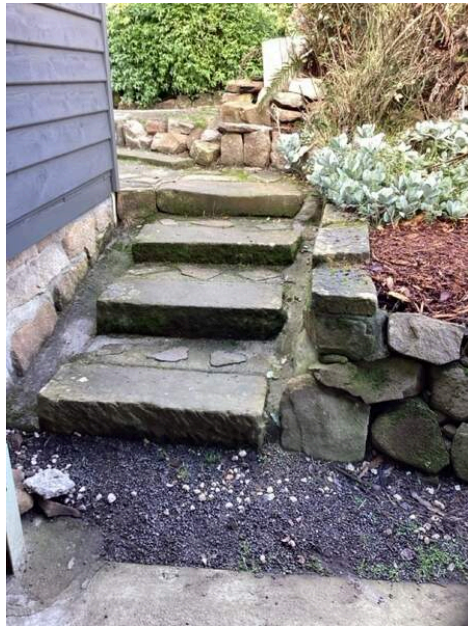
Photo Ref #49

Reasonable condition at the time of inspection.
Gravel areas subject to wash and erosion.
Mild deflection in some areas.
Timber areas have element weathering and some areas of pathways may be slippery when wet

Defect Significance: Minor

Defect Type: D (Material Deterioration: rusting, rotting, corrosion, decay)

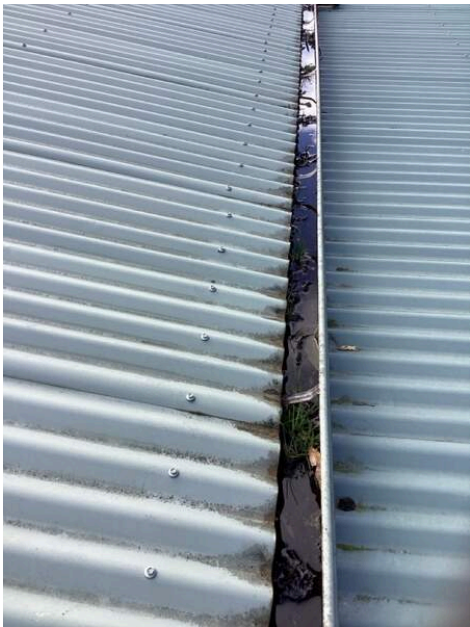
Photo Ref #54

Comments : Reasonable condition for the age. Cleaning of some areas may improve function.

Defect Significance: Minor

Defect Type: E (Operational)
