BUILDING INSPECTION

Complies with Australian Standard AS 4349.1-2007
Inspection of Buildings Part 1: Pre-Purchase
Inspections of Residential Buildings - Appendix C

Jun 11, 2025

76 Hilton Road
Claremont, TAS
, Australia

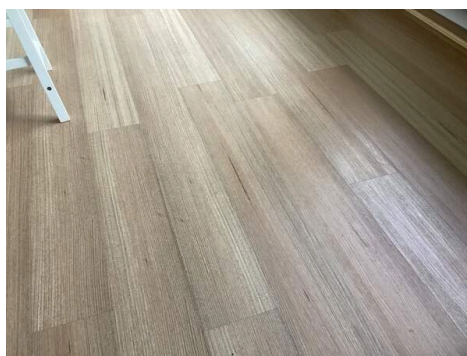
Photo Ref #1

Comments : Good condition and sound under foot with no significant spring or bounce.
Mild deflection evident

Defect Significance: Minor

Defect Type: B (Distortion, Warping, Twisting)

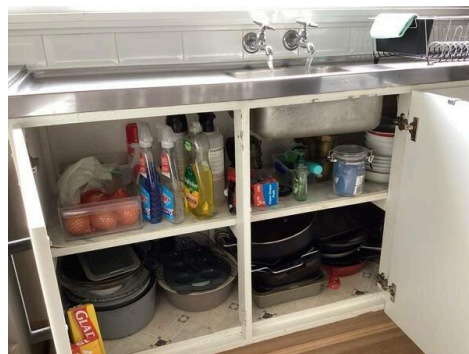
Photo Ref #2

Comments : Reasonably good condition for the age with typical wear and tear evident

Defect Significance: Minor

Defect Type: A (Damage)

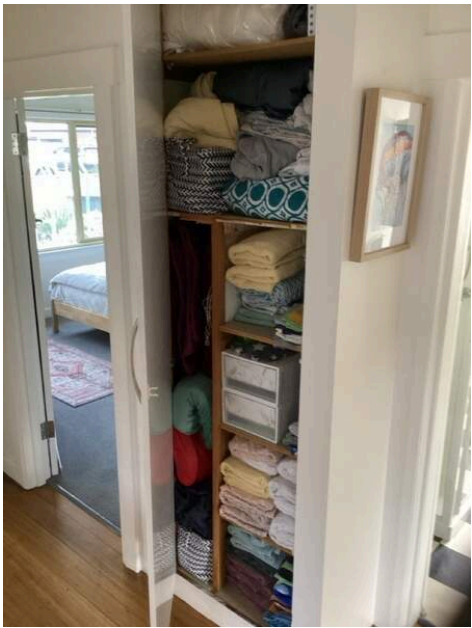
Photo Ref #3

Comments : Functional, with typical wear and tear evident
Defect Significance: Minor
Defect Type: A (Damage)

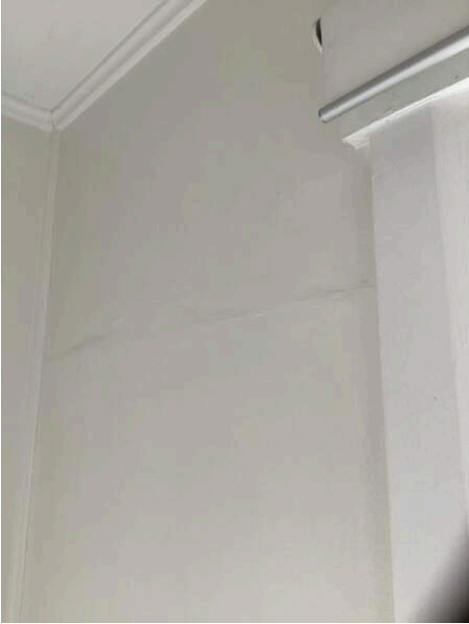
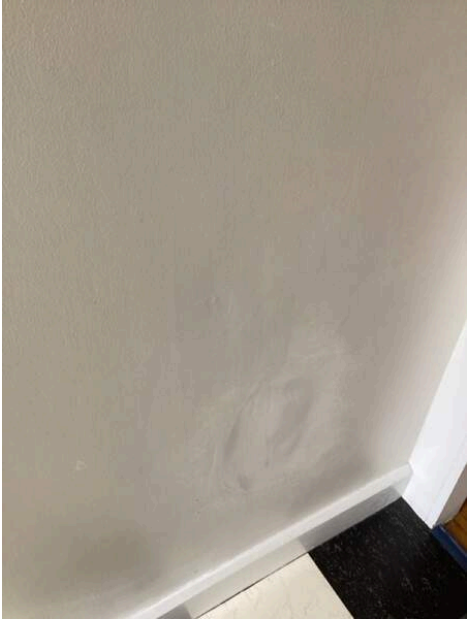
Photo Ref #4

EXPLANATIONS	Comments :	Reasonable condition for the age. Minor cosmetic defects and repair evident
	Defect Significance: Defect Type:	Minor A (Damage)
IMAGES

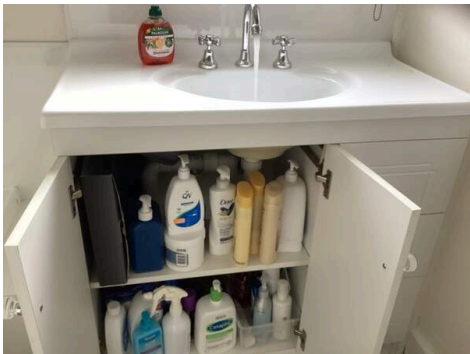
Photo Ref #6

Comments : Good condition with minor wear evident
Defect Significance: Minor
Defect Type: A (Damage)

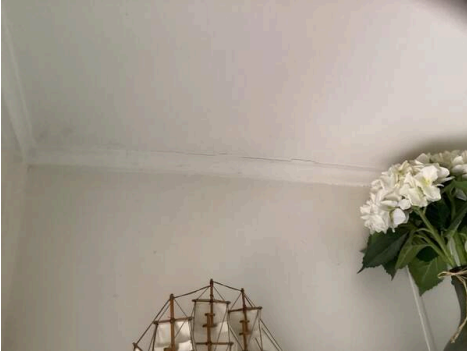
</div> <div>Photo Ref #7</div>

EXPLANATIONS	<div>Comments : Reasonable condition with fine crack at ceiling junction evident</div> <div>Defect Significance: Minor</div> <div>Defect Type: B (Distortion, Warping, Twisting)</div>
IMAGES	<div>

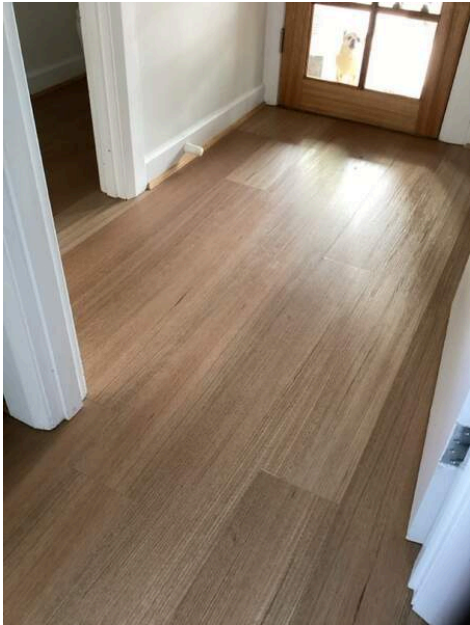
Photo Ref #8

EXPLANATIONS	<div>Comments : Generally good condition and sound under foot with no significant spring or bounce. Mild deflection is evident</div> <div>Defect Significance: Minor</div> <div>Defect Type: B (Distortion, Warping, Twisting)</div>
--------------	--

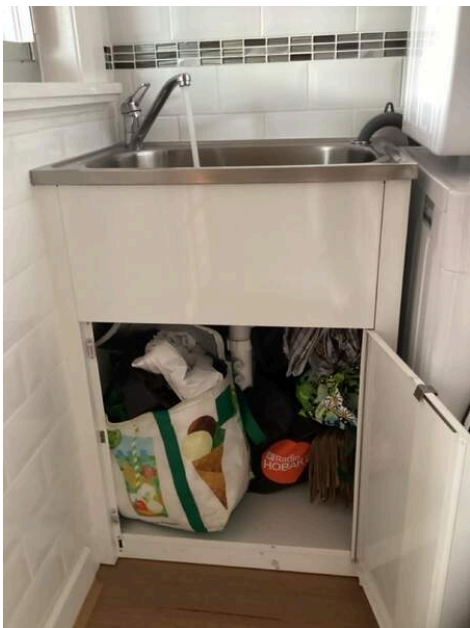
Photo Ref #9

Comments : Good condition with minor wear
Defect Significance: Minor
Defect Type: A (Damage)

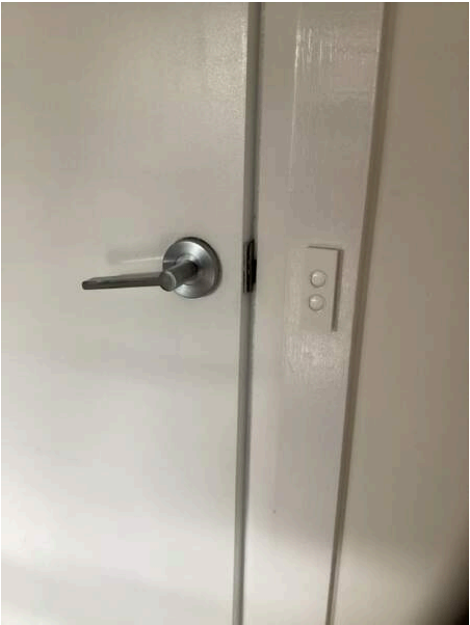
Photo Ref #10

Defect Significance: Minor

Defect Type: A (Damage)

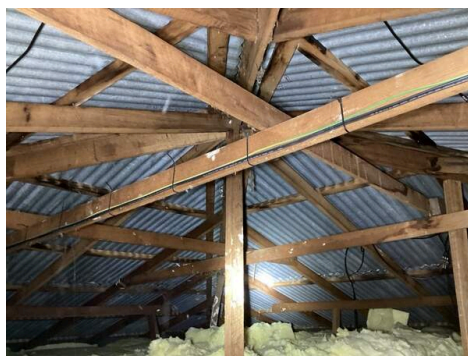
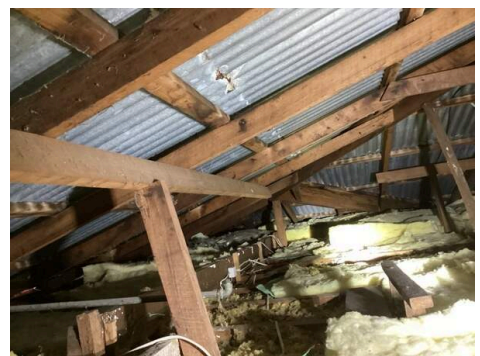
Photo Ref #11

Comments : Reasonable condition for the age with typical green timber framing seasoning and settlement evident.

Defect Significance: Minor

Defect Type: B (Distortion, Warping, Twisting)

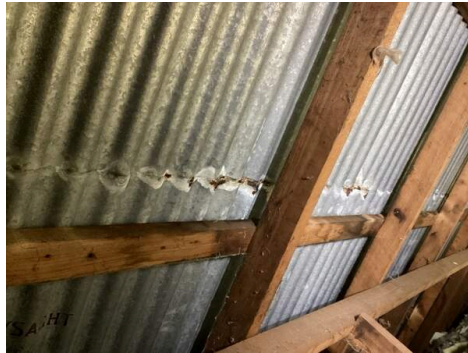
Photo Ref #13

Comments : No reflective foil installed.
Rust at sheet overlap junctions evident in some areas

Defect Significance: Minor

Defect Type: D (Material Deterioration: rusting, rotting, corrosion, decay)

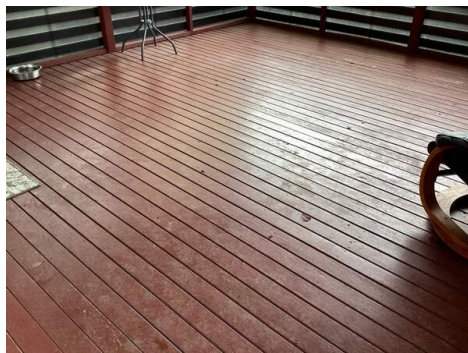
Photo Ref #14

Comments : Generally good condition with minor wear and tear
Defect Significance: Minor
Defect Type: A (Damage)

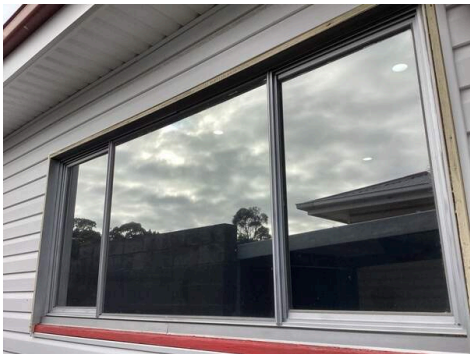
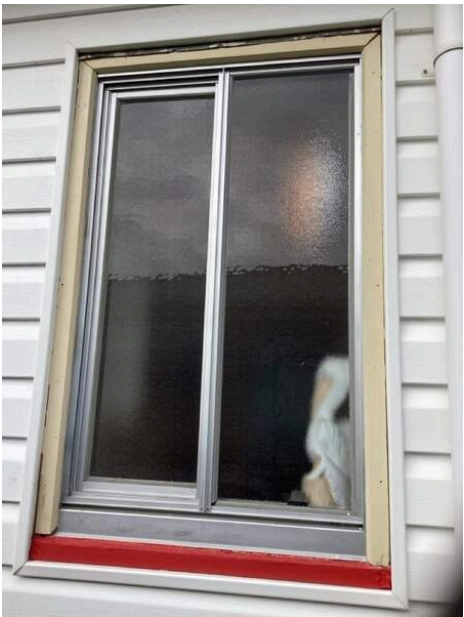
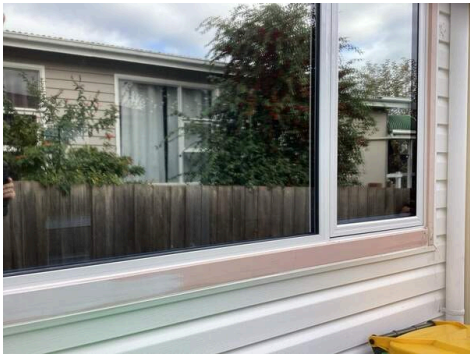
Photo Ref #15

Comments : Generally reasonable condition throughout. Timber trims have element weathering and one window timber trims not painted in its entirety.

Defect Significance: Minor

Defect Type: D (Material Deterioration: rusting, rotting, corrosion, decay)

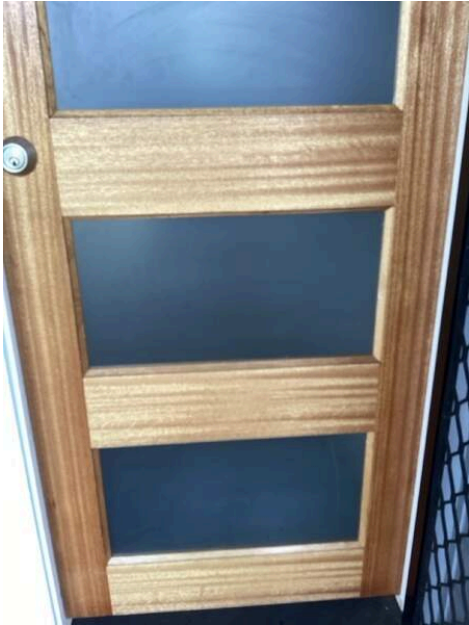
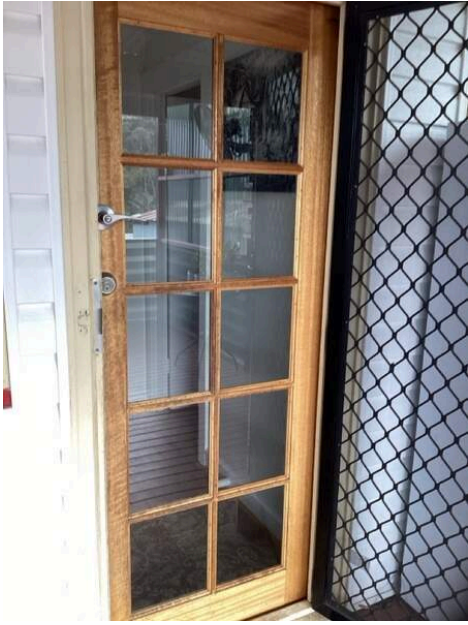
Photo Ref #18	Photo Ref #19

EXPLANATIONS	Comments :	Generally good condition with mild weathering, minor wear and tear
	Defect Significance:	Minor
	Defect Type:	D (Material Deterioration: rusting, rotting, corrosion, decay)
IMAGES

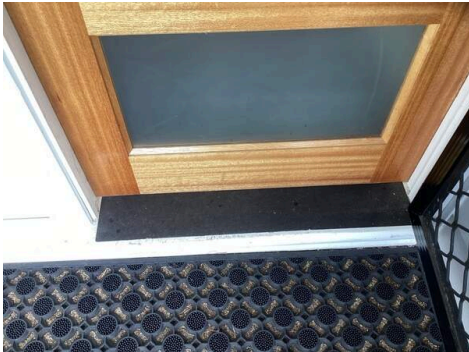
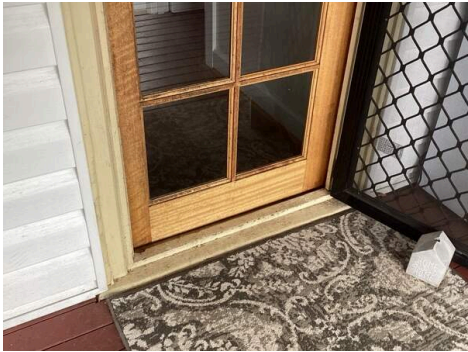
Photo Ref #20	Photo Ref #21

EXPLANATIONS	Comments :	Generally good condition with typical wear and tear
	Defect Significance:	Minor
	Defect Type:	A (Damage)
IMAGES

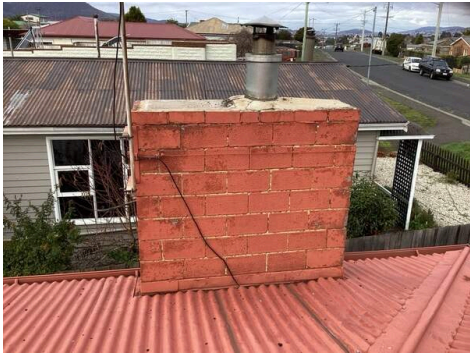
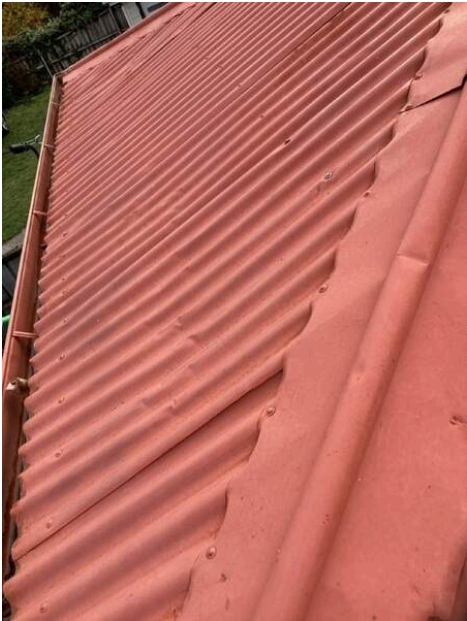
Photo Ref #22

Comments : Reasonable condition with minor surface weathering
Defect Significance: Minor
Defect Type: D (Material Deterioration: rusting, rotting, corrosion, decay)

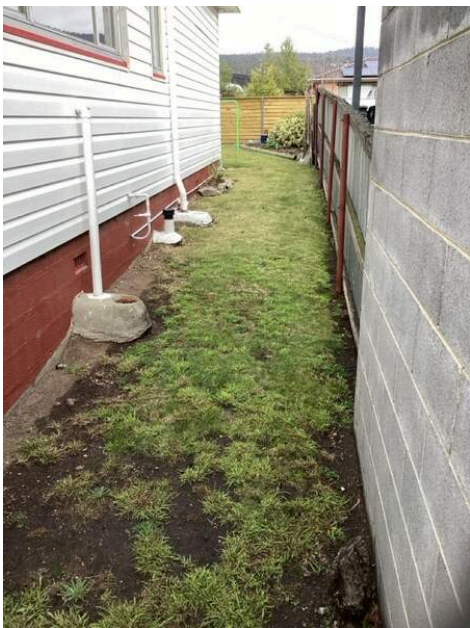
Photo Ref #24

Comments : The site appeared relatively well drained at the time of inspection.
Subfloor area was dry.
Drainage monitoring is always recommended as a matter of course as drainage conditions have potential to change, particularly overtime.
If drainage conditions and/or moisture become problematic, remedial measures may be required

Defect Significance: Further Investigation
Defect Type: E (Operational)

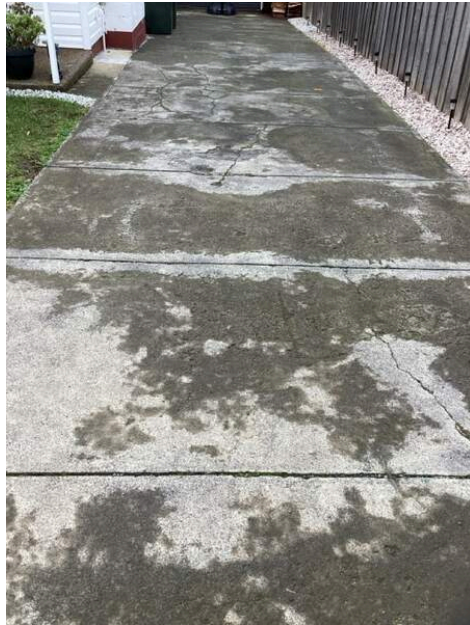
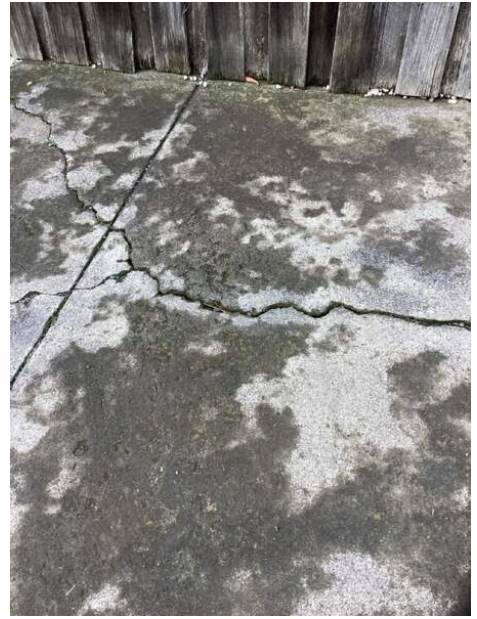
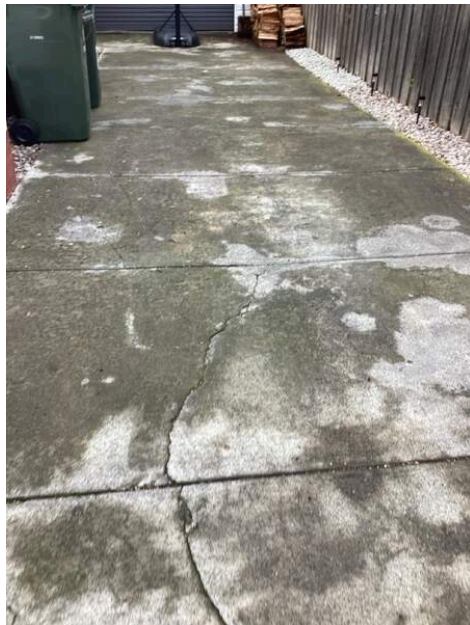
Photo Ref #31

Comments :	Some areas of surface wear, noticeable cracking and deflection evident
Defect Significance:	Minor
Defect Type:	B (Distortion, Warping, Twisting)

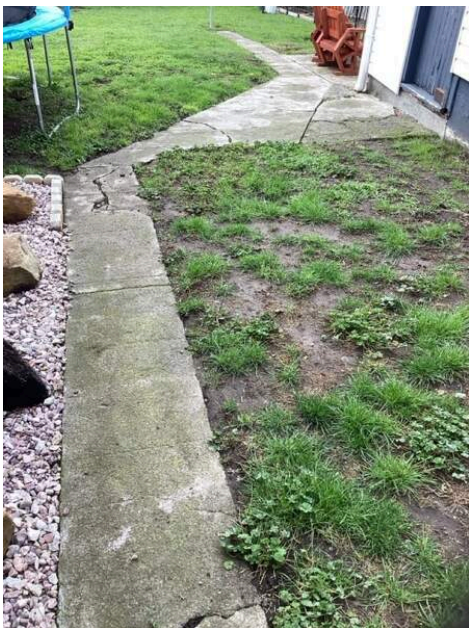
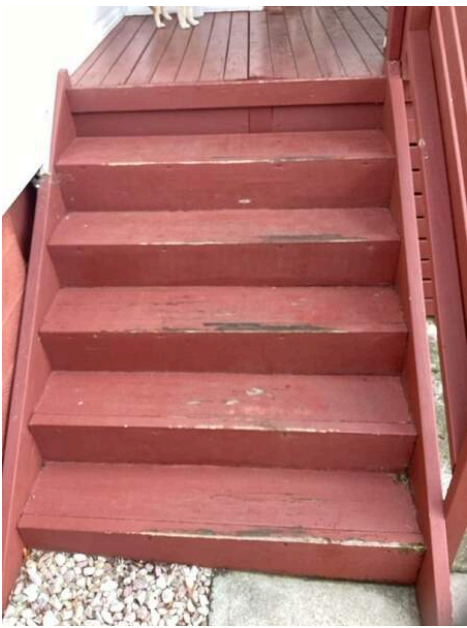
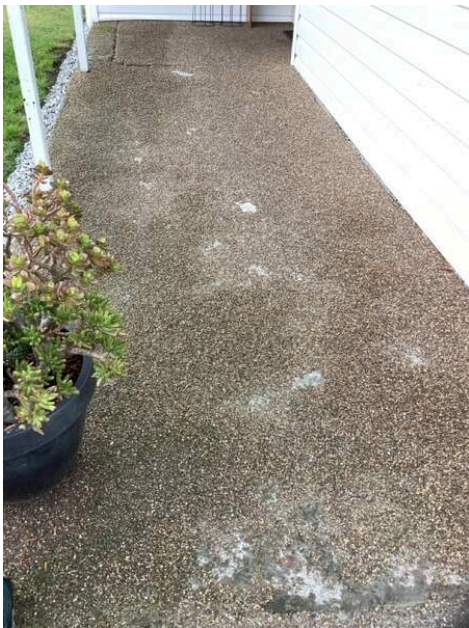
Photo Ref #34

Reasonable condition for the age.
Front deck has areas of cracking at junctions evident.
Timber steps have typical element weathering, wear and tear and may be slippery when wet.
Areas of cracking to concrete evident in some areas and gravel areas are subject to wash and erosion.
Some areas of uneven surfaces exist

Defect Significance: Minor

Defect Type: E (Operational)

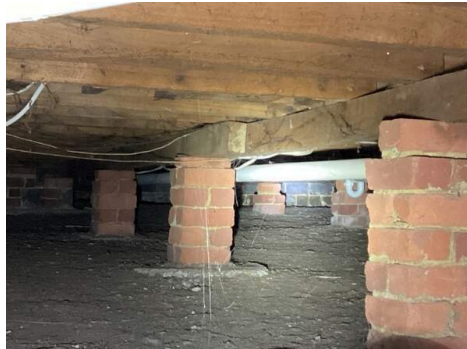
Photo Ref #38

Comments : Reasonable condition for the age with areas of typical green timber framing seasoning and settlement

Defect Significance: Minor

Defect Type: B (Distortion, Warping, Twisting)

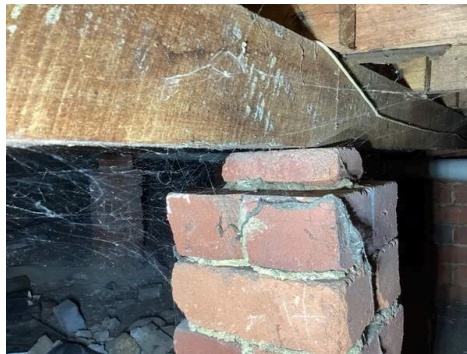
Photo Ref #39

Comments : Damp proof course does not appear to have been installed in some areas.
There was no associated defect at the time of inspection.

Defect Significance: Minor

Defect Type: F (Installation, including omissions)

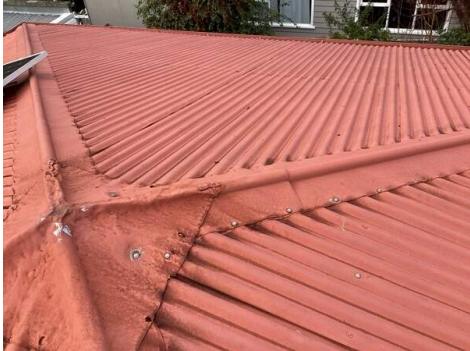
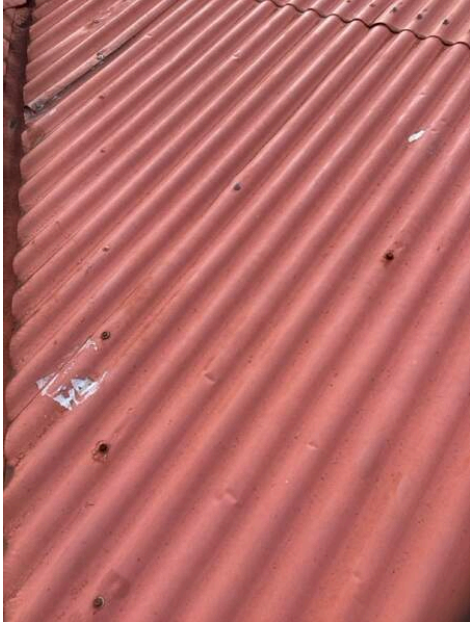
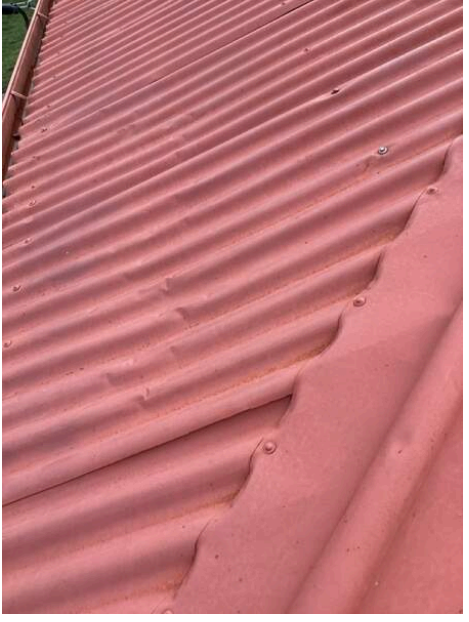
Photo Ref #40

Comments : Generally reasonable condition for the age. Areas of paint weathering evident. silicon sealant applied in some areas
Some fixings have been replaced. One or more fixings slightly loose.

Defect Significance: Minor

Defect Type: D (Material Deterioration: rusting, rotting, corrosion, decay)

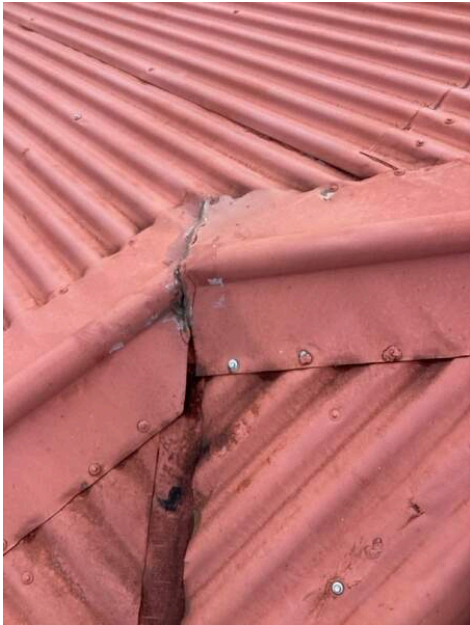
Photo Ref #45

Comments :	Some areas of silicon have been applied Typical weathering evident
Defect Significance:	Minor
Defect Type:	D (Material Deterioration: rusting, rotting, corrosion, decay)

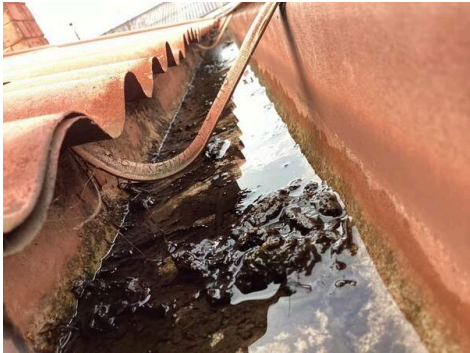
Photo Ref #47

Comments : Gutters appear to be in reasonable condition for the age. Typical minor element weathering evident.

Defect Significance: Minor

Defect Type: D (Material Deterioration: rusting, rotting, corrosion, decay)
