BUILDING INSPECTION

Complies with Australian Standard AS 4349.1-2007
Inspection of Buildings Part 1: Pre-Purchase
Inspections of Residential Buildings - Appendix C

10 Sanders Street
Glenorchy, TAS
, Australia

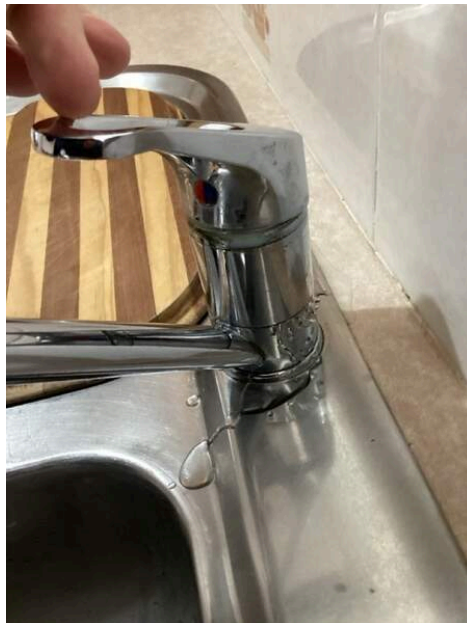
Photo Ref #2

Comments : Slight leak from tap flange during operation.
Minor maintenance recommended

Defect Significance: Minor

Defect Type: E (Operational)

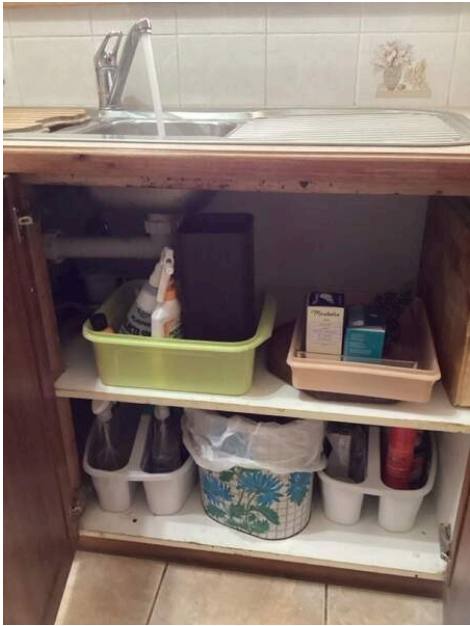
Photo Ref #3

Comments : Cupboards are in reasonable condition for the age with typical minor element wear and tear evident

Defect Significance: Minor

Defect Type: A (Damage)

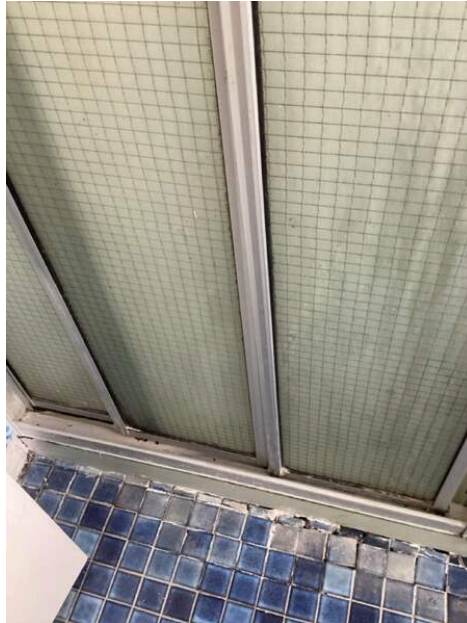
Photo Ref #14

Comments : Shower screen rollers has minor wear and tear and require requires minor adjustment/repair to improve function

Defect Significance: Minor

Defect Type: E (Operational)

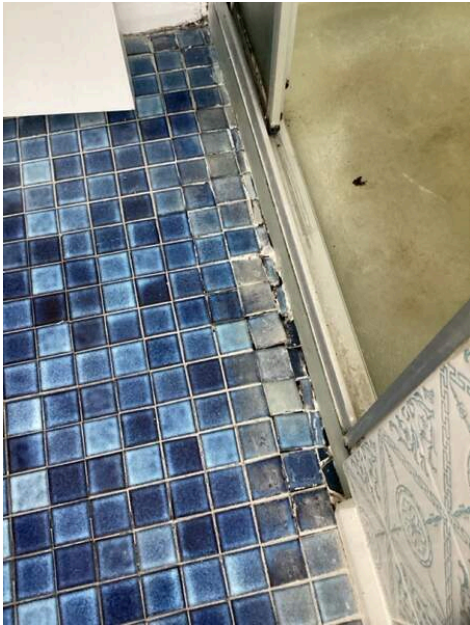
Photo Ref #15

Comments : Moisture damage to floor tiles and tile underlay is evident adjacent shower base. Subfloor area inspection did not reveal structure damage. Recommend repairs to prevent any further moisture damage occurring.

Defect Significance: Minor

Defect Type: A (Damage)

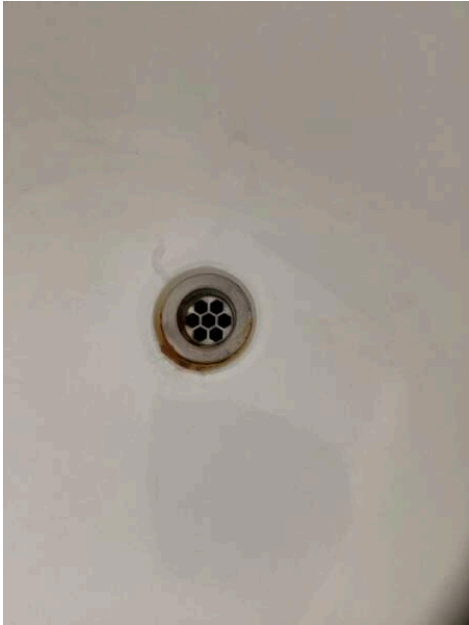
</div> <div>Photo Ref #17</div>

EXPLANATIONS	<div>Comments : Rust around bath outlet is evident. Repairable defect.</div> <div>Defect Significance: Minor</div> <div>Defect Type: D (Material Deterioration: rusting, rotting, corrosion, decay)</div>
IMAGES	<div>

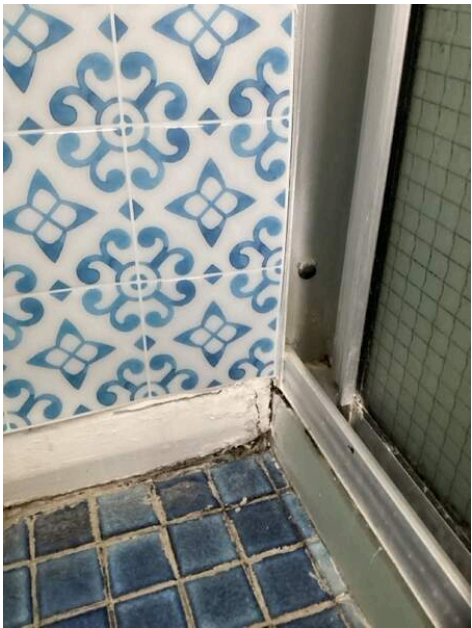
Photo Ref #18

Comments : Moisture damage is evident to skirting adjacent shower. Dry at the time of inspection. Minor aesthetic repairs recommended.

Defect Significance: Minor

Defect Type: A (Damage)

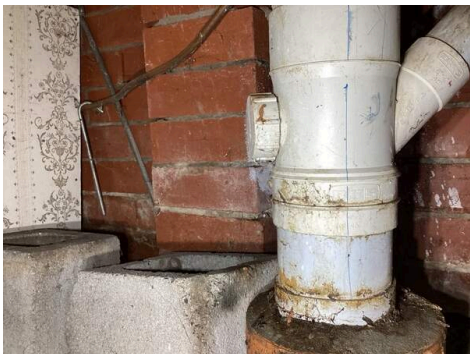
Comments : Very minor drip/leak from waste pipe in subfloor area. Suspect Seal requires maintenance. Recommend plumber to inspect and repair where required.

Defect Significance: Minor

Defect Type: E (Operational)

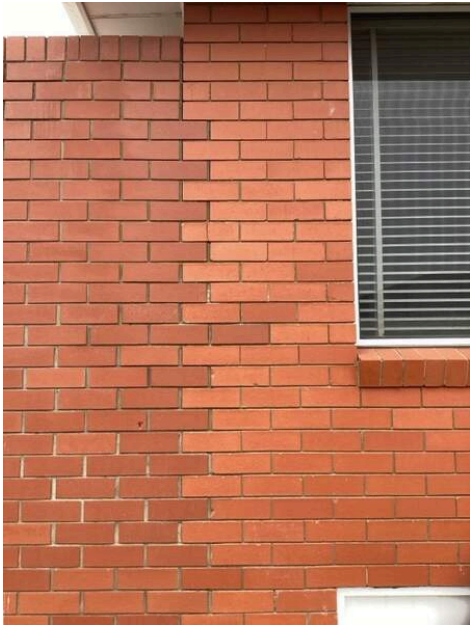
Photo Ref #26

Brickwork is generally in good condition for the age. Typical fine cracking is evident at garage edition/ original brickwork junction. Cracking is reflective of typical addition settlement.

B (Distortion, Warping, Twisting)

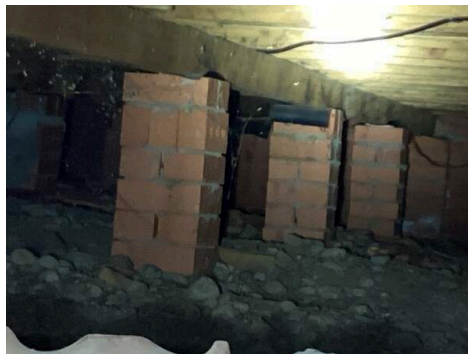
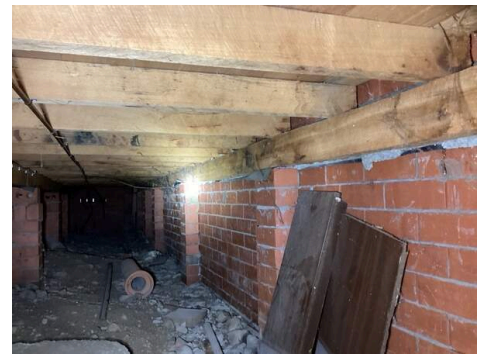
Comments : Generally good condition for the age with typical minor bowing/green timber framing seasoning and settlement evident

Defect Significance: Minor

Defect Type: B (Distortion, Warping, Twisting)
