BUILDING INSPECTION

Complies with Australian Standard AS 4349.1-2007
Inspection of Buildings Part 1: Pre-Purchase
Inspections of Residential Buildings - Appendix C

297 Glenluske Road
Glenluske, TAS
, Australia

Inspection Date: 07 Jul 2025
T: 0418 125 624

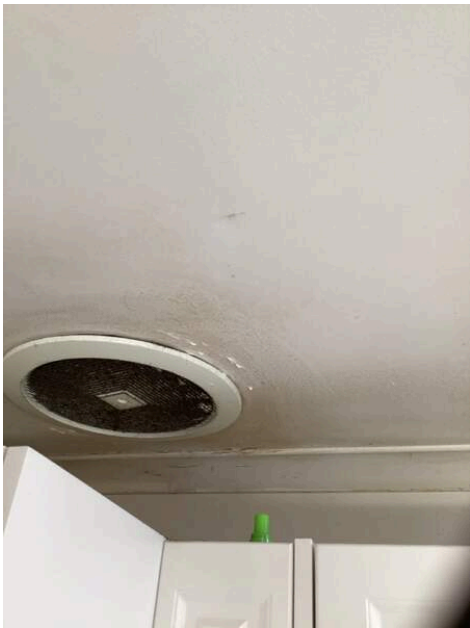
Photo Ref #1

Comments : Reasonable condition with minor cosmetic paint defects

Defect Significance: Minor

Defect Type: A (Damage)

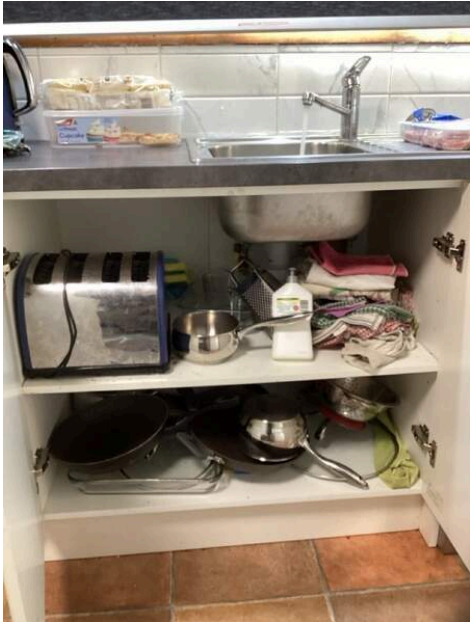
Photo Ref #2

Comments : Generally good condition for the age with minor wear and tear throughout kitchen cabinets

Defect Significance: Minor

Defect Type: A (Damage)

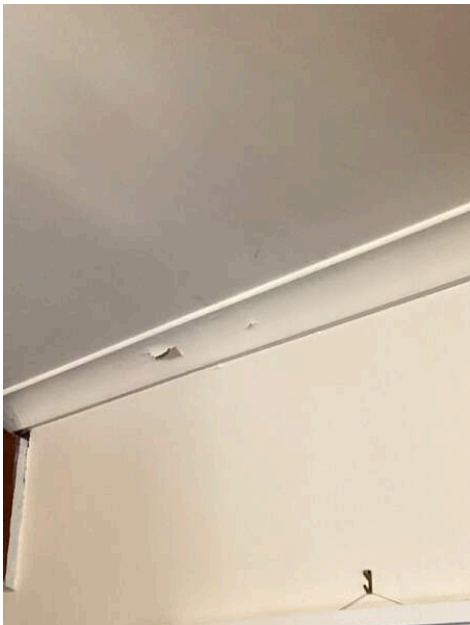
Photo Ref #3

Comments : Reasonable condition with minor cosmetic paint defects
Defect Significance: Minor
Defect Type: A (Damage)

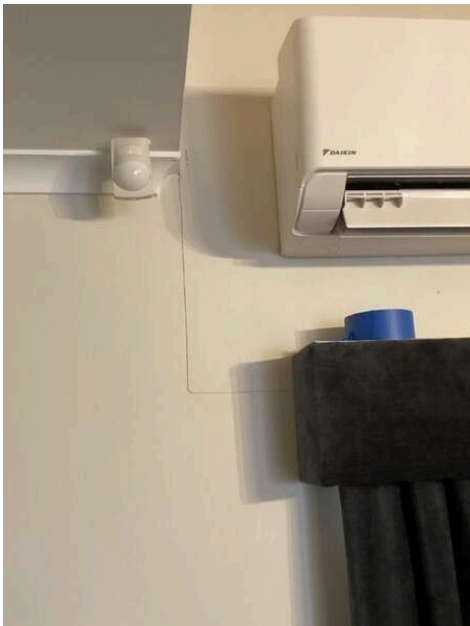
Photo Ref #4

Comments : Generally reasonable condition for the age.
Fine cracking is evident to wall lining sheet joints adjacent air conditioning unit

Defect Significance: Minor

Defect Type: A (Damage)

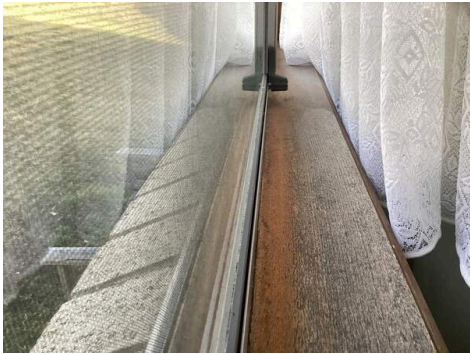
Photo Ref #5

Comments : Reasonable condition with typical windowsill reveal staining evident

Defect Significance: Minor

Defect Type: A (Damage)

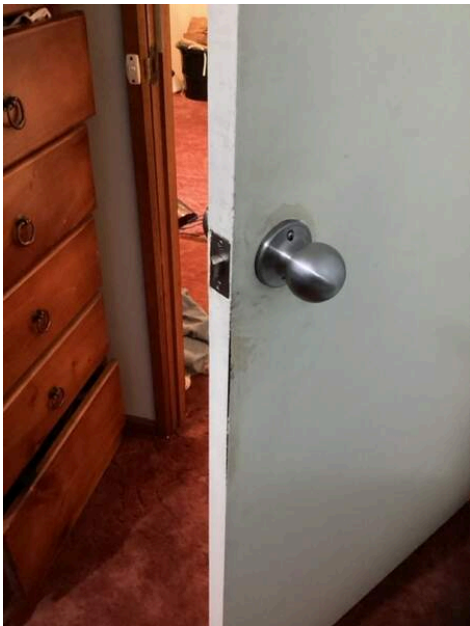
Photo Ref #6

Comments : Reasonable condition and functional with typical wear and tear evident

Defect Significance: Minor

Defect Type: A (Damage)

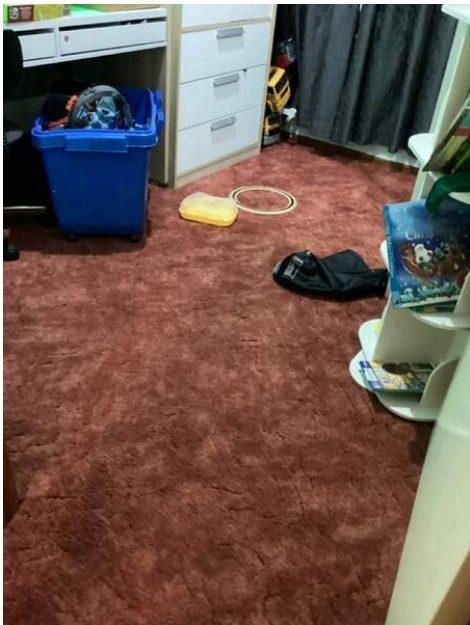
Photo Ref #7

Comments : Good condition and sound under foot with no significant spring or bounce.
Mild deflection is evident near threshold and reflective of typical green timber framing seasoning and settlement

Defect Significance: Minor

Defect Type: B (Distortion, Warping, Twisting)

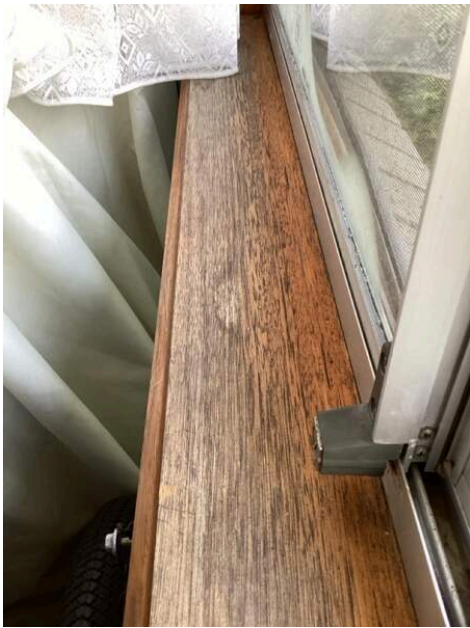
Photo Ref #8

Comments : Typical timber windowsill reveal staining evident. Consistent through out the dwelling.

Defect Significance: Minor

Defect Type: A (Damage)

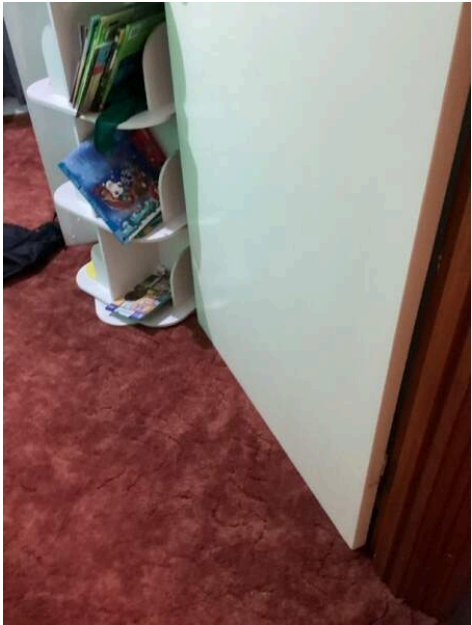
Photo Ref #9

Comments : Reasonable condition and functional. Door rubs on floor coverings and minor adjustment would improve operation.

Defect Significance: Minor

Defect Type: E (Operational)

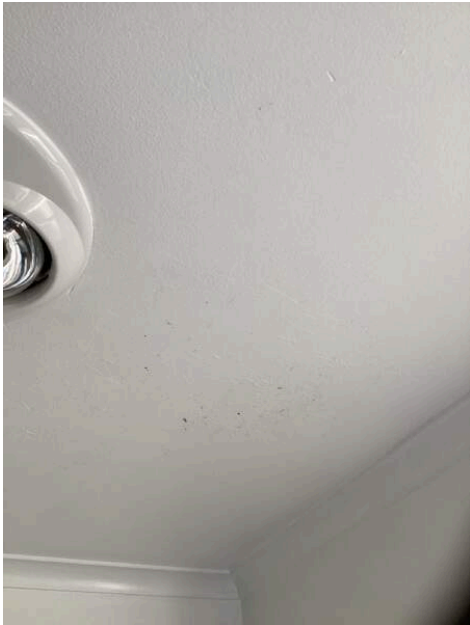
Photo Ref #10

Comments : Reasonable condition with minor cosmetic paint defects above bath

Defect Significance: Minor

Defect Type: A (Damage)

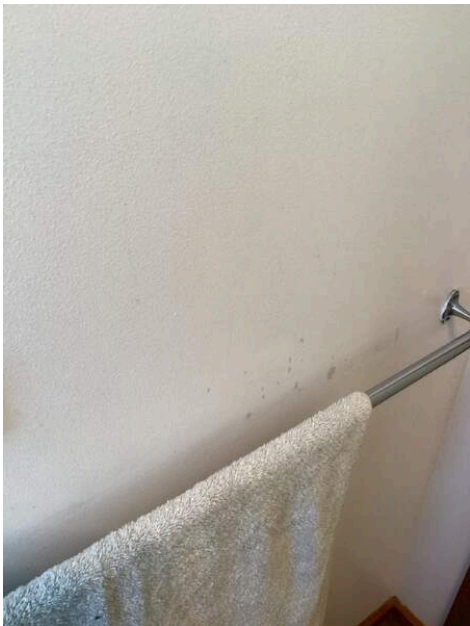
Photo Ref #11

Comments : Reasonable condition with minor cosmetic paint defects evident

Defect Significance: Minor

Defect Type: A (Damage)

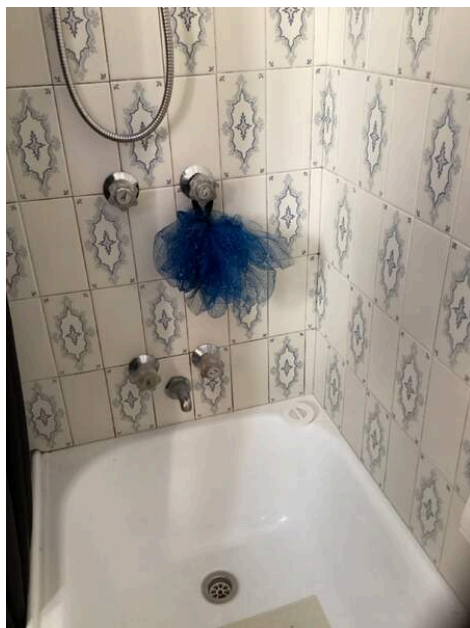
Photo Ref #12

Comments : Reasonable condition with minor stain to some areas of grout lines evident

Defect Significance: Minor

Defect Type: A (Damage)

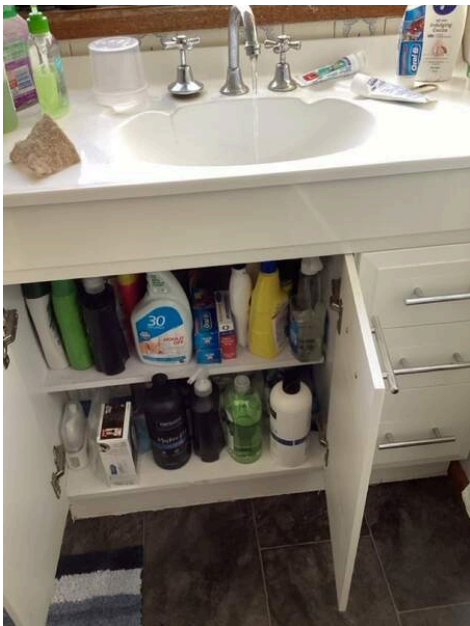
Photo Ref #14

Comments : Reasonable condition with minor wear and tear
Defect Significance: Minor
Defect Type: A (Damage)

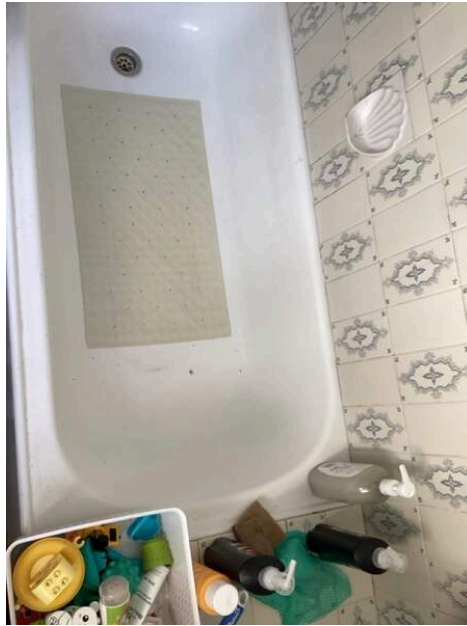
Photo Ref #15

Comments : Reasonable condition with typical wear and tear evident
Defect Significance: Minor
Defect Type: A (Damage)

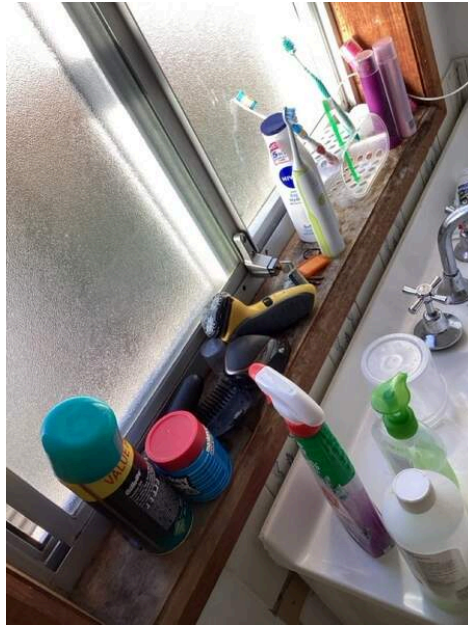
Photo Ref #16

Comments : Reasonable condition with typical timber windowsill reveal staining evident
Defect Significance: Minor
Defect Type: A (Damage)

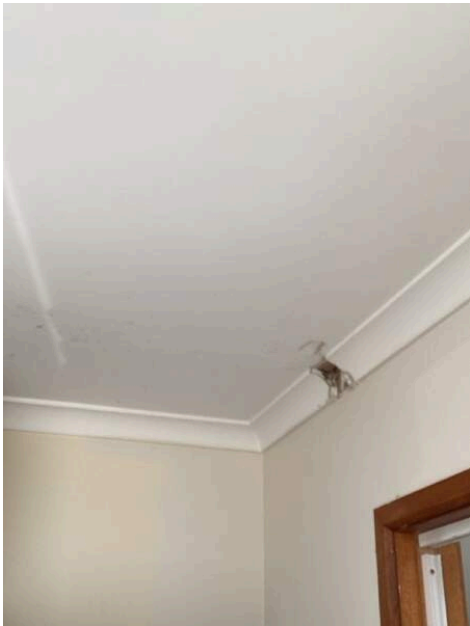
Photo Ref #17

Comments : Minor cosmetic defects. Assume cupboard framing has been removed.

Defect Significance: Minor

Defect Type: A (Damage)

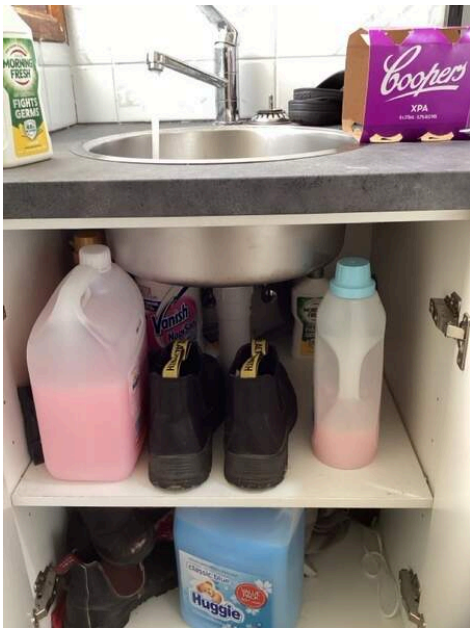
Photo Ref #18

Comments : Good condition for the age with minor wear evident
Defect Significance: Minor
Defect Type: A (Damage)

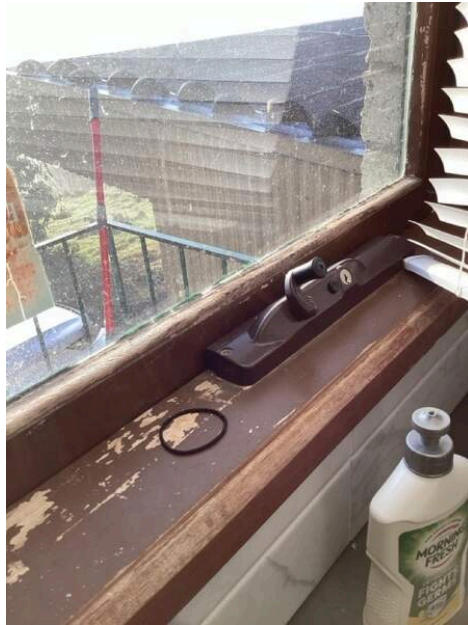
Photo Ref #19

Comments : Reasonable condition with typical paint weathering evident
Defect Significance: Minor
Defect Type: A (Damage)

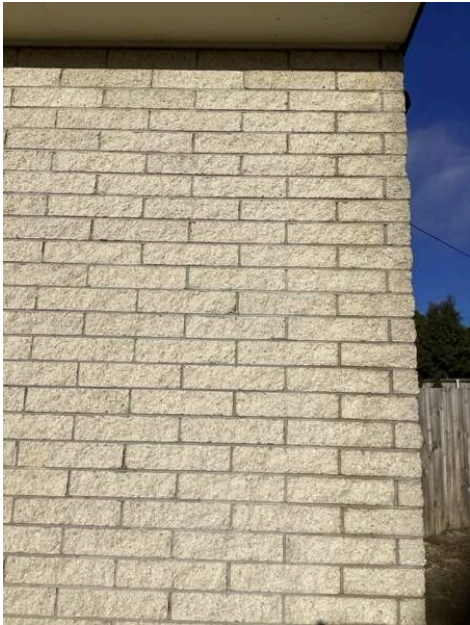
Photo Ref #24

Generally good condition for the age with some areas of typical fine mortar cracking evident. Cracking is consistent with typical lateral/thermal movement.

B (Distortion, Warping, Twisting)

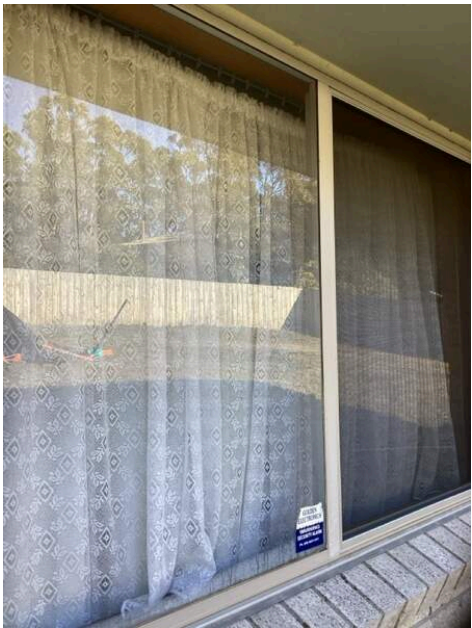
Photo Ref #27

Comments : Aluminium windows appear to be in good condition for the age with typical mild element weathering

Defect Significance: Minor

Defect Type: D (Material Deterioration: rusting, rotting, corrosion, decay)

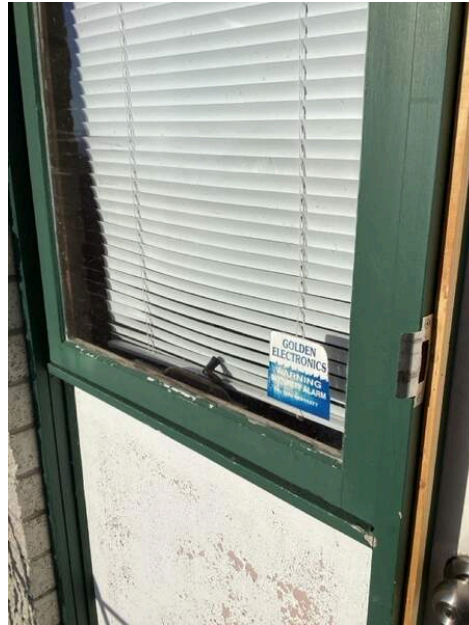
Photo Ref #28

Comments : Reasonable condition for the age with typical paint and element weathering

Defect Significance: Minor

Defect Type: D (Material Deterioration: rusting, rotting, corrosion, decay)

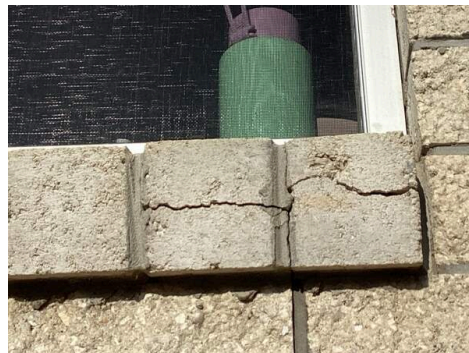
Photo Ref #29

Comments : Generally good condition. Two cracked sill bricks evident at kitchen window.

Defect Significance: Minor

Defect Type: A (Damage)

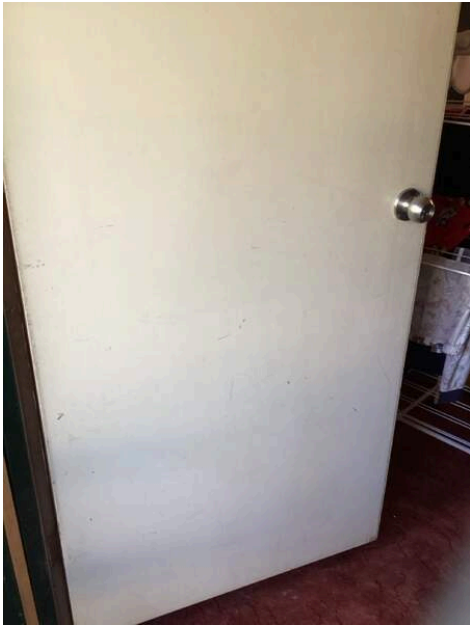
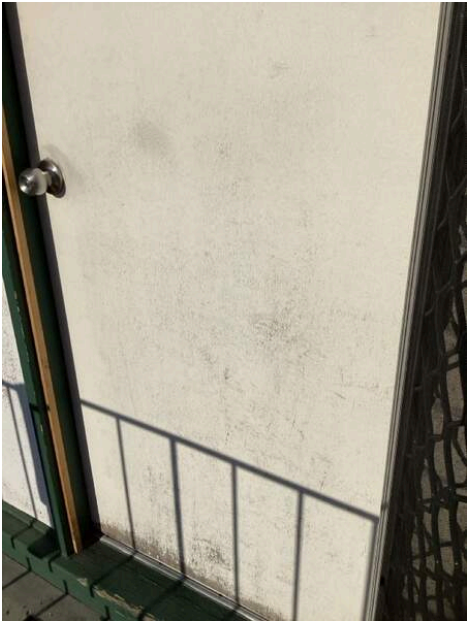
Photo Ref #30

Comments : Reasonable condition for the age with typical paint element weathering evident.

Defect Significance: Minor

Defect Type: D (Material Deterioration: rusting, rotting, corrosion, decay)

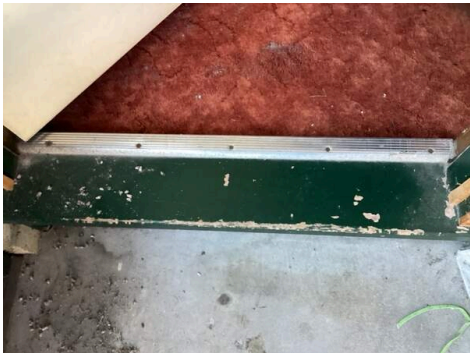
Photo Ref #32

Comments : Reasonable condition for the age with typical paint and element weathering evident

Defect Significance: Minor

Defect Type: A (Damage)

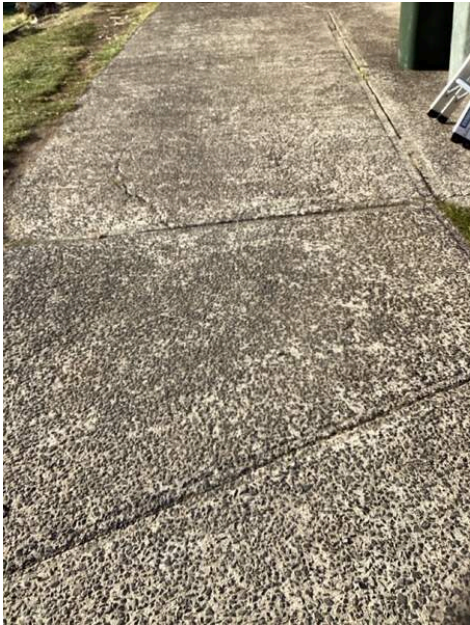
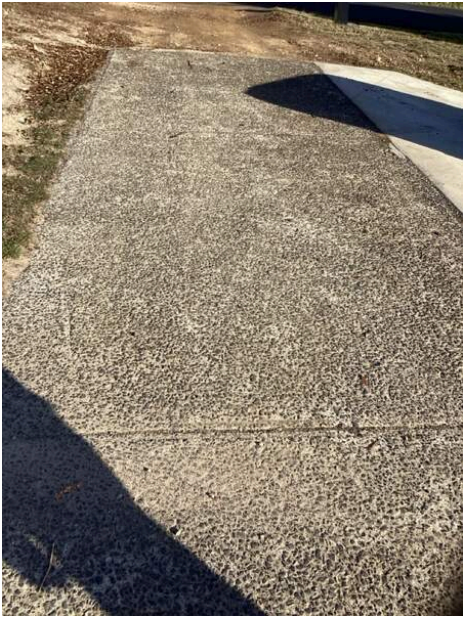
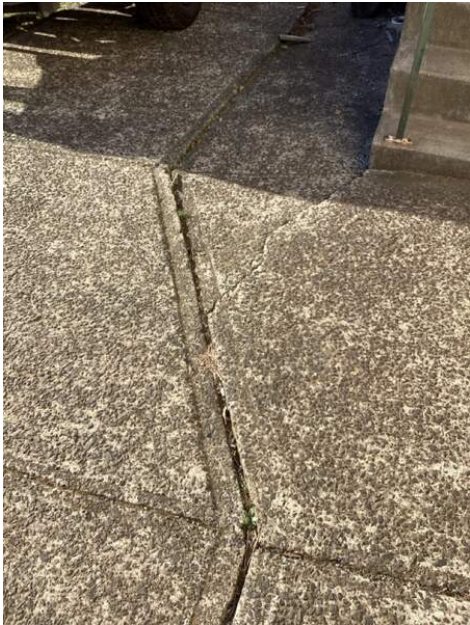
Photo Ref #40

Comments :	Areas of typical surface and cracking evident.
Defect Significance:	Minor
Defect Type:	B (Distortion, Warping, Twisting)

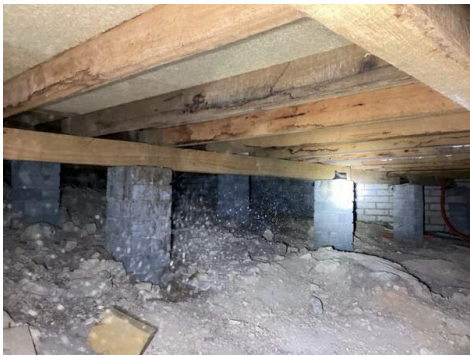
Photo Ref #43

Comments : Good condition for the age with typical green timber framing seasoning and settlement evident

Defect Significance: Minor

Defect Type: B (Distortion, Warping, Twisting)

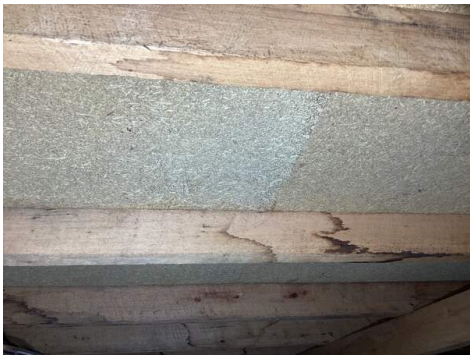
Photo Ref #44

Comments : Good condition for the age with typical green timber framing seasoning and settlement evident

Defect Significance: Minor

Defect Type: B (Distortion, Warping, Twisting)

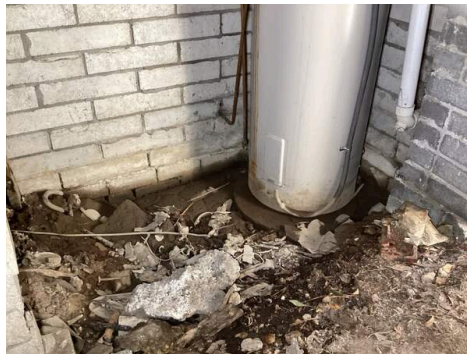
Photo Ref #45

Comments : The subfloor area was generally dry throughout. Slight moisture is evident beneath the rear balcony where HWC installed. Monitoring of the area is recommended and if moisture becomes problematic, some remedial works/drainage control may be required

Defect Significance: Minor
Defect Type: E (Operational)

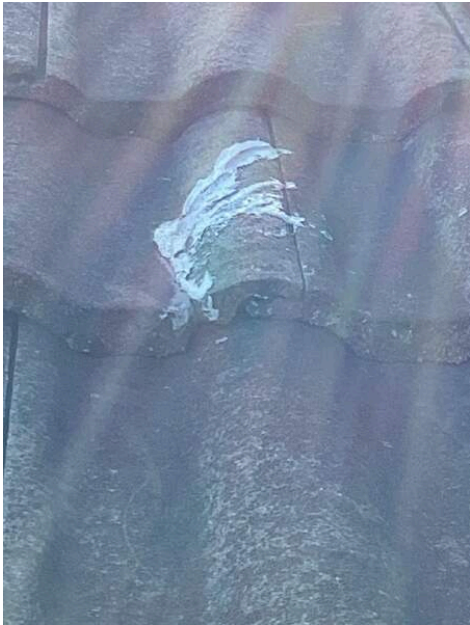
Photo Ref #46

Comments : Generally good condition for the age with typical surface weathering evident. One or more tile cracks and crack repairs are evident

Defect Significance: Minor
Defect Type: A (Damage)

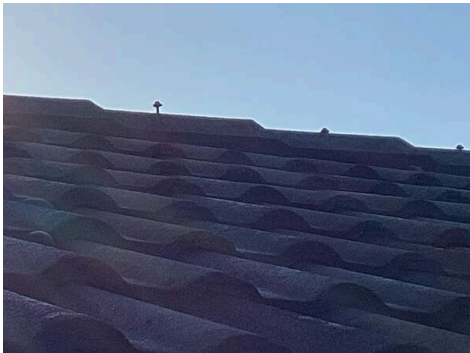
Photo Ref #47

Comments : Reasonable condition for the age.
One or more fixings appear slightly loose

Defect Significance: Minor

Defect Type: A (Damage)

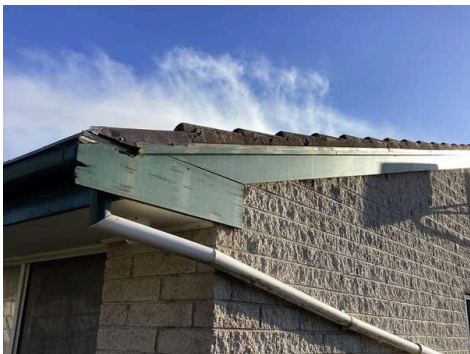
Photo Ref #50

Comments : Typical paint and timber element weathering is evident in some areas with deterioration evident in one or more small sections

Defect Significance: Minor

Defect Type: D (Material Deterioration: rusting, rotting, corrosion, decay)
