BUILDING INSPECTION

Complies with Australian Standard AS 4349.1-2007
Inspection of Buildings Part 1: Pre-Purchase
Inspections of Residential Buildings - Appendix C

8 Mercer Street
New Town, TAS
, Australia

Inspection Date: 22 Jul 2025
T: 0418 125 624

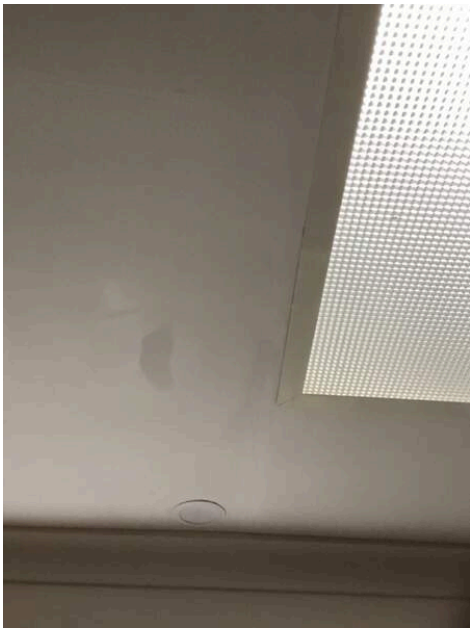
Comments : Minor cosmetic defects and fine crack evident adjacent skylight. Dry at the time of inspection.

Defect Significance: Minor

Defect Type: A (Damage)

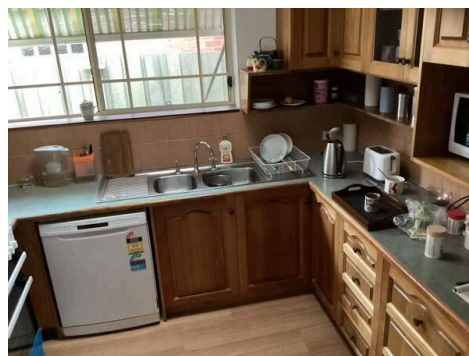
Photo Ref #3

Comments : Reasonable condition for the age with typical minor element weathering evident

Defect Significance: Minor

Defect Type: A (Damage)

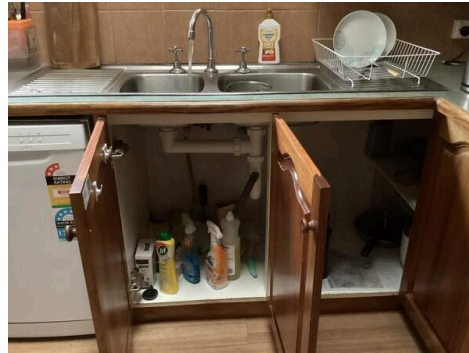
Photo Ref #4

Comments : Reasonable condition for the age with typical wear and tear

Defect Significance: Minor

Defect Type: A (Damage)

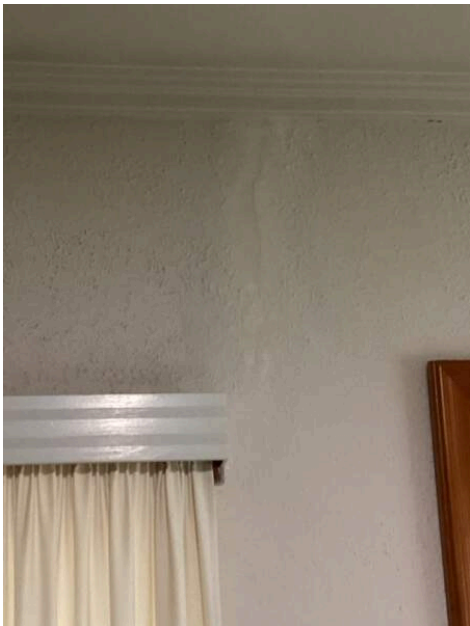
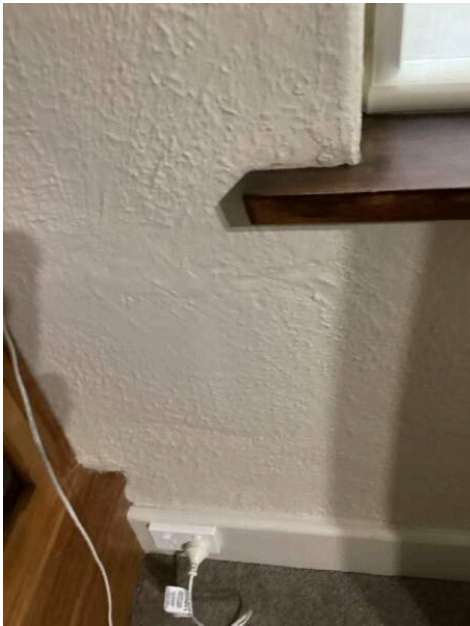
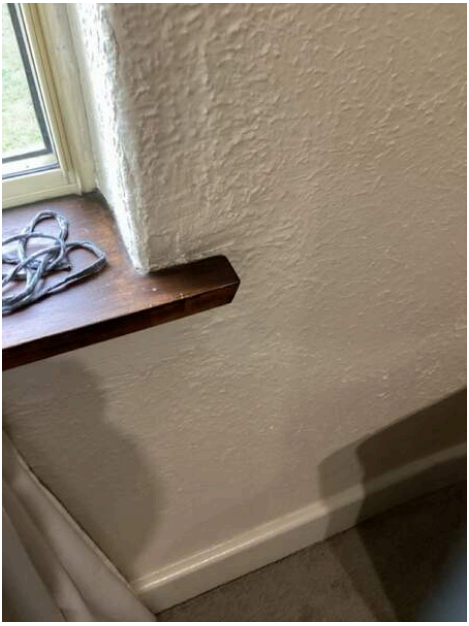
Comments : Areas of crack repair to internal render is evident. Cracking repair appears intact at the time of inspection. Cracking is likely reflective of typical structure settlement.

Defect Significance: Minor

Defect Type: B (Distortion, Warping, Twisting)

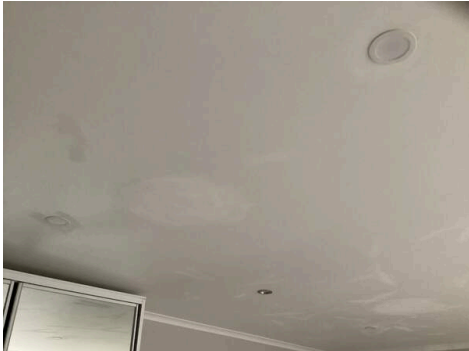
Photo Ref #11

EXPLANATIONS	<div>Comments :Minor cosmetic paint defects and potential minor repairs evident. Ceiling was dry at the time of inspection</div> <div>Defect Significance: Minor</div> <div>Defect Type: F (Installation, including omissions)</div>	
IMAGES

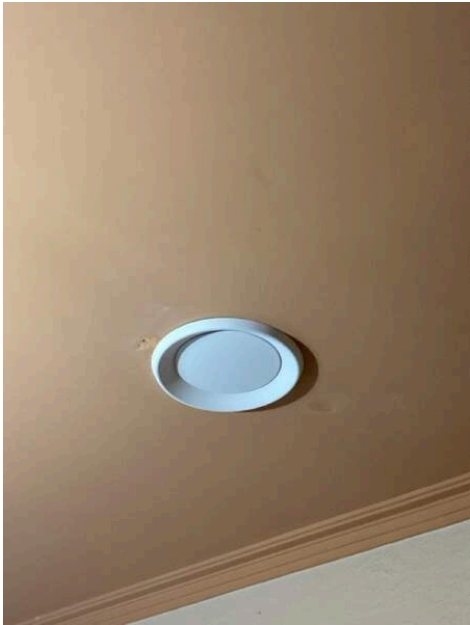
Photo Ref #15

Comments : Reasonable condition for the age with minor cosmetic defects evident

Defect Significance: Minor

Defect Type: A (Damage)

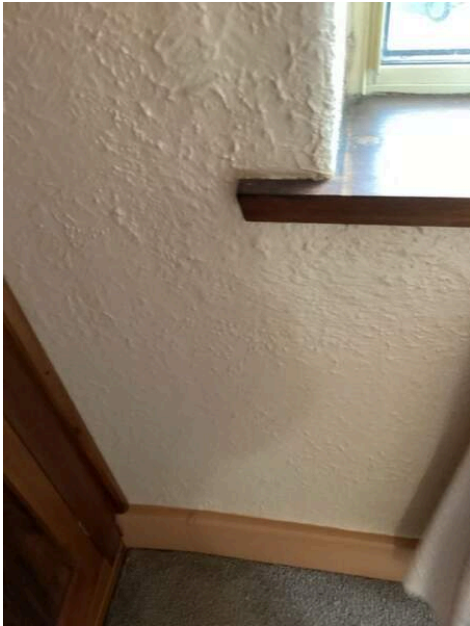
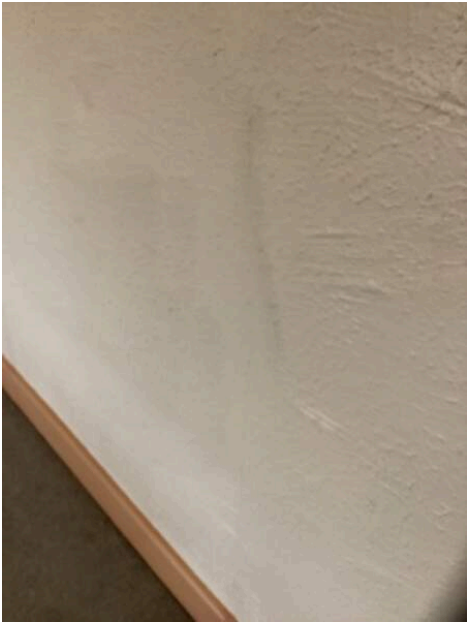
Comments : Generally good condition with some areas of minor cosmetic defects/crack repair evident

Defect Significance: Minor

Defect Type: A (Damage)

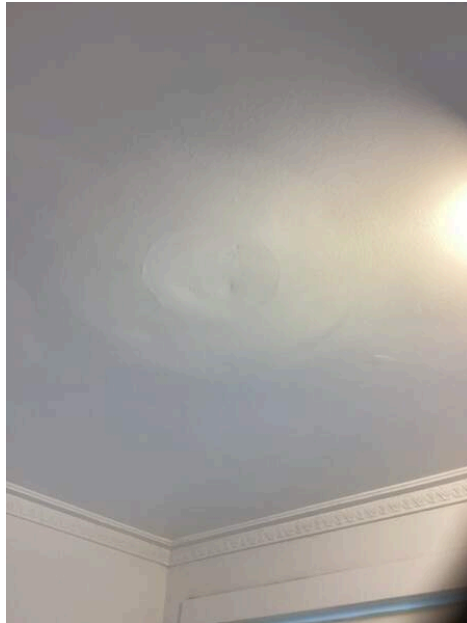
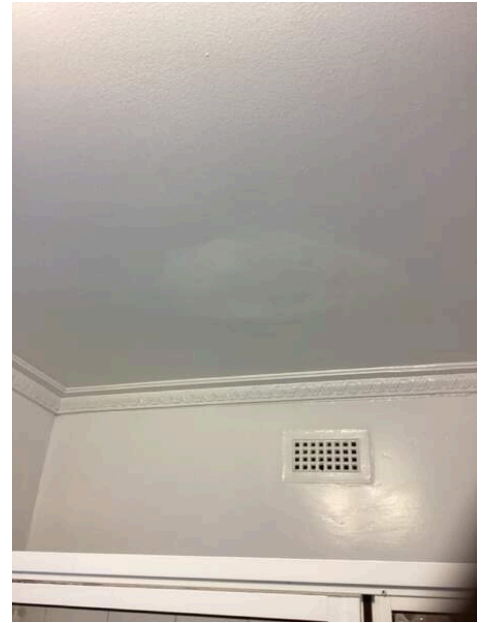
Comments : Minor ceiling repairs evident.
Defect Significance: Minor
Defect Type: F (Installation, including omissions)

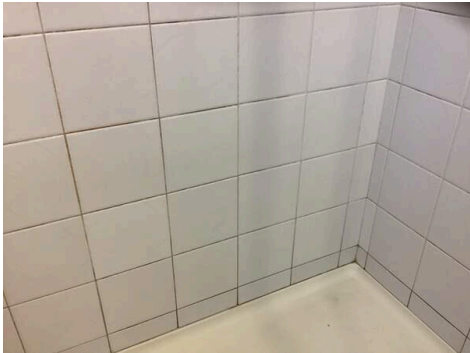
Photo Ref #20

Comments : Generally reasonable condition for the age with minor staining to tile grout evident
Defect Significance: Minor
Defect Type: A (Damage)

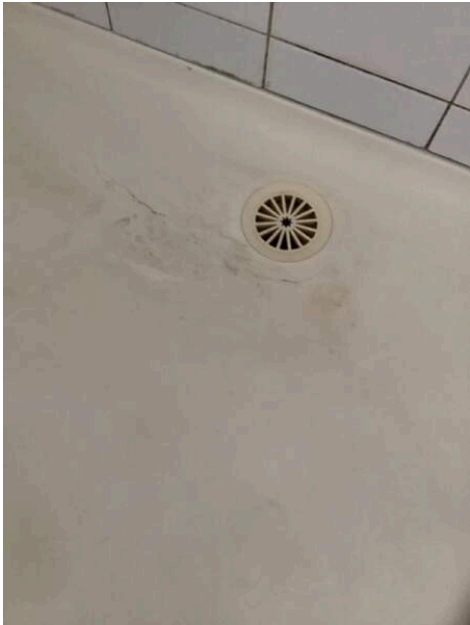
Photo Ref #21

Comments : Minor cosmetic surface wear and tear/damage evident

Defect Significance: Minor

Defect Type: A (Damage)

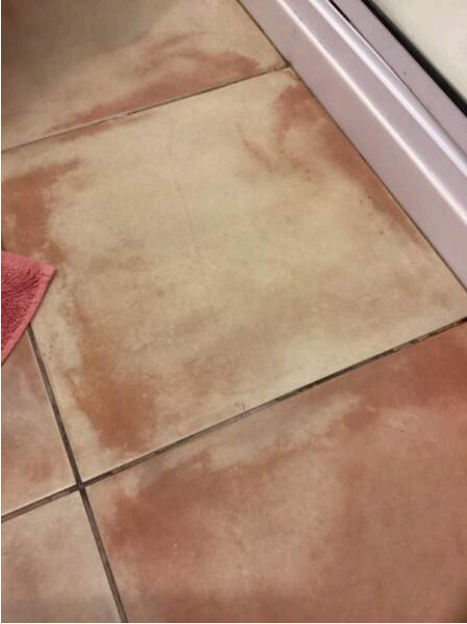
Photo Ref #22

EXPLANATIONS	Comments :	Reasonable condition for the age with some mild distortion to grout lines and cracking of grout evident
	Defect Significance:	Minor
	Defect Type:	A (Damage)
IMAGES

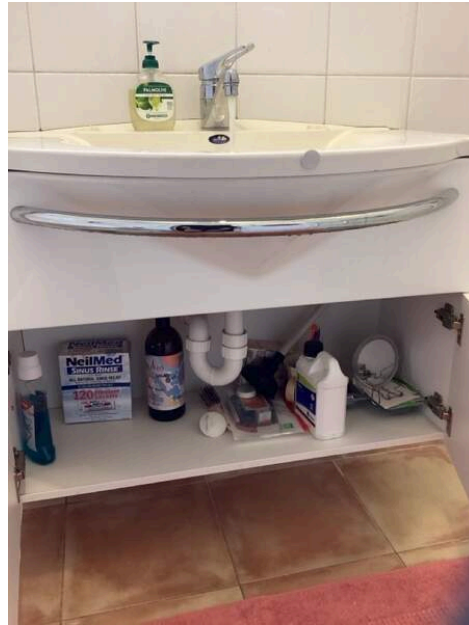
Photo Ref #23

EXPLANATIONS	Comments :	Reasonable condition for the age with typical wear and tear
	Defect Significance:	Minor
	Defect Type:	A (Damage)

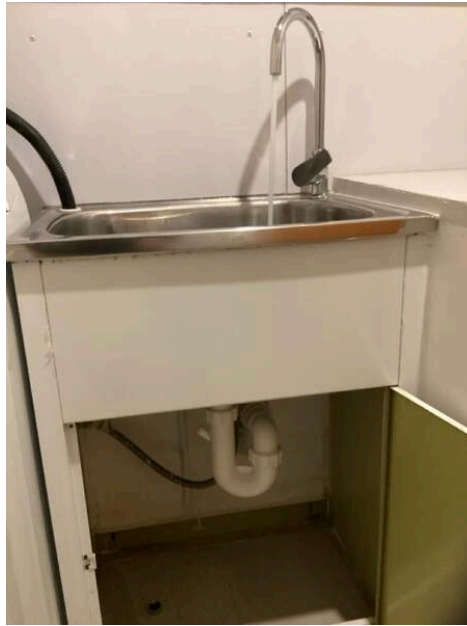
Photo Ref #24

Comments : Reasonable condition for the age with typical wear and tear evident

Defect Significance: Minor

Defect Type: A (Damage)

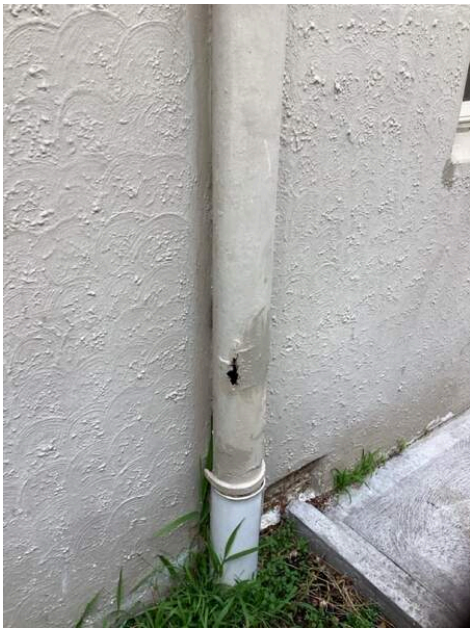
Photo Ref #25

Comments : Section of rust penetration to metal breather pipe. Repairs recommended.

Defect Significance: Minor

Defect Type: D (Material Deterioration: rusting, rotting, corrosion, decay)

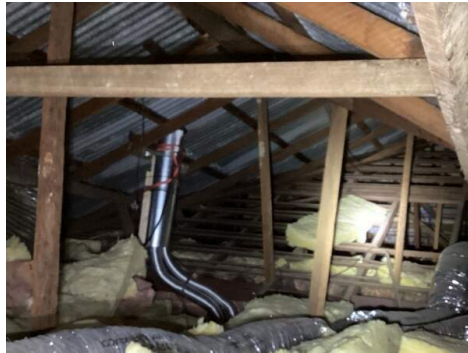
Photo Ref #26

Comments : Roof structure were visible appears to be in reasonable condition for the age with typical green timber framing seasoning and settlement evident

Defect Significance: Minor

Defect Type: B (Distortion, Warping, Twisting)

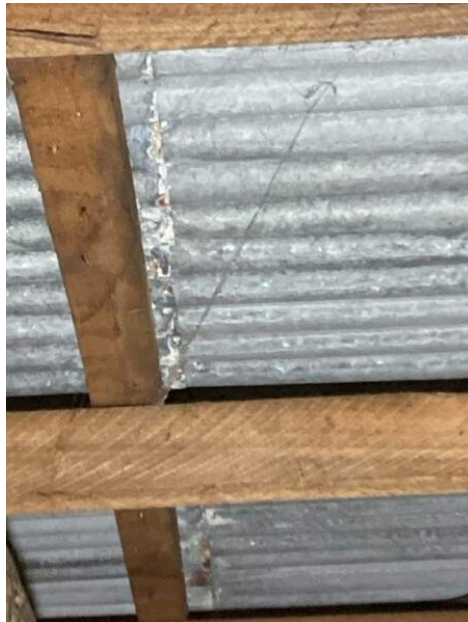
Photo Ref #28

Comments : No and reflective foil installed.
No evidence of moisture ingress or condensation defects evident.
Slight oxidisation at sheet overlaps evident

Defect Significance: Minor

Defect Type: F (Installation, including omissions)

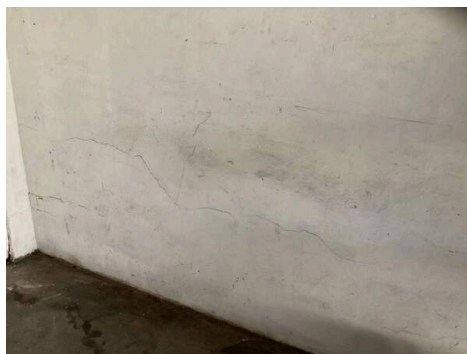
Photo Ref #30

Comments : Generally reasonable condition with fine cracking to internal render on perimeter boundary wall

Defect Significance: Minor

Defect Type: B (Distortion, Warping, Twisting)

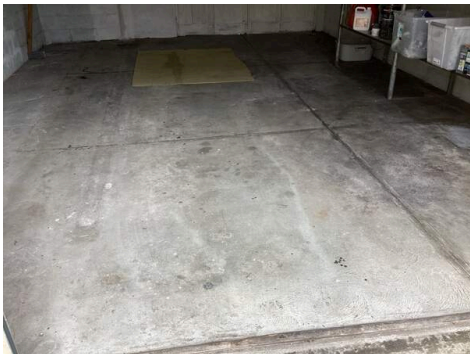
Photo Ref #31

Comments : Reasonable condition for the age with minor surface wear and tear evident
Minor moisture staining at perimeter wall

Defect Significance: Minor

Defect Type: A (Damage)

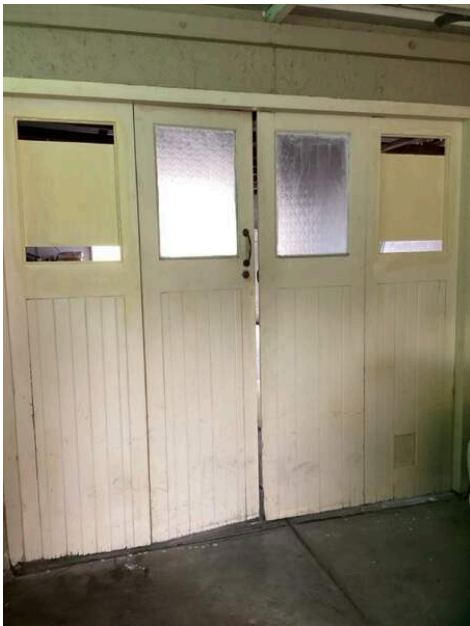
Photo Ref #33

Comments : Minor weathering, wear and tear evident

Defect Significance: Minor

Defect Type: A (Damage)

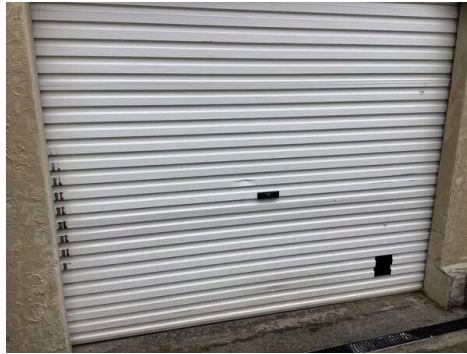
Photo Ref #34

Comments : Functional with rub marks and minor damage evident

Defect Significance: Minor

Defect Type: A (Damage)

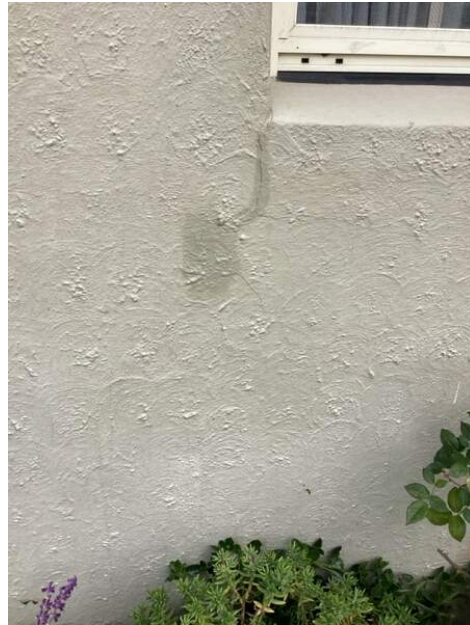
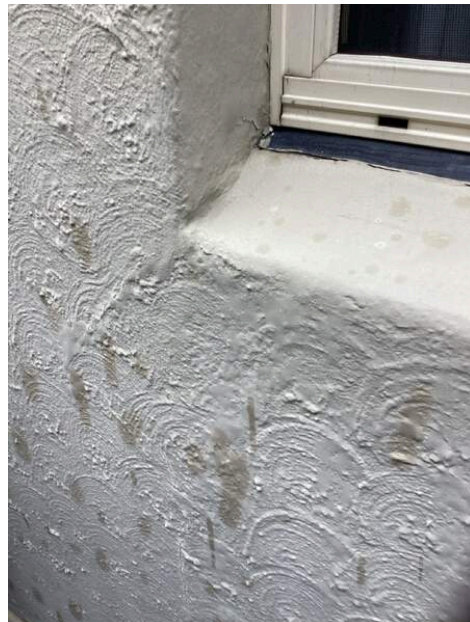
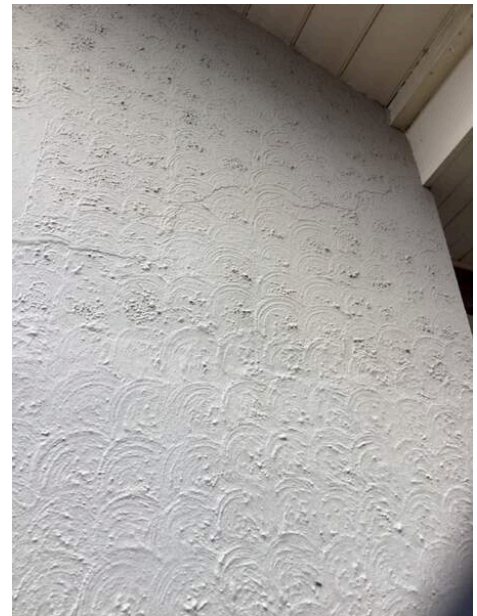
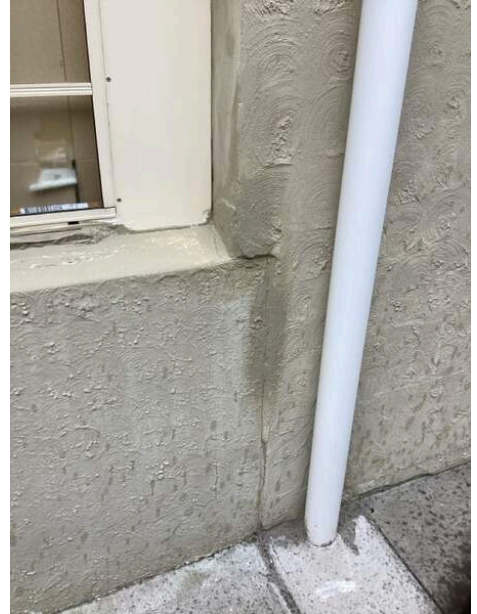
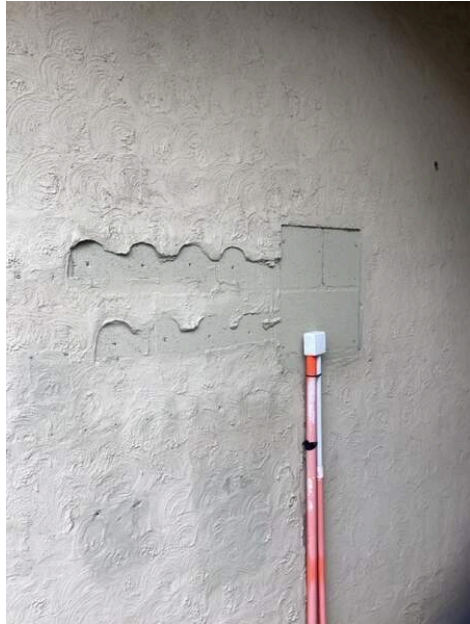
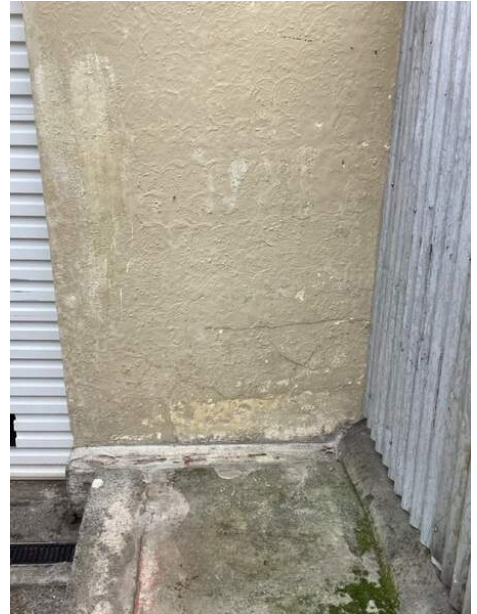
Comments : External render appears to be generally in reasonable condition for the age. Some areas of cracks and crack repair with some areas of minor cosmetic defects evident.

Defect Significance: Minor

Defect Type: A (Damage)

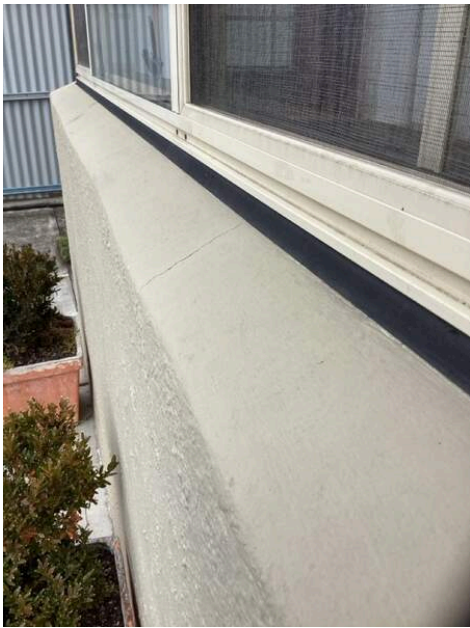
Photo Ref #44

Comments : Fine render cracks are evident in some areas
Defect Significance: Minor
Defect Type: B (Distortion, Warping, Twisting)

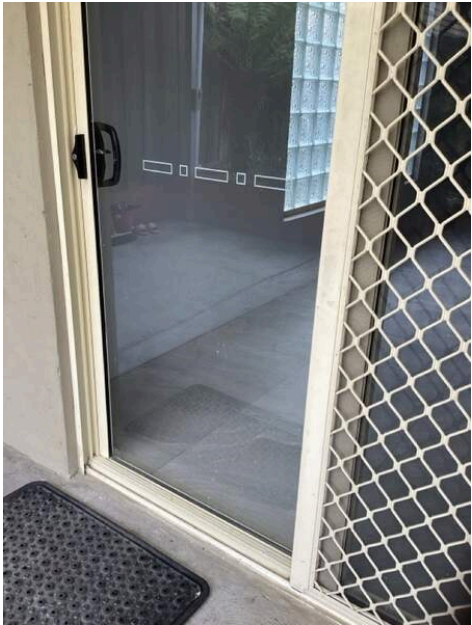
Photo Ref #45

Comments : Generally good condition with mild element, weathering and typical track and roller wear
Defect Significance: Minor
Defect Type: D (Material Deterioration: rusting, rotting, corrosion, decay)

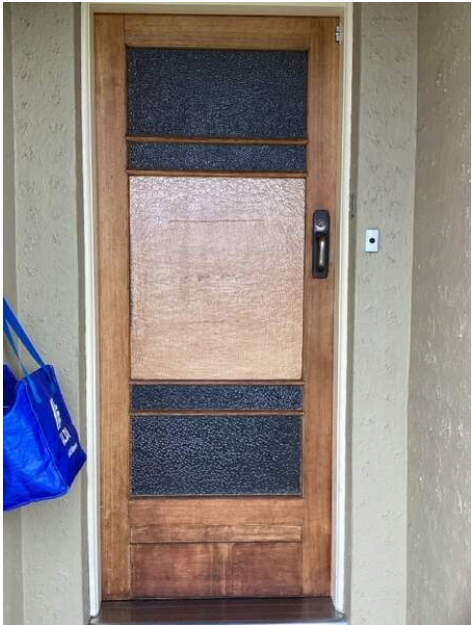
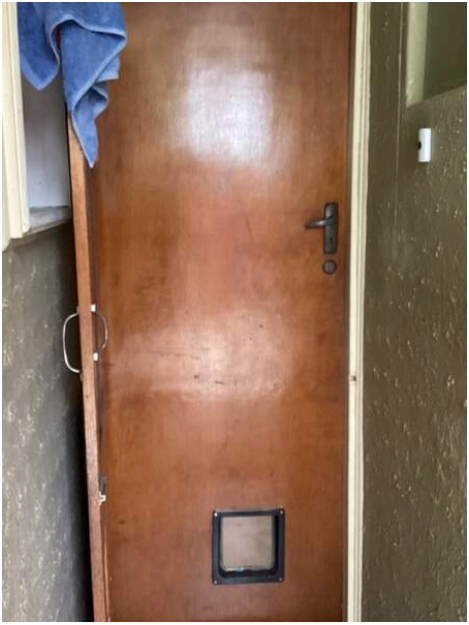
Comments : Reasonable condition for the age with wild element weathering, typical wear and tear evident

Defect Significance: Minor

Defect Type: D (Material Deterioration: rusting, rotting, corrosion, decay)

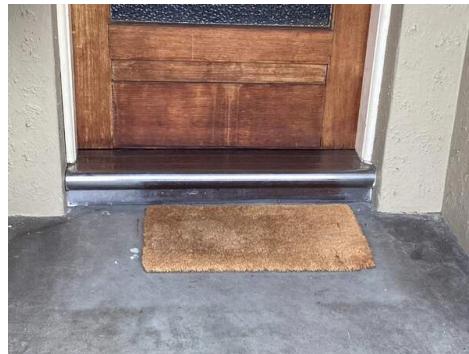
Photo Ref #48

Comments : Reasonable condition with minor wear and tear. Rear door seal has carpet protruding and no sill/floor level height difference exists and no weather proofing method is installed

Defect Significance: Minor

Defect Type: F (Installation, including omissions)

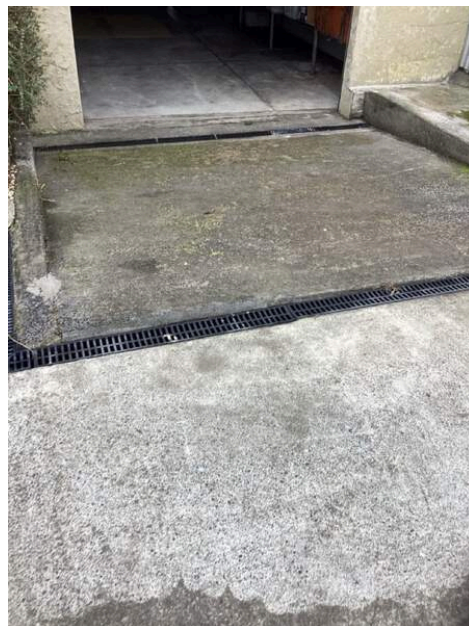
Photo Ref #50

The site is relatively level. No drainage defects were evident at the time of inspection.

Monitoring of drainage is always recommended as a matter of course as drainage conditions have potential to change, particularly overtime and during heavy or prolonged rain events. If drainage conditions or moisture become problematic, remedial measures may be required.

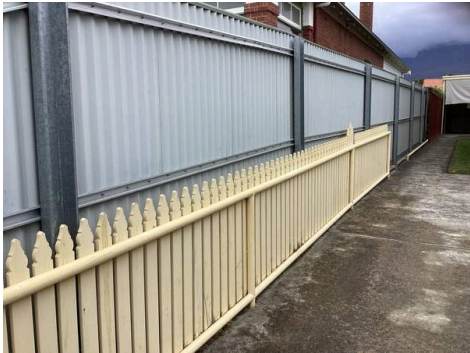
Photo Ref #52

Reasonable condition for the age with typical element weathering evident

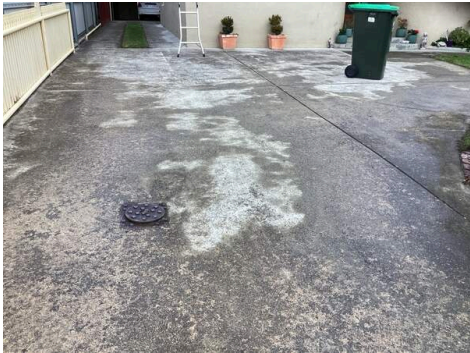
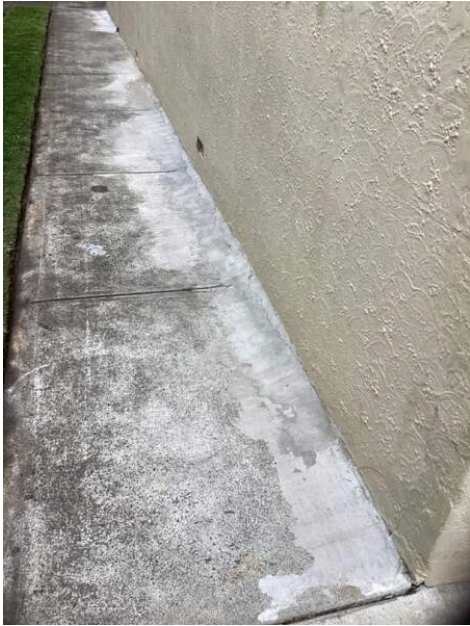
Comments : Reasonable condition for the age with typical surface wear and fine crack evident

Defect Significance: Minor

Defect Type: B (Distortion, Warping, Twisting)

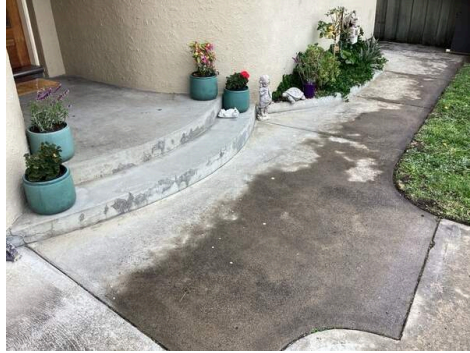
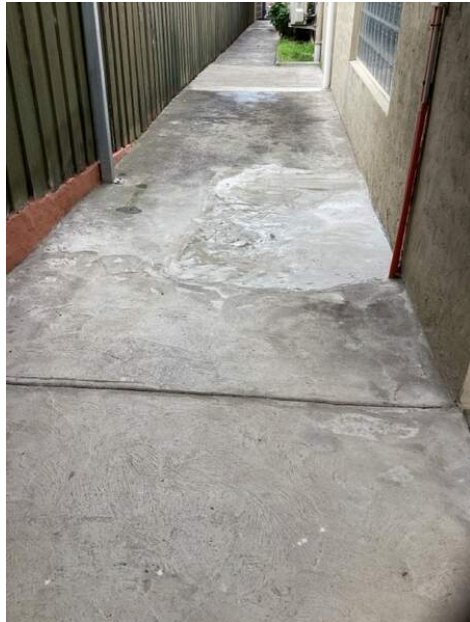
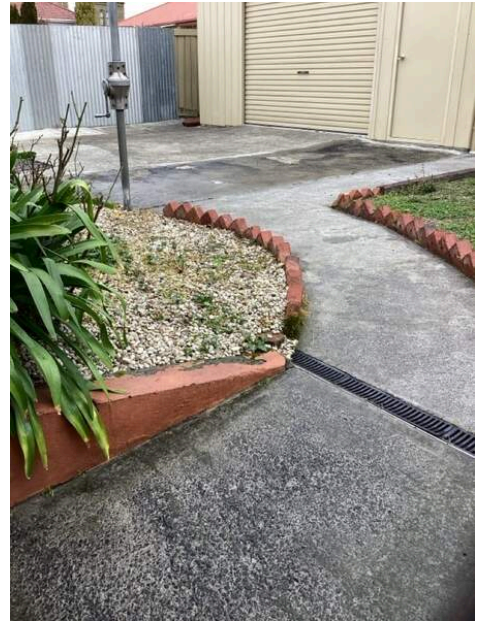
Comments :	Typical surface wear and fine cracks evident
Defect Significance:	Minor
Defect Type:	B (Distortion, Warping, Twisting)

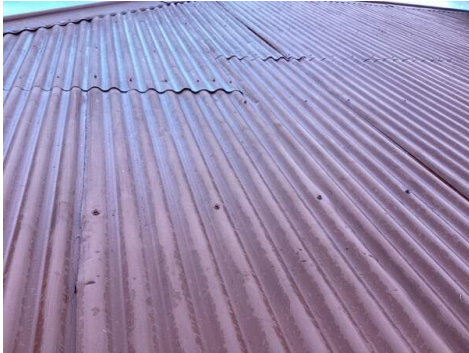
Photo Ref #65

Comments : Generally good condition throughout with some areas of typical paint weathering evident

Defect Significance: Minor

Defect Type: D (Material Deterioration: rusting, rotting, corrosion, decay)

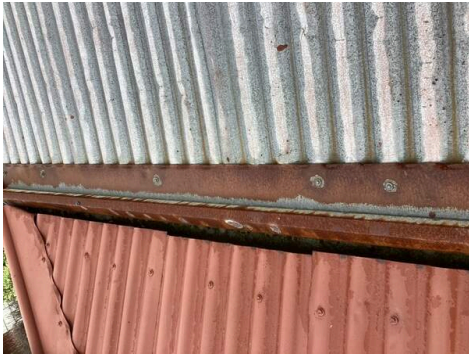
Photo Ref #66

Comments : Generally reasonable condition throughout with some areas of rust evident

Defect Significance: Minor

Defect Type: D (Material Deterioration: rusting, rotting, corrosion, decay)

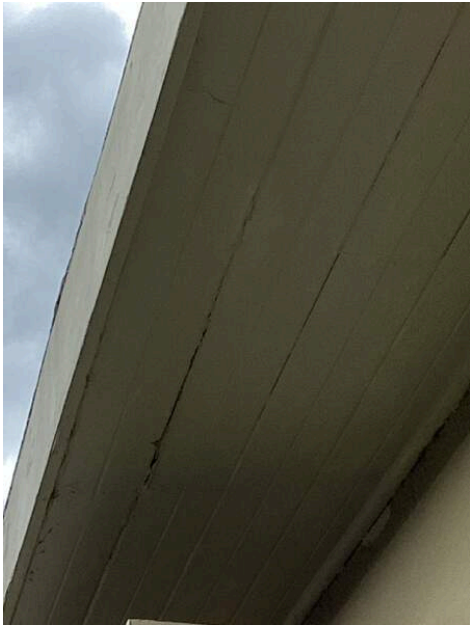
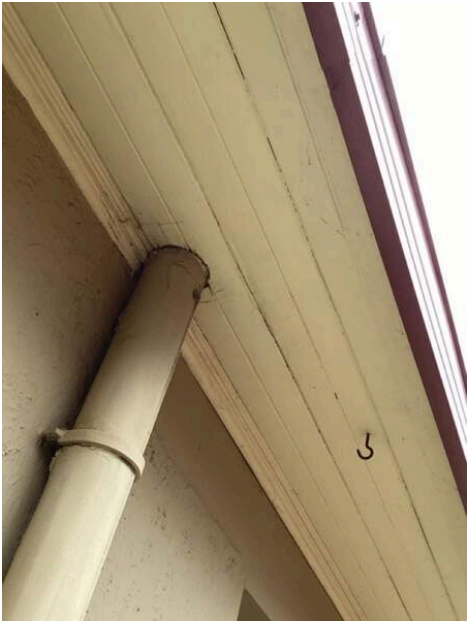
Comments : Reasonable condition with small area of defect, likely water related around plumbing breather pipe. Dry at the time of inspection.

Defect Significance: Minor

Defect Type: A (Damage)

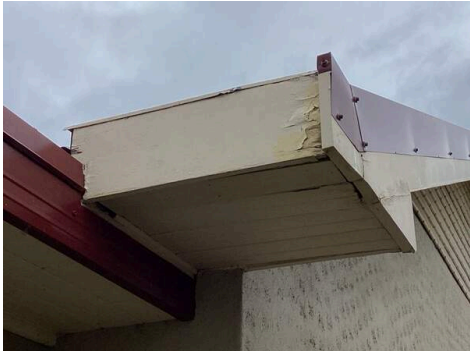
Photo Ref #71

Comments : Areas of paint and element weathering evident
Defect Significance: Minor
Defect Type: D (Material Deterioration: rusting, rotting, corrosion, decay)

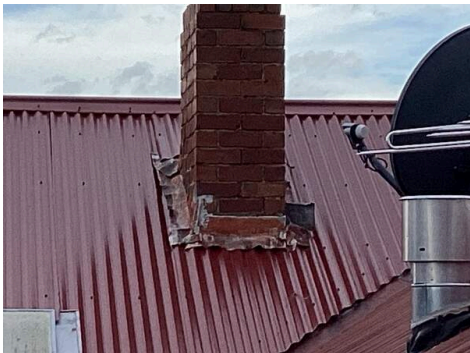
Photo Ref #75

Comments : Areas of flashing around chimney are untidy. There was no evidence of moisture ingress at the time of inspection.

Defect Significance: Minor

Defect Type: F (Installation, including omissions)
