# BUILDING INSPECTION

Complies with Australian Standard AS 4349.1-2007  
Inspection of Buildings Part 1: Pre-Purchase  
Inspections of Residential Buildings - Appendix C

9 Bland Court  
Rokeby, TAS  
, Australia

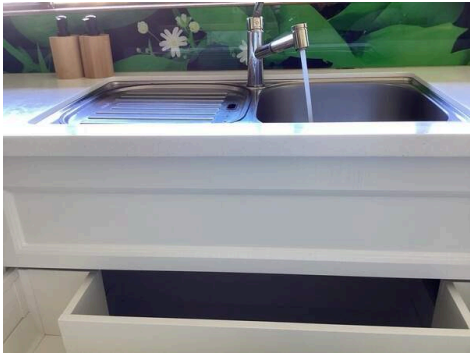
Photo Ref #1

Comments : Good condition with minor wear  
Defect Significance: Minor  
Defect Type: A (Damage)

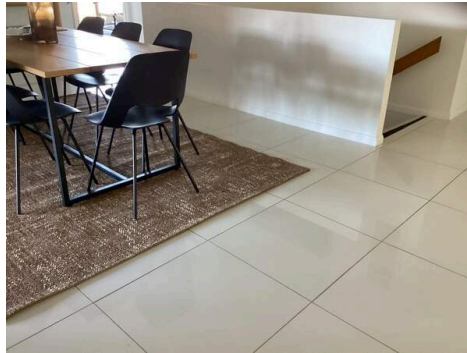
Photo Ref #2

Comments : Good condition and sound throughout. Minor deflection evident.

Defect Significance: Minor

Defect Type: B (Distortion, Warping, Twisting)

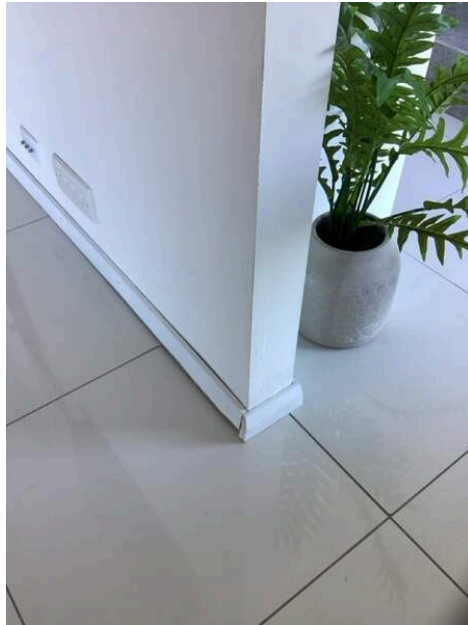
Photo Ref #3

Defect Significance: Minor

Defect Type: F (Installation, including omissions)

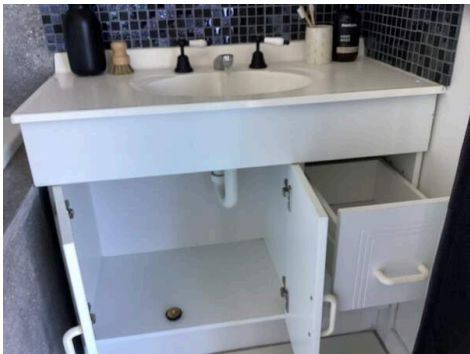
Photo Ref #4

Comments : Generally good condition with minor wear and tear  
Defect Significance: Minor  
Defect Type: A (Damage)

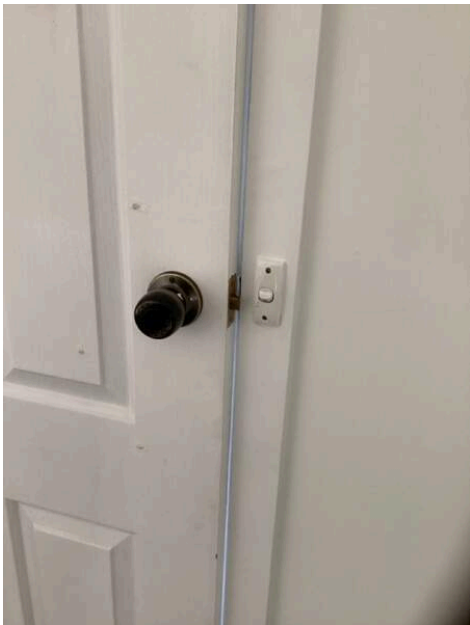
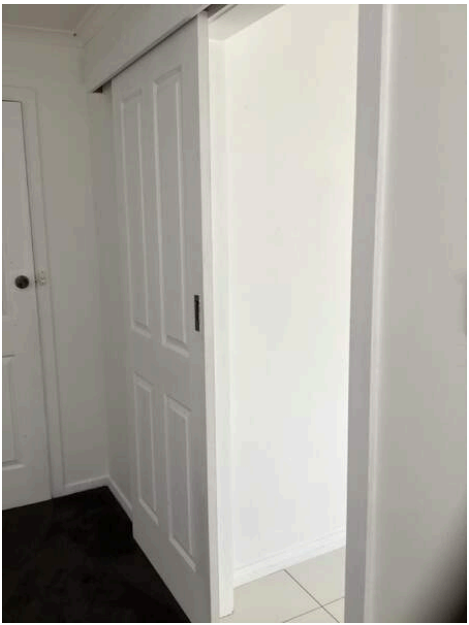
Photo Ref #5

Defect Significance: Minor

Defect Type: E (Operational)

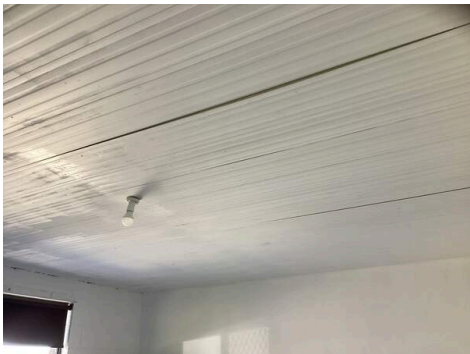
Photo Ref #7

Comments : Minor cosmetic defects to ceiling lining evident  
Defect Significance: Minor  
Defect Type: F (Installation, including omissions)

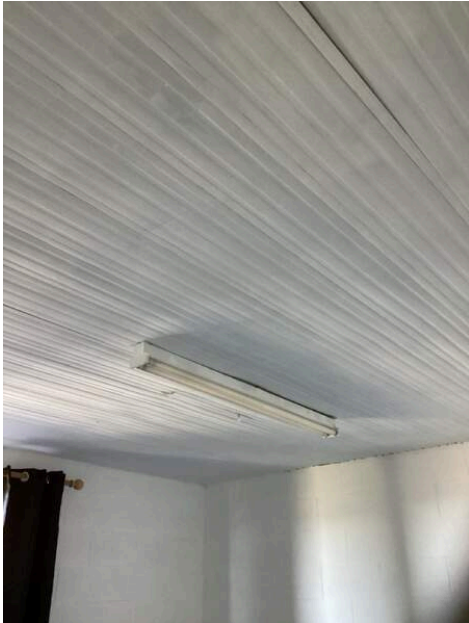
</div> <div>Photo Ref #8</div>

EXPLANATIONS	<div>Comments : Ceiling lining has minor cosmetic defects evident</div> <div>Defect Significance: Minor</div> <div>Defect Type: F (Installation, including omissions)</div>
IMAGES	<div>

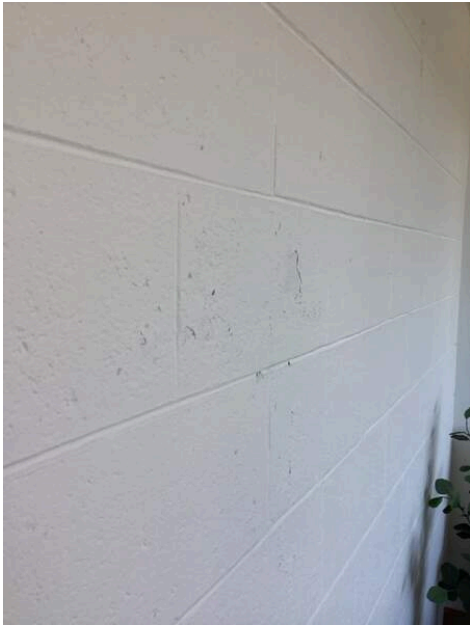
Photo Ref #9

Comments : Generally good condition with minor cosmetic paint defects

Defect Significance: Minor

Defect Type: F (Installation, including omissions)

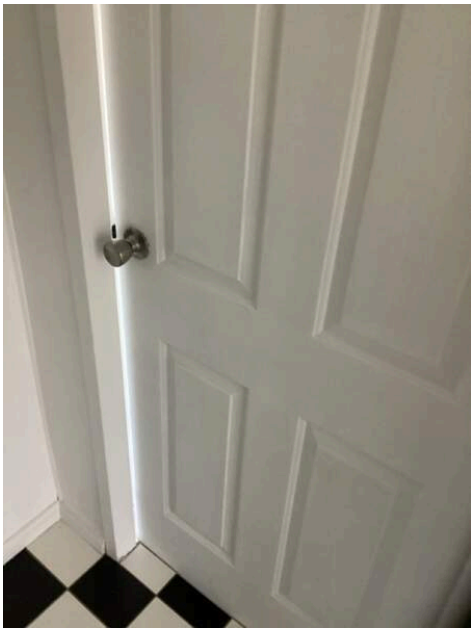
Photo Ref #10

Defect Significance: Minor

Defect Type: E (Operational)

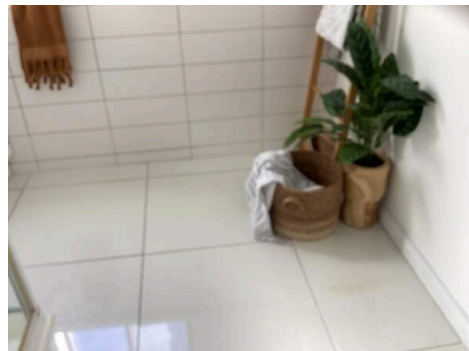
Photo Ref #11

**Comments :** Floor is sound underfoot. Generally good condition with mild deflection and floor is not level throughout.

**Defect Significance:** Minor

**Defect Type:** F (Installation, including omissions)

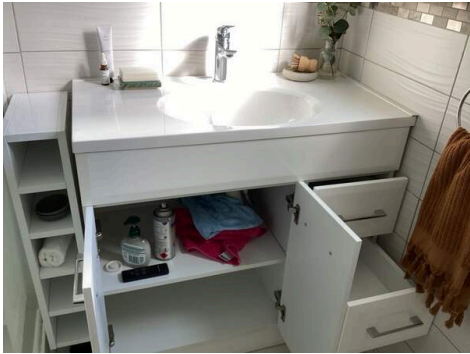
Photo Ref #12

Comments : Reasonable condition with minor wear and tear  
Defect Significance: Minor  
Defect Type: A (Damage)

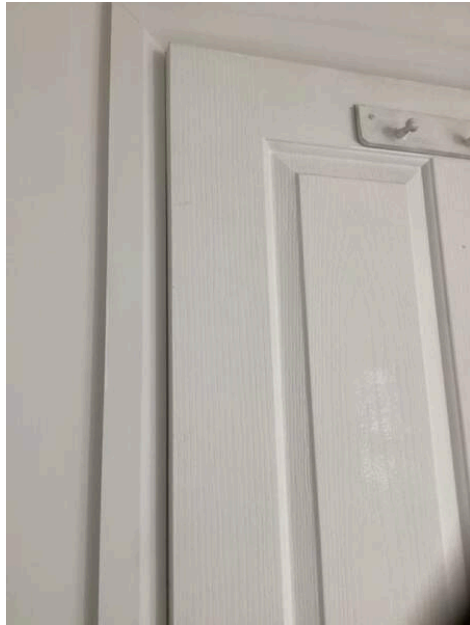
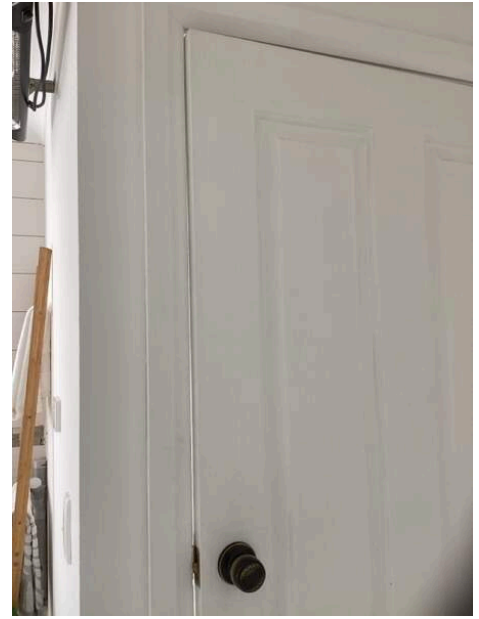
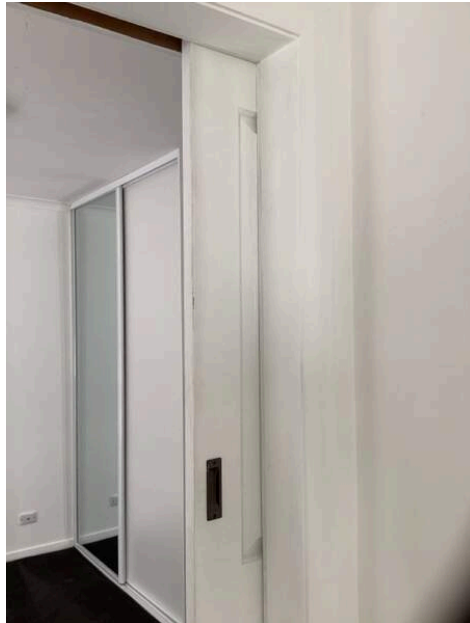
Photo Ref #14

Comments : Doors require minor adjustment to improve function  
Defect Significance: Minor  
Defect Type: E (Operational)

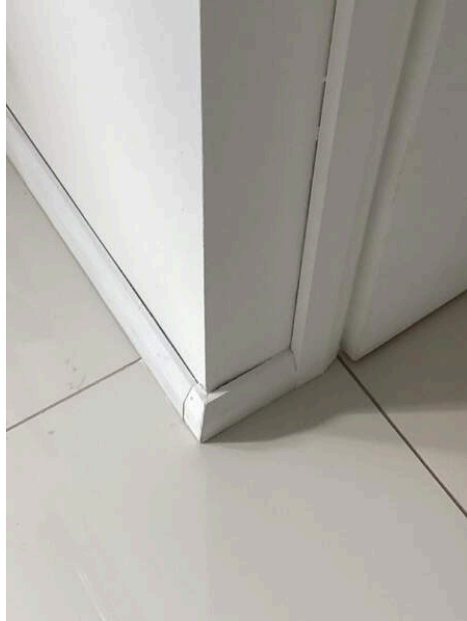
Photo Ref #17

Comments : Skirting boards installation not trades like quality  
Defect Significance: Minor  
Defect Type: F (Installation, including omissions)

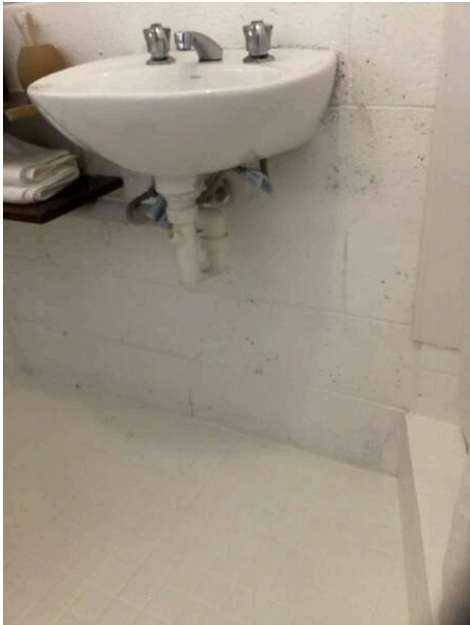
Photo Ref #18

Comments : Reasonable condition for the age with minor cosmetic paint defects  
Defect Significance: Minor  
Defect Type: F (Installation, including omissions)

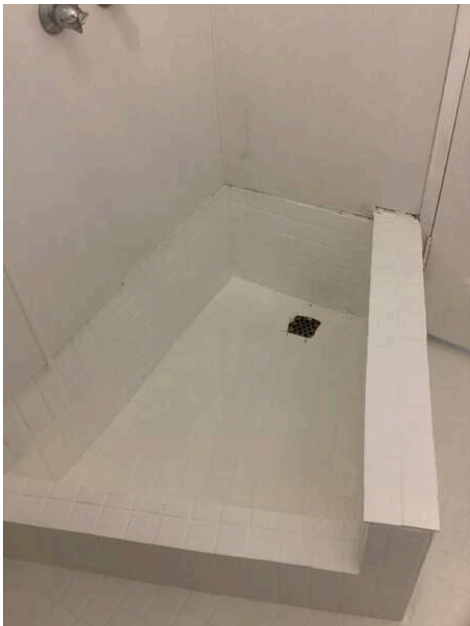
Photo Ref #19

Comments :	Recently painted. Minor wear and tear
Defect Significance:	Minor
Defect Type:	F (Installation, including omissions)

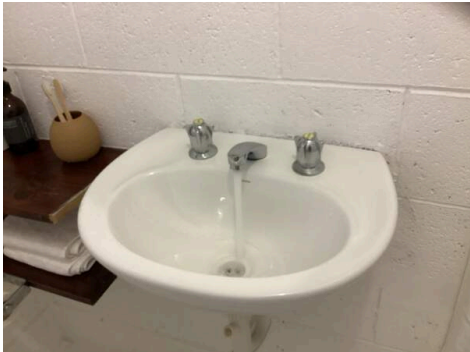
Photo Ref #20

Comments : No splashback tiles installed.  
Defect Significance: Minor  
Defect Type: F (Installation, including omissions)

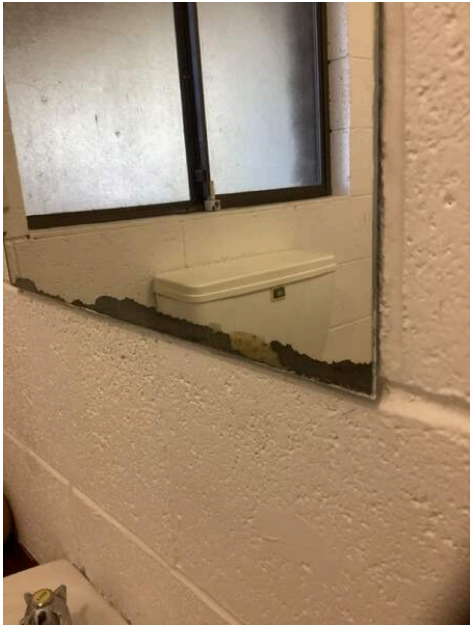
Photo Ref #21

Comments : Minor defects evident  
Defect Significance: Minor  
Defect Type: A (Damage)

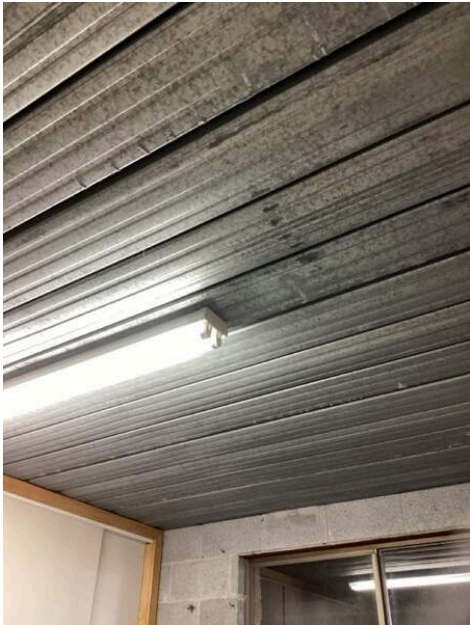
Photo Ref #22

Comments : No ceiling lining installed  
Defect Significance: Minor  
Defect Type: F (Installation, including omissions)

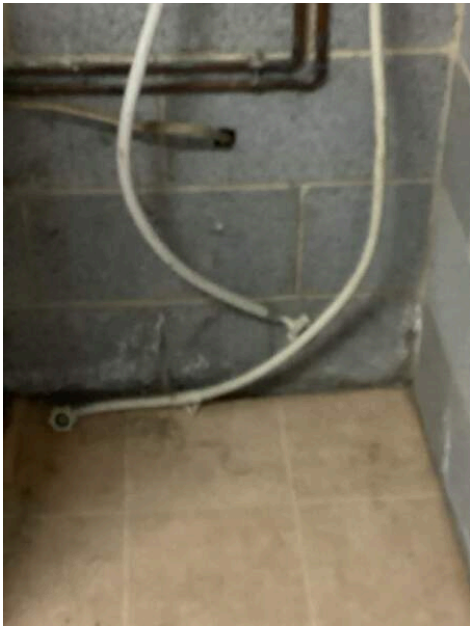
Photo Ref #23

**Comments :** Small area of salt and mineral growth. Generally indicative of minor moisture levels. Moisture readings did not indicate moisture ingress or damp at the time of inspection.

**Defect Significance:** Minor

**Defect Type:** A (Damage)

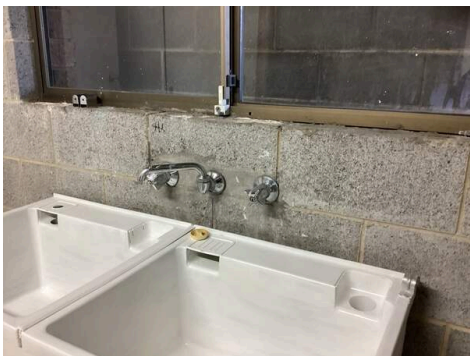
Photo Ref #24

Comments : No splashback installed  
Defect Significance: Minor  
Defect Type: F (Installation, including omissions)

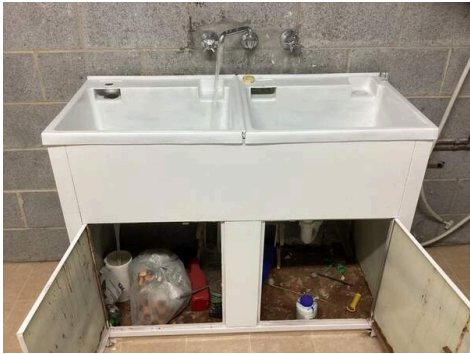
Photo Ref #25

Comments : Reasonable condition for the age with typical wear and tear evident.  
Defect Significance: Minor  
Defect Type: A (Damage)

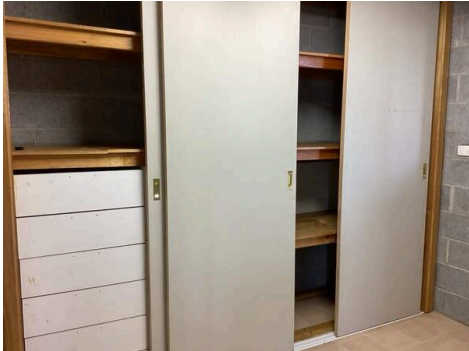
</div> <div>Photo Ref #26</div>

EXPLANATIONS	<div>Comments : Minor wear and tear evident</div> <div>Defect Significance: Minor</div> <div>Defect Type: A (Damage)</div>
IMAGES	<div>

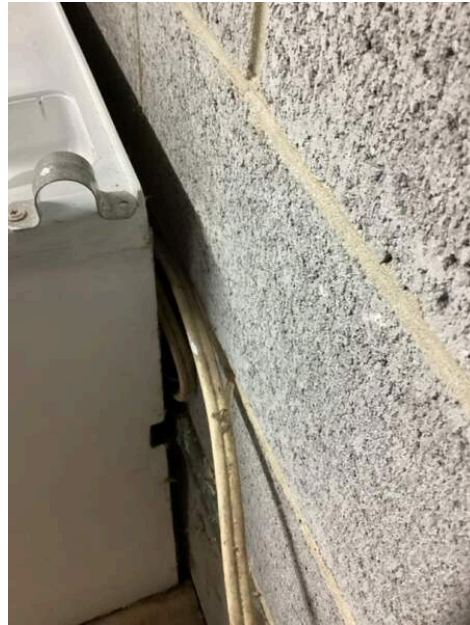
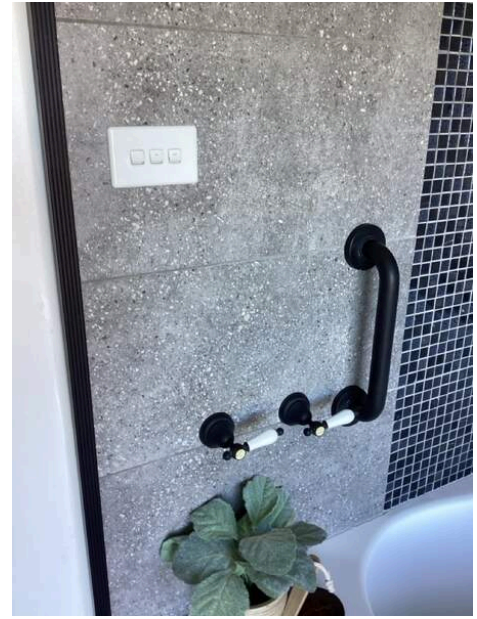
Photo Ref #27

EXPLANATIONS	<div>Comments : Cable in laundry exposed. Does not appear alive. Not correctly terminated. Some switches maybe incorrectly located and or not operable.</div> <div>Defect Significance: Further Investigation</div> <div>Defect Type: F (Installation, including omissions)</div>
--------------	---

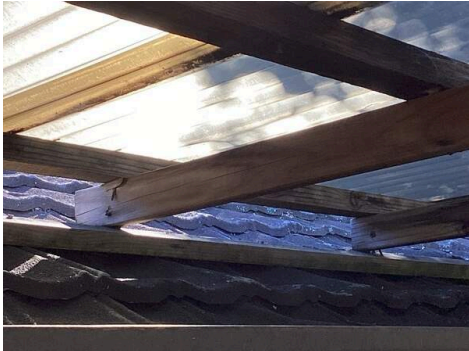
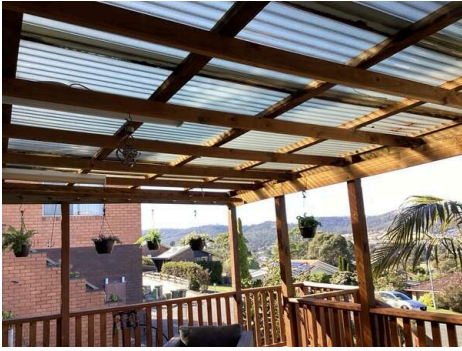
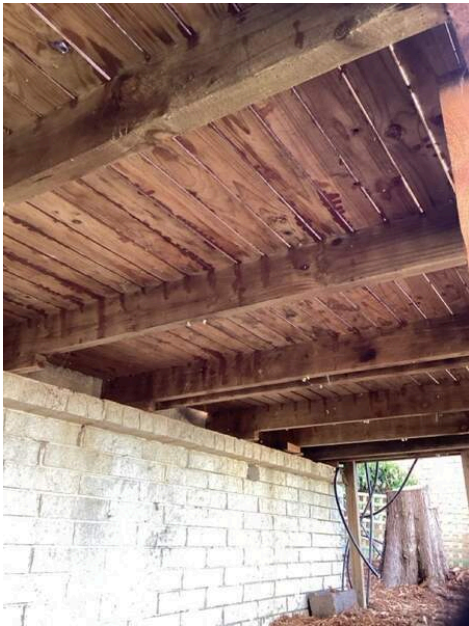
Photo Ref #30	Photo Ref #31
IMAGES

EXPLANATIONS	<div>Comments : Reasonable condition for the age with typical element weathering.</div> <div>Defect Significance: Minor</div> <div>Defect Type: D (Material Deterioration: rusting, rotting, corrosion, decay)</div>	
IMAGES

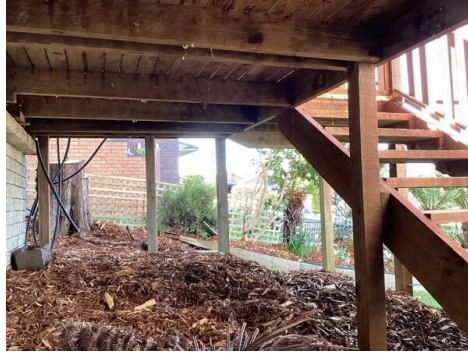
Photo Ref #33

EXPLANATIONS	<div>Comments : Reasonable condition for the age with typical element weathering</div> <div>Defect Significance: Minor</div> <div>Defect Type: D (Material Deterioration: rusting, rotting, corrosion, decay)</div>	
--------------	---	--

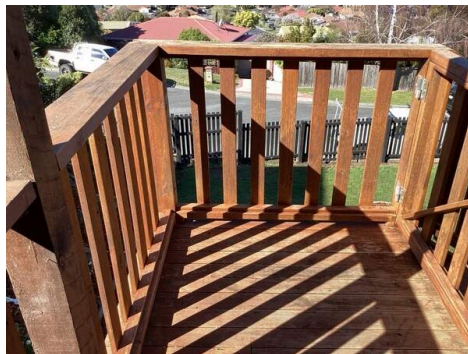
Photo Ref #34

**Comments :** Reasonable condition.  
Element weathering evident

**Defect Significance:** Minor

**Defect Type:** D (Material Deterioration: rusting, rotting, corrosion, decay)

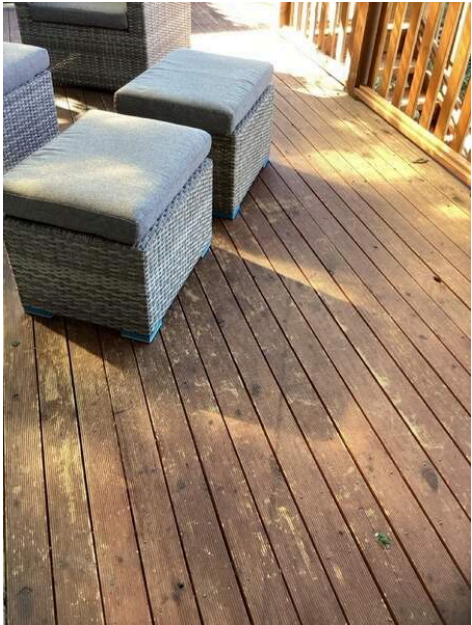
Photo Ref #35

**Comments :** Areas of typical weathering, wear and tear evident

**Defect Significance:** Minor

**Defect Type:** A (Damage)

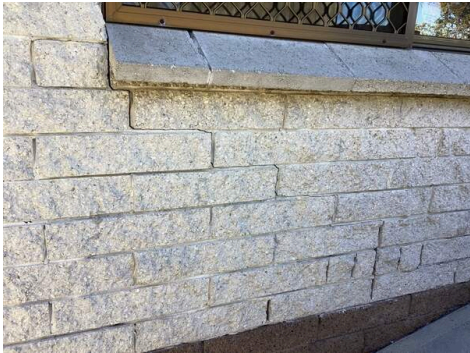
Photo Ref #36

**Comments :** External brickwork appears to be in reasonable condition for the age with one or more areas of fine mortar cracking evident. Cracking appears consistent with typical lateral/thermal movement

**Defect Significance:** Minor

**Defect Type:** B (Distortion, Warping, Twisting)

External brickwork was in reasonable condition for the age with one or more areas of fine mortar joint cracks evident

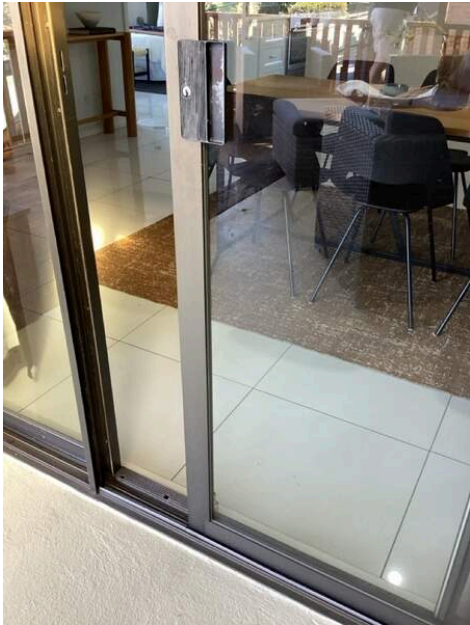
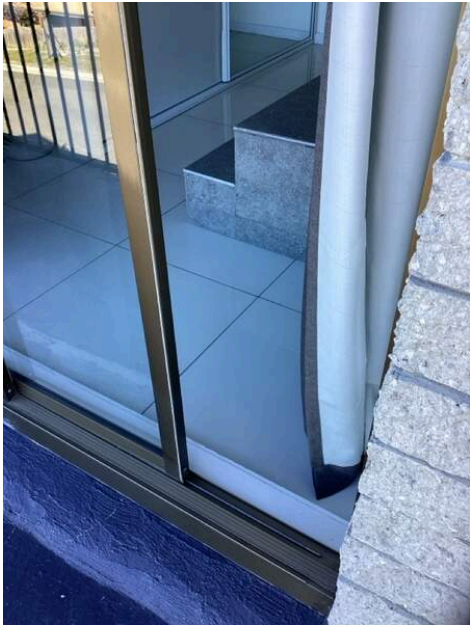
Photo Ref #39

**Comments :** Reasonable condition for the age with typical element weathering, minor track and roller wear evident

**Defect Significance:** Minor

**Defect Type:** D (Material Deterioration: rusting, rotting, corrosion, decay)

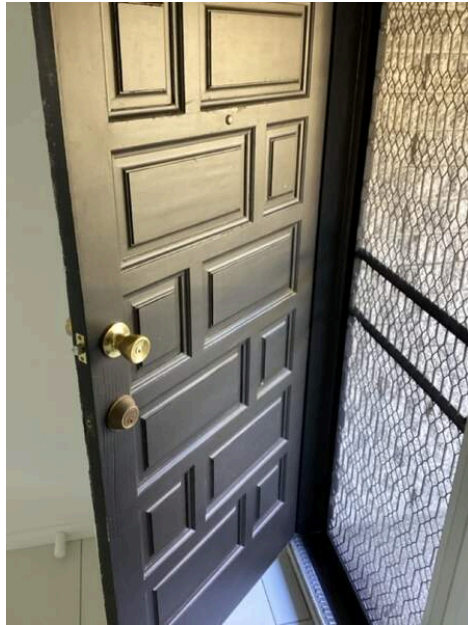
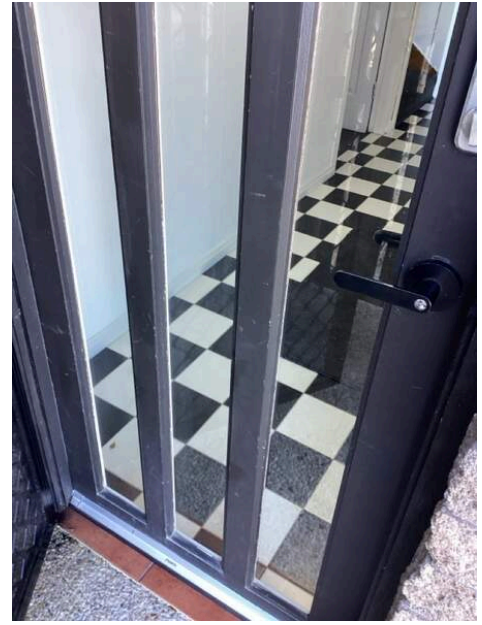
Photo Ref #42

Comments :	Generally good condition for the age with minor weathering evident
Defect Significance:	Minor
Defect Type:	D (Material Deterioration: rusting, rotting, corrosion, decay)

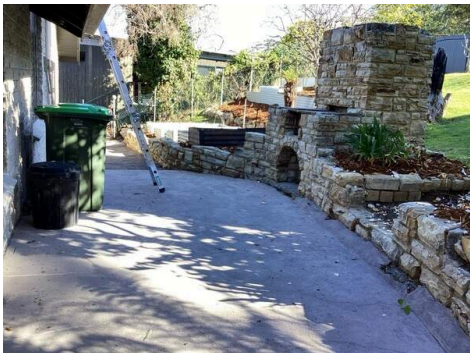
Photo Ref #44

**Comments :** At the time of inspection, the site was dry and no drainage defects were evident.  
The rear slope of the property falls toward the dwelling. Rear footpath does not appear to fall away from the dwelling providing natural run-off for stormwater.  
Monitoring of drainage conditions is always recommended as a matter of course as drainage conditions have potential to change, particularly overtime and during prolonged or heavy rain events. If moisture or drainage conditions become problematic, remedial measures may be required?

**Defect Significance:** Further Investigation  
**Defect Type:** E (Operational)

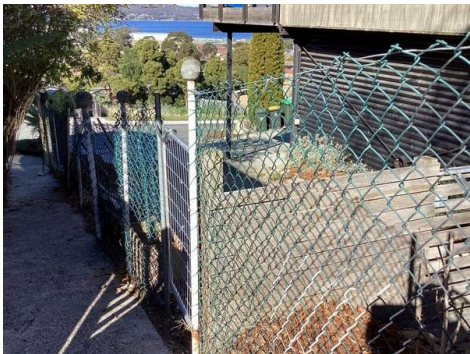
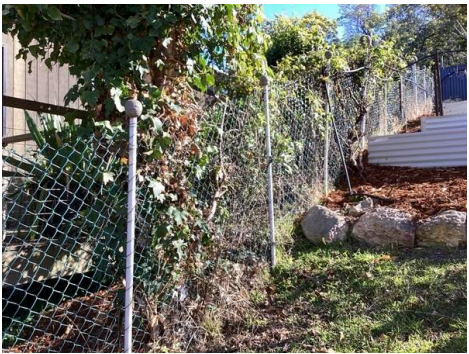
Photo Ref #46

**Comments :** Typical element weathering with areas of minor defect evident

**Defect Significance:** Minor  
**Defect Type:** D (Material Deterioration: rusting, rotting, corrosion, decay)

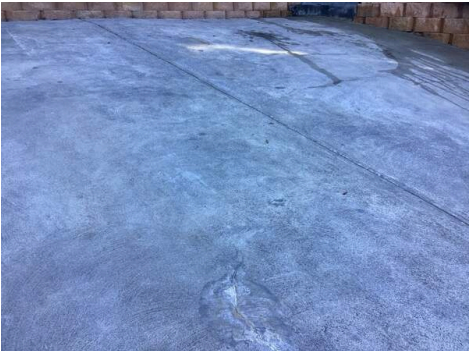
Photo Ref #50

**Comments :** Generally good condition with minor surface wear and fine crack evident

**Defect Significance:** Minor

**Defect Type:** B (Distortion, Warping, Twisting)

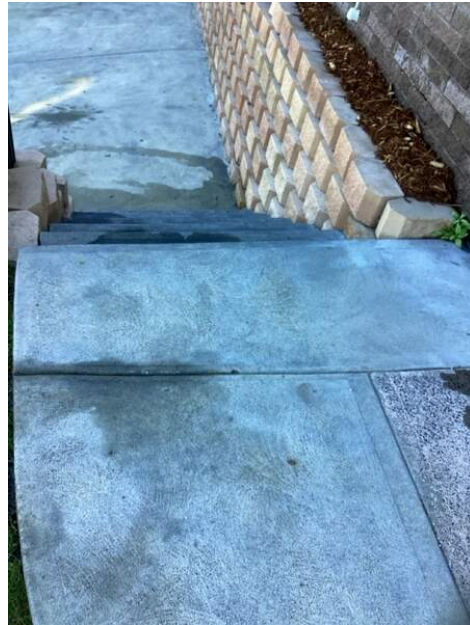
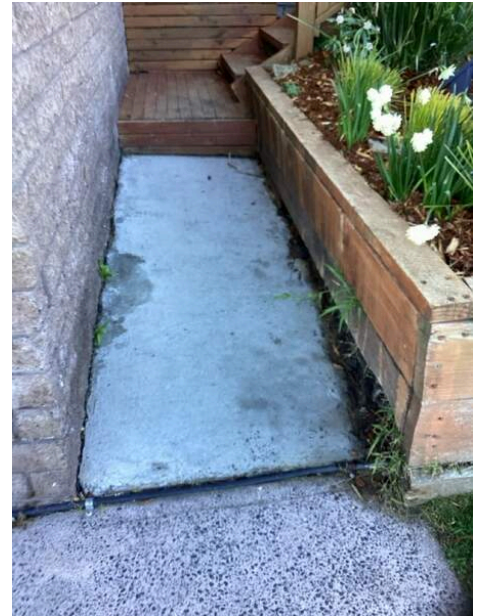
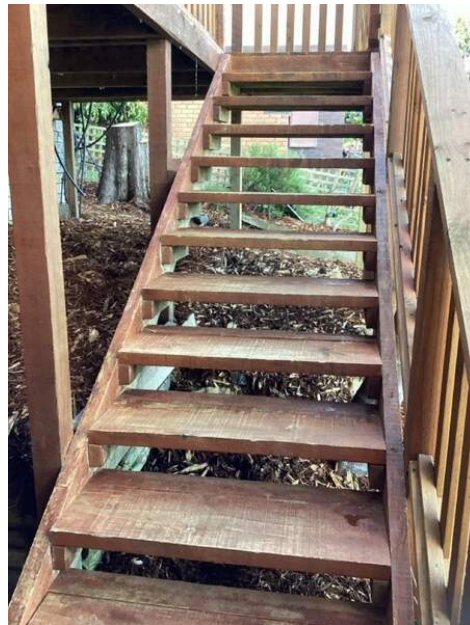
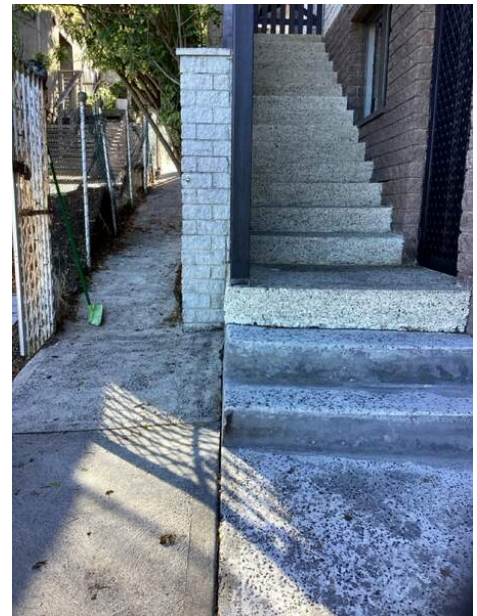
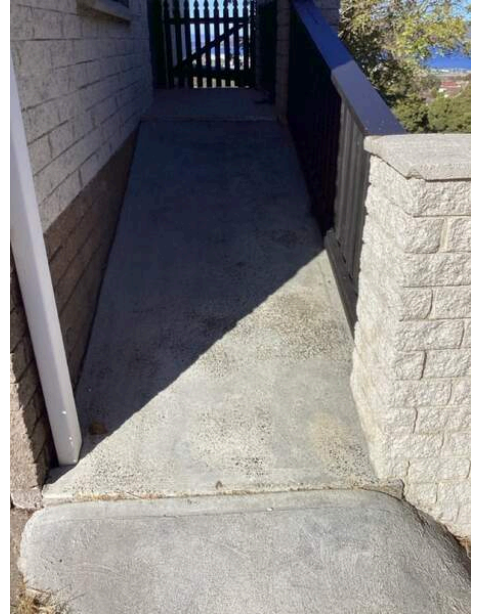
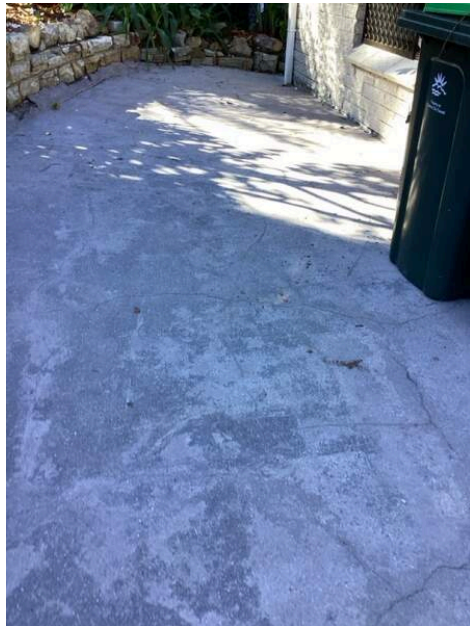
Photo Ref #51

**Comments :** Some areas of cracking and deflection evident. Rear pathway movement is evident and pathway does not appear to provide run-off for stormwater away from the building. Timber steps have typical element weathering and may be slippery when wet. Some areas of uneven surfaces exist

**Defect Significance:** Minor

**Defect Type:** B (Distortion, Warping, Twisting)

Some areas of cracking and deflection evident. Rear pathway movement is evident and pathway does not appear to provide run-off for stormwater away from the building. Timber steps have typical element weathering and may be slippery when wet. Some areas of uneven surfaces exist

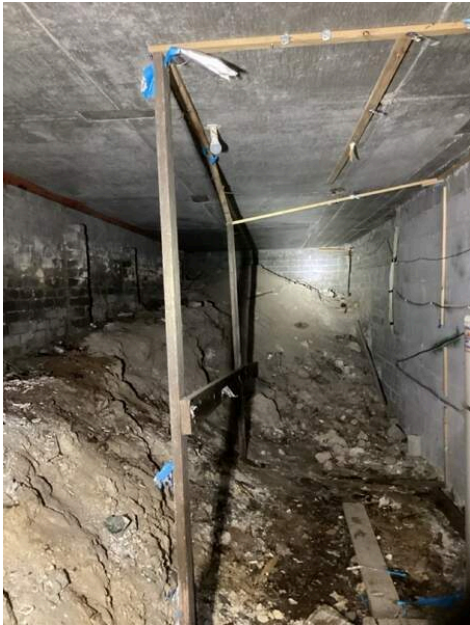
Photo Ref #60

Some areas of da brickwork are evident and some small areas of natural ground dampness evident. Ventilation could be improved by adding ventilation to subfloor door and/all introduction of mechanical ventilation if required. The foundation wall is not designed as a retaining wall. Any future repairs or improvements will need to work within those restrictions

C (Water Penetration Damp Related)

Some areas of da brickwork are evident and some small areas of natural ground dampness evident. Ventilation could be improved by adding ventilation to subfloor door and/all introduction of mechanical ventilation if required. The foundation wall is not designed as a retaining wall. Any future repairs or improvements will need to work within those restrictions

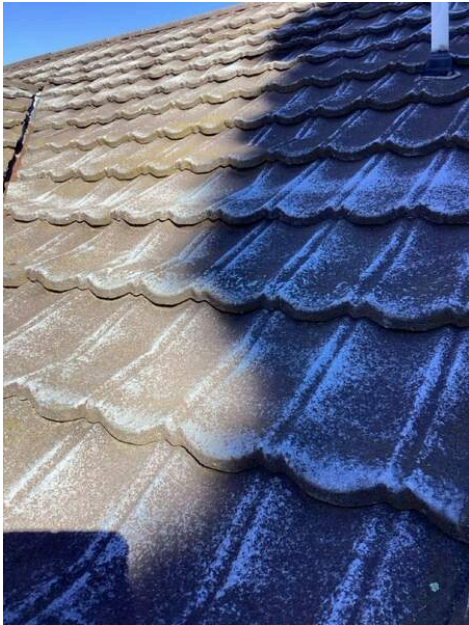
Photo Ref #63

Comments : Areas of surface weathering, minor dents evident  
Defect Significance: Minor  
Defect Type: A (Damage)

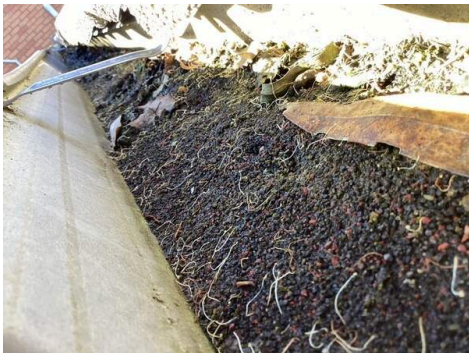
Photo Ref #65

**Comments :** Gutters appear to be in reasonable condition for the age.  
Typical minor weathering and cleaning of some areas may improve function

**Defect Significance:** Minor

**Defect Type:** D (Material Deterioration: rusting, rotting, corrosion, decay)

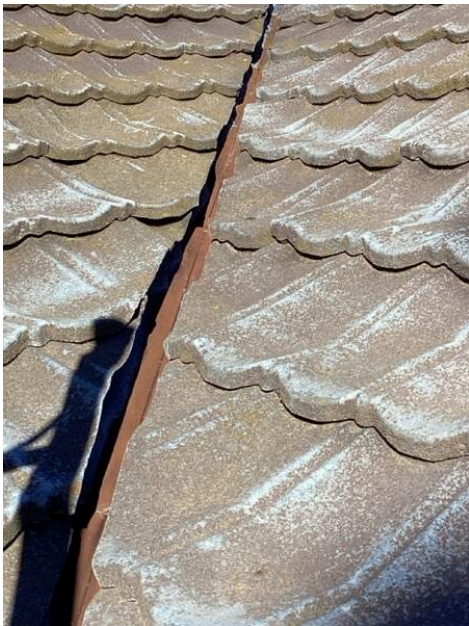
Photo Ref #66

Comments : Reasonable condition for the age.  
Surface rust evident

Defect Significance: Minor

Defect Type: D (Material Deterioration: rusting, rotting, corrosion, decay)

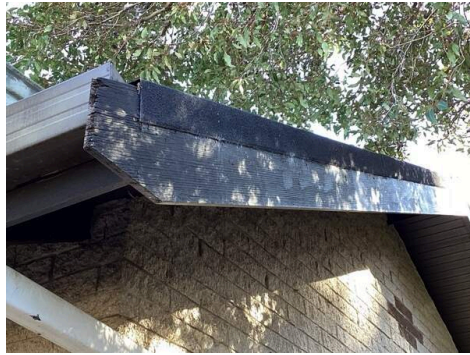
Photo Ref #68

Defect Significance: Minor

Defect Type: D (Material Deterioration: rusting, rotting, corrosion, decay)
