# Safety Report

## SUNRIDGE ESTATE

674 Ranginui Road, Welcome Bay

Report details	
Inspection date:	9 February 2022
Inspector:	Jared Fisher
Weather conditions at time of Inspection:	Overcast
Total items identified:	10
Major hazards:	0
Moderate hazards:	2
Minor hazards:	8
Additional comments:	7
Report Expiry Date:	9 February 2023

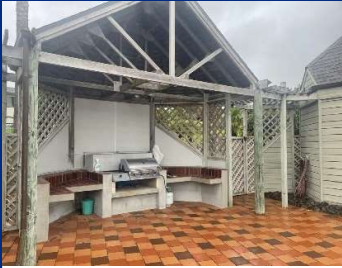
Item	Reference	Item Description	Photo	Trade
<b>BARBEQUE AREA</b>				
1		<b>Location:</b> BBQ area <b>Action:</b> The barbeque area / s was neat, tidy and was in good condition. No hazards were observed at the time of inspection.  <b>Risk level:</b> <b>NH - No Hazard</b>

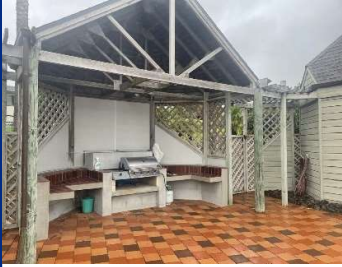
2		<b>Location:</b> BBQ area <b>Action:</b> The barbeque area was free of any obstructions or significant deterioration. No hazards were observed at the time of inspection.  <b>Risk level:</b> <b>NH - No Hazard</b>

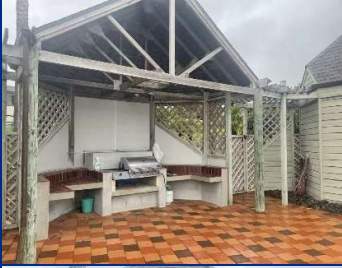
3		<b>Location:</b> BBQ area <b>Action:</b> The gas cylinder were free of significant corrosion. No hazards were observed at the time of inspection.  <b>Risk level:</b> <b>NH - No Hazard</b>

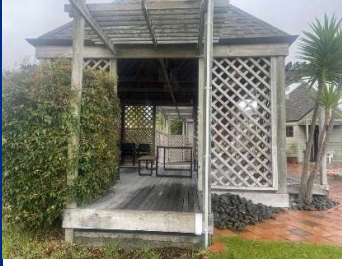
4		<b>Location:</b> BBQ and pool covered area <b>Action:</b> The barbeque area / s was neat, tidy and was in good condition. No hazards were observed at the time of inspection. (Photo 1)  <b>Risk level:</b> <b>NH - No Hazard</b>

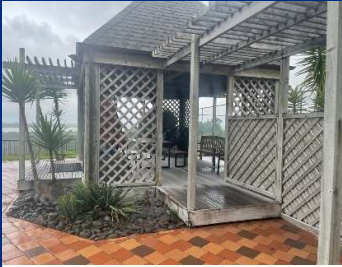
Item	Reference	Item Description	Photo	Trade
5		<b>Location:</b> BBQ and pool covered area <b>Action:</b> The barbeque area / s was neat, tidy and was in good condition. No hazards were observed at the time of inspection. (Photo 2) <b>Risk level:</b> <b>NH - No Hazard</b>

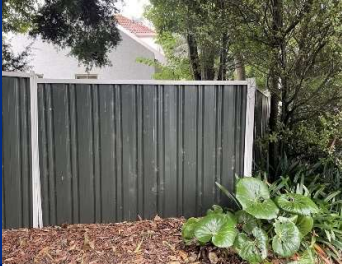
<b>FENCE</b>				
6		<b>Location:</b> Boundary fences - general <b>Action:</b> The fencing was free of significant deterioration or damage and all components were in place. No hazards were observed at the time of inspection. (Photo 1) <b>Risk level:</b> <b>NH - No Hazard</b>

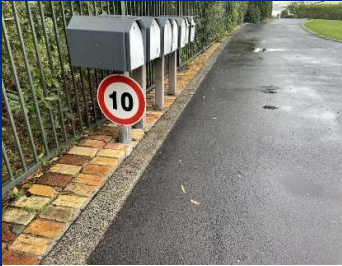
7		<b>Location:</b> Boundary fences - general <b>Action:</b> The fencing was free of significant deterioration or damage and all components were in place. No hazards were observed at the time of inspection. (Photo 2) <b>Risk level:</b> <b>NH - No Hazard</b>

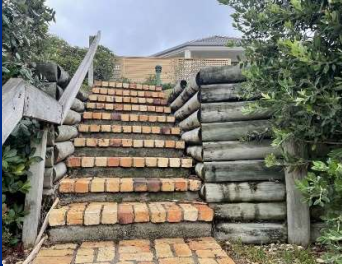
<b>PEDESTRIAN ACCESS</b>				
8	AS/NZS ISO 31000; NZBC cl F4; Building Regulations 1992	<b>Location:</b> Stair access between levels of units <b>Reference:</b> Drop - Install Barrier Right hand side of stair retaining <b>Action:</b> We recommend that you install a balustrade or barrier, measuring not less than 1 metre in height and which meets the current guidelines, where the drop is in excess of 1 metre <b>as soon as possible</b> as this represents a <b>falling hazard</b> . <b>Risk level:</b> <b>2 - Moderate</b>

Action list			
Item	Details	Location	Date actioned
<b>Moderate hazards</b>			
8	We recommend that you install a balustrade or barrier, measuring not less than 1 metre in height and which meets the current guidelines, where the drop is in excess of 1 metre <b>as soon as possible</b> as this represents a <b>falling hazard</b> .

<b>By whom:</b> Metalworker

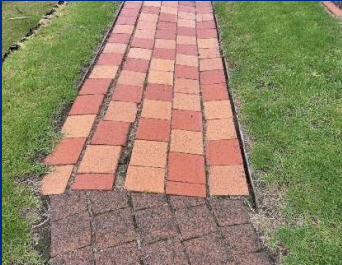
Item	Reference	Item Description	Photo	Trade
9	AS/NZS ISO 31000; NZBC cl F4; Building Regulations 1992	<b>Location:</b> Pedestrian walkway - first gate entry to second gate entry <b>Reference:</b> Pavers - Uneven <b>Action:</b> We recommend that you re-lay the uneven pavers <b>as soon as possible</b> as this represents a <b>tripping hazard</b> .  <b>Risk level:</b> <b>2 - Moderate</b>

Stair access between levels of units	
9	We recommend that you re-lay the uneven pavers <b>as soon as possible</b> as this represents a <b>tripping hazard</b> .

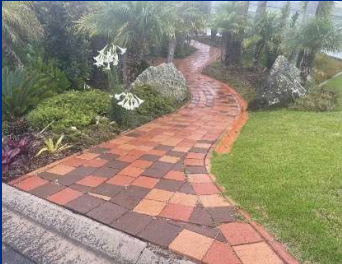
<b>By whom:</b> Handyperson
10	NZ Transport Agency (2009) Pedestrian Planning and Design Guide, 3.9	<b>Location:</b> Path to tennis courts and pool <b>Reference:</b> Anti Slip Treatment for Steep Pathway <b>Action:</b> We recommend that an anti-slip treatment be applied to the steep pathway <b>as soon as possible</b> as this represents a <b>tripping / falling hazard</b> .  <b>Risk level:</b> <b>3 - Minor</b>

Pedestrian walkway - first gate entry to second gate entry	
<b>Minor hazards</b>			
10	We recommend that an anti-slip treatment be applied to the steep pathway <b>as soon as possible</b> as this represents a <b>tripping / falling hazard</b> .

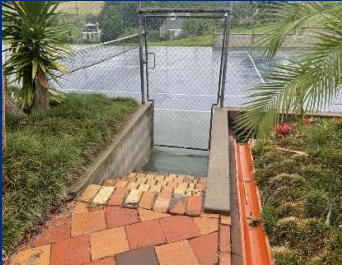
<b>By whom:</b> Handyperson
11	AS/NZS ISO 31000; NZBC cl F4; Building Regulations 1992	<b>Location:</b> Paving walkway to tennis courts <b>Reference:</b> Pavers - Uneven <b>Action:</b> We recommend that you re-lay the uneven pavers <b>as soon as possible</b> as this represents a <b>tripping hazard</b> .  <b>Risk level:</b> <b>3 - Minor</b>

Path to tennis courts and pool	
11	We recommend that you re-lay the uneven pavers <b>as soon as possible</b> as this represents a <b>tripping hazard</b> .

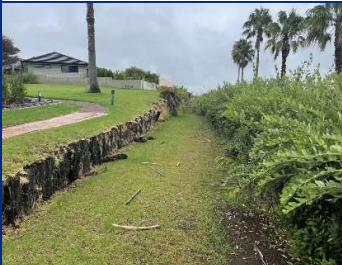
12	AS/NZS ISO 31000; NZBC cl F4; Building Regulations 1992	<b>Location:</b> Landscaped ground walkways <b>Reference:</b> Drop - Install Barrier <b>Action:</b> We recommend that you install a balustrade or barrier, measuring not less than 1 metre in height and which meets the current guidelines, where the drop is in excess of 1 metre as soon as possible as this represents a falling hazard.  <b>Risk level:</b> <b>C - Comment</b>

<b>By whom:</b> Metalworker

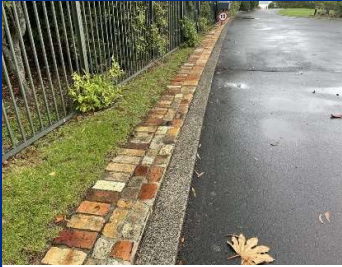
Item	Reference	Item Description	Photo	Trade
13		<p><b>Location:</b> Pedestrian walkway - first gate entry</p> <p><b>Action:</b> The external pathways and walkways were inspected for hazardous conditions that may contribute to slips, trips, falls or impacts. No hazards were observed at the time of inspection. (Photo 1)</p> <p>Please note: Slip-resistance testing to AS / NZS 4663 was not conducted as a part of this inspection. Our observations regarding slip hazards are based upon our inspector's experience under the conditions prevailing during the inspection.</p> <p><b>Risk level:</b> <b>NH - No Hazard</b></p>

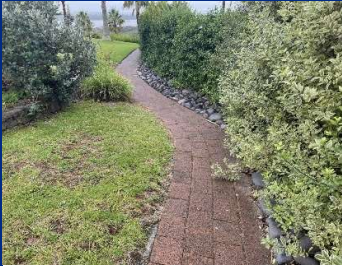
14		<p><b>Location:</b> Pedestrian walkway - first gate entry to second gate entry</p> <p><b>Action:</b> The external pathways and walkways were inspected for hazardous conditions that may contribute to slips, trips, falls or impacts. No hazards were observed at the time of inspection. (Photo 2)</p> <p>Please note: Slip-resistance testing to AS / NZS 4663 was not conducted as a part of this inspection. Our observations regarding slip hazards are based upon our inspector's experience under the conditions prevailing during the inspection.</p> <p><b>Risk level:</b> <b>NH - No Hazard</b></p>

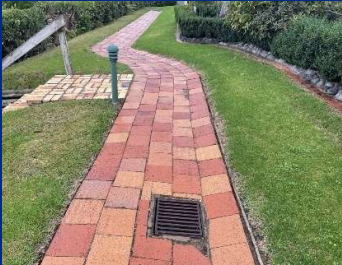
Item	Reference	Item Description	Photo	Trade
15		<p><b>Location:</b> Pedestrian walkway - first gate entry to second gate entry</p> <p><b>Action:</b> The external pathways and walkways were inspected for hazardous conditions that may contribute to slips, trips, falls or impacts. No hazards were observed at the time of inspection. (Photo 3)</p> <p>Please note: Slip-resistance testing to AS / NZS 4663 was not conducted as a part of this inspection. Our observations regarding slip hazards are based upon our inspector's experience under the conditions prevailing during the inspection.</p> <p><b>Risk level:</b> <b>NH - No Hazard</b></p>

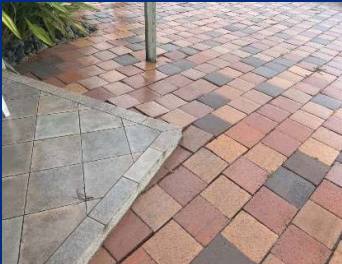
<b>POOL</b>				
16	AS/NZS ISO 31000; NZBC cl F4; Building Regulations 1992	<p><b>Location:</b> Paving walkway - changing room area</p> <p><b>Reference:</b> Pavers - Uneven</p> <p><b>Action:</b> We recommend that you re-lay the uneven pavers around the pool <b>as soon as possible</b>. The change in level is unexpected, which may cause a person to miss their footing and fall. The current situation represents a <b>tripping / drowning hazard</b>.</p> <p><b>Risk level:</b> <b>3 - Minor</b></p>

16	We recommend that you re-lay the uneven pavers around the pool <b>as soon as possible</b> . The change in level is unexpected, which may cause a person to miss their footing and fall. The current situation represents a <b>tripping / drowning hazard</b> .

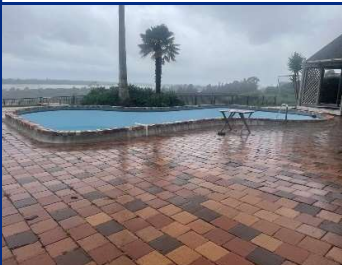
17	Building Regulations, Clause F8.1	<p><b>Location:</b> Pool</p> <p><b>Reference:</b> Signage recommended - Depth Marker</p> <p><b>Action:</b> We recommend that you install depth marker signage displaying maximum depth of the pool <b>as soon as possible</b> as this represents a <b>drowning / personal injury hazard</b>.</p> <p><b>Risk level:</b> <b>3 - Minor</b></p>

Paving walkway - changing room area	
17	We recommend that you install depth marker signage displaying maximum depth of the pool <b>as soon as possible</b> as this represents a <b>drowning / personal injury hazard</b> .

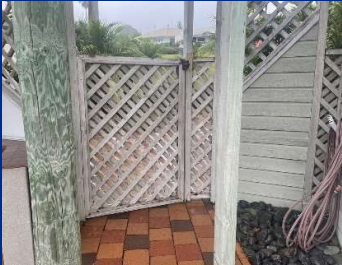
Item	Reference	Item Description	Photo	Trade
18		<p><b>Location:</b> Pool gate</p> <p><b>Action:</b> An outdoor pool enclosure must not be able to be directly accessed from any building, even where a child-resistant door restricts access. The pool area could only be accessed through an approved gate. No hazards were observed at the time of inspection.</p> <p><b>Risk level:</b> <b>C - Comment</b></p>

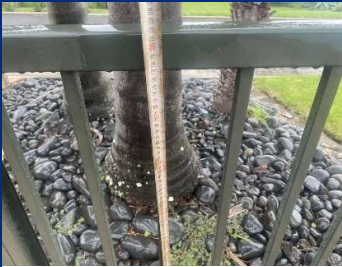
19		<p><b>Location:</b> Pool fencing</p> <p><b>Action:</b> The effective height of the pool area fence was at least 1200mm where measured. No hazards were observed at the time of inspection.</p> <p><b>Risk level:</b> <b>NH - No Hazard</b></p>

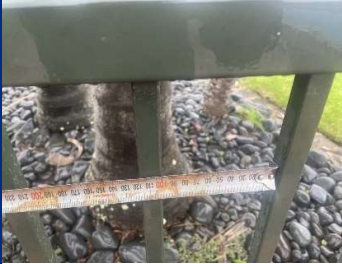
20		<p><b>Location:</b> Pool fencing</p> <p><b>Action:</b> The gaps between the vertical members of the fence were no greater than 100mm where measured (including deflection). No hazards were observed at the time of inspection.</p> <p><b>Risk level:</b> <b>NH - No Hazard</b></p>

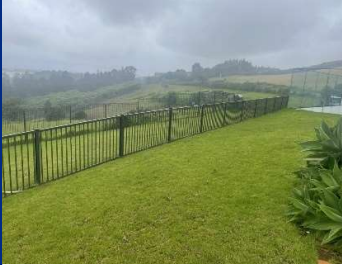
21		<p><b>Location:</b> Pool fencing</p> <p><b>Action:</b> The gap at the bottom of the fence was less than 100mm where measured. No hazards were observed at the time of inspection.</p> <p><b>Risk level:</b> <b>NH - No Hazard</b></p>

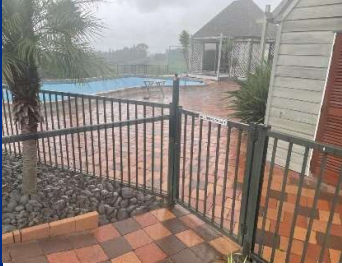
22		<p><b>Location:</b> Pool gate</p> <p><b>Action:</b> An outdoor pool enclosure must not be able to be directly accessed from any building, even where a child-resistant door restricts access. The pool area could only be accessed through an approved gate. No hazards were observed at the time of inspection.</p> <p><b>Risk level:</b> <b>NH - No Hazard</b></p>

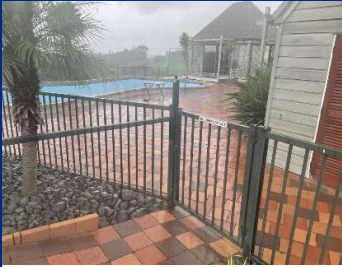
Item	Reference	Item Description	Photo	Trade
23		<b>Location:</b> Pool gate <b>Action:</b> The gate self-closed and self-latched from any position, from resting against the lock mechanism to being fully open. No hazards were observed at the time of inspection. <b>Risk level:</b> NH - No Hazard

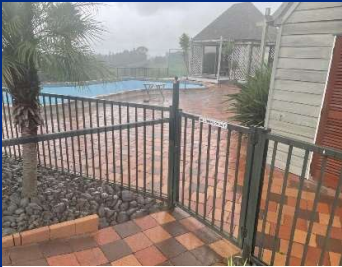
24		<b>Location:</b> Pool gate <b>Action:</b> The latching device was at least 1500mm above the ground and 1400mm above the highest lower member. No hazards were observed at the time of inspection. <b>Risk level:</b> NH - No Hazard

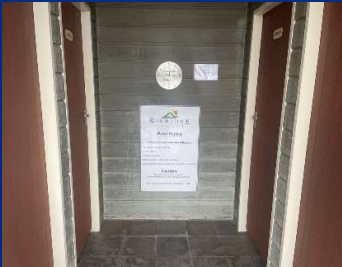
25		<b>Location:</b> Pool signage <b>Action:</b> Signage showing that children must be supervised was evident at the pool area. <b>Risk level:</b> NH - No Hazard

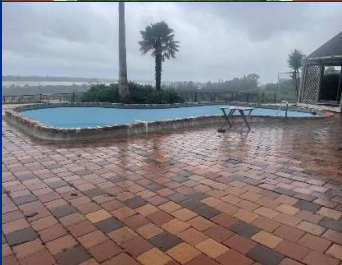
26		<b>Location:</b> Paving walkway - pool <b>Action:</b> The pavement surrounding the pool container was inspected for hazardous conditions that would contribute to slips, trips, falls or impacts. No hazards were observed at the time of inspection. <b>Risk level:</b> NH - No Hazard

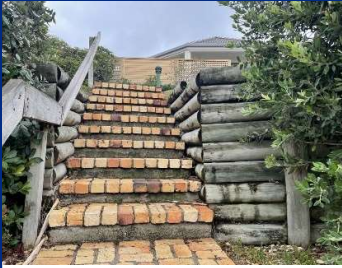
Item	Reference	Item Description	Photo	Trade
<b>STAIRWAYS</b>				
27	AS/NZS ISO 31000; NZBC cl D1; Building Regulations 1992	<p><b>Location:</b> Stair access between levels of units</p> <p><b>Reference:</b> Structure - Standard comment</p> <p><b>Action:</b> We have assumed that any stairways inspected are the original stairways that were passed by the authorities at the time of construction and therefore would have complied with the Building Codes of that time. For that reason, as we are unable to determine the structural safety of these stairs, we make no recommendations with regards to the structure of these stairs. (Photo 1)</p> <p>Please note that the current building code requires stairs to have a non-slip finish or anti-slip strip on each tread for all new or renovated stairs.</p> <p><b>Risk level:</b> <b>C - Comment</b></p>

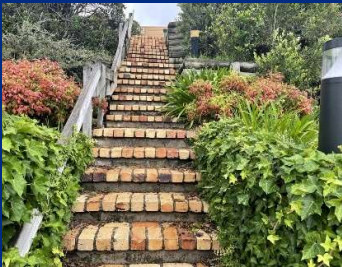
<p><b>By whom:</b> Suitably Qualified Contractor</p>
28	AS/NZS ISO 31000; NZBC cl D1; Building Regulations 1992	<p><b>Location:</b> Stair access between levels of units</p> <p><b>Reference:</b> Structure - Standard comment</p> <p><b>Action:</b> We have assumed that any stairways inspected are the original stairways that were passed by the authorities at the time of construction and therefore would have complied with the Building Codes of that time. For that reason, as we are unable to determine the structural safety of these stairs, we make no recommendations with regards to the structure of these stairs. (Photo 2)</p> <p>Please note that the current building code requires stairs to have a non-slip finish or anti-slip strip on each tread for all new or renovated stairs.</p> <p><b>Risk level:</b> <b>C - Comment</b></p>

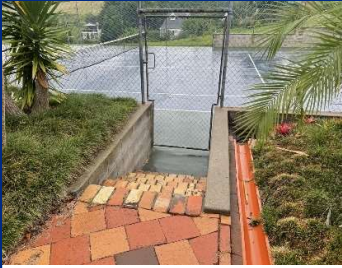
Item	Reference	Item Description	Photo	Trade
<b>TENNIS COURT</b>				
29	ISO 31000	<b>Location:</b> Tennis court <b>Reference:</b> Signage recommended - Rules <b>Action:</b> No signage was evident regarding the rules of use of the tennis court (e.g. opening hours, child supervision etc). We recommend that this signage be erected as soon as possible as this represents a personal injury hazard.  <b>Risk level:</b> <b>C - Comment</b>

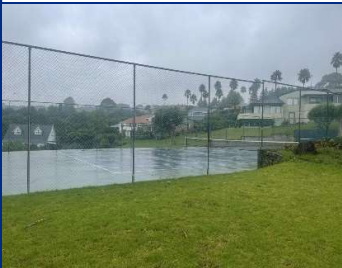
By whom: Signwriter
30		<b>Location:</b> Tennis court <b>Action:</b> The tennis court was clean, tidy and in good condition at time of inspection. No hazards were observed at the time of inspection.  <b>Risk level:</b> <b>NH - No Hazard</b>

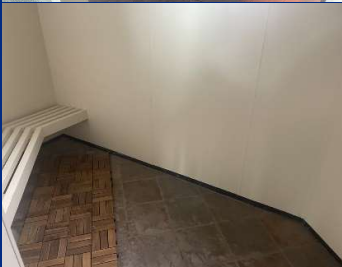
32		<b>Location:</b> Pool toilet and change rooms <b>Action:</b> The floor surface of the toilets did appear to have a non-slip surface. No hazards were observed at the time of inspection.  <b>Risk level:</b> <b>NH - No Hazard</b>

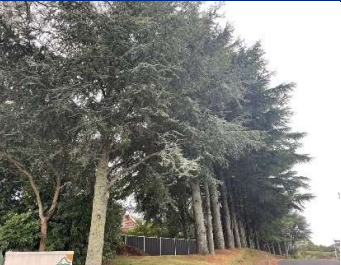
Item	Reference	Item Description	Photo	Trade
34	Electricity Act 1992, s 169(g)	<p><b>Location:</b> Trees / vegetation</p> <p><b>Reference:</b> Pruning recommended (outside common property)</p> <p><b>Action:</b> We recommend that the trees and vegetation outside the common property areas are trimmed as necessary <b>as soon as possible</b>. (Photo 1)</p> <p><b>Risk level:</b> <b>3 - Minor</b></p>

Action list			
Item	Details	Location	Date actioned
34	We recommend that the trees and vegetation outside the common property areas are trimmed as necessary <b>as soon as possible</b> . (Photo 1)

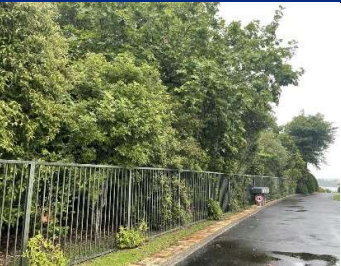
<b>By whom:</b> Gardener
35	Electricity Act 1992, s 169(g)	<p><b>Location:</b> Trees - left hand side first gate entry</p> <p><b>Reference:</b> Pruning recommended (outside common property)</p> <p><b>Action:</b> We recommend that the trees and vegetation outside the common property areas are trimmed as necessary <b>as soon as possible</b>. (Photo 3)</p> <p><b>Risk level:</b> <b>3 - Minor</b></p>

Trees / vegetation	
35	We recommend that the trees and vegetation outside the common property areas are trimmed as necessary <b>as soon as possible</b> . (Photo 3)

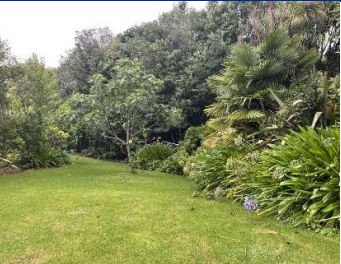
<b>By whom:</b> Gardener
36	Electricity Act 1992, s 169(g)	<p><b>Location:</b> Boundary trees - general</p> <p><b>Reference:</b> Pruning recommended (outside common property)</p> <p><b>Action:</b> We recommend that the trees and vegetation outside the common property areas are trimmed as necessary <b>as soon as possible</b>. (Photo 4)</p> <p><b>Risk level:</b> <b>3 - Minor</b></p>

Trees - left hand side first gate entry	
36	We recommend that the trees and vegetation outside the common property areas are trimmed as necessary <b>as soon as possible</b> . (Photo 4)

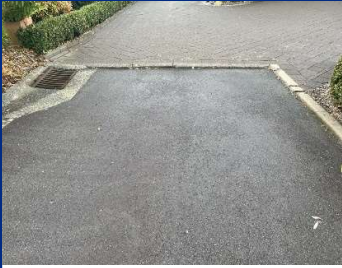
Item	Reference	Item Description	Photo	Trade
<b>VEHICLE ACCESSWAYS</b>				
37	AS/NZS ISO 31000; NZBC cl F4; Building Regulations 1992	<p><b>Location:</b> Vehicle accessway - first gate entry - end of common property road to unit entry</p> <p><b>Reference:</b> Concrete - Raised Lip</p> <p><b>Action:</b> We recommend that you grind back flush, the lip along the joins in the surface <b>as soon as possible</b> as this represents a <b>tripping / personal injury hazard</b>.</p> <p><b>Risk level:</b> <b>3 - Minor</b></p>

Boundary trees - general	
37	We recommend that you grind back flush, the lip along the joins in the surface <b>as soon as possible</b> as this represents a <b>tripping / personal injury hazard</b> .

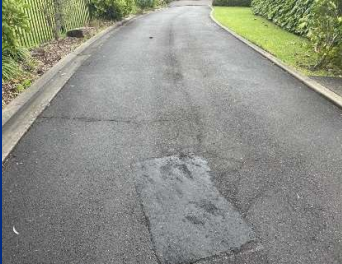
<b>By whom:</b> Handyperson / Concreter
38		<p><b>Location:</b> Vehicle accessway - first gate entry</p> <p><b>Reference:</b> Bitumen - Damaged</p> <p><b>Action:</b> We recommend that you repair the damaged bitumen as soon as possible as this creates an uneven surface that represents a tripping / personal injury hazard. Although this is not a designated walkway the area is accessible to pedestrians.</p> <p><b>Risk level:</b> <b>C - Comment</b></p>

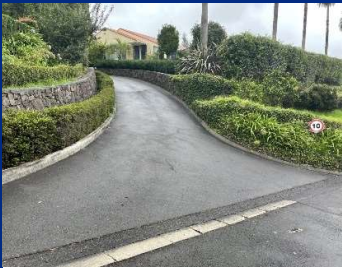
39		<p><b>Location:</b> Vehicle accessway - second gate entry</p> <p><b>Reference:</b> Bitumen – Hole and cracks.</p> <p><b>Action:</b> We recommend that you repair the hole in the bitumen as soon as possible as this represents a tripping / personal injury hazard to anyone crossing that area. The cracks in the bitumen are indicative of the vehicle accessways in several areas. We recommend that these are monitored and repaired regularly to prevent them becoming deeper and wider where a heel or sole of a shoe could catch.</p> <p><b>Risk level:</b> <b>C - Comment</b></p>

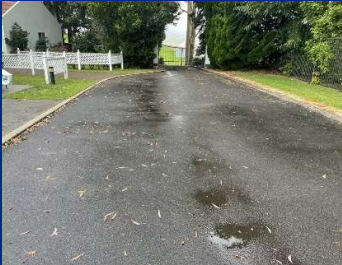
Item	Reference	Item Description	Photo	Trade
40		<p><b>Location:</b> Vehicle accessway - first gate entry</p> <p><b>Action:</b> The vehicle accessways were inspected for hazardous conditions that may contribute to slips, trips, falls, impacts or vehicle related accidents. No hazards were observed at the time of inspection. (Photo 1)</p> <p>Please note: Slip-resistance testing to AS / NZS 4663 was not conducted as a part of this inspection. Our observations regarding slip hazards are based upon our inspector's experience under the conditions prevailing during the inspection.</p> <p><b>Risk level:</b> <b>NH - No Hazard</b></p>

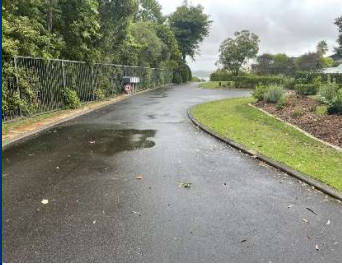
41		<p><b>Location:</b> Vehicle accessway - first gate entry</p> <p><b>Action:</b> The vehicle accessways were inspected for hazardous conditions that may contribute to slips, trips, falls, impacts or vehicle related accidents. No hazards were observed at the time of inspection. (Photo 2)</p> <p>Please note: Slip-resistance testing to AS / NZS 4663 was not conducted as a part of this inspection. Our observations regarding slip hazards are based upon our inspector's experience under the conditions prevailing during the inspection.</p> <p><b>Risk level:</b> <b>NH - No Hazard</b></p>

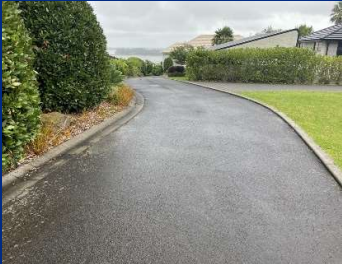
42		<p><b>Location:</b> Vehicle accessway - first gate entry</p> <p><b>Action:</b> The vehicle accessways were inspected for hazardous conditions that may contribute to slips, trips, falls, impacts or vehicle related accidents. No hazards were observed at the time of inspection. (Photo 3)</p> <p>Please note: Slip-resistance testing to AS / NZS 4663 was not conducted as a part of this inspection. Our observations regarding slip hazards are based upon our inspector's experience under the conditions prevailing during the inspection.</p> <p><b>Risk level:</b> <b>NH - No Hazard</b></p>

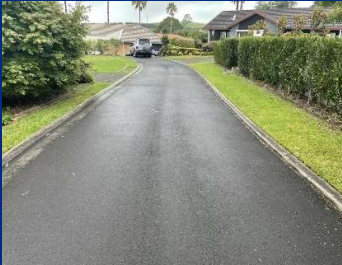
Item	Reference	Item Description	Photo	Trade
43		<p><b>Location:</b> Vehicle accessway - first gate entry</p> <p><b>Action:</b> The vehicle accessways were inspected for hazardous conditions that may contribute to slips, trips, falls, impacts or vehicle related accidents. No hazards were observed at the time of inspection. (Photo 4)</p> <p>Please note: Slip-resistance testing to AS / NZS 4663 was not conducted as a part of this inspection. Our observations regarding slip hazards are based upon our inspector's experience under the conditions prevailing during the inspection.</p> <p><b>Risk level:</b> <b>NH - No Hazard</b></p>

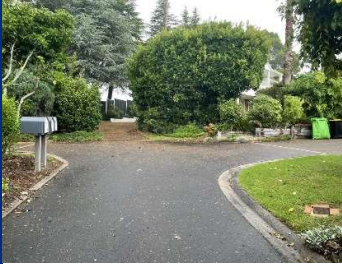
44		<p><b>Location:</b> Vehicle accessway - second gate entry</p> <p><b>Action:</b> The vehicle accessways were inspected for hazardous conditions that may contribute to slips, trips, falls, impacts or vehicle related accidents. No hazards were observed at the time of inspection. (Photo 5)</p> <p>Please note: Slip-resistance testing to AS / NZS 4663 was not conducted as a part of this inspection. Our observations regarding slip hazards are based upon our inspector's experience under the conditions prevailing during the inspection.</p> <p><b>Risk level:</b> <b>NH - No Hazard</b></p>

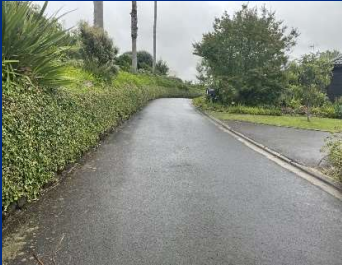
Item	Reference	Item Description	Photo	Trade
45		<p><b>Location:</b> Vehicle accessway - second gate entry</p> <p><b>Action:</b> The vehicle accessways were inspected for hazardous conditions that may contribute to slips, trips, falls, impacts or vehicle related accidents. No hazards were observed at the time of inspection. (Photo 6)</p> <p>Please note: Slip-resistance testing to AS / NZS 4663 was not conducted as a part of this inspection. Our observations regarding slip hazards are based upon our inspector's experience under the conditions prevailing during the inspection.</p> <p><b>Risk level:</b> <b>NH - No Hazard</b></p>

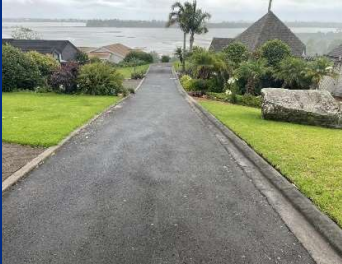
46		<p><b>Location:</b> Vehicle accessway - second gate entry</p> <p><b>Action:</b> The vehicle accessways were inspected for hazardous conditions that may contribute to slips, trips, falls, impacts or vehicle related accidents. No hazards were observed at the time of inspection. (Photo 7)</p> <p>Please note: Slip-resistance testing to AS / NZS 4663 was not conducted as a part of this inspection. Our observations regarding slip hazards are based upon our inspector's experience under the conditions prevailing during the inspection.</p> <p><b>Risk level:</b> <b>NH - No Hazard</b></p>
