# LIM

## Land Information Memorandum

Applicant	<b>Robert Shaw</b>
Property Address	<b>6/674L Ranginui Road Tauranga</b>
Legal Description	<b>Unit 6 DPS 62811 Interest in Lot 1 DPS 62448</b>
Application Date	<b>9 July 2025</b>

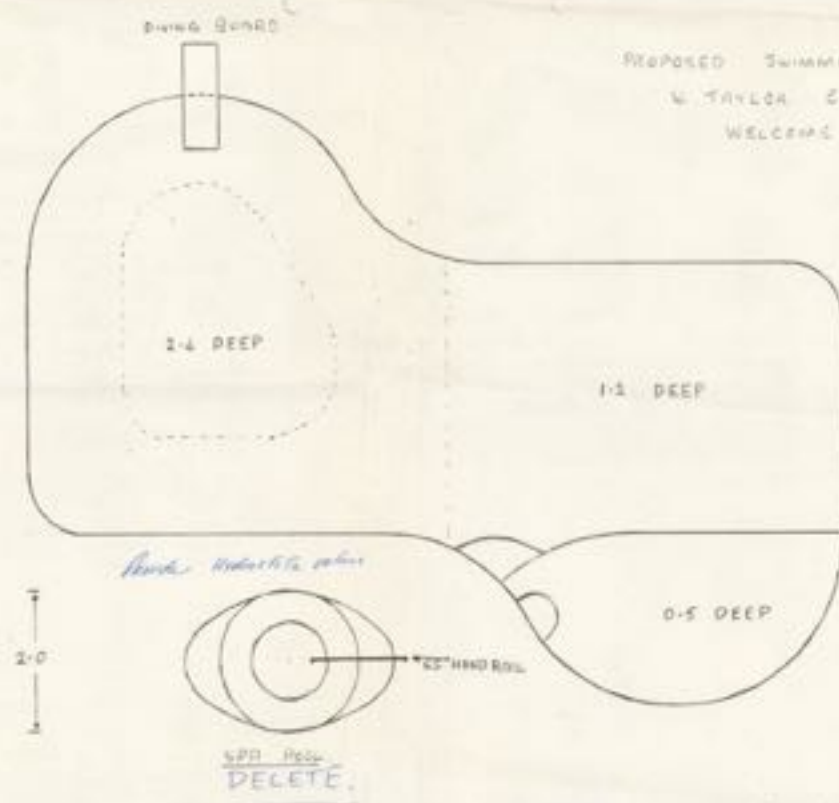
Layout PLAN 1:50

Pool CAPACITY 24,000 LITRES  
 FILLING BY FILTERMETER QPSP/1961  
 BACKWASH WATER TO GULLY TEND ✓  
 FILLING FROM HOT WATER HEAT  
 GROUND SUPPLETS - CHECK FLOW TO RECHARGE BR42 ✓

PROPOSED SWIMMING POOL  
 W. TAYLOR SCHOOL  
 WELLSVILLE GRV

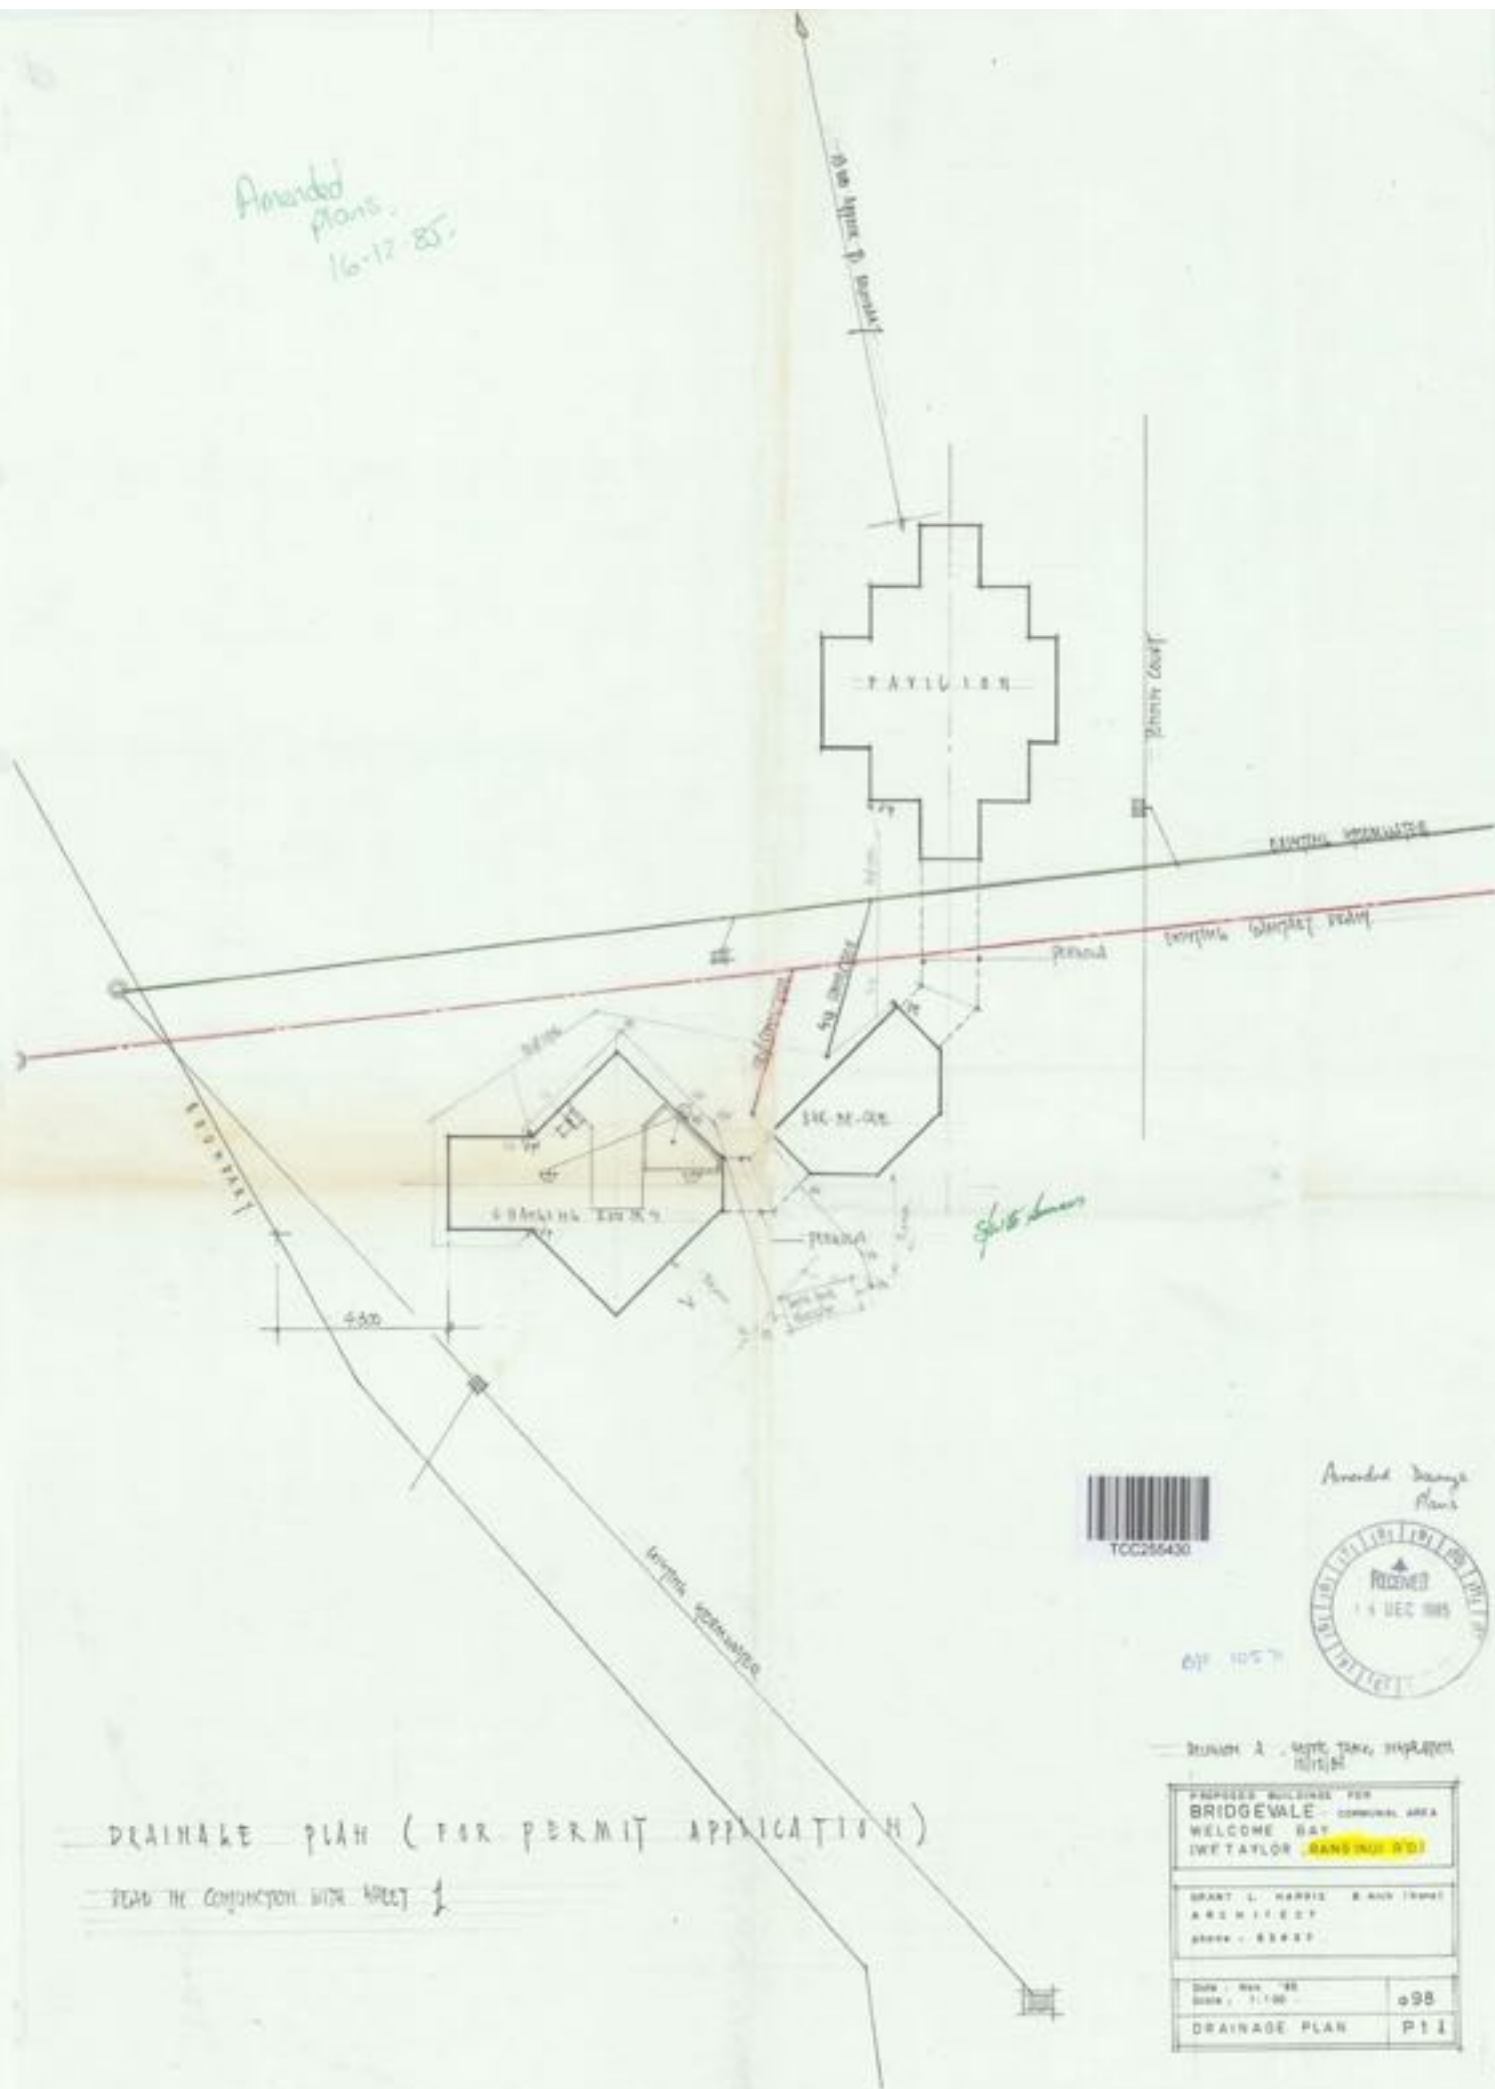
Amended Drainage  
Plans

DRAINAGE PLAN (FOR PERMIT APPLICATION)

READ IN CONJUNCTION WITH SHEET 1

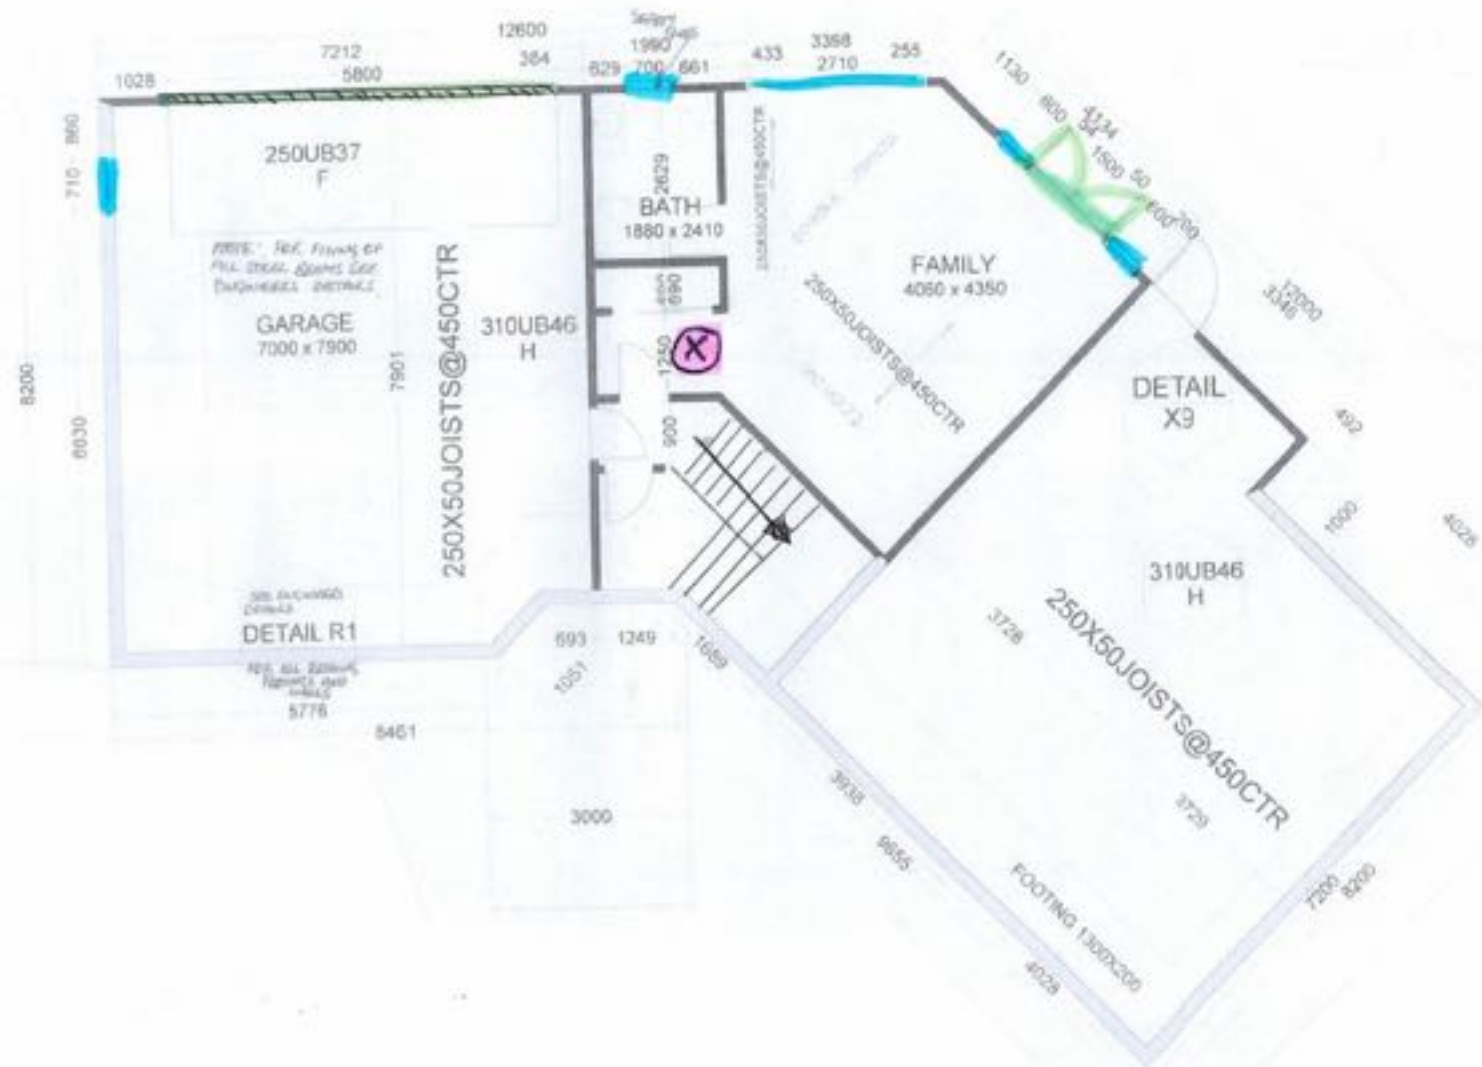
## Installation of Yunca Woodburner

Smoke Alarms to comply with F7 Warning systems (3m from every sleeping space and on exit path) Smoke Alarms will be centrally located in hallway which measures at least 800mm. Smoke alarms will not be installed in any dead air spaces.

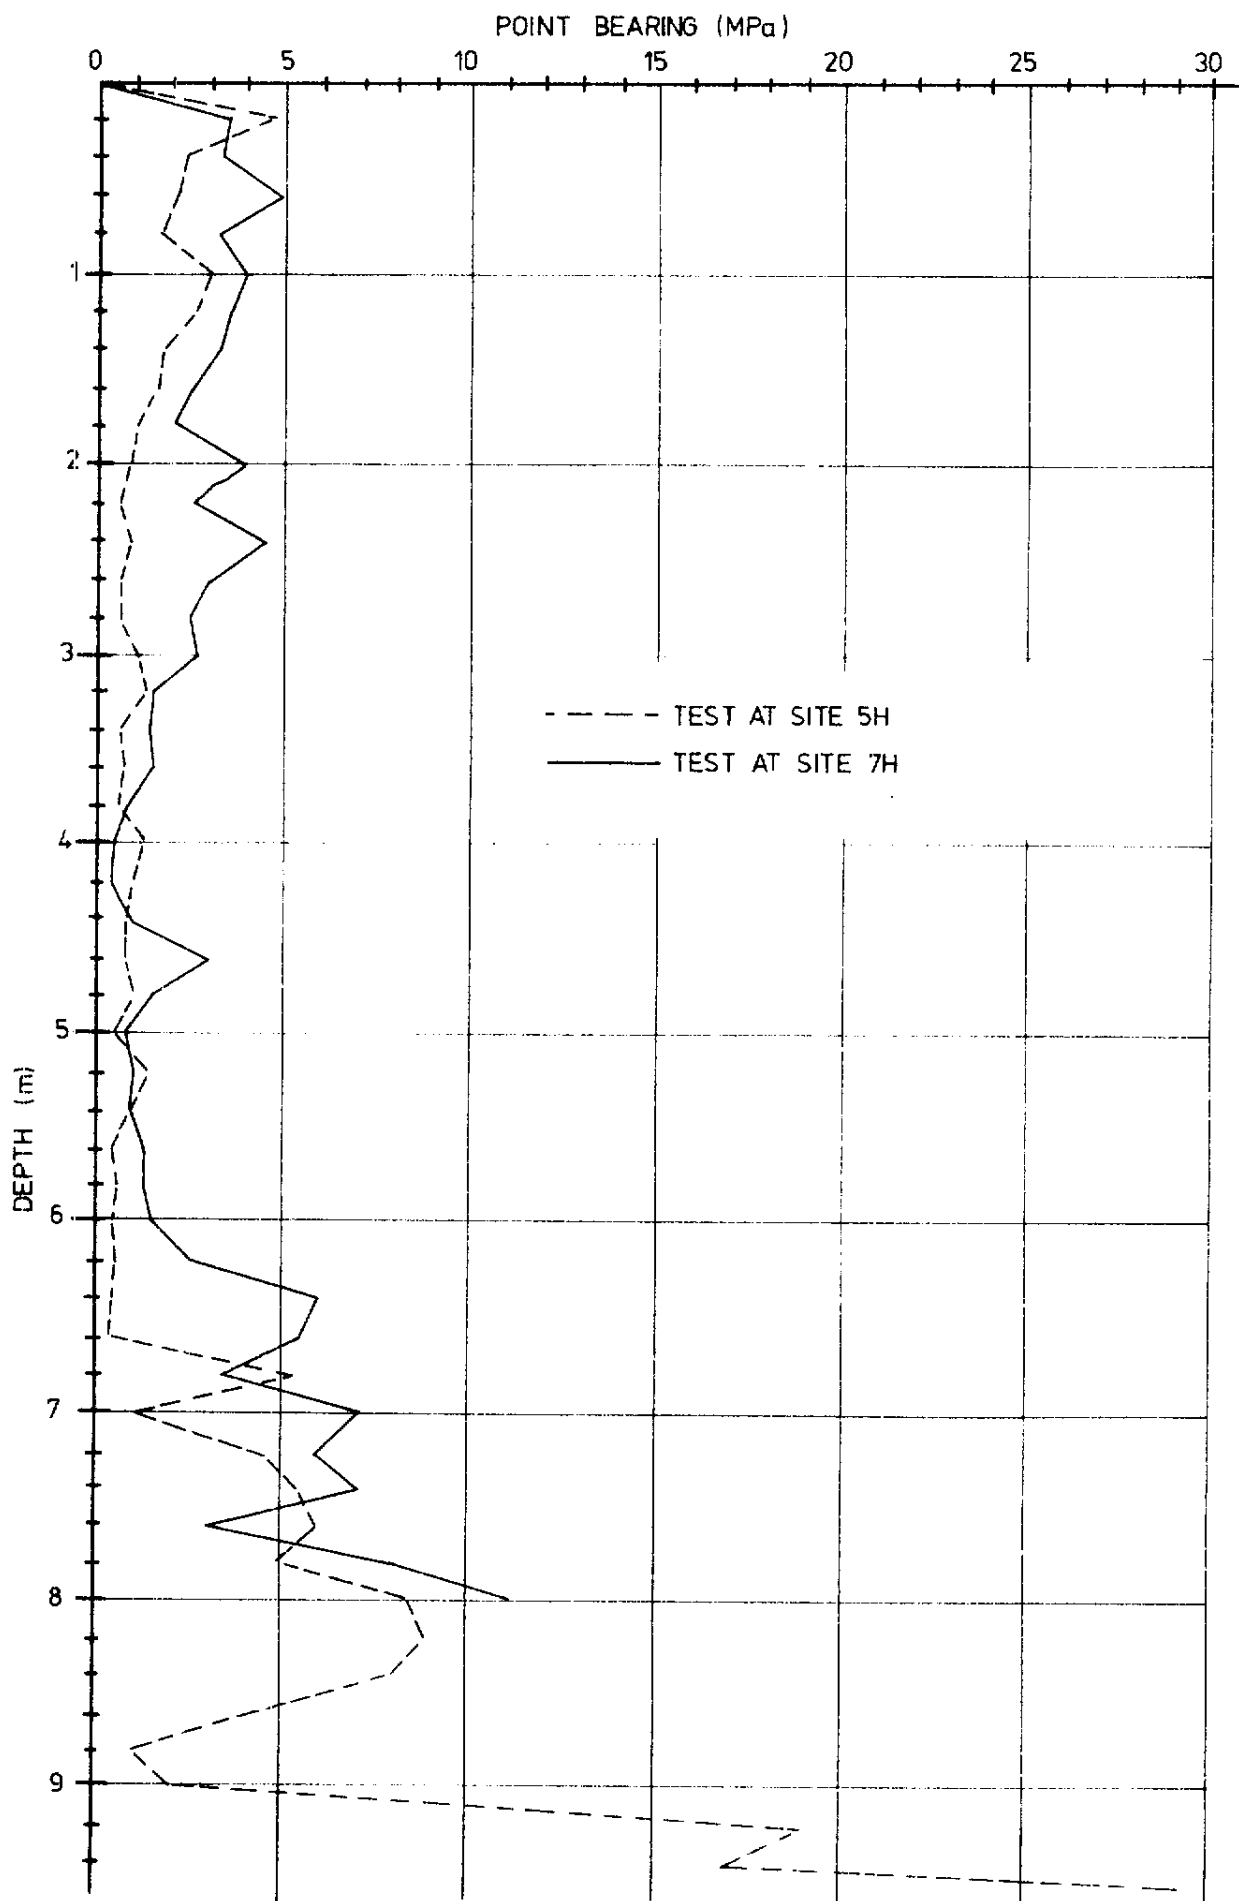
APPENDIX III

Dutch Cone Penetrometer Test Results

The Scala penetrometer results and Dutch Cone penetrometer results indicate that the soils at the site both in natural ground and filled ground have bearing capacities satisfactory for residential structures, provided that foundation bearing pressures do not exceed 50 kPa. This maximum allowable bearing pressure is to allow for weaker soils encountered near the surface at several test locations. Conventional footings for timber framed residential structures would not usually exceed 50 kPa, but if heavier loadings are required, specific site investigations and foundation design will be required.

The Dutch Cone Penetrometer results indicate that the ground beneath the fill at positions 5H and 7H (locations of proposed building platform areas) is hard. The fill material itself is hard near the ground surface, but becomes softer at depth. In view of the length of time that the fill has been in place (about 6 years) and the relatively light loading produced by most residential buildings, it is considered that any further settlement of the ground surface will be inconsequential to the completed structures. However, for any proposed structure which may be particularly susceptible to damage from differential settlement, site-specific investigations would be required to determine settlement characteristics of the soils, and the likely effect on the structure.

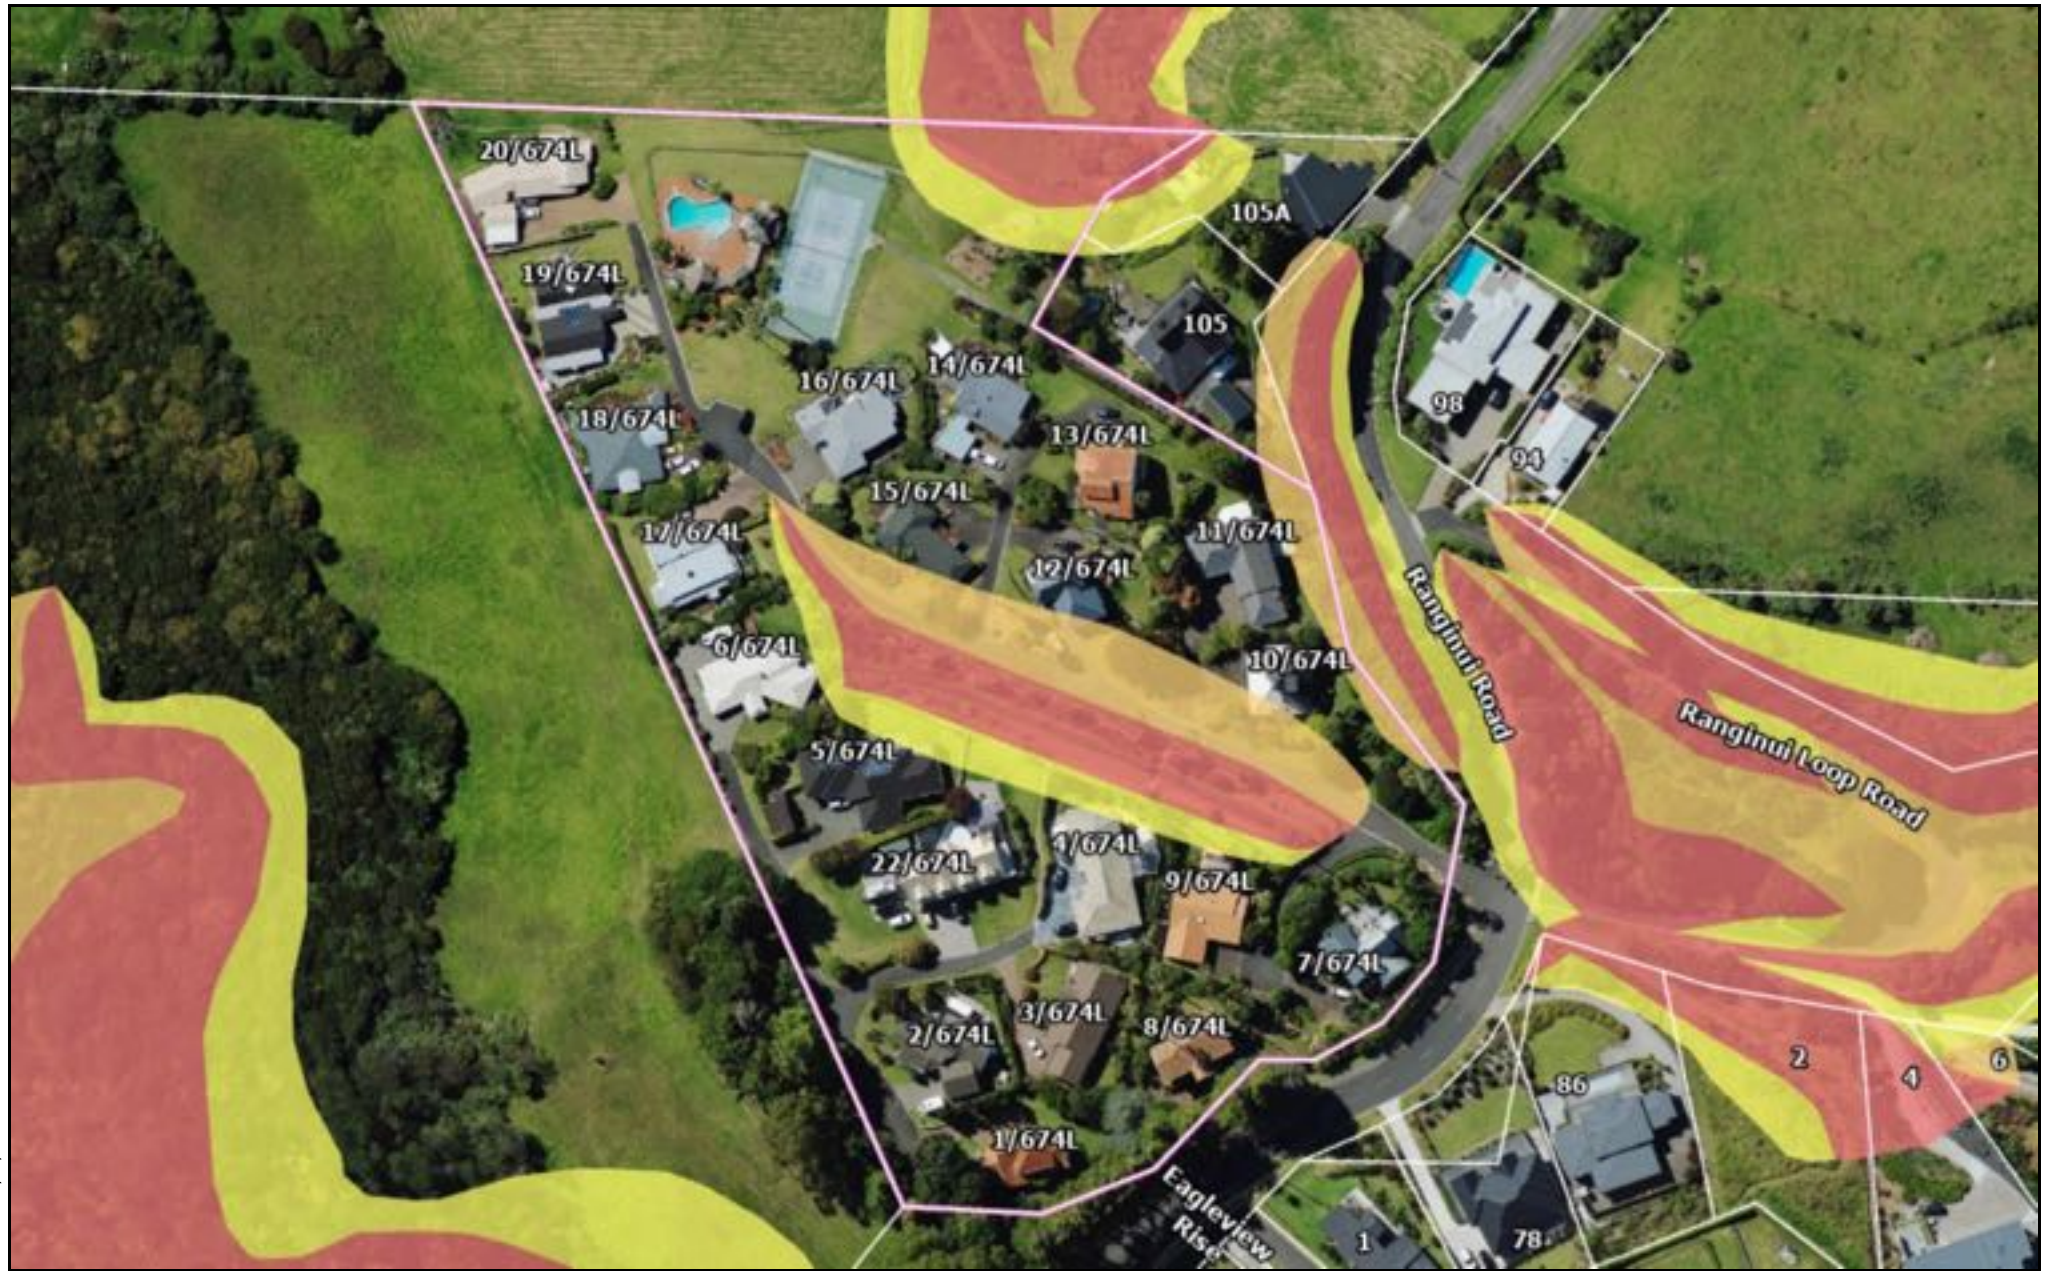
## Slope Hazard Zones Plan

## Slope Hazard Zones

Failure Zone 2:1
