**9 AUGUSTA RISE CENTRAL**

# Land Information Memorandum

**Barrett Homes  
Stage 1 Residential Subdivision  
27 Kayelene Place, Omokoroa**

**Geotechnical Completion Report**

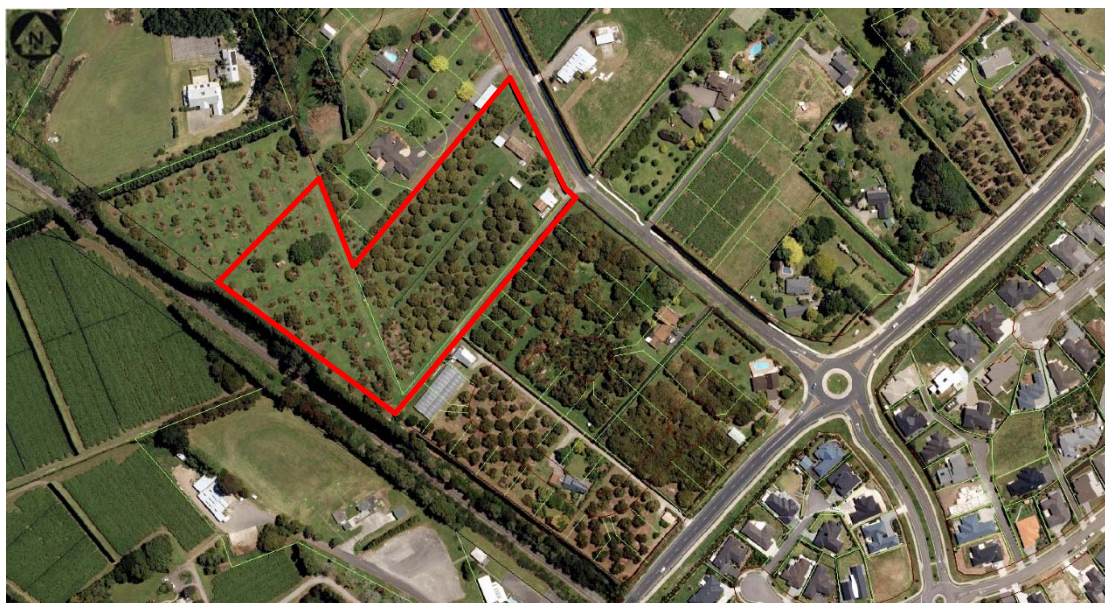
Figure 1: Site Location

The site is located at 19 and 27 Kayelene Place, Omokoroa, as shown on Figure 1 below, legally described as Lot 1 DP 29449 and Lot 2 DP 522664. The site is an 'L shaped' residential zoned property that is approximately 2.14 ha. The site previously had a dwelling at the front of the section with the land primarily being used for an avocado orchard.

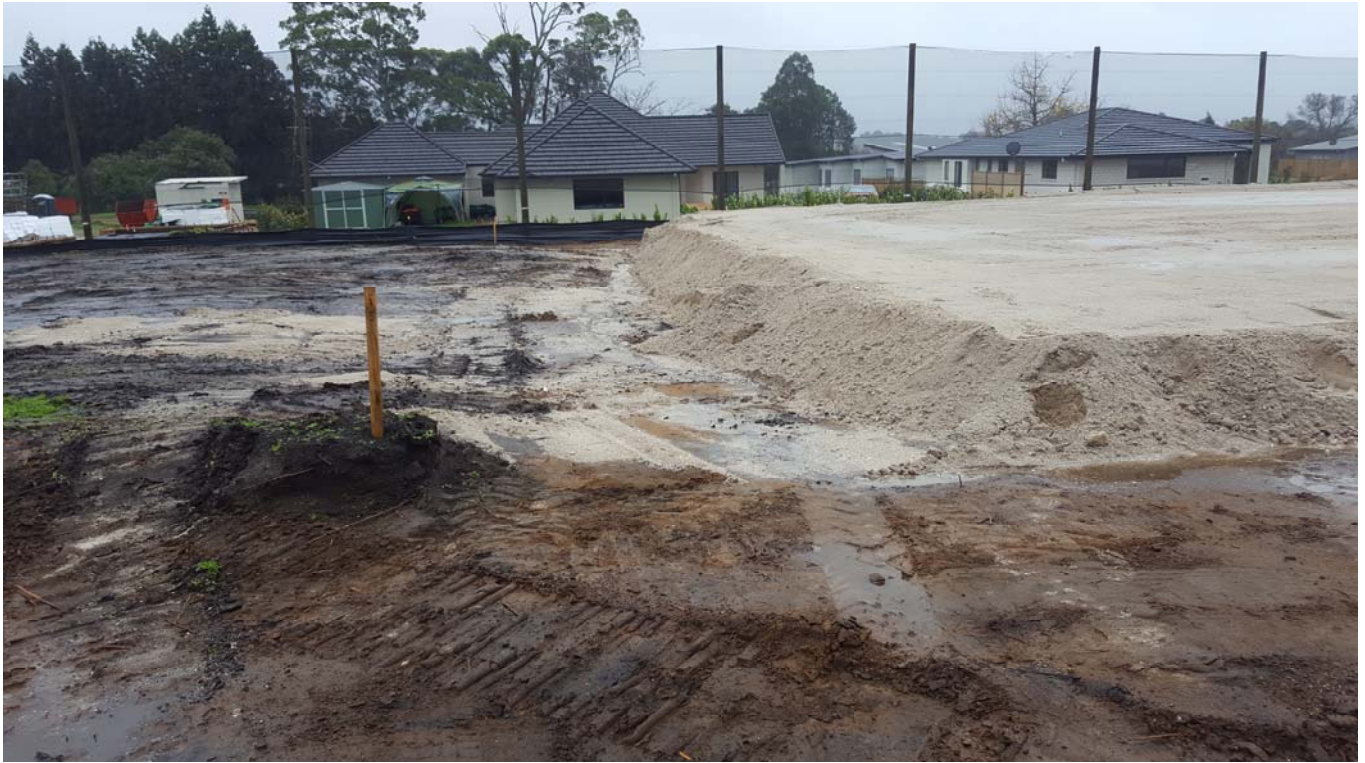
**Figure 1: Stake showing boundary for lots 6/7. Photo facing north west.**

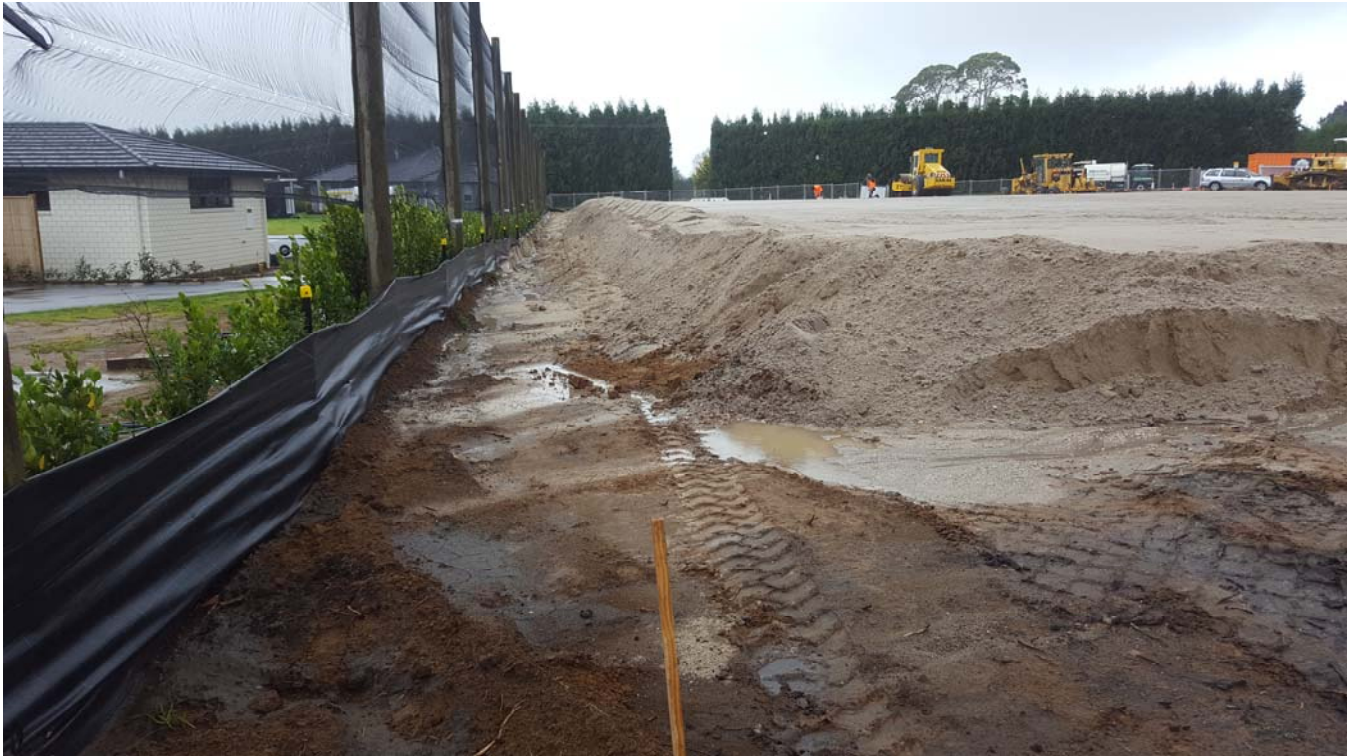
**Figure 3: Battered fill behind lots 1 - 6. Photo facing north east.**

Lots 1 to 11 and Lots 30 to 33 required filling up to 1.7m. These lots were inspected prior to any fill being placed to confirm a suitable level of root mass was observed with areas with large root mass percentages being required to undercut further. The fill within Lots 1 to 11 was compacted behind a 1.5m high retaining wall which was constructed on the north-western boundary of these lots.

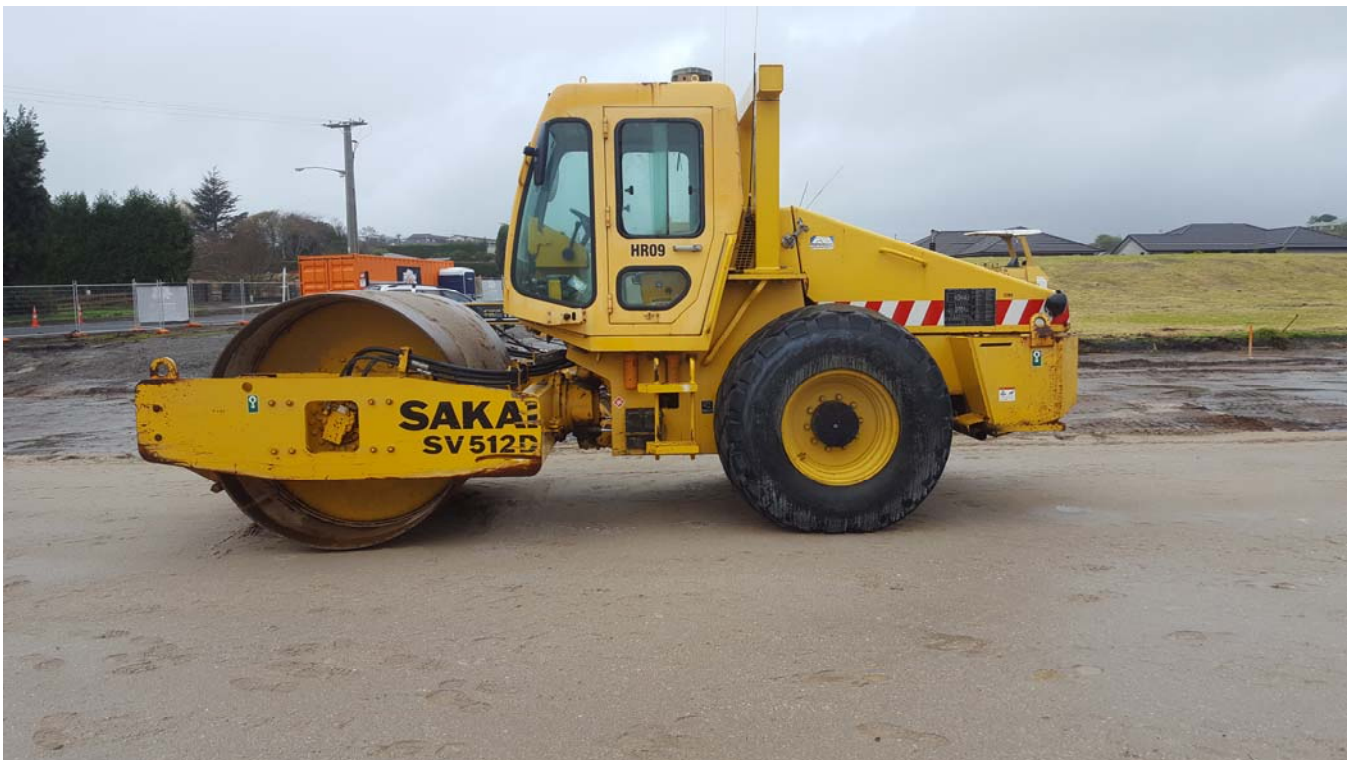
**Figure 4: 10T roller used.**

All fill material was placed in loose lifts up to 0.3 metres thick with cohesive fill being compacted using a sheep-foot vibrating roller, whereas granular fill was compacted using a smooth barrel roller. The filling operation was monitored by Stratum.

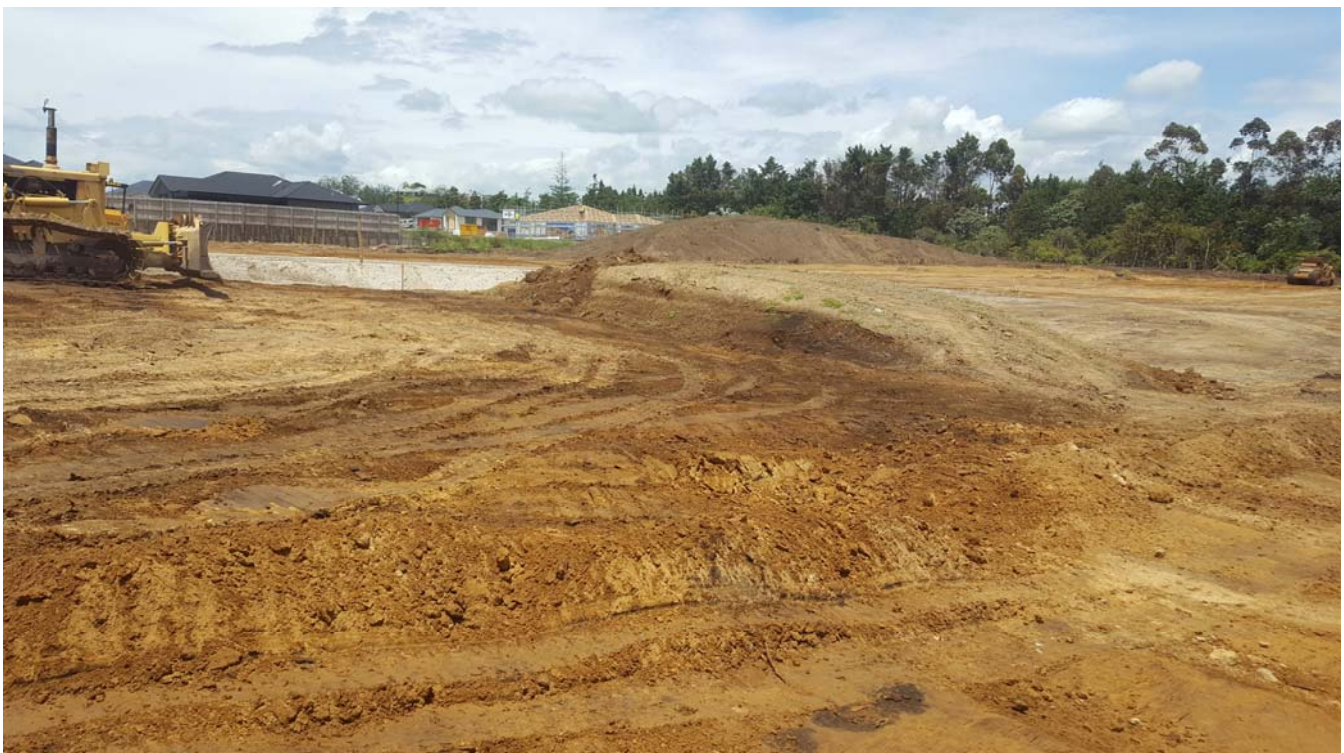
**Figure 2: Photo taken facing south. Stockpile in photo fell within Lot 9 and was removed after photo was taken to confirm no topsoil was underlying it.**

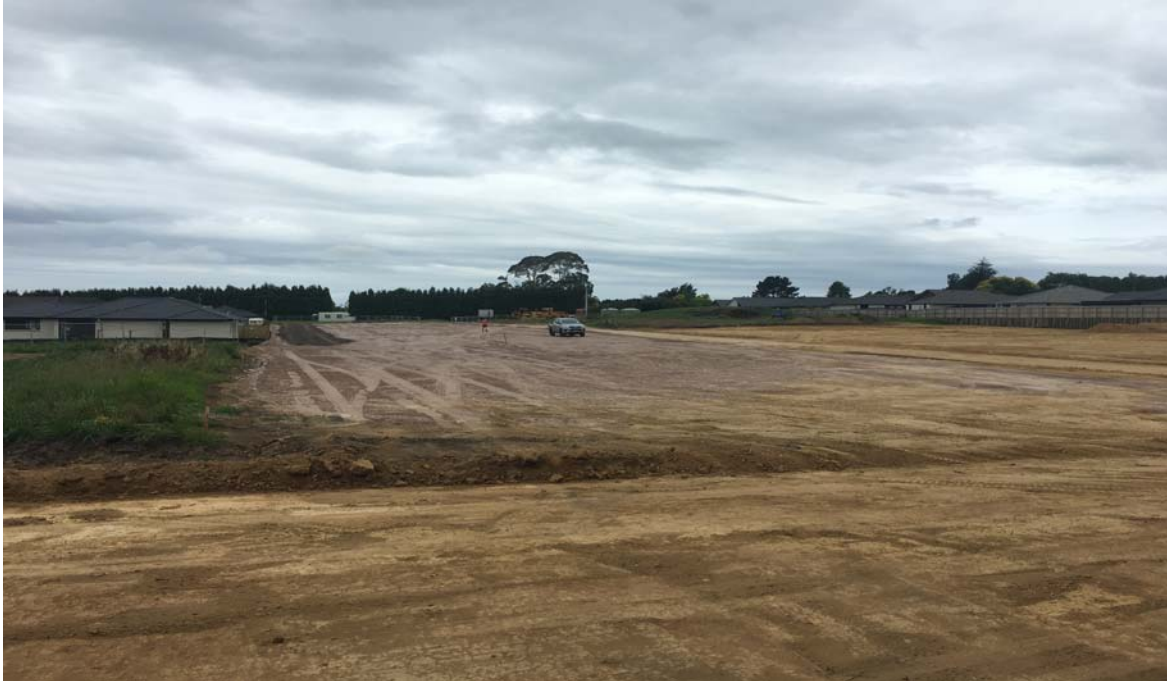
**Figure 1: Photo showing extent of fill Photo facing north.**
