# Residential Pre-Sale Building & Pest Report

**42 Bouganvillea Dr Middle Ridge QLD 4350**

Report prepared: 02/09/2025

## PRE-PURCHASE INSPECTION RESIDENTIAL BUILDING REPORT

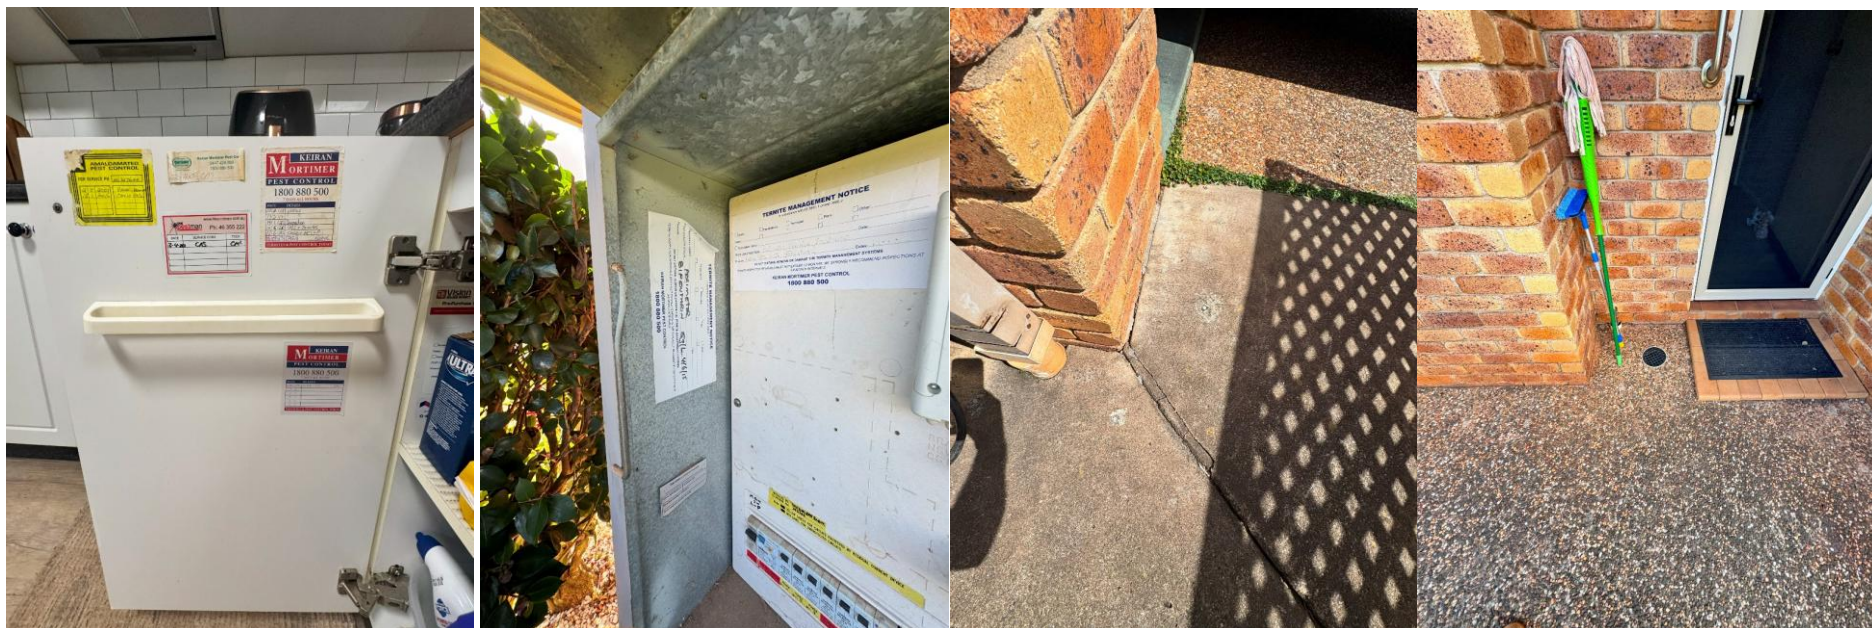
Was evidence of a possible previous termite management program found? Yes, annual chemical treatment has been observed and perimeter subterranean treatment completed
