# Property and Timber Pest Report

Inspection Date: 11 Sep 2025

Property Address: 129 Fuller Street Lutwyche 4030

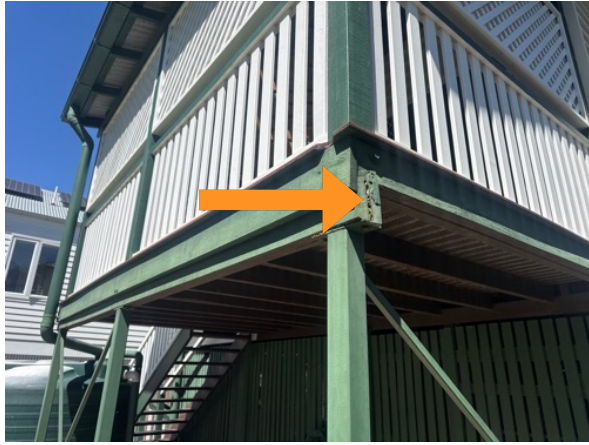
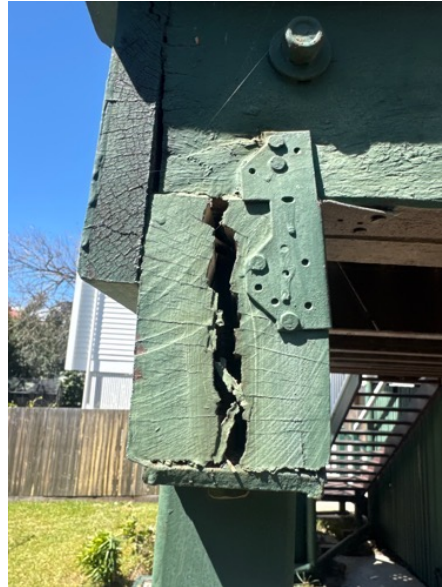
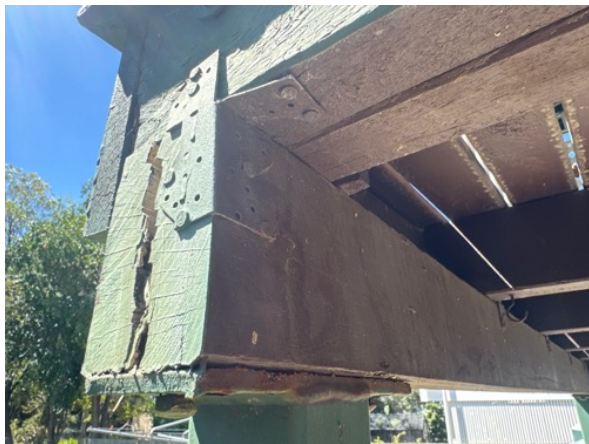
### Minor Defect 2.01

**Finding:** Ends of deck floor bearer are split.  
Timber is solid.

Recommend filling and painting ends to reduce risk of rot, seal and preserve timber.

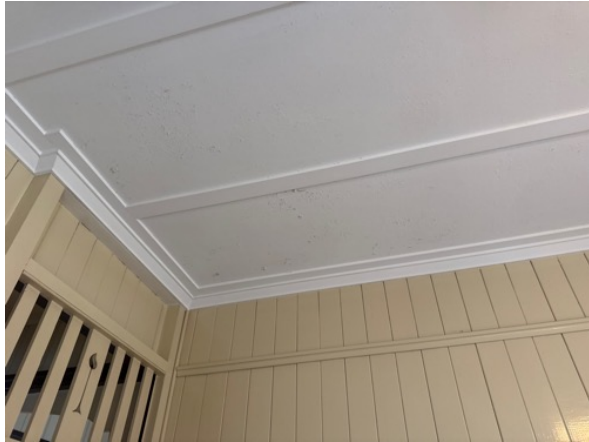
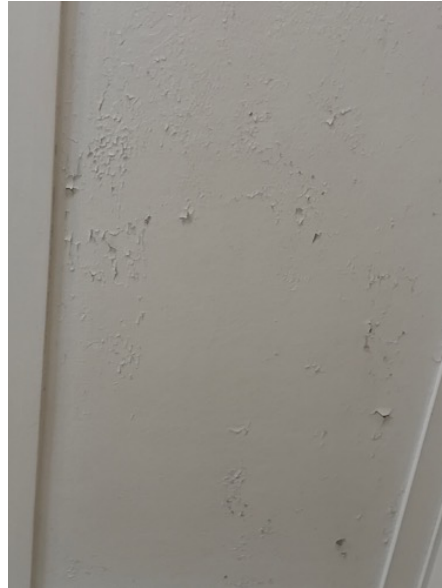
## Minor Defect 2.02

Appears to be poor surface preparation due to nature and pattern of flakes and detachment.

No elevated moisture readings detected.

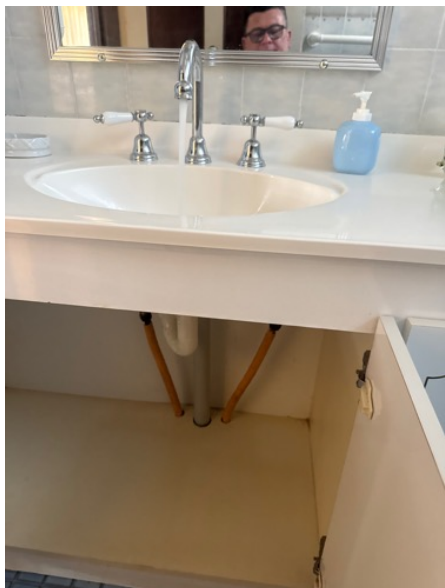
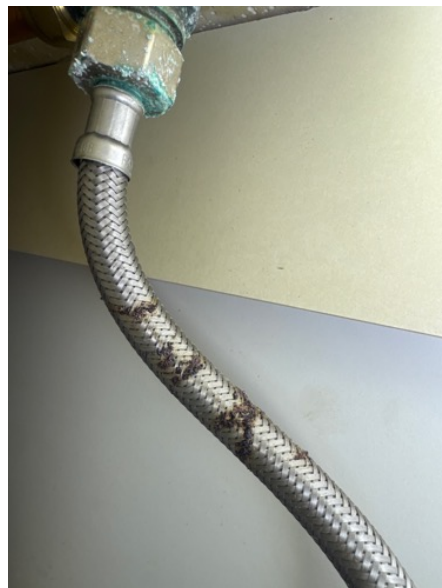
## Minor Defect 2.03

| Bathroom | Vanity flexi hose displays minor corrosion. |

Ruptured flexi hoses can cause significant and widespread damage.

Whilst listed as a Minor Defect currently, replacement recommended of both hoses to reduce risk of rupture and resultant water damage.

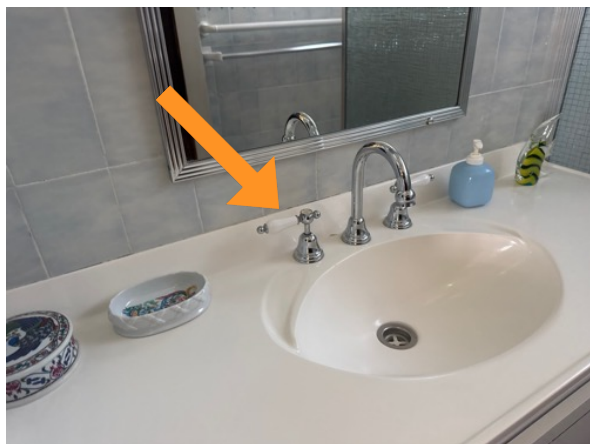
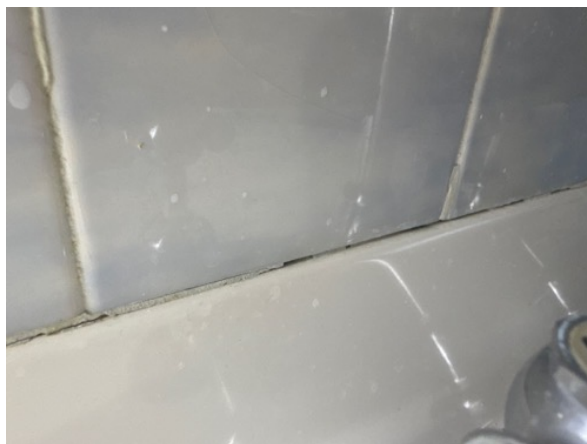
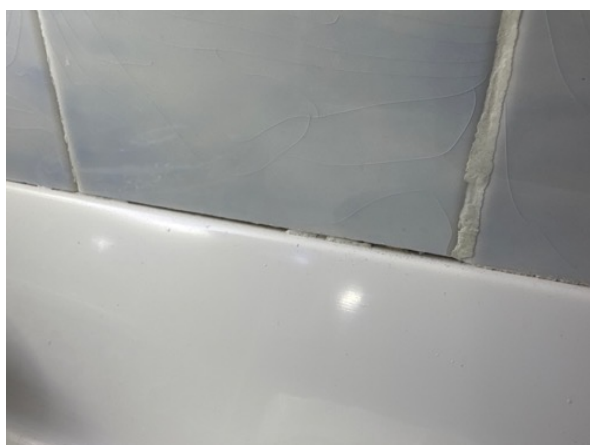
## Minor Defect 2.04

This inadequate seal may allow splashed and spilled water to breach the surface junction and seep behind cabinet/bench top and cause water damage, hold water and promote mould growth.

Replacement of silicon recommended to ensure wet areas are well sealed and to maintain structure, health and amenity.

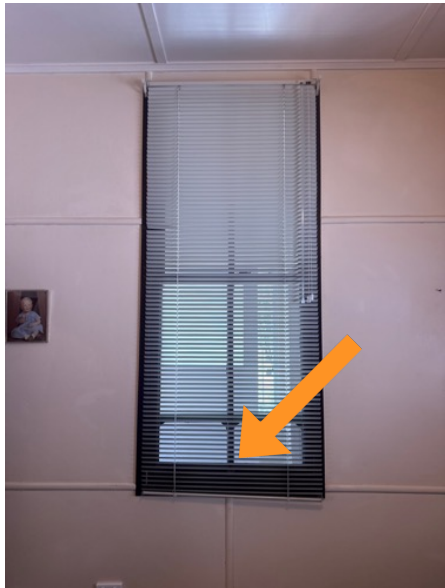
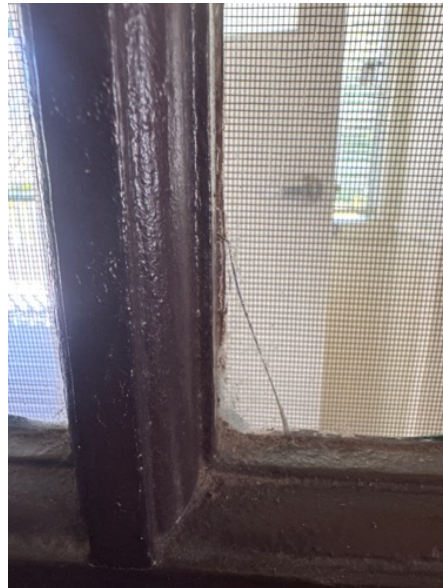
**Location:** Bedroom 3

| Bedroom 3 | Cracked window pane. |

**Finding:** Cracked window pane.  
Whilst minor, replacement is recommended.

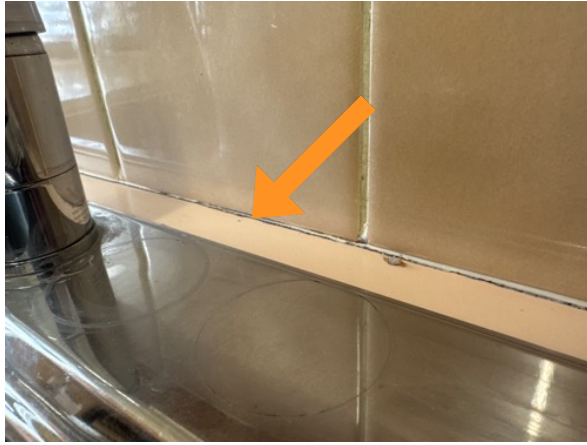
## Minor Defect 2.07

This inadequate seal may allow splashed and spilled water to breach the surface junction and seep behind cabinet/bench top and cause water damage, hold water and promote mould growth.

Replacement of silicon recommended to ensure wet areas are well sealed and to maintain structure, health and amenity.

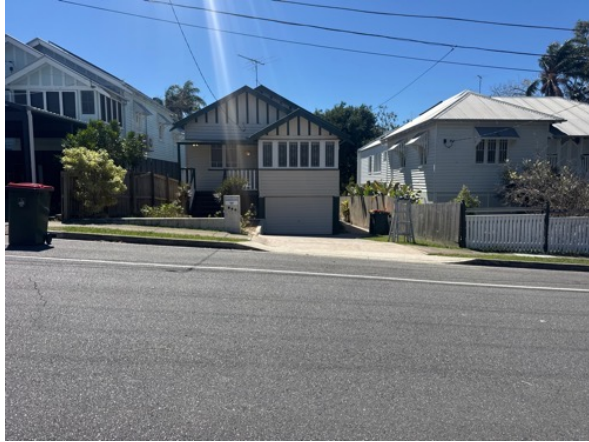
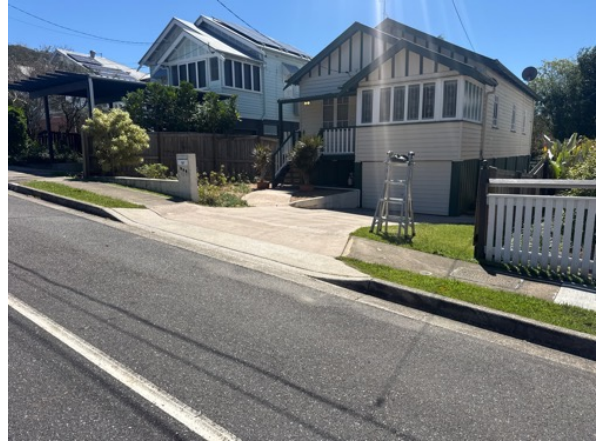
**Location:** The Site

**Finding:** Property is located below street level on gently sloping land.

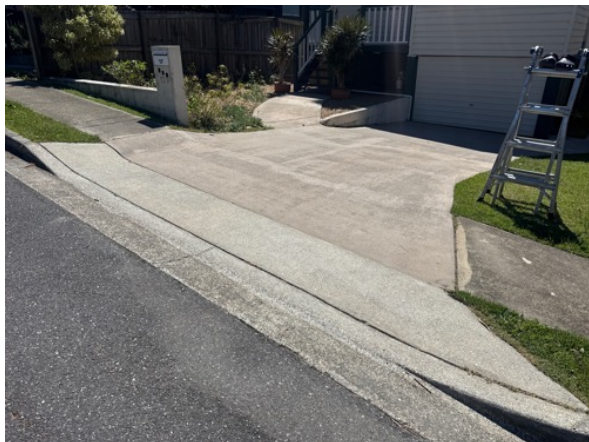
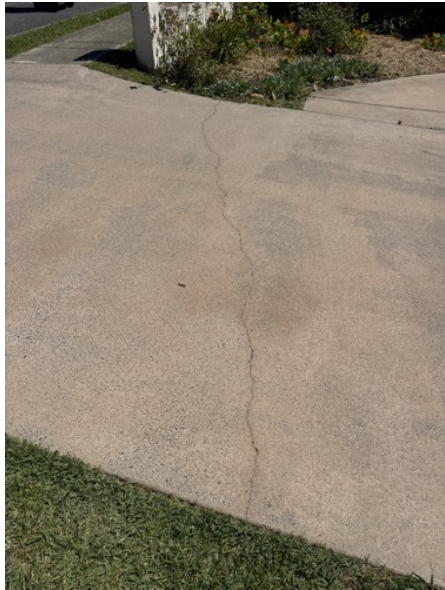
## For your information 3.02

**Finding:** Concrete driveway is in good condition.

Some minor cracks noted- driveways and pavement are non-structural installations and minor cracking is common.

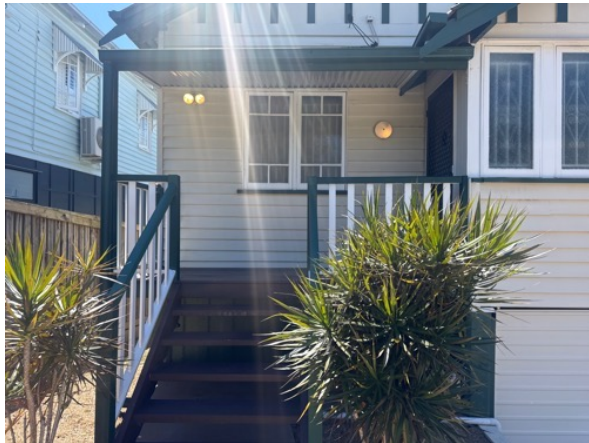
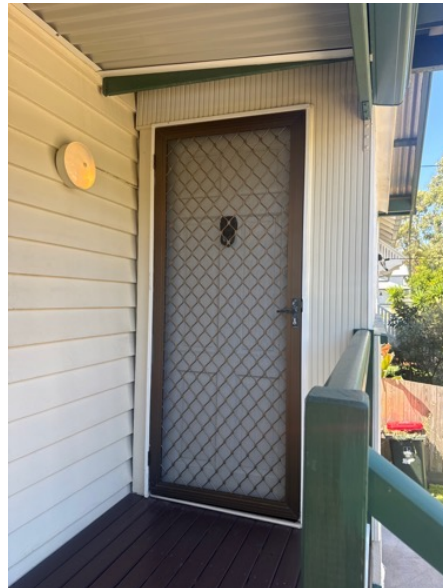
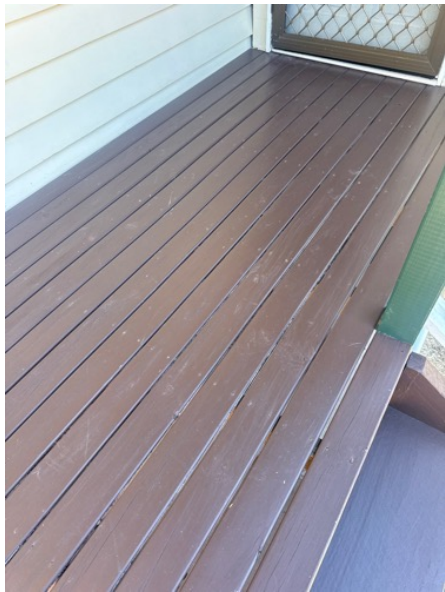
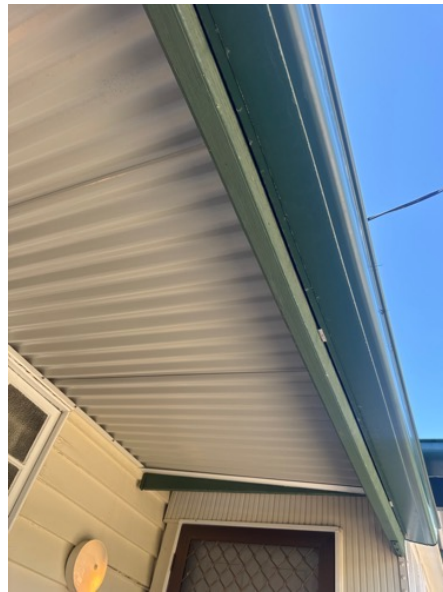
### For your information 3.03

**Finding:** Entry presents in good condition with roof extending over.

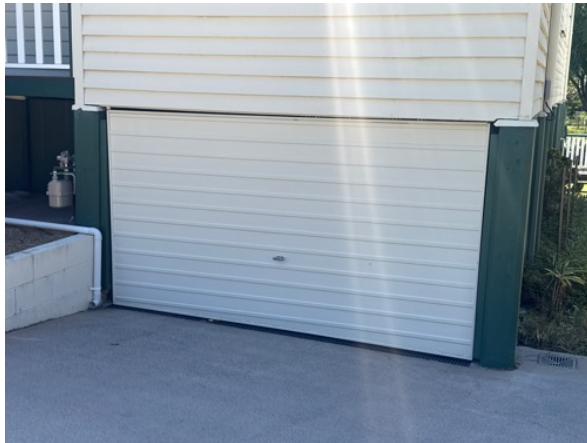
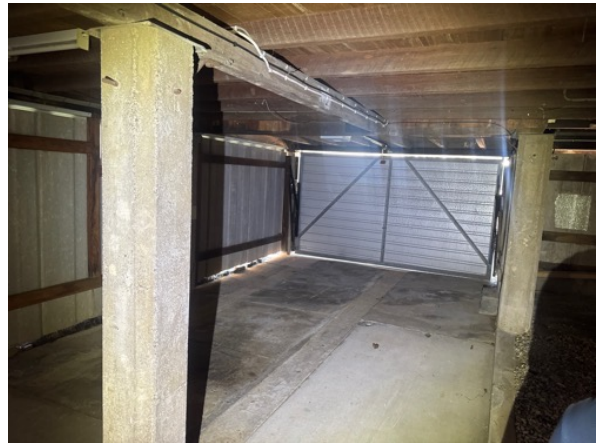
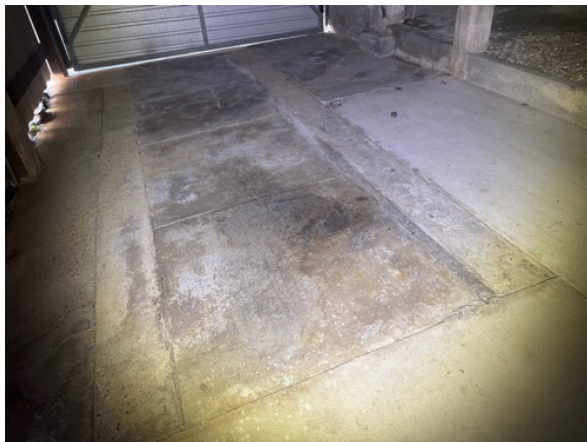
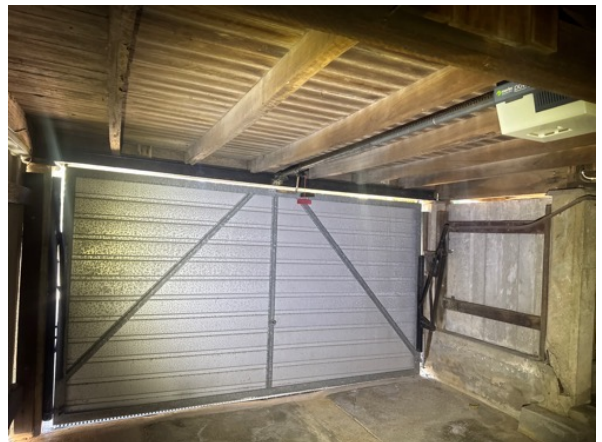
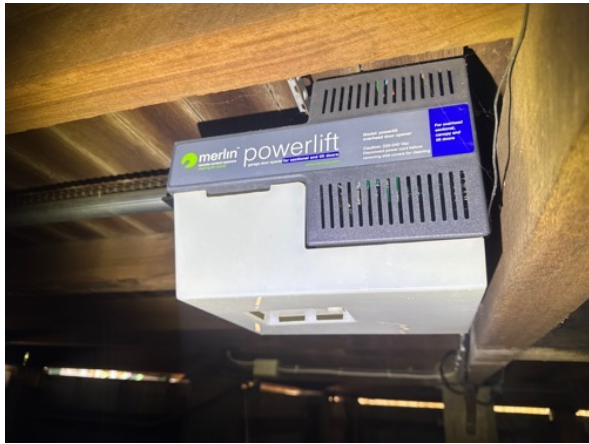
### For your information 3.04

**Finding:** Garage appears in good condition with functional remote door.

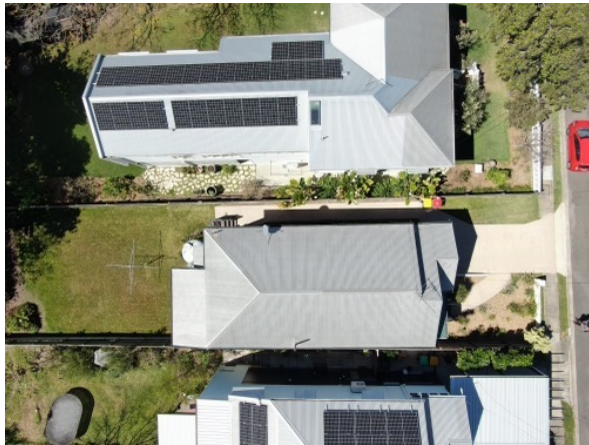
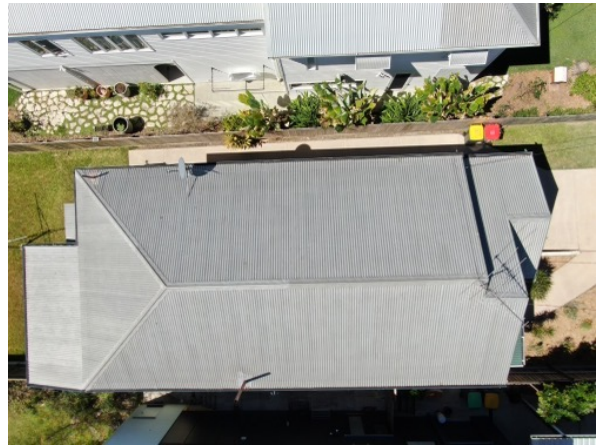
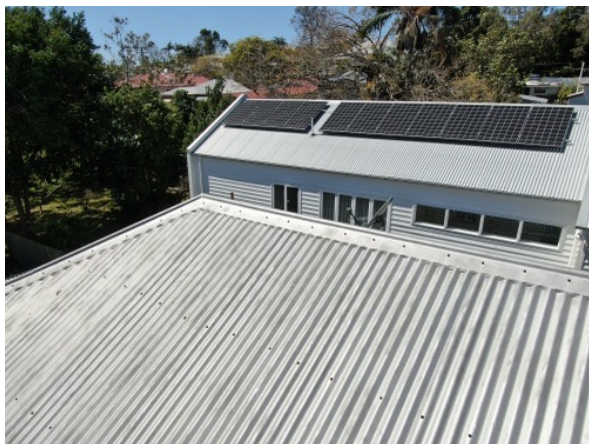
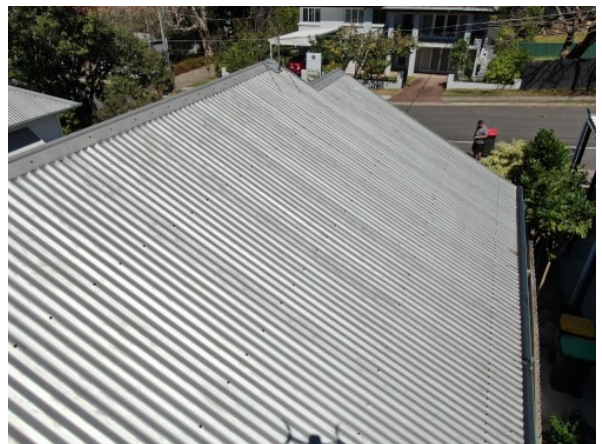
## For your information 3.05

**Finding:** Roof exterior (sheet metal) appears in good condition.  
Corrugated profile.

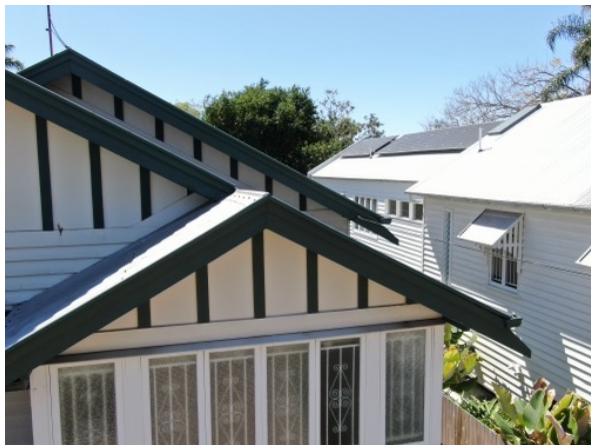
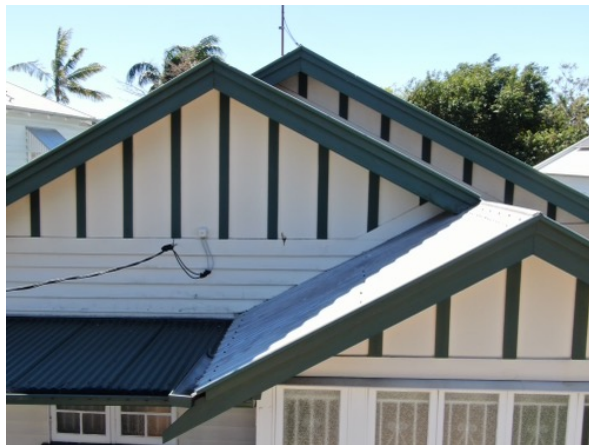
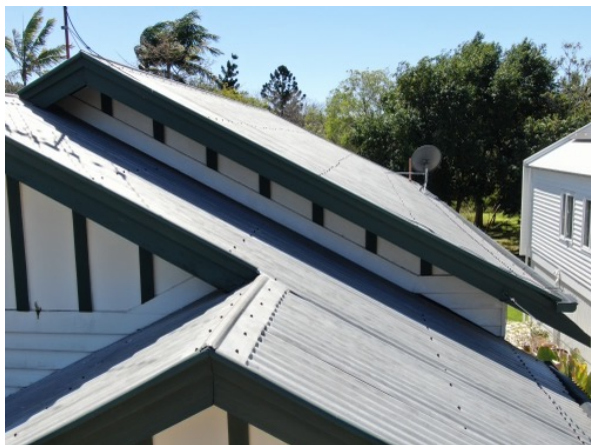
## For your information 3.06

**Finding:** Gables appear in good condition.

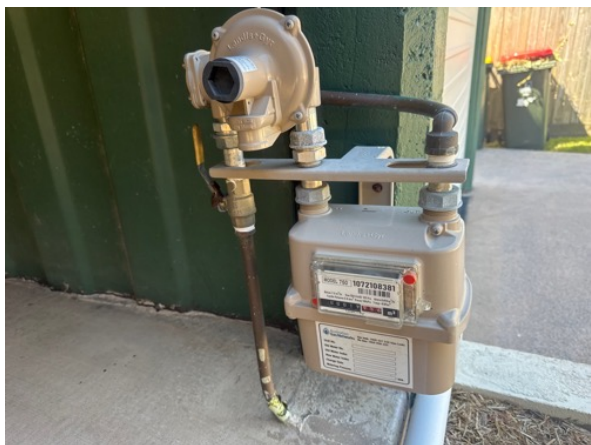
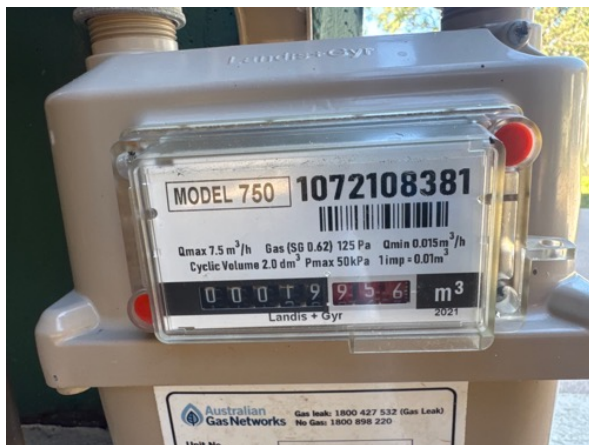
## For your information 3.07

**Finding:** Mains gas supplies cooktop.

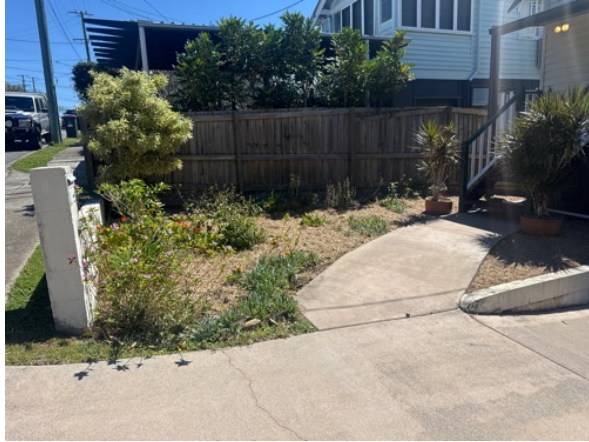
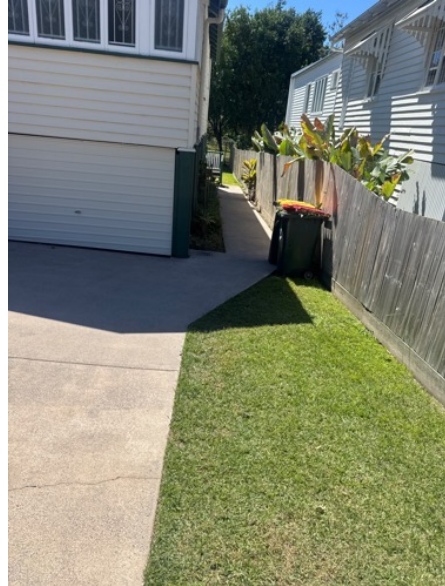
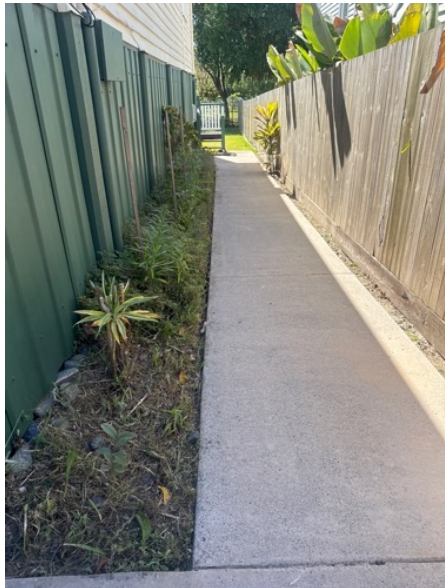
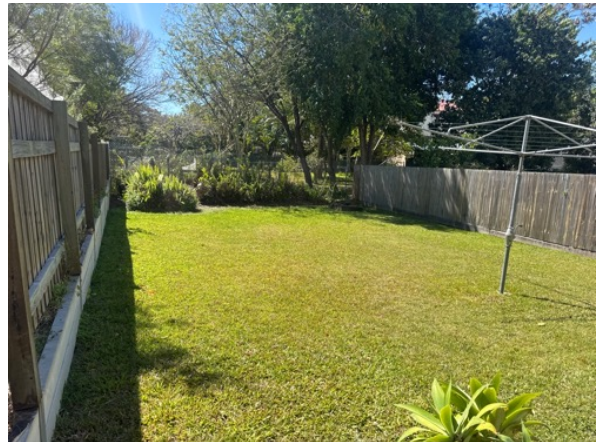
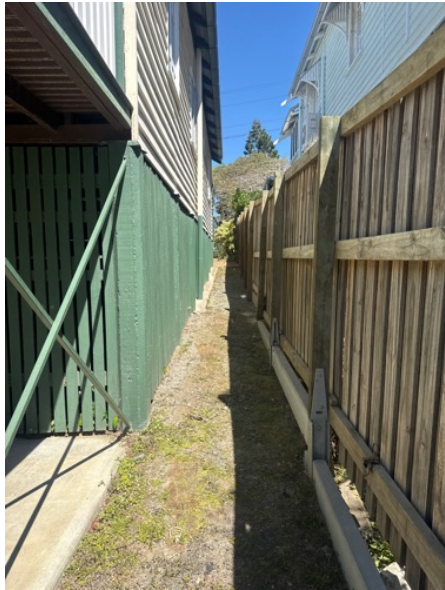
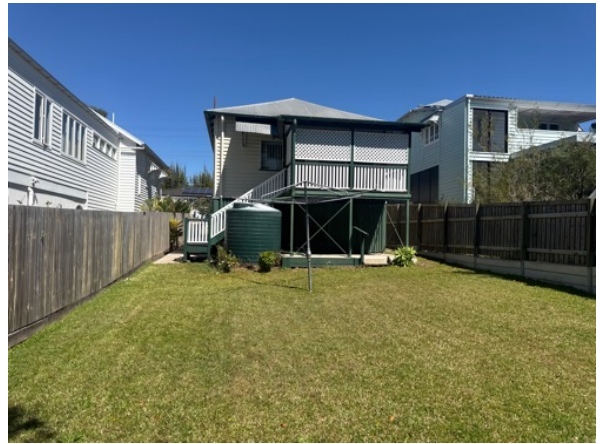
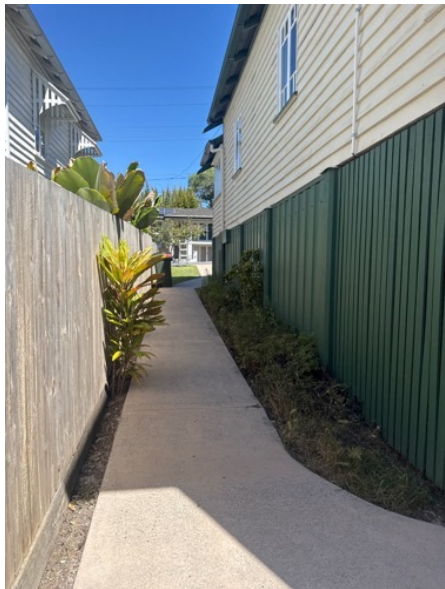
## For your information 3.08

**Finding:** Grounds are landscaped with established gardens in good tidy condition.  
Lawn and gardens are maintained.

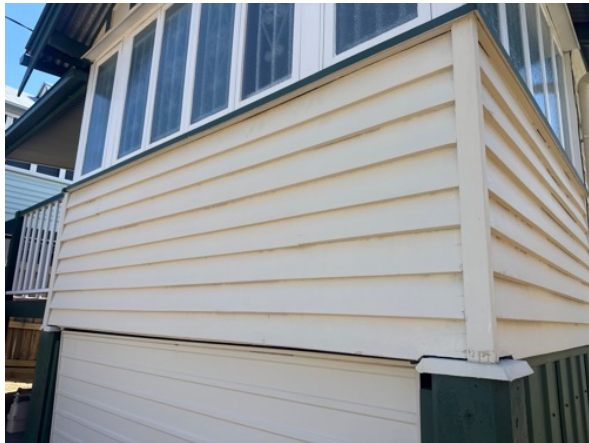
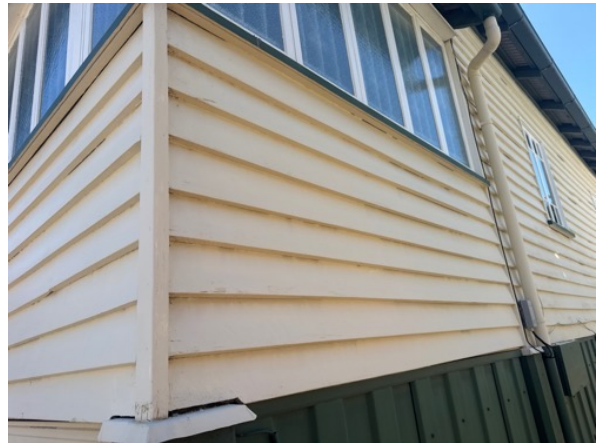
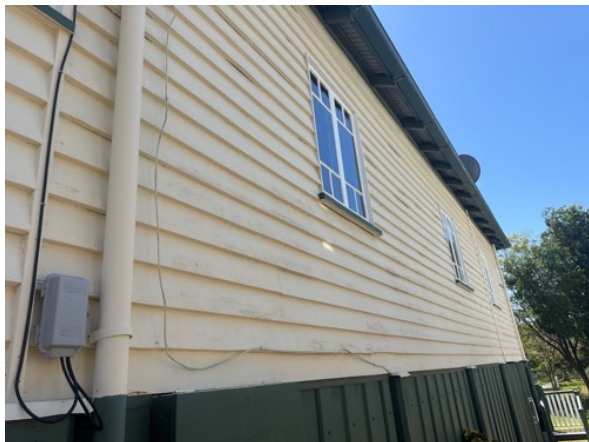
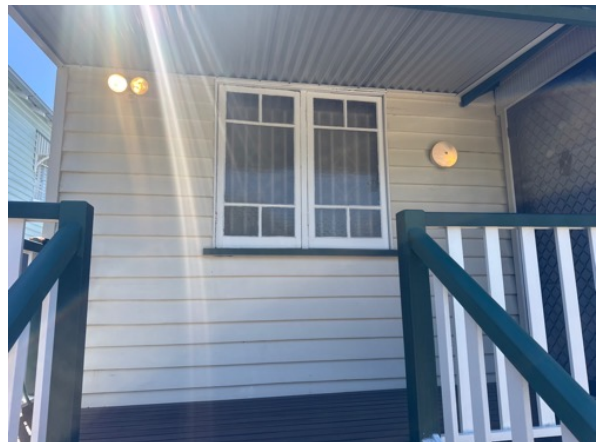
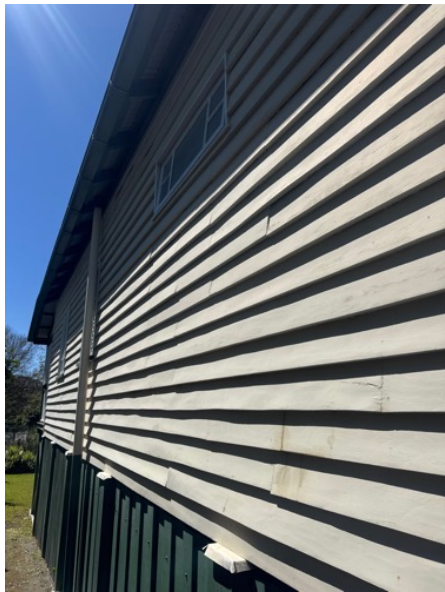
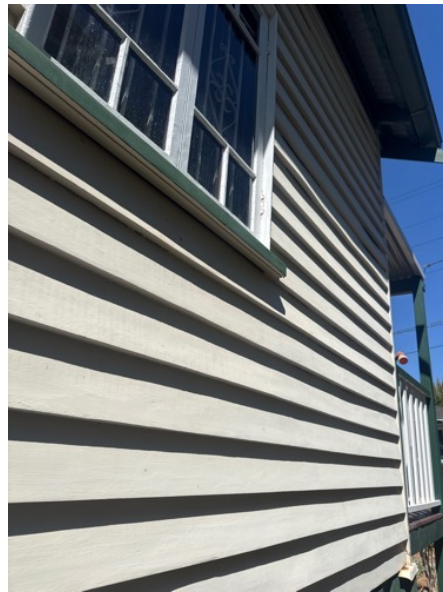
**Finding:** Timber weatherboard cladding appears in good condition and well sealed.

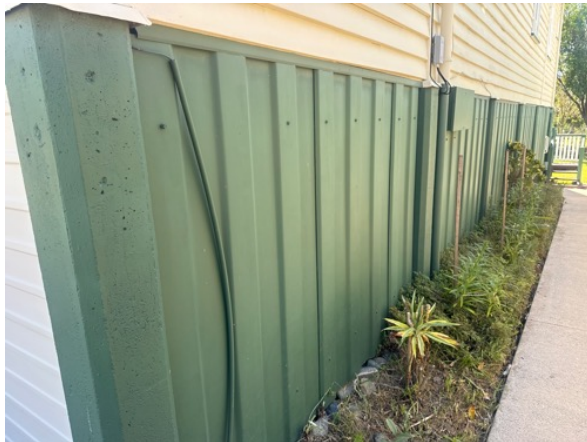
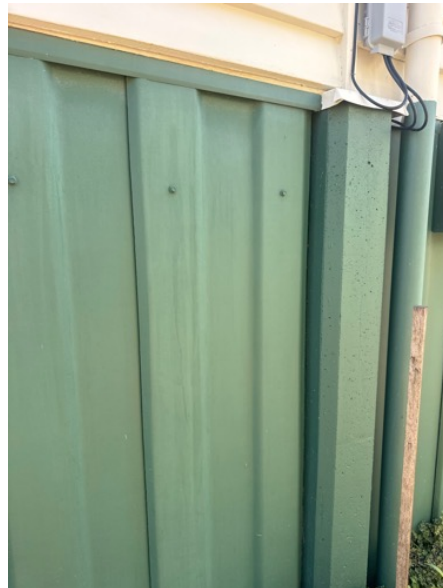
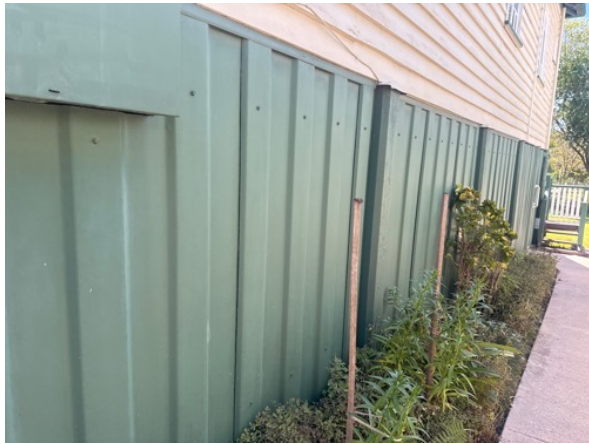
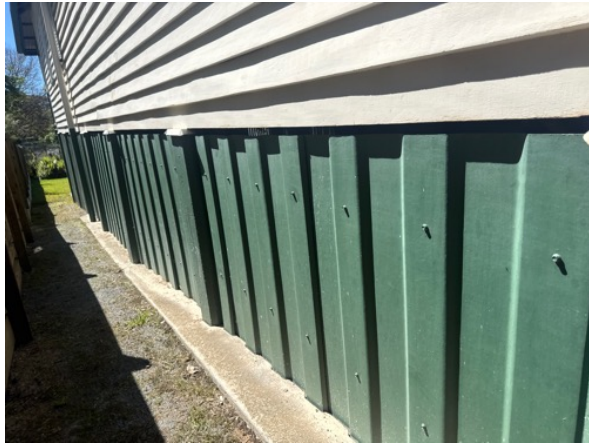
### For your information 3.11

**Finding:** Fibre cement cladding appears in good condition and well sealed with paint.

Asbestos is likely present internally and externally due to vintage and visual indicators. A QBCC Licenced Asbestos professional should provide further advice prior to any building works or modifications are undertaken.  
No cracked or broken sheets observed.

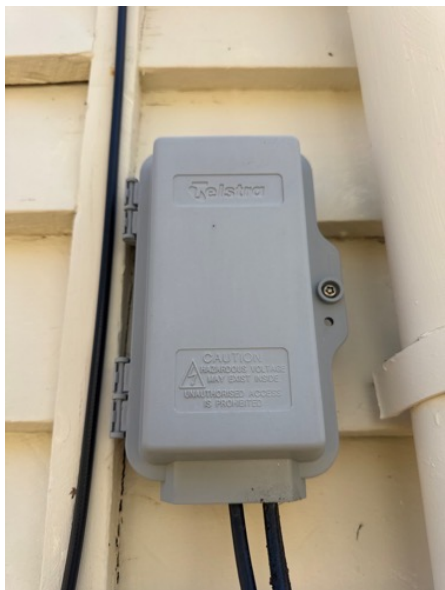
## For your information 3.12

**Finding:** Data installed to property.  
Not confirmed to be NBN and not tested for function.

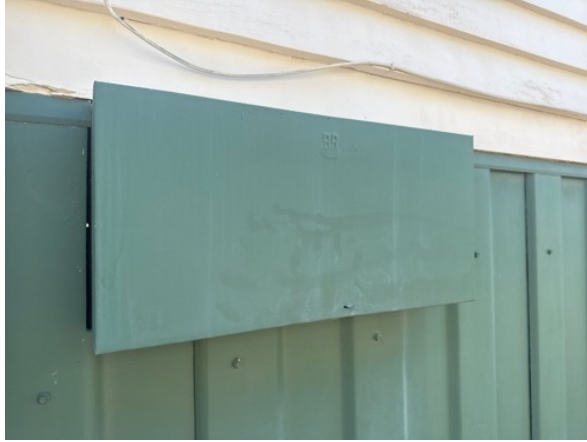
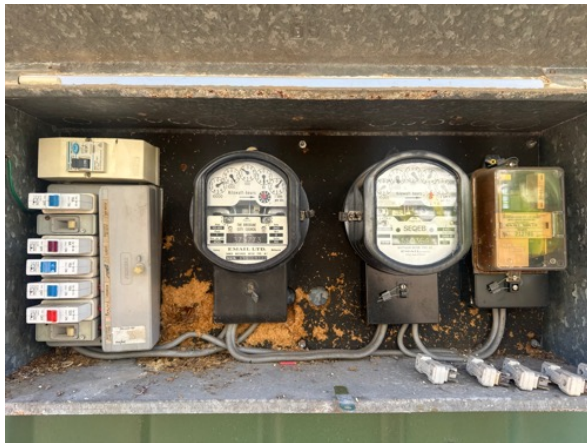
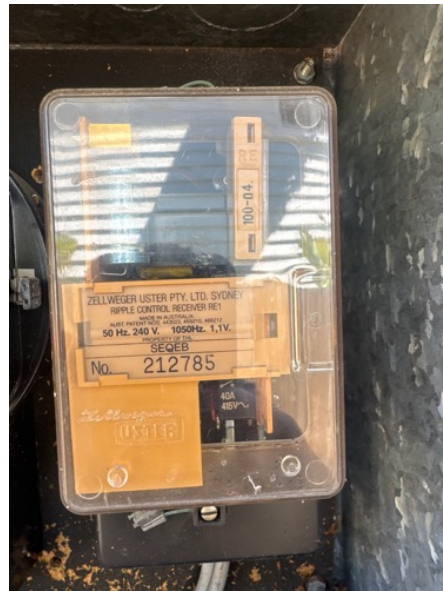
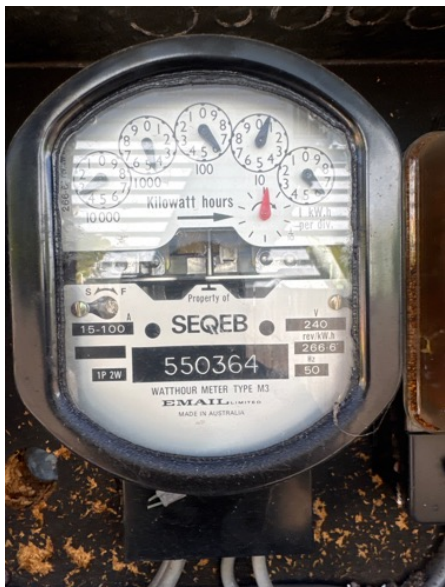
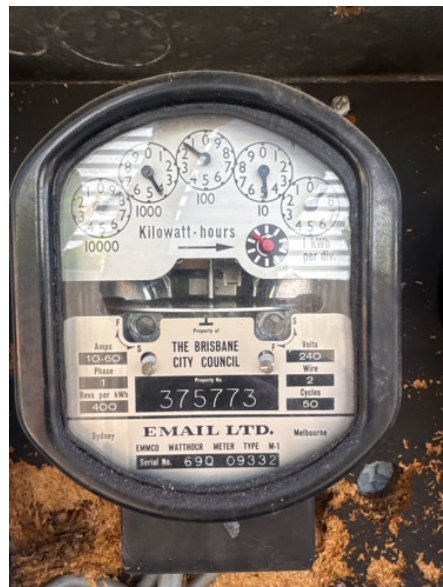
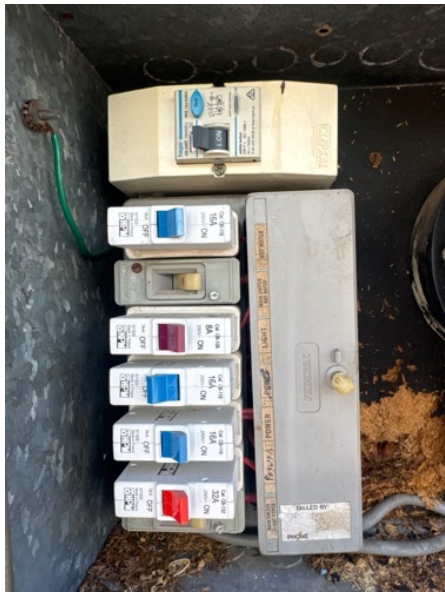
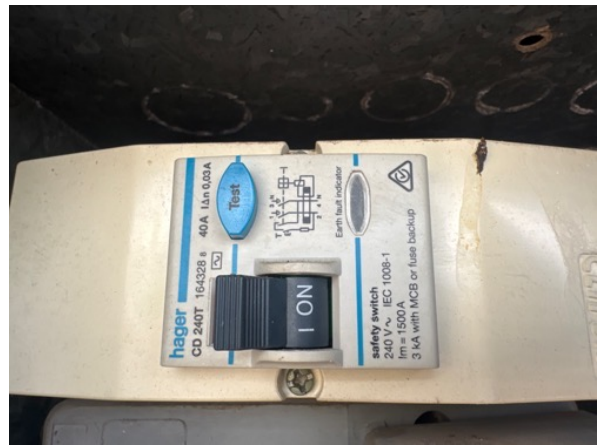
## For your information 3.13

**Finding:** RCD (Electrical safety switch) installed to power circuits.

A Licenced Electrician is recommended to test all circuits to confirm compliance and safety as outside scope of Building Inspector.

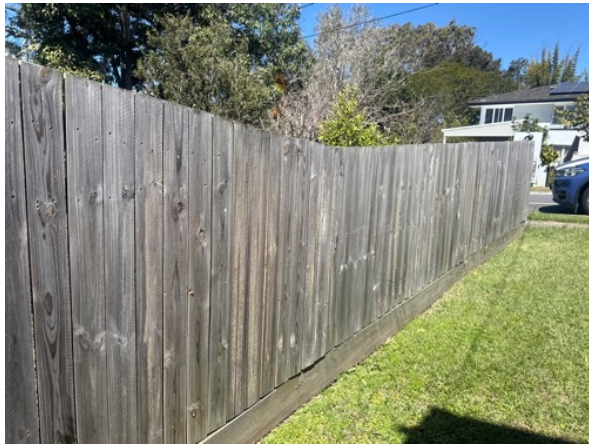
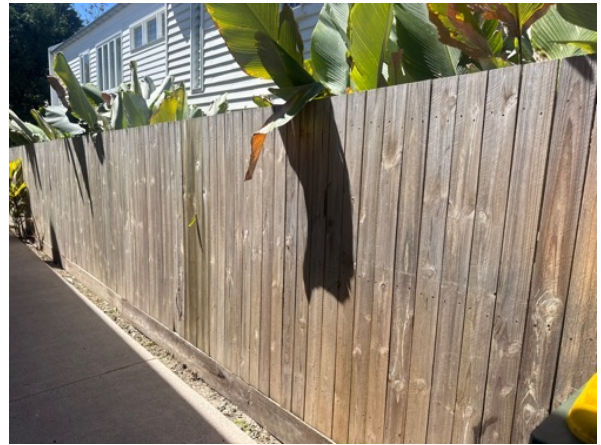
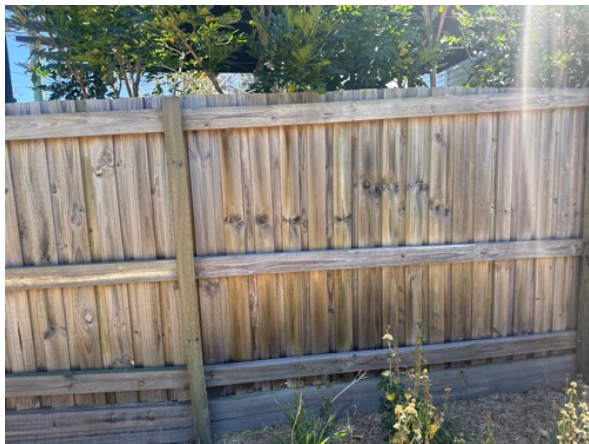
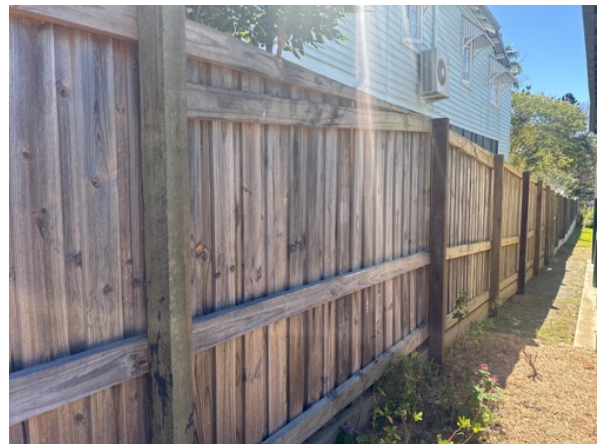
**Location:** Fences

**Finding:** Timber fences appear in good condition.

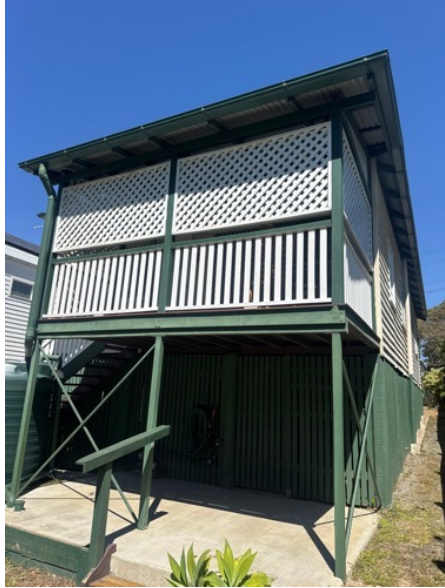
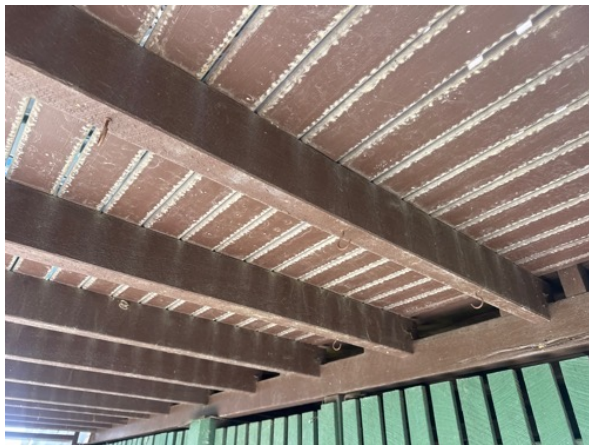
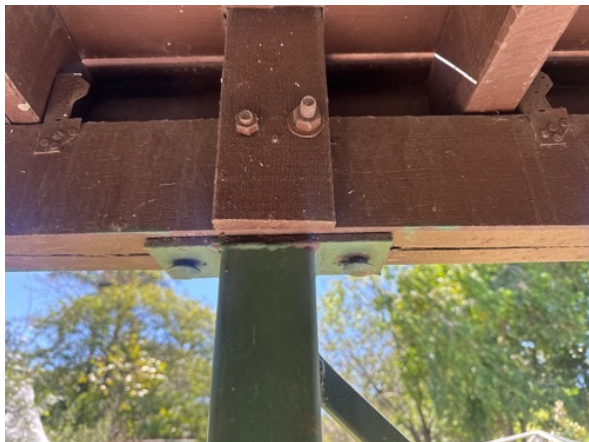
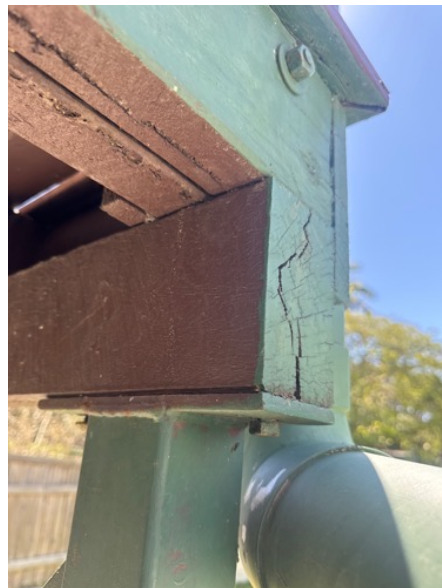
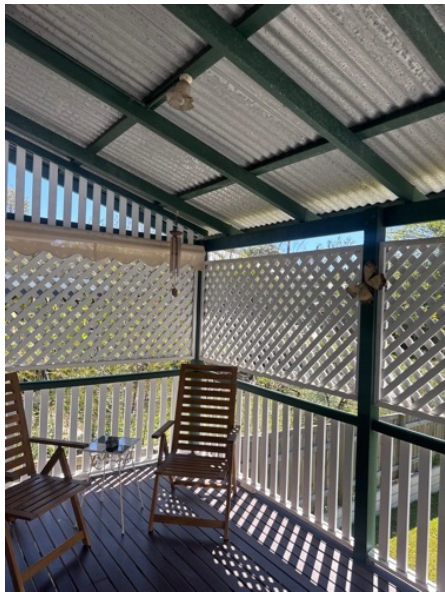
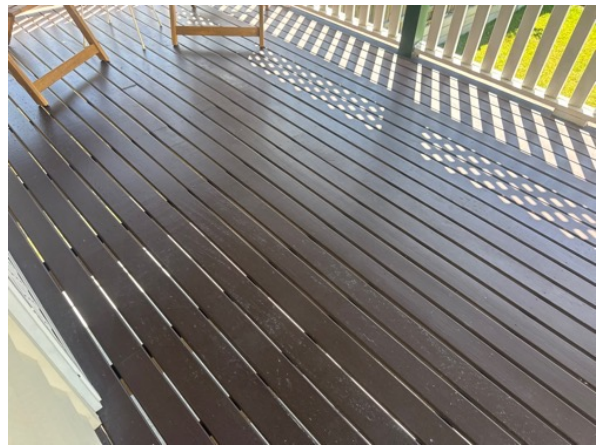
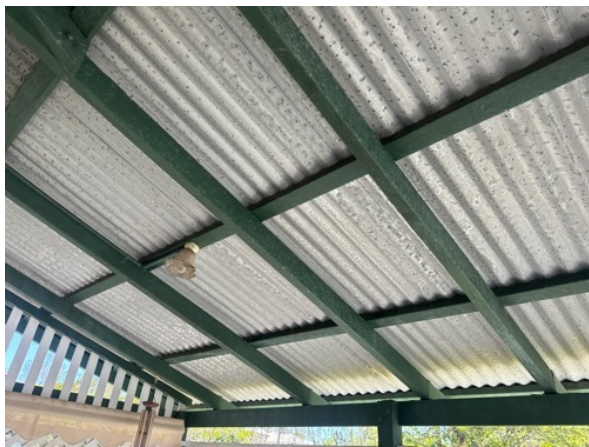
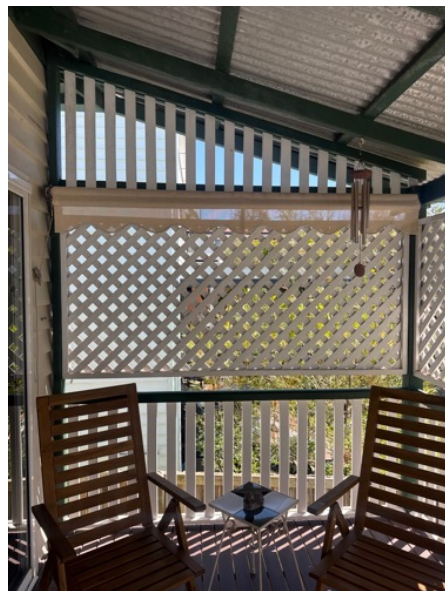
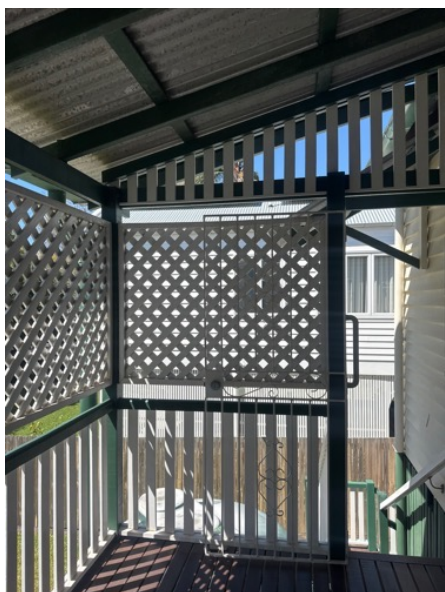
**Location:** Deck

**Finding:** Deck is timber structure with hardwood sub floor and decking.  
Presents in good condition.

Ensure external timber is well sealed to preserve timber.

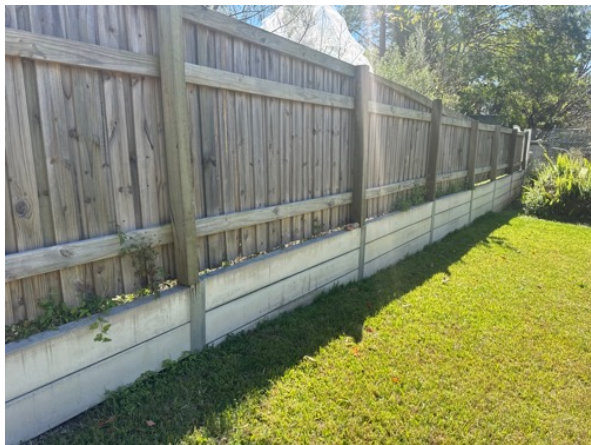
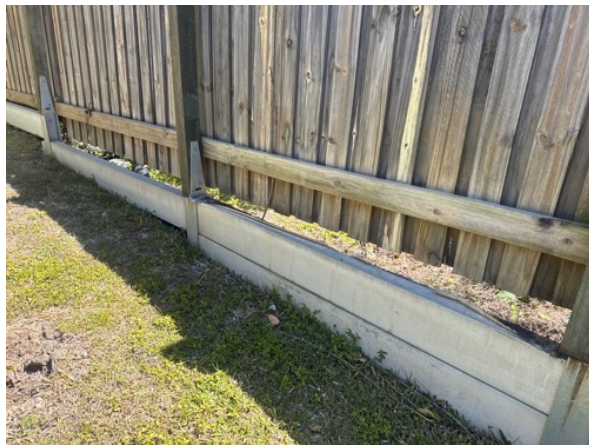
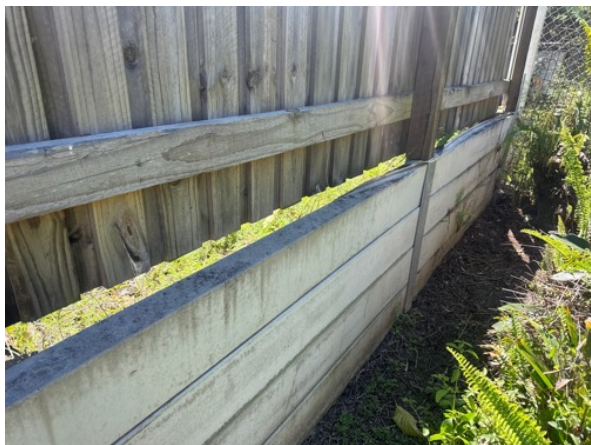
**Location:** Retaining Walls

**Finding:** Concrete sleeper retaining walls appear in good condition.  
Concrete sleeper systems are more durable than timber.

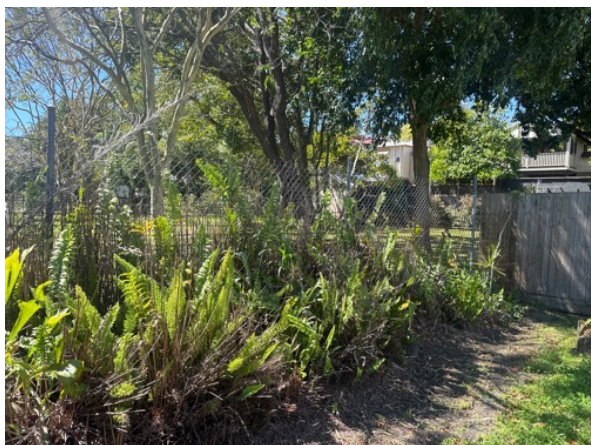
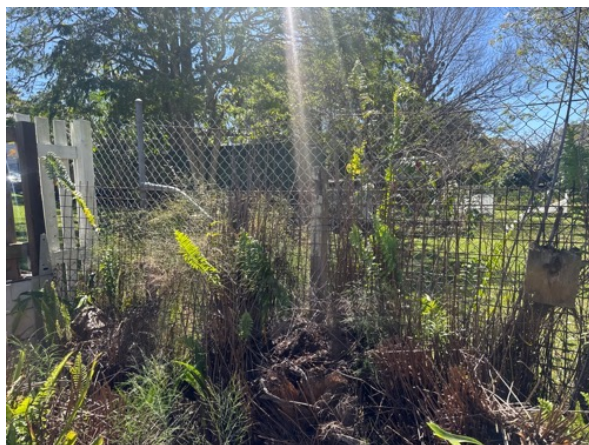
**Location:** Fences

**Finding:** Steel mesh fences appear in sound condition.

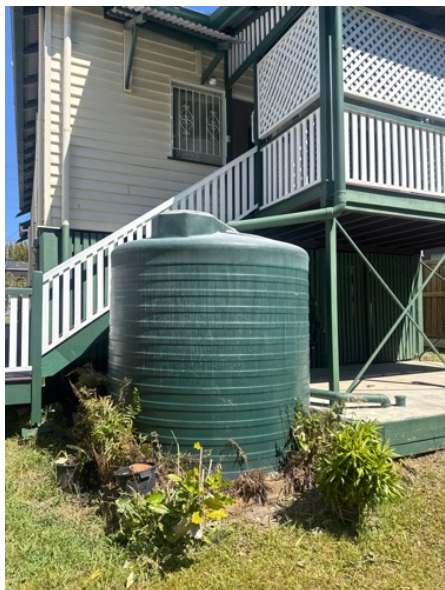
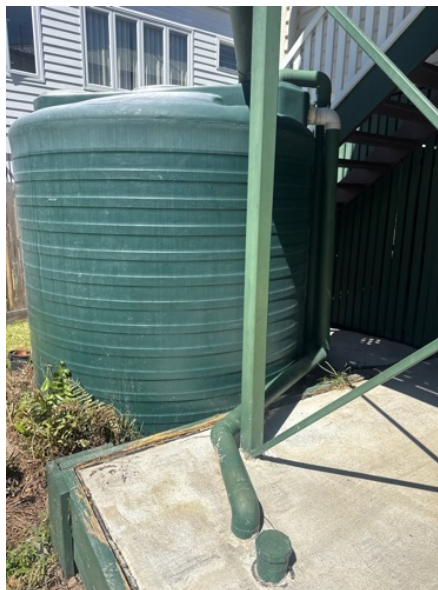
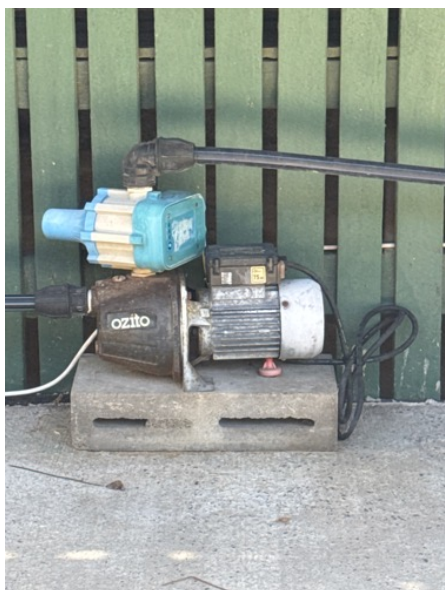
**Location:** Water Tank

**Finding:** Poly water tank installed.  
Electric pump installed.  
Overflow is connected to a drain.
