# Property and Timber Pest Report

Inspection Date: 11 Sep 2025

Property Address: 129 Fuller Street Lutwyche 4030

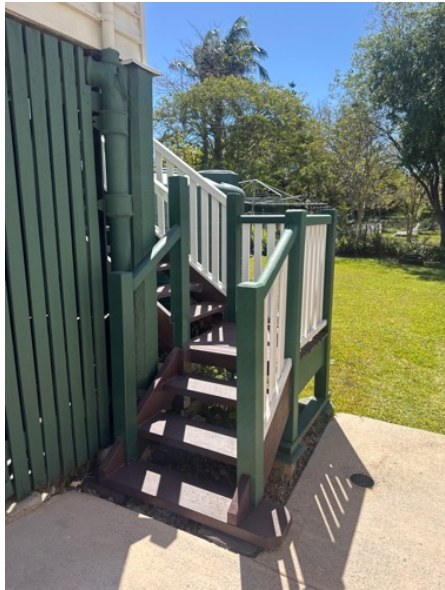
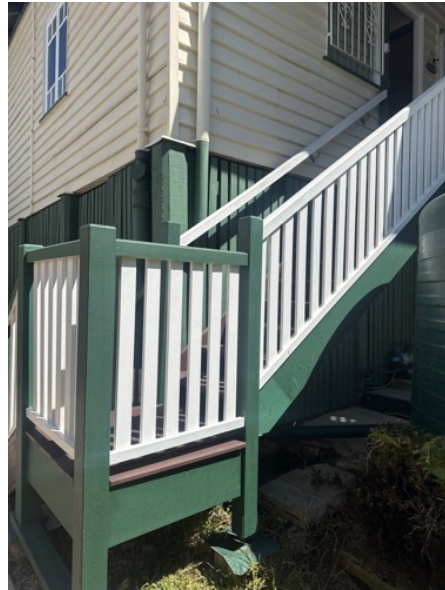
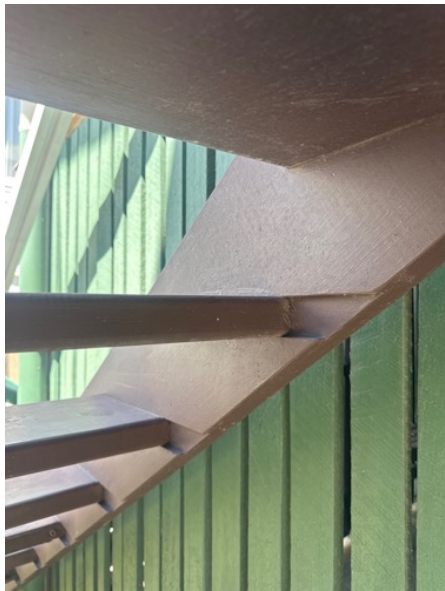
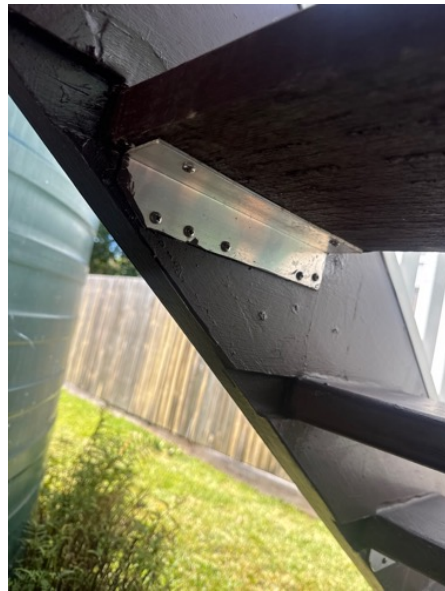
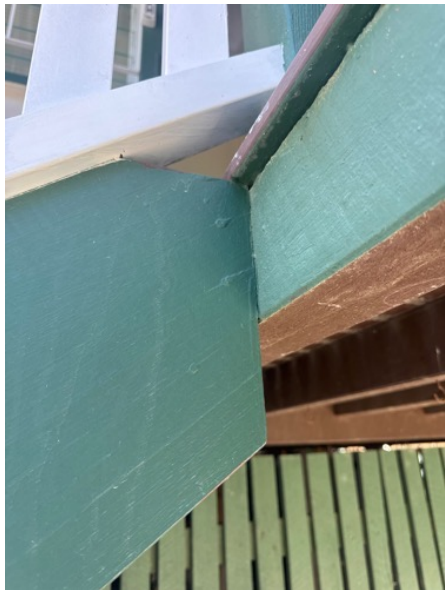
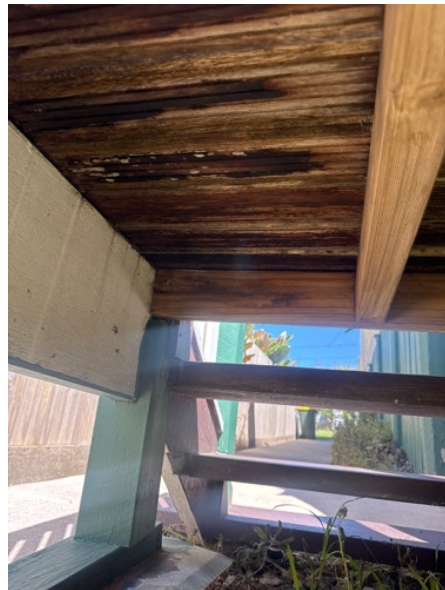
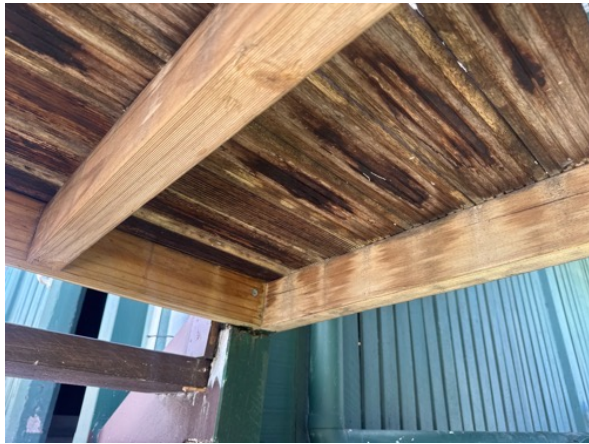
**Location:** External Stairs

**Finding:** Stairs and handrail are in good sturdy condition.

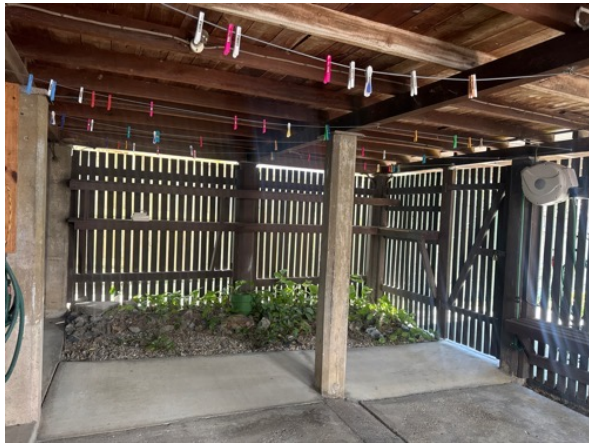
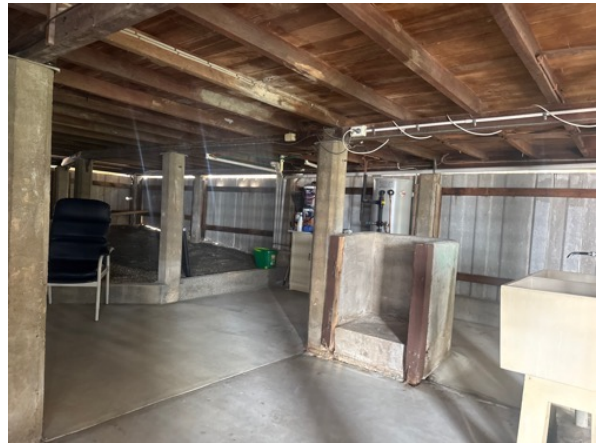
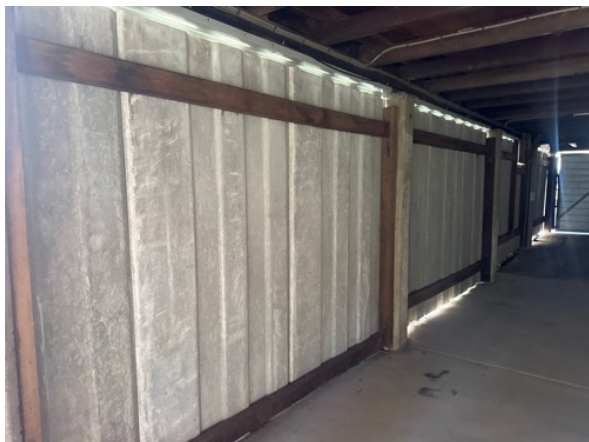
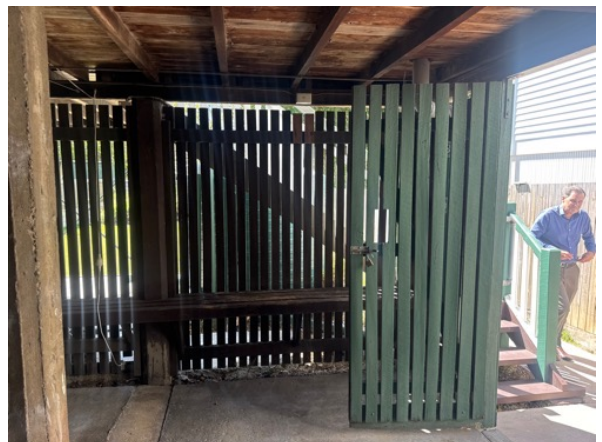
**Location:** Undercroft Area

**Finding:** Sub floor area is semi enclosed storage with concrete slab floor.  
Appears in good condition.

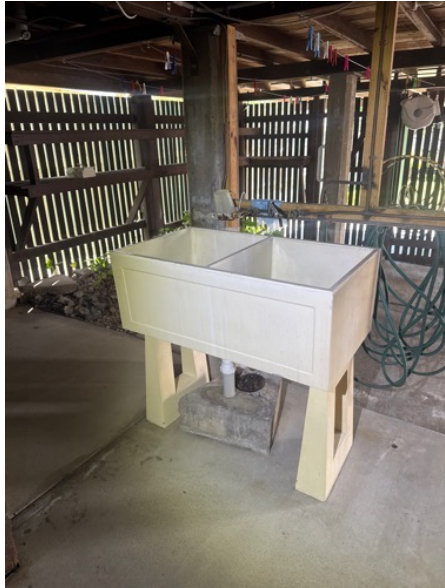
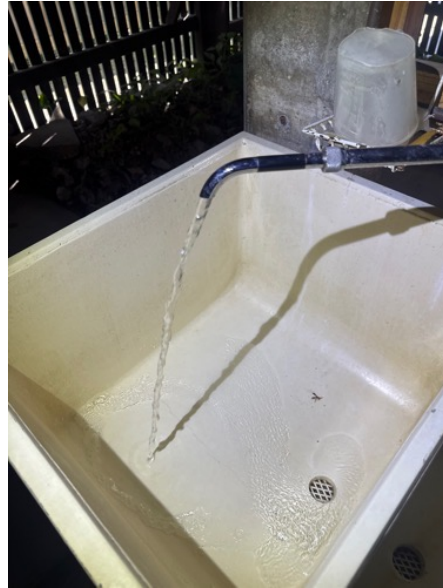
**Location:** Laundry

**Finding:** Laundry and facilities appear in good functional condition.  
Water pressure is satisfactory with water draining away.

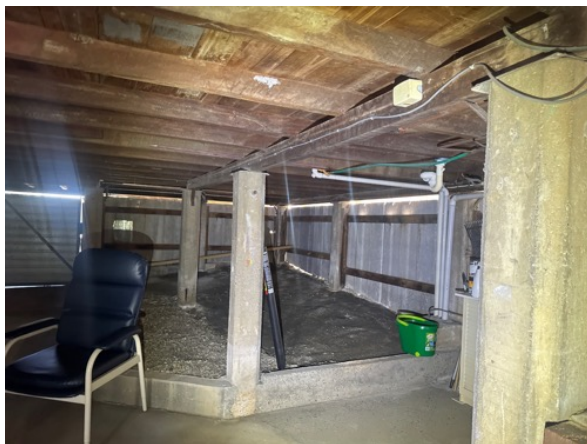
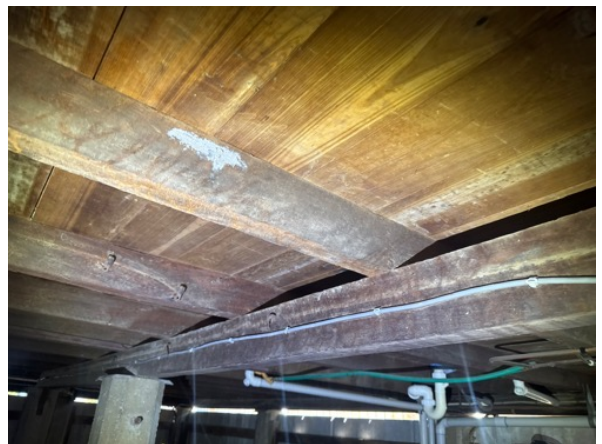
**Location:** Subfloor

Appears in good condition.

No water stains or moisture observed around plumbing drain floor penetrations.

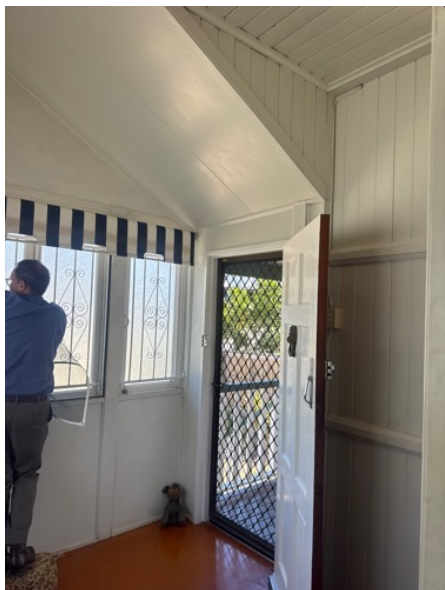
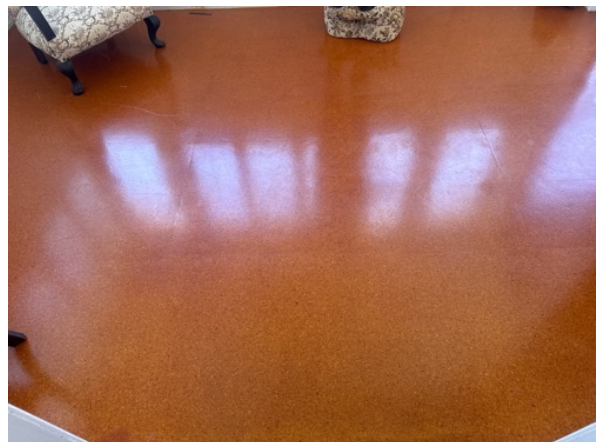
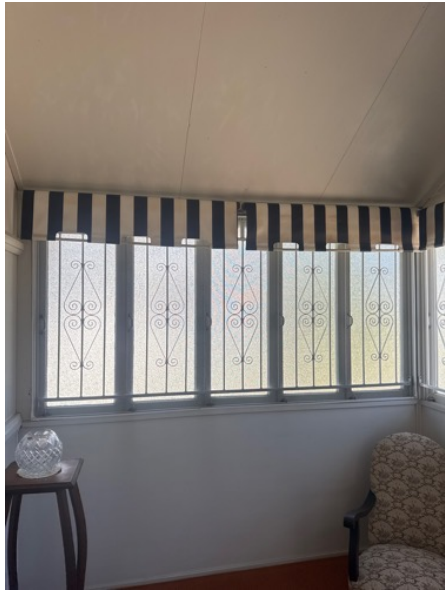
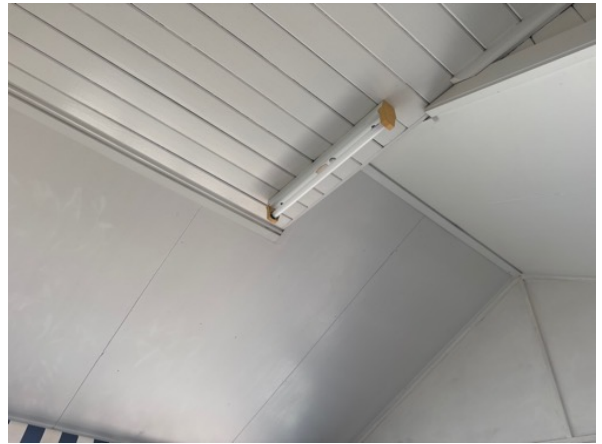
**Location:** Sunroom

**Finding:** Sunroom presents in good condition and has been well maintained.

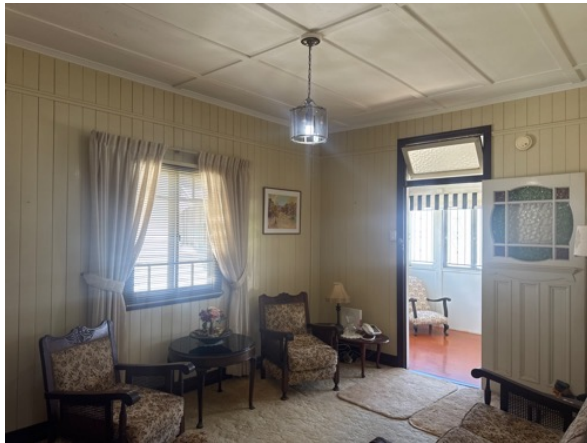
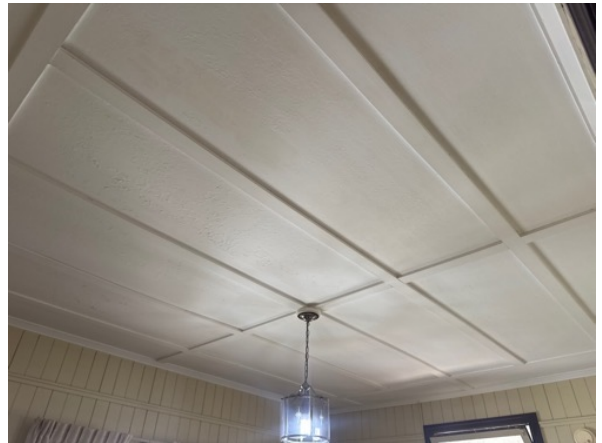
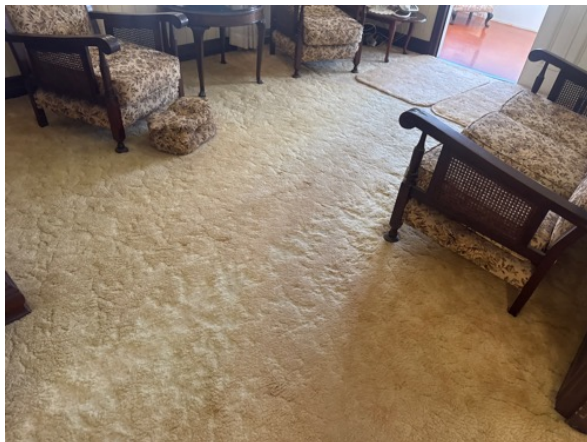
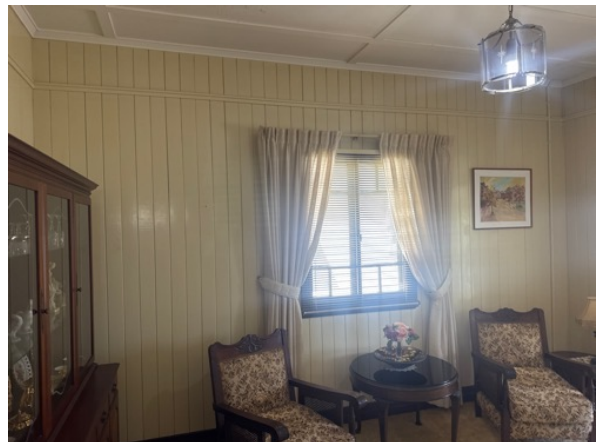
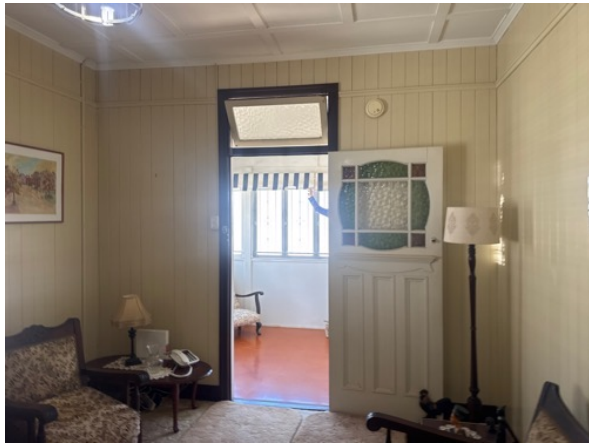
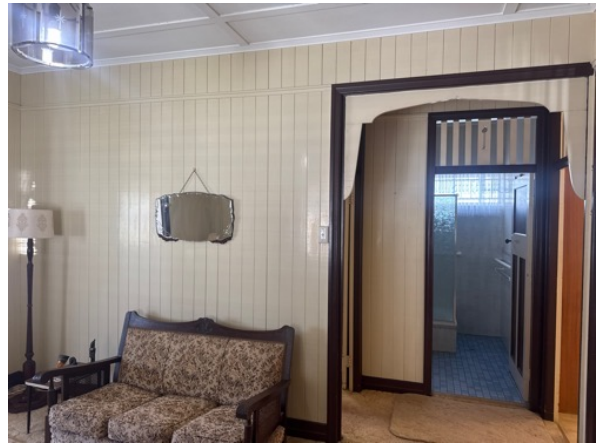
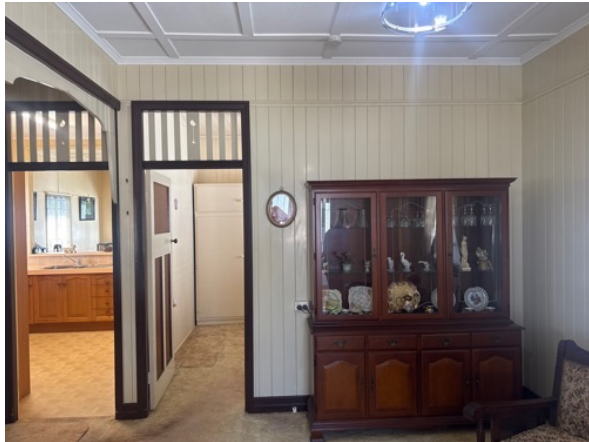
**Location:** Living area

**Finding:** Living area presents in good condition and has been well maintained.  
Good condition.

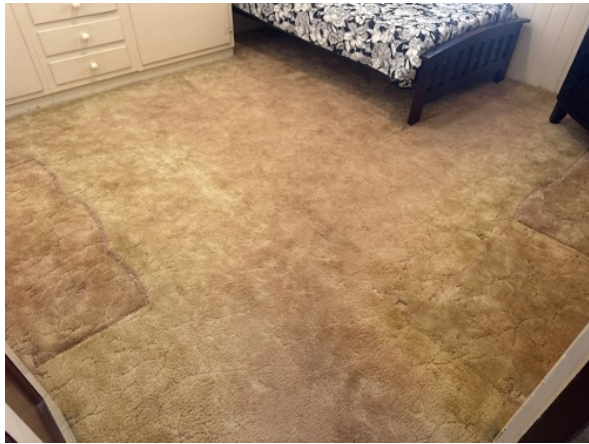
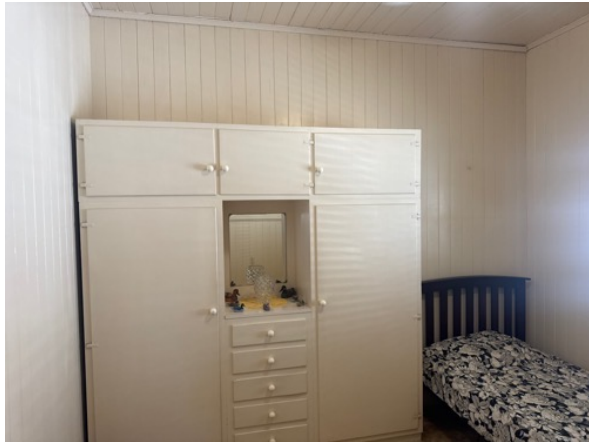
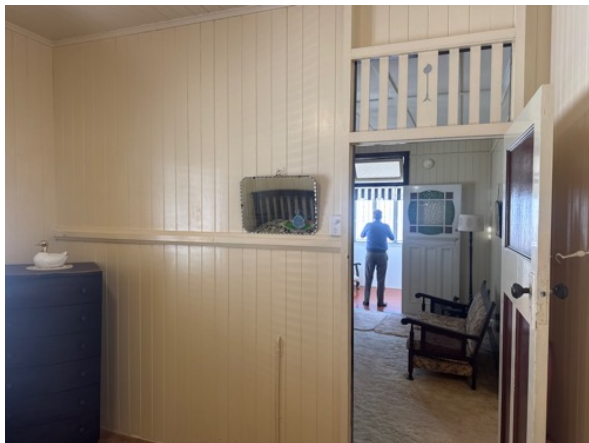
**Location:** Bedroom 2

**Finding:** Bedroom- presents in good condition and has been well maintained.  
Smoke detector NOT installed- Vendor to provide smoke detector compliance certification.

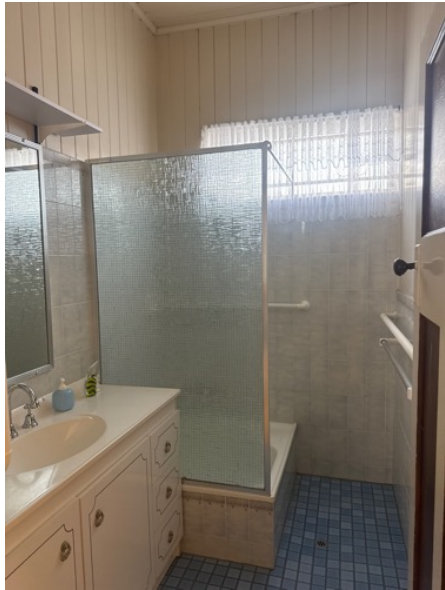
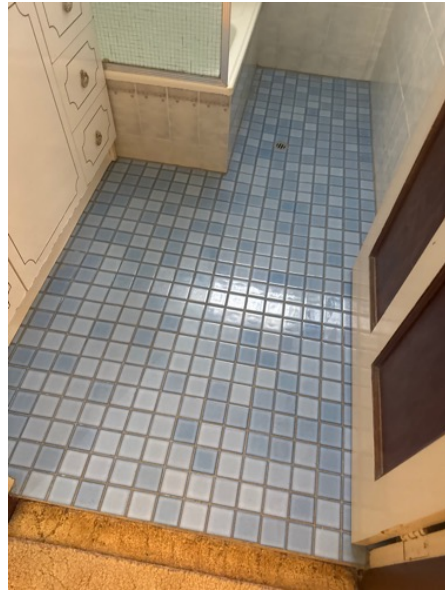
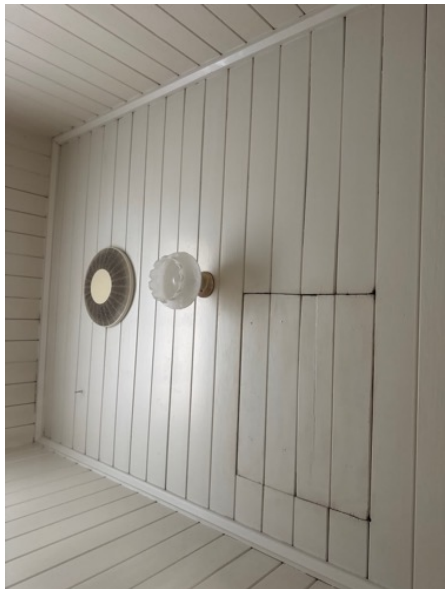
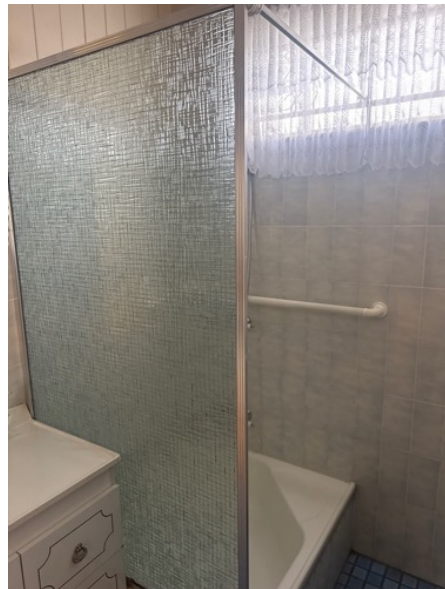
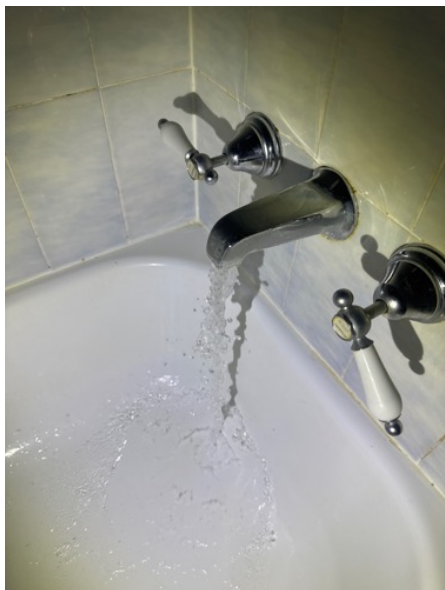
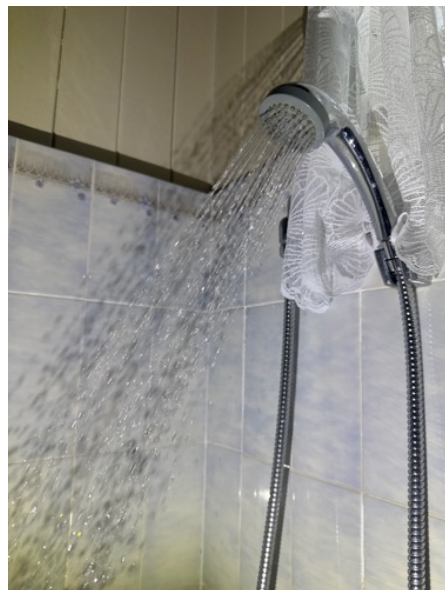
**Location:** Bathroom

**Finding:** Bathroom- good functional condition and has been well maintained.

Ventilation: Natural (window) and mechanical exhaust.

Water pressure is satisfactory with water draining away.

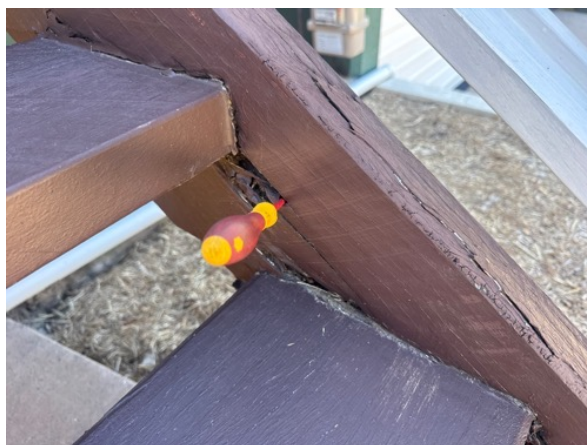
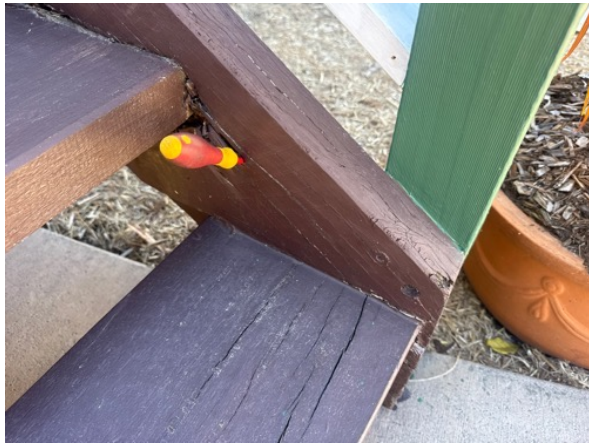
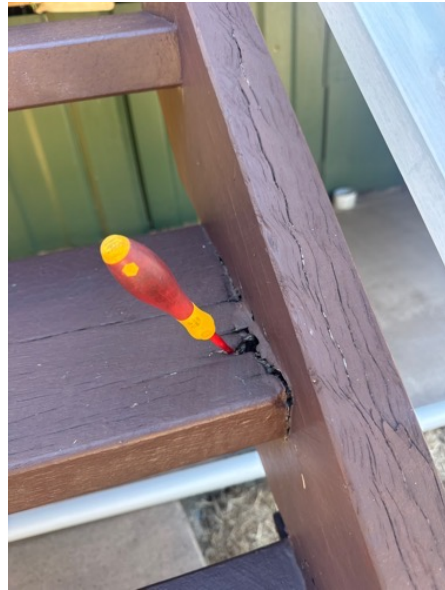
**Location:** External Stairs

**Finding:** Timber decay (rot) confirmed to sections of front stairs  
Replacement of affected members required.

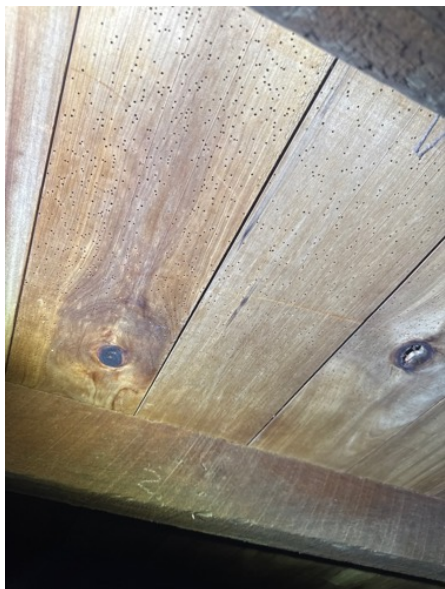
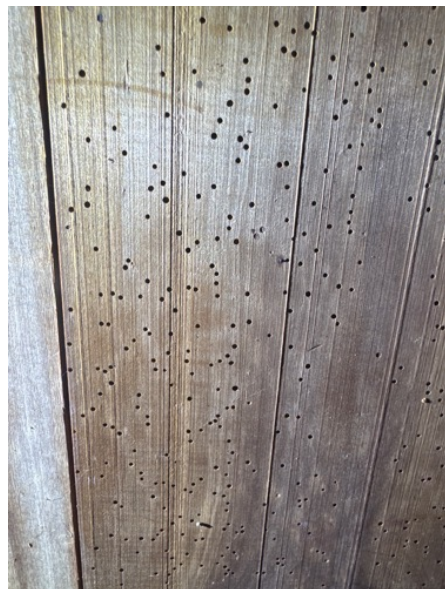
This is common for older pine floors throughout QLD.

Agent has provided an invoice for chemical treatment in 1969.

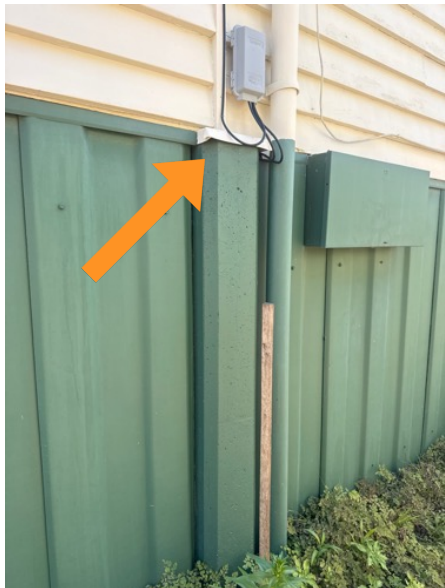
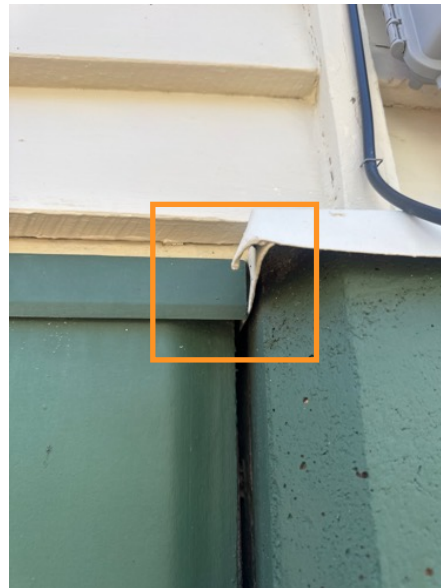
**Location:** Subfloor

**Finding:** Metal ant caps have been modified to accomodate walls built in to ground level.  
These are not effective termite management, with chemical termite barrier recommended to reduce risk of concealed termite access.

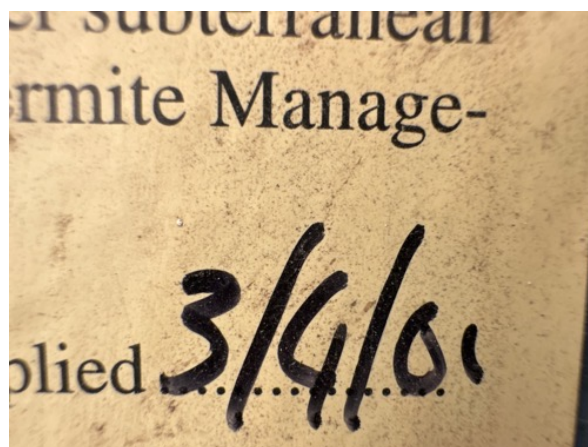
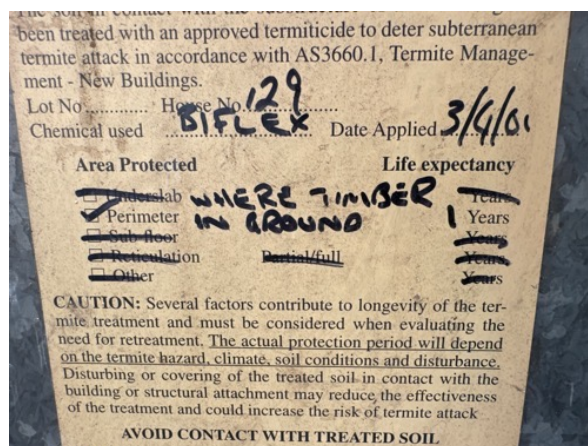
This system has expired- recommend a new chemical termite barrier be installed to reduce risk of concealed termite access.

Seek advice on termite management options from a QBCC Licensed Timber Pest Contractor.
