# Inspection Report

## Abode Building and Pest

4 Pelion Street, Bardon

### Pest And Building Inspection

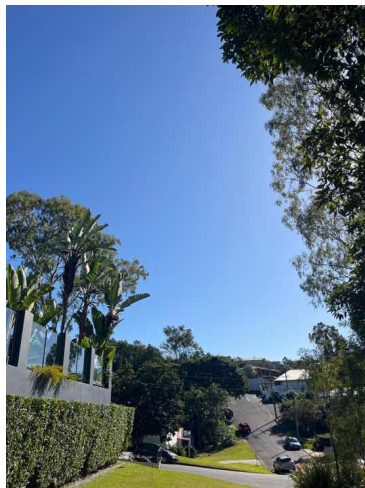
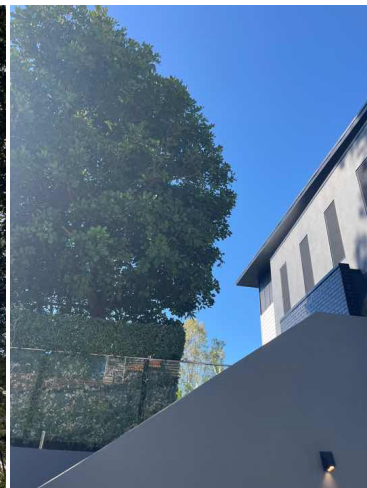
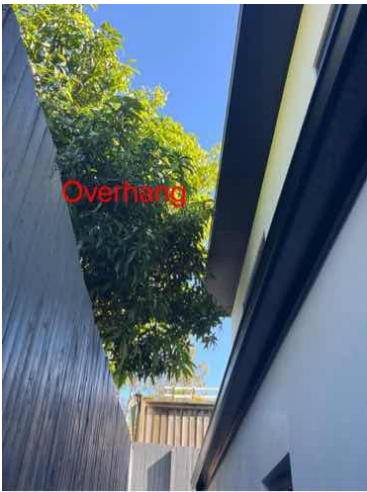
Trees are overhanging roof areas. These should be cut back away from the roof line and gutters.

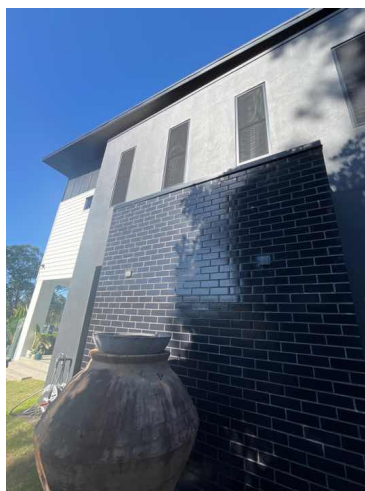
Render crack deterioration (minor) on wall visible - Recommendations: Engage a renderer for advice and repair.

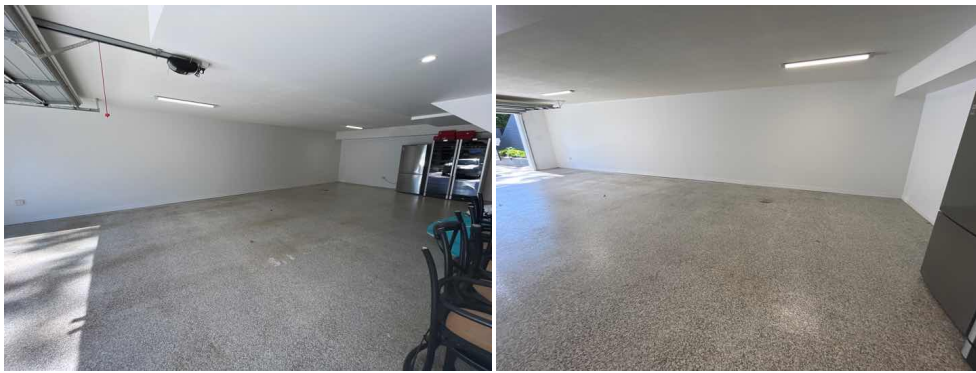
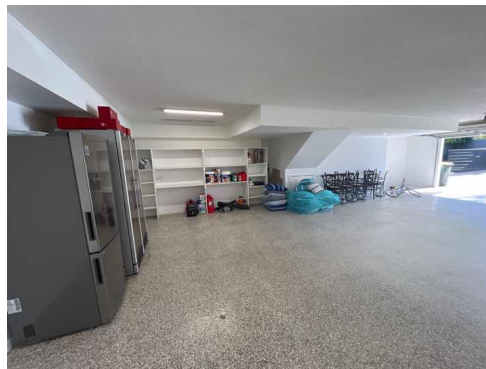
On inspection, defects were present that will require further assessing and recommendations by qualified trades persons, please read below for details.

Minor deteriorated on surface- Note. contact a qualified tradesman for further advice.

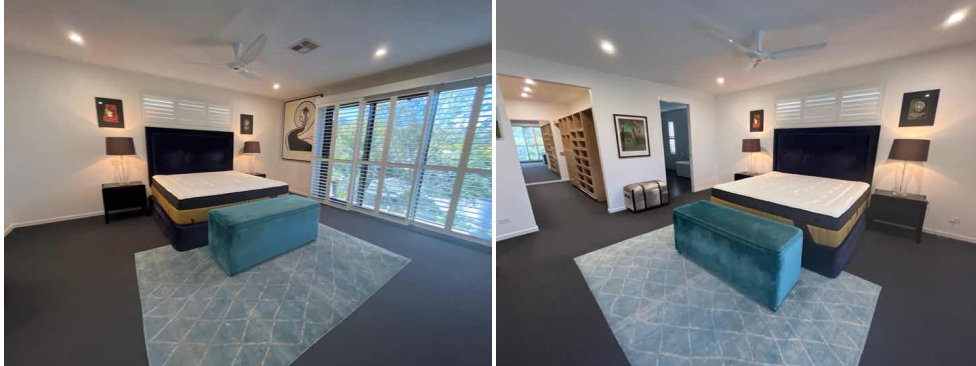
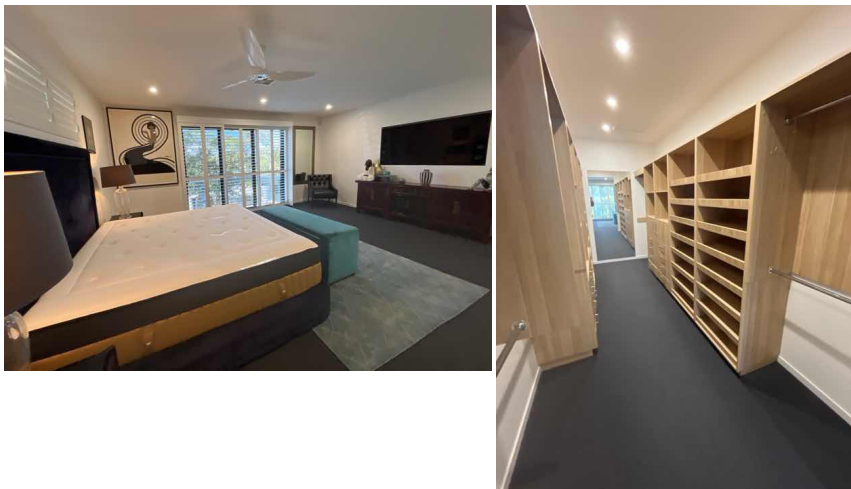
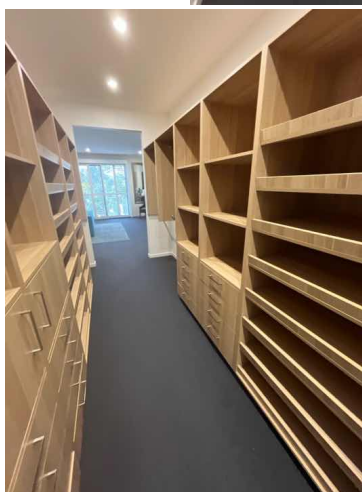
On inspection, defects were present that will require further assessing and recommendations by a qualified trades persons, please read below for details.

General carpet deterioration. Replacement may be required A qualified carpet layer should be engaged.

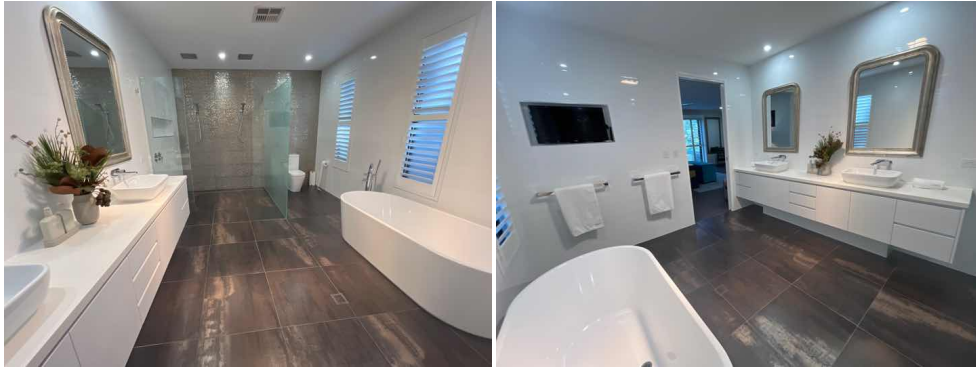
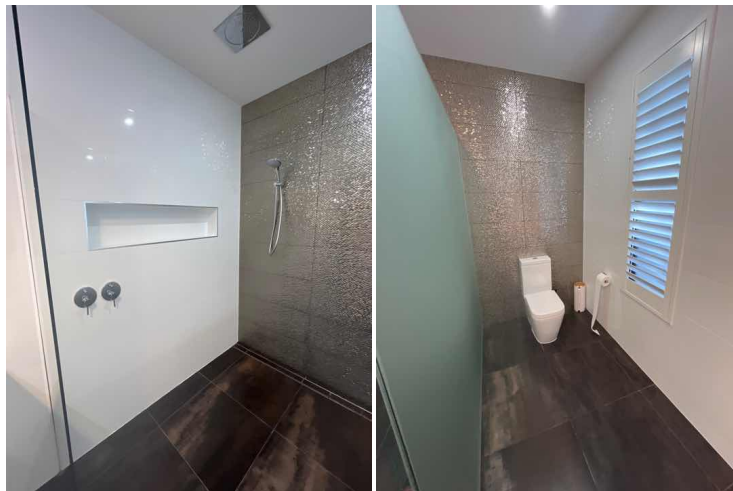
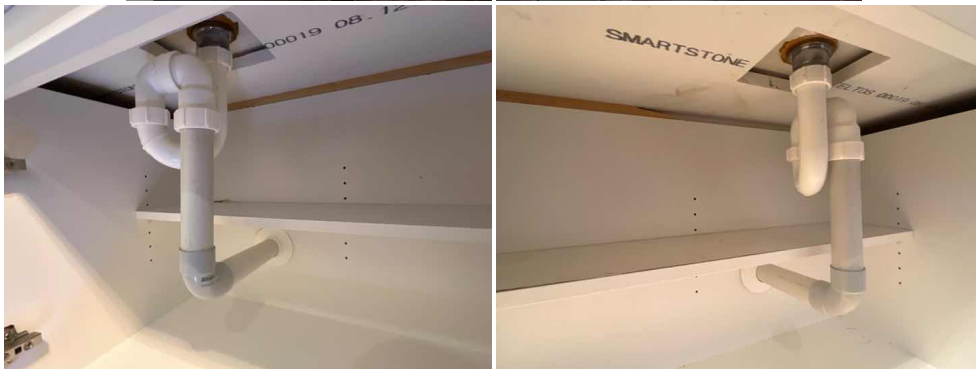
On inspection, defects were present that will require further assessing and recommendations by licensed and qualified trades persons, please read below for details.

The shower mixer is dripping in the open position. Please contact plumber to repair.

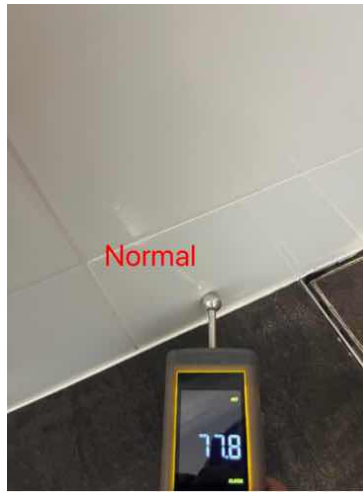
Cracked tile/s noted. High moisture readings close to cracked tile. No moisture detected to adjacent wall and ceiling under. Waterproofing should be working properly. A qualified tiler should be engaged for advice and recommendations.

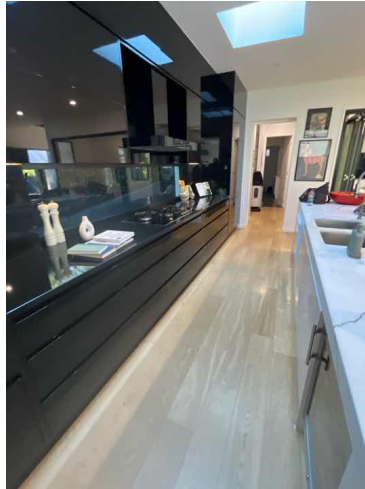
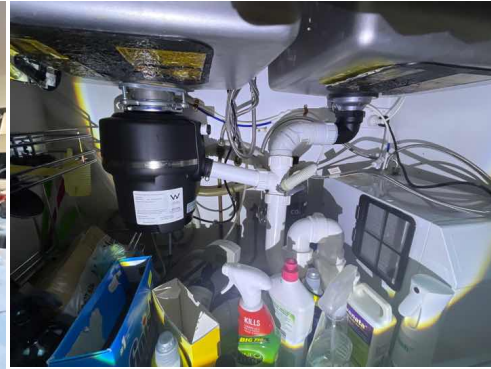
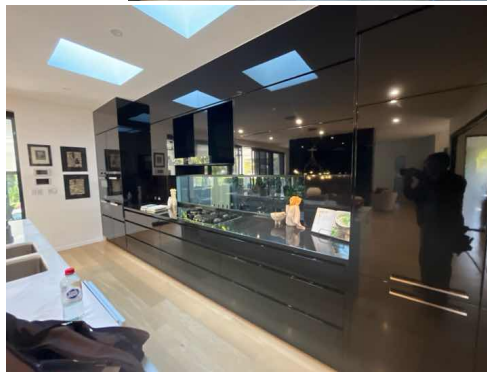
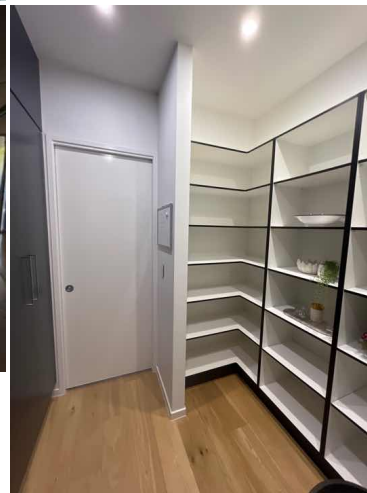
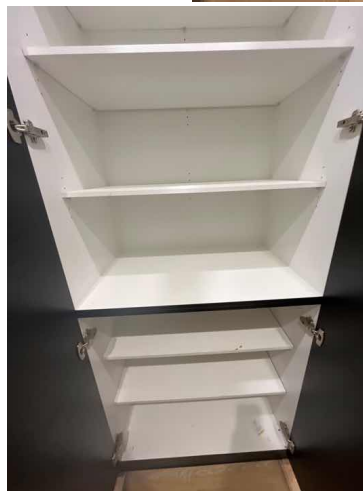
Of the visible areas, the general condition of the kitchen and pantry is serviceable or in reasonable condition for age of dwelling.

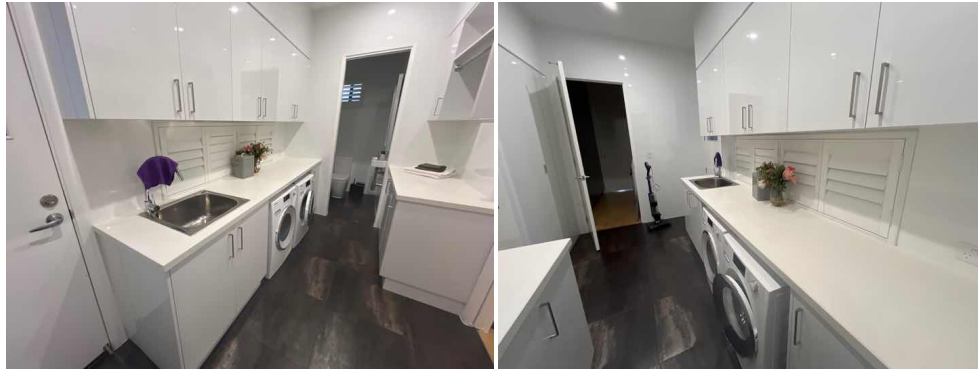
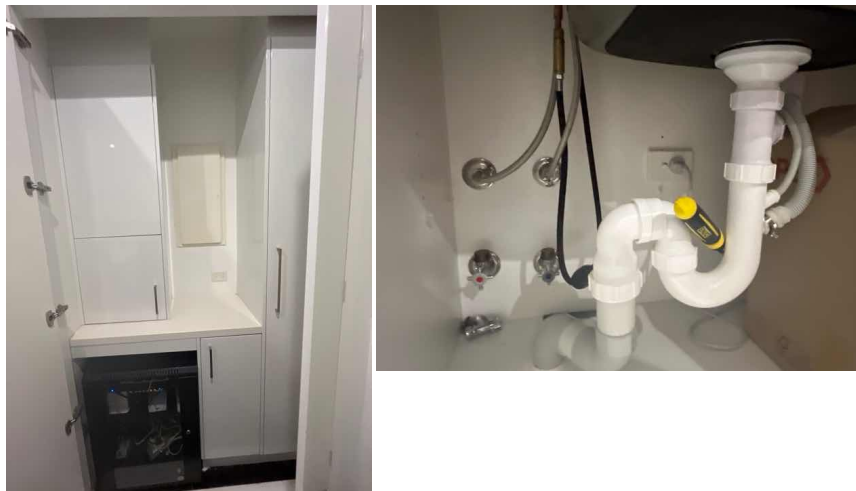
Of the visible areas, the general condition of the laundry is serviceable or in reasonable condition for age of dwelling.

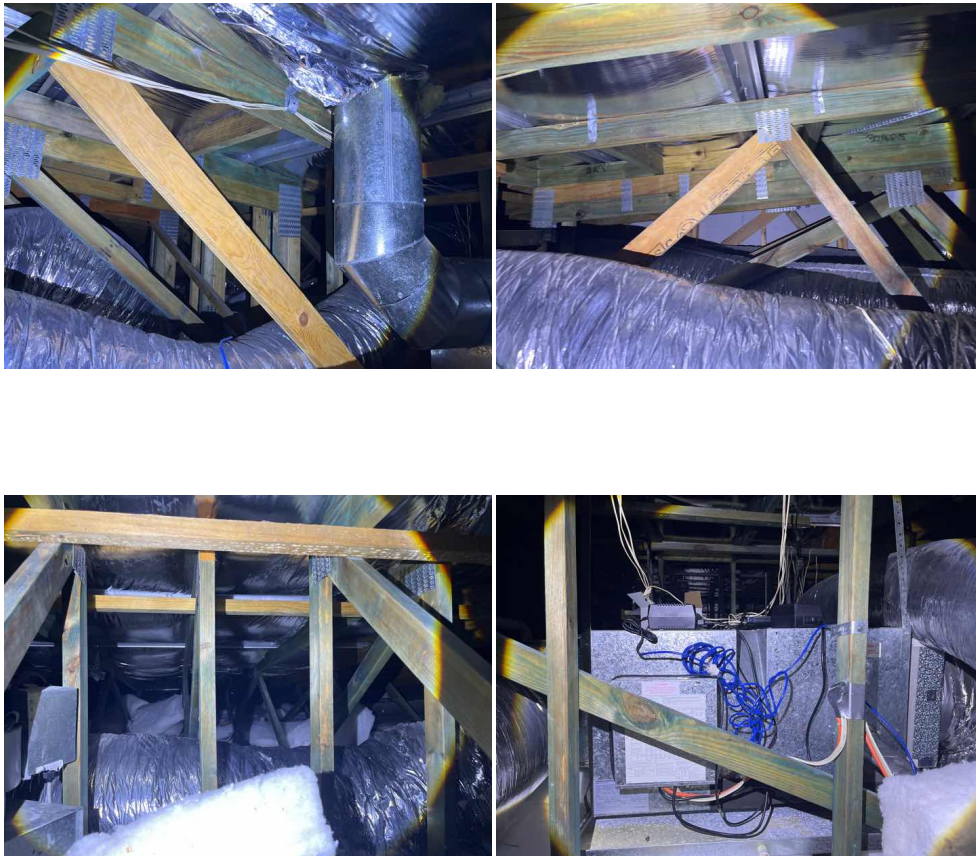
Visible sections of the roof void is in a serviceable condition for age of this dwelling.

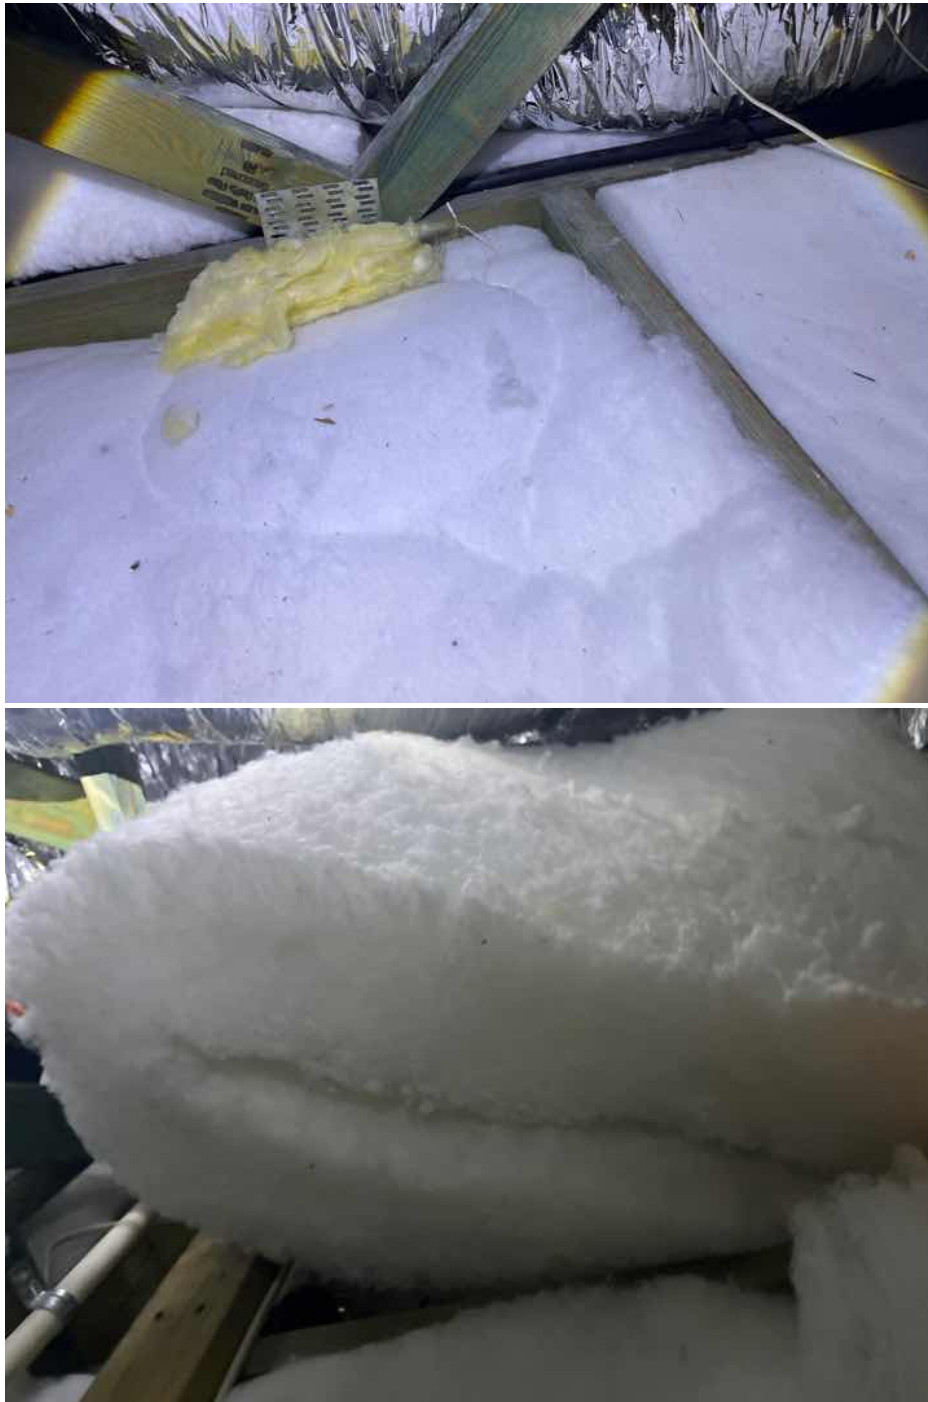
Where visible and accessible, the insulation appears to be in a serviceable condition.

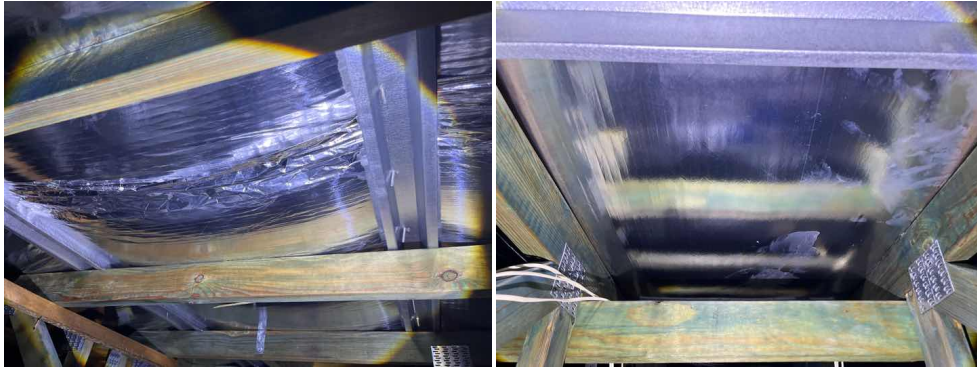
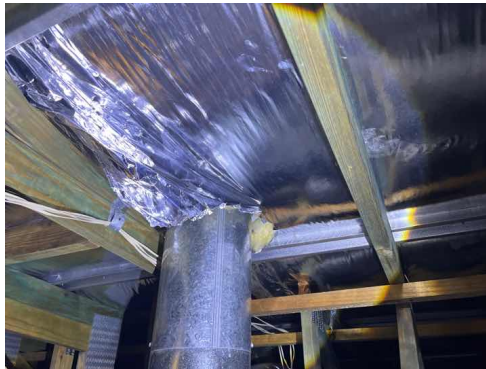
Anticon is installed. Anticon is a foil-faced insulation blanket.

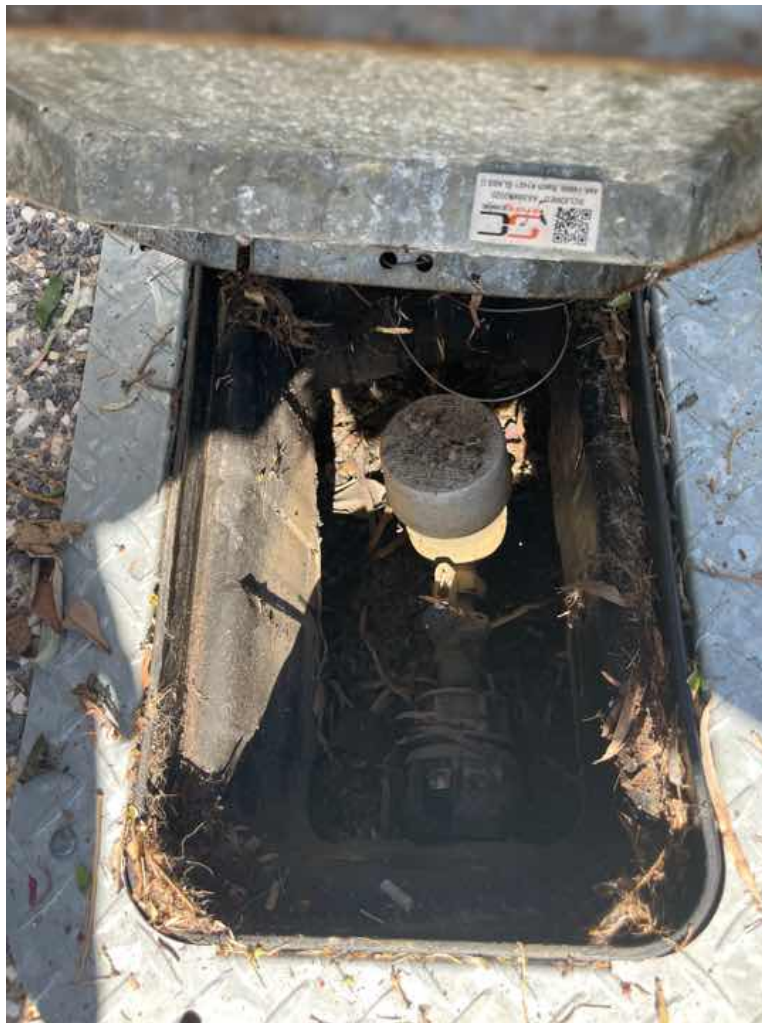
The water was Connected. All plumbing pipe installation should be assessed by a licensed plumber.

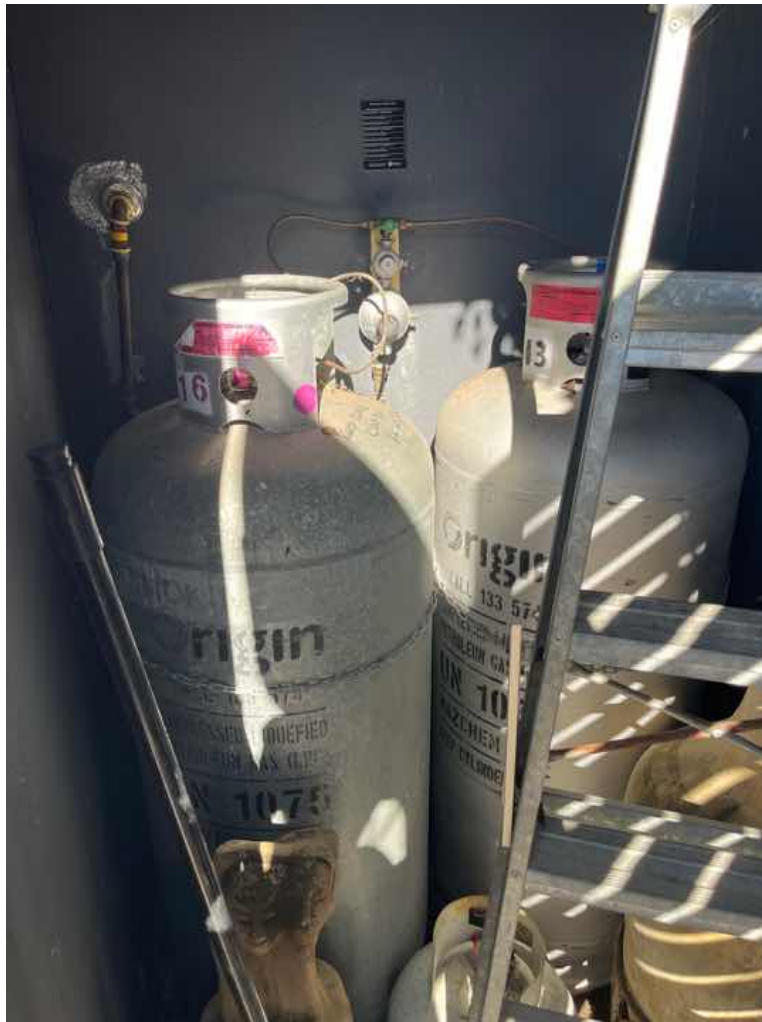
The gas bottles was Connected. All gas pipe installation should be assessed by a licensed gas fitter.

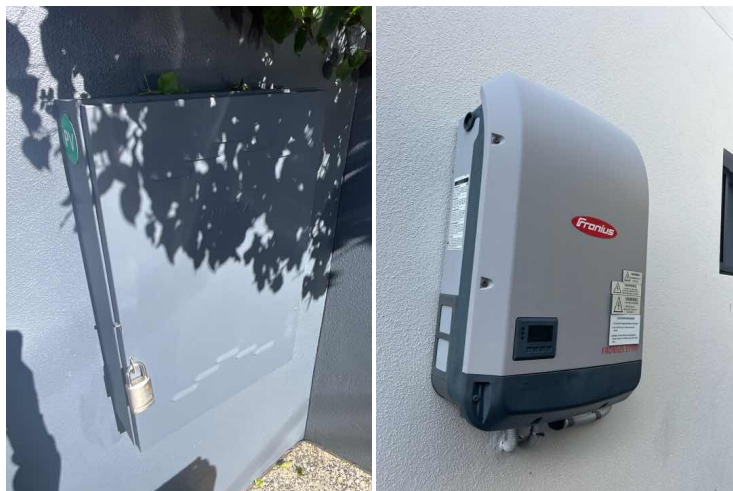
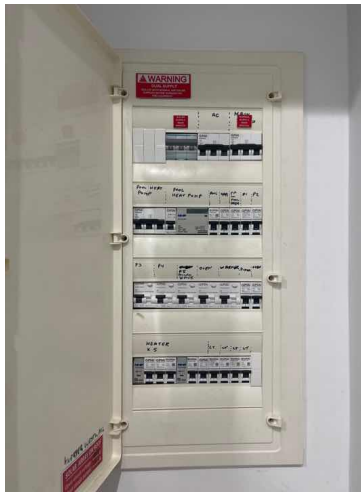
Electricity to the dwelling was connected. Note: We do not carry out electrical inspections for wiring or safety. This must be carried out by a licensed electrician and I recommend you have all electrical wiring and components assessed by a licensed electrician.

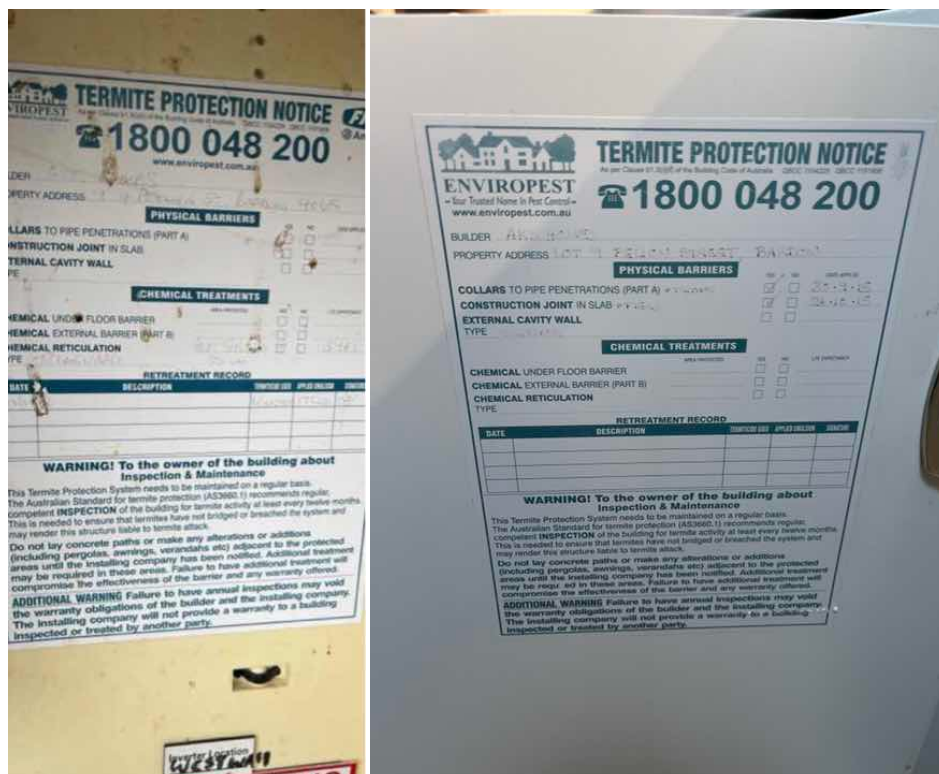
Yes, a durable notice was found in the meter-box during the inspection.

This firm can give no assurances with regard to work that may have been previously performed by other firms. You should obtain copies of all paperwork and make your own inquiries as to the quality of the treatment, when it was carried out and warranty information. In most cases you should arrange for a treatment in accord with Australian Standard 3660 be carried out to reduce the risk of further attack.
