BIR_1820. Pre-Sale Building Inspection

Property Address: 30/20 Bognor Street Tingalpa 4173

Inspection Date: 24 Jun 2025

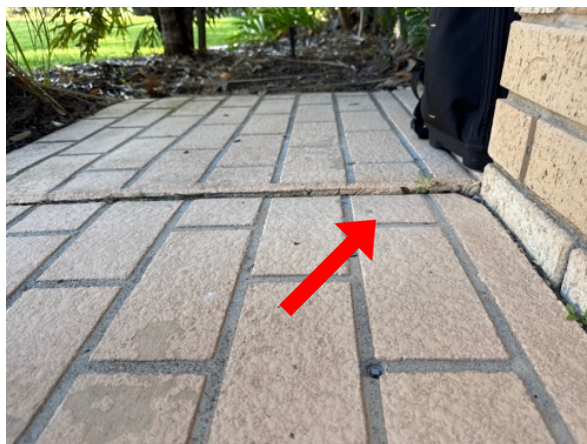
Location: Paths

The pathways have experienced some movement over time. There is a small amount of lippage that could pose a trip hazard. Repairing the paths to eliminate this hazard would

lippage that could pose a trip hazard. Repairing the paths to eliminate this hazard would ensure the safety of individuals using the area.

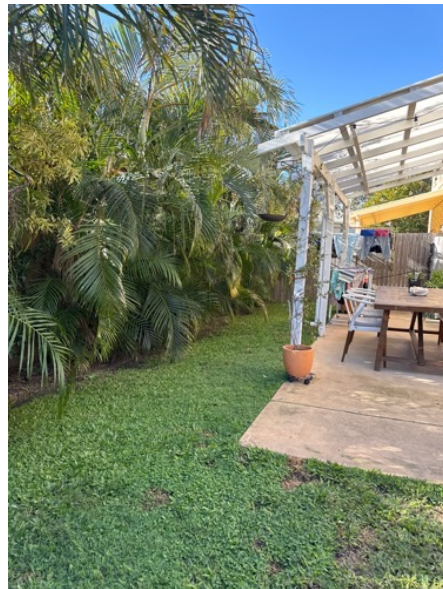
The fence was heavily obstructed with vegetation. From the areas that could be viewed, it appeared to be in fair condition for its age.

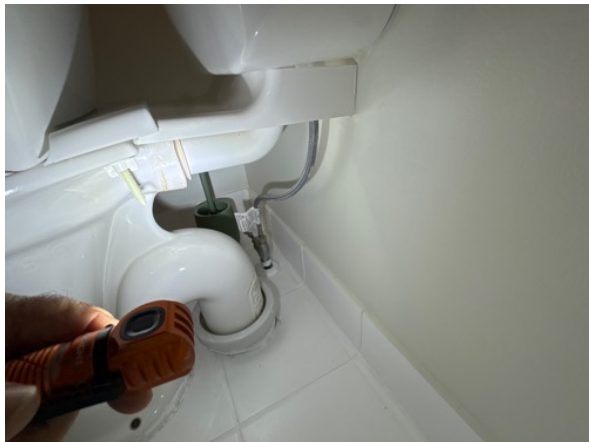
Location: Upper Floor Toilet

Finding: No visible Leak

The flexible hoses are prone to deteriorate. It is always recommended to replace the flexible hoses every five years.

It is recommended to have the sticking flush button adjusted to prevent the water from running.

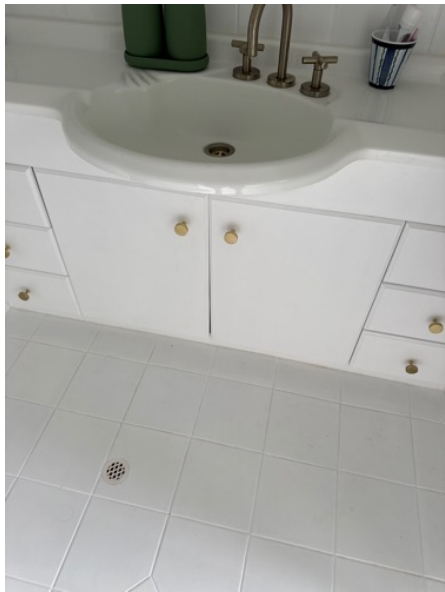
Location: Ensuite

Finding: Align cabinet doors and draws as required.

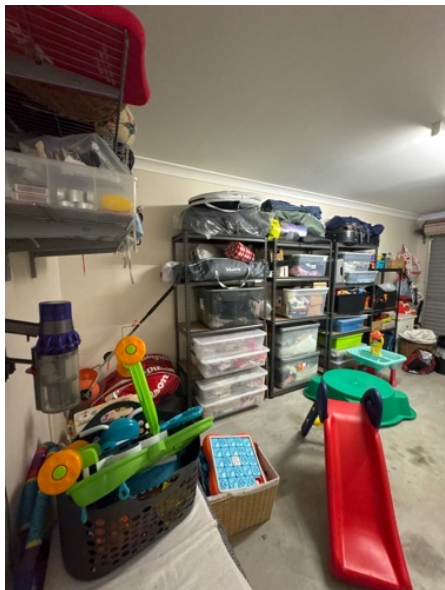
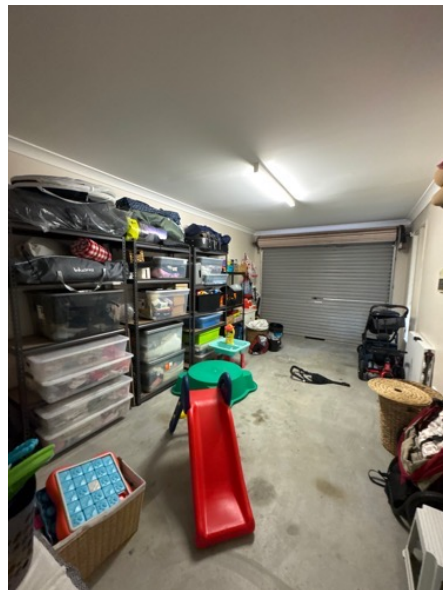
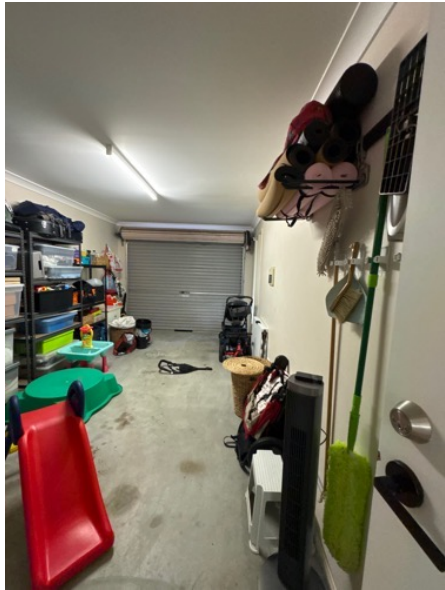
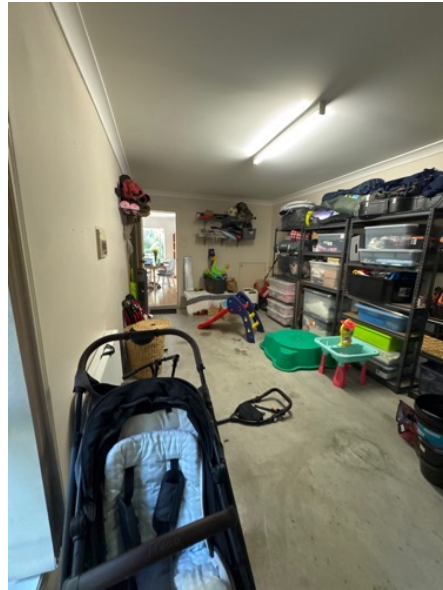
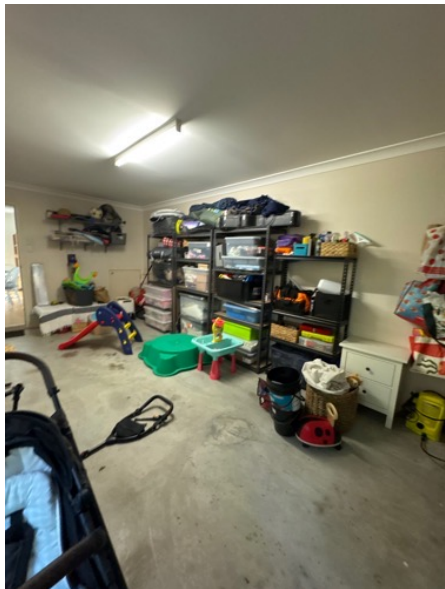
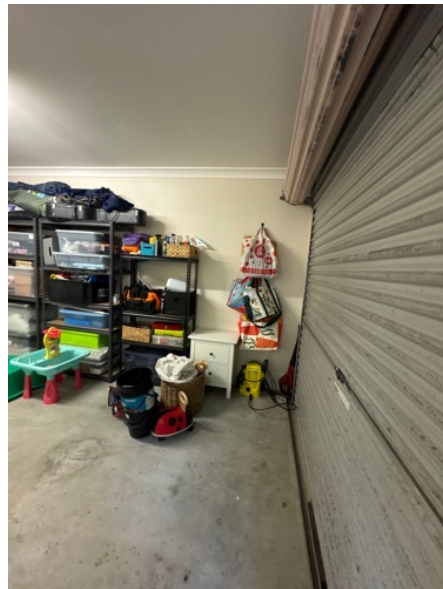
Location: Garage

Finding: Obstruction to garage walls and floor in some areas-Unable to inspect all areas due to stored items.

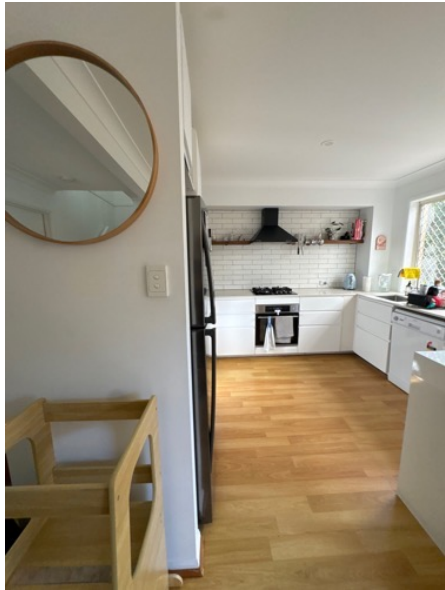
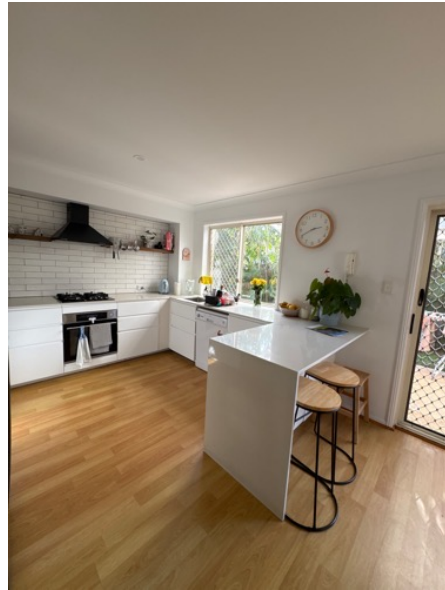
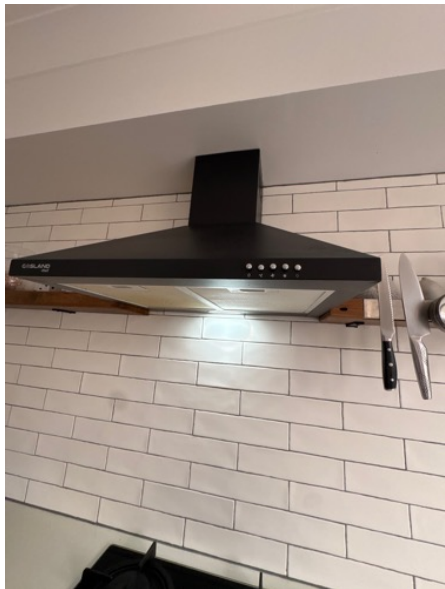
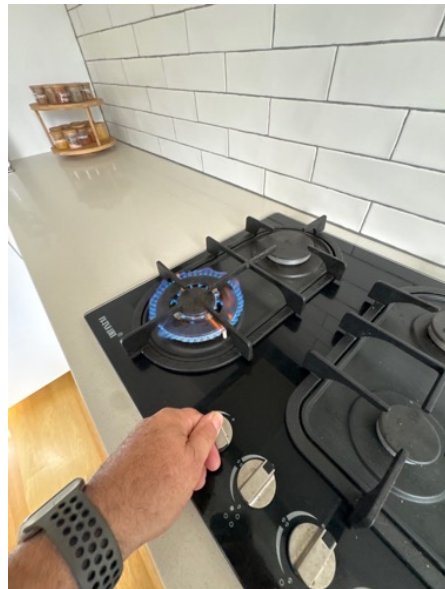
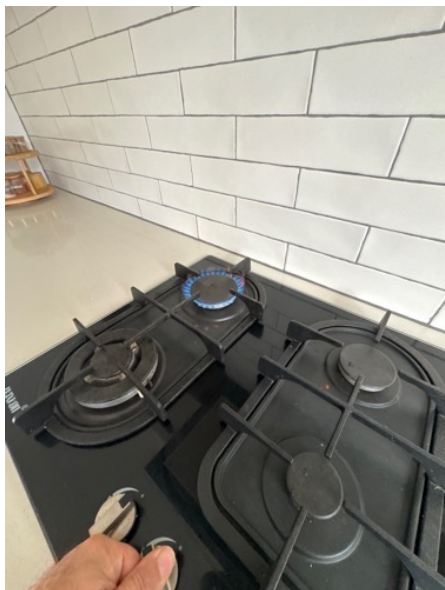
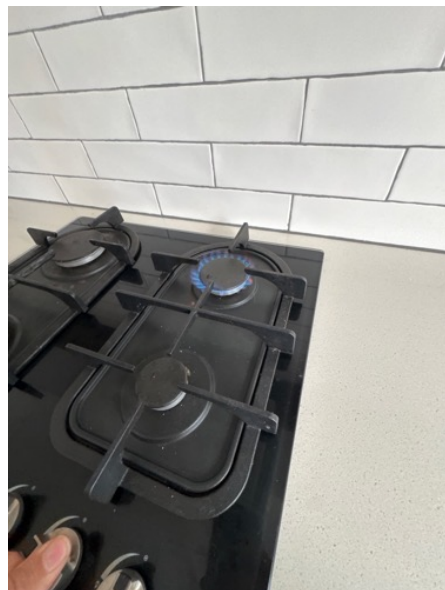
Operational at the time of inspection.

However, All electrical wiring, switches, power points, air-conditioning and associated items and appliances need to be serviced and maintained in good working order. Electrical, gas and plumbing inspections are outside the scope of this type of building inspection and must be conducted by a Licensed and registered Tradesperson. It is highly recommended that the client makes arrangements to have all electrical items and appliances checked to ensure that the appliances are working safely and efficiently.

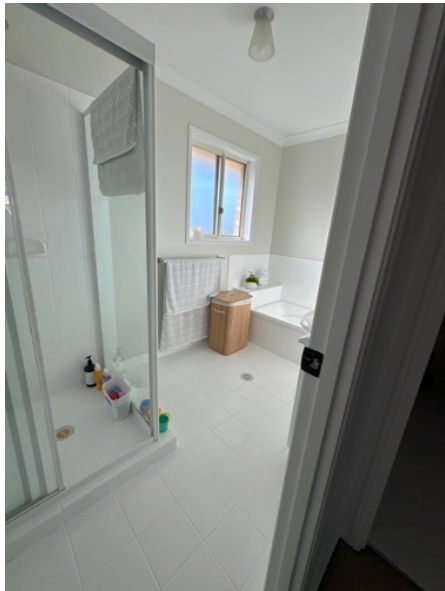
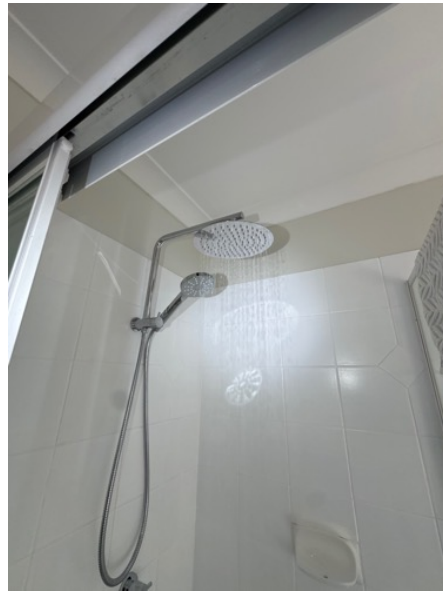
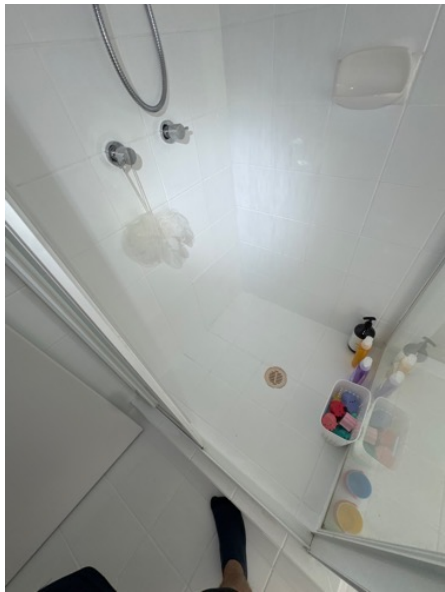
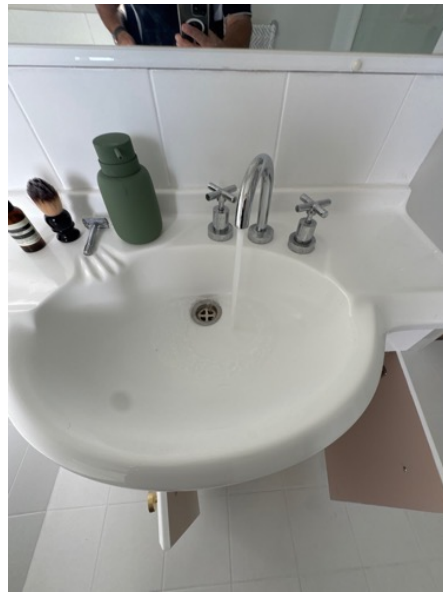
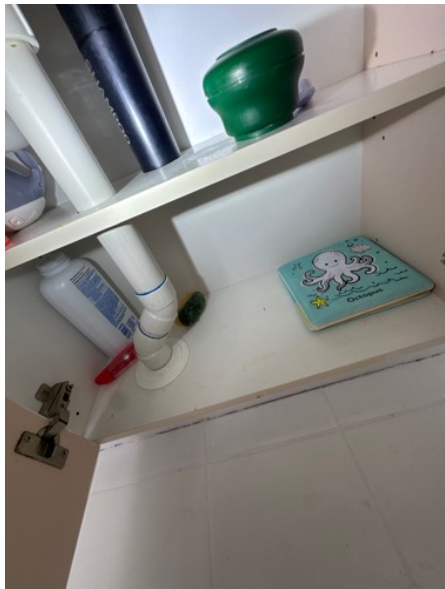
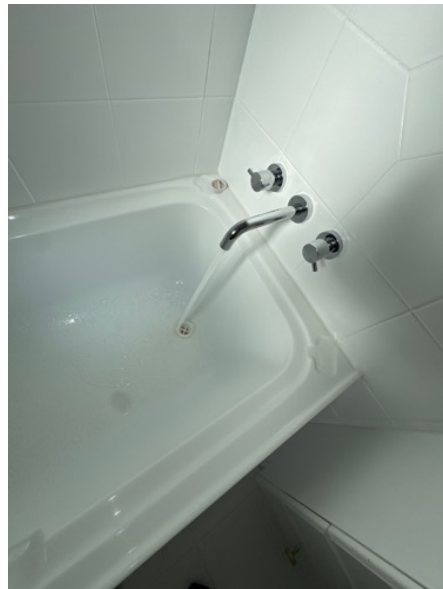
Location: Upper Floor Bathroom

No visible leak was observed at the time of inspection.

The flexible hoses are prone to deteriorate. It is always recommended to replace the flexible hoses every five years.

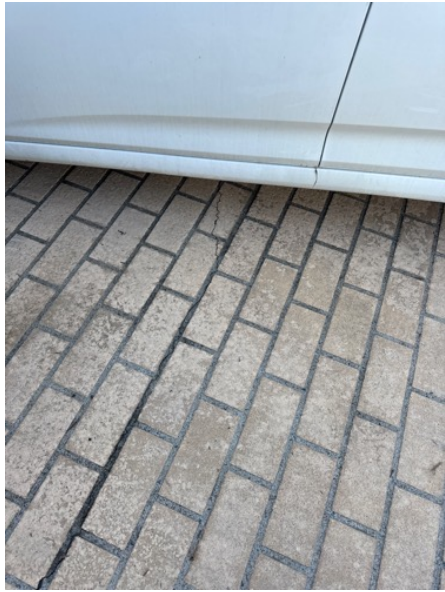
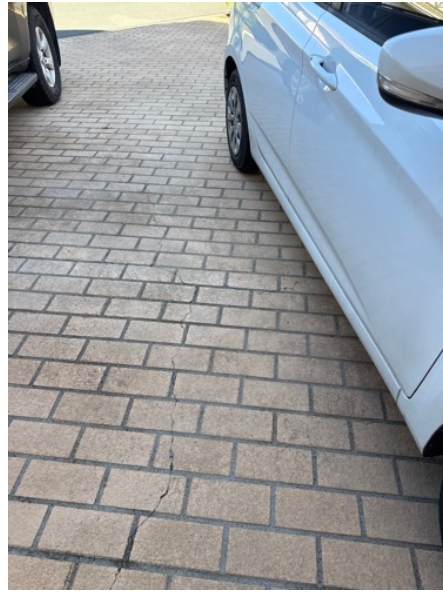
Location: Driveway
Finding: Driveway Condition

On visual inspection, the general condition of the driveway is in a serviceable condition. Concrete Cracking evident to the driveway is generally typical and what is normally observed. Note: Regardless of the appearance of the cracks a Pre-Purchase Building Inspector is unable to determine the expected consequences of the cracks. A structural engineer should be consulted in relation to all cracking.

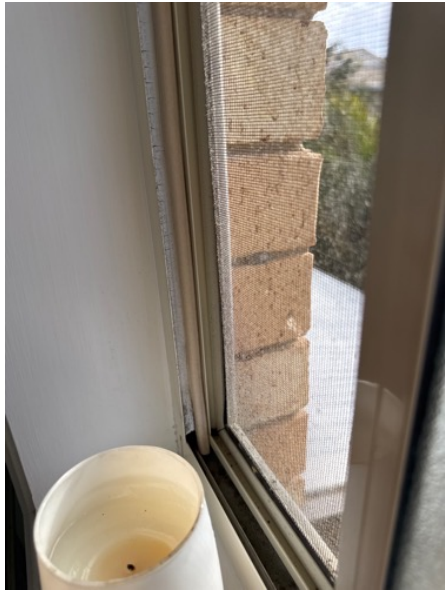
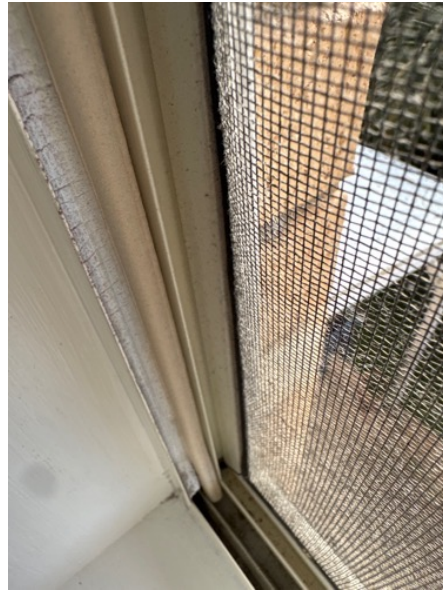
Location: Upper Floor Bathroom

Finding: Remove rubber seals to allow windows to lock properly.

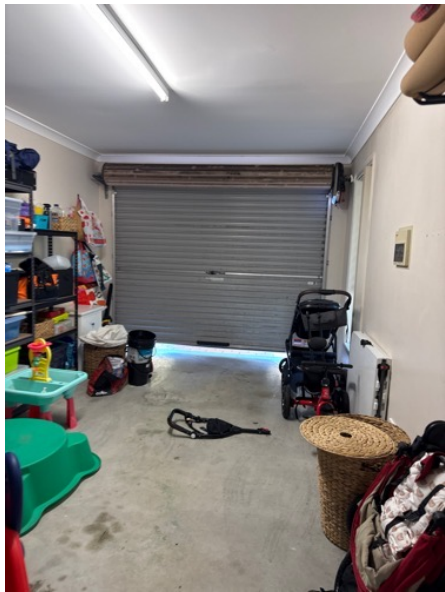
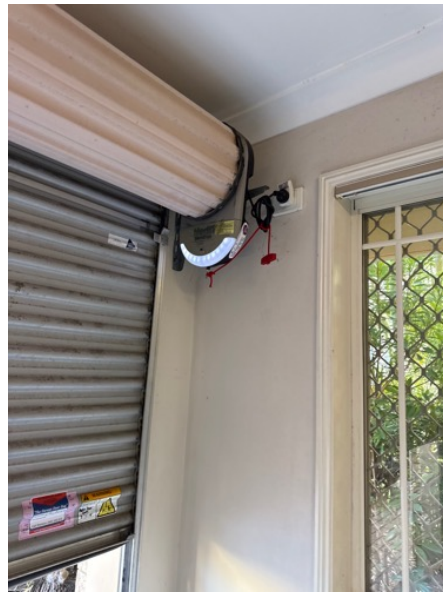
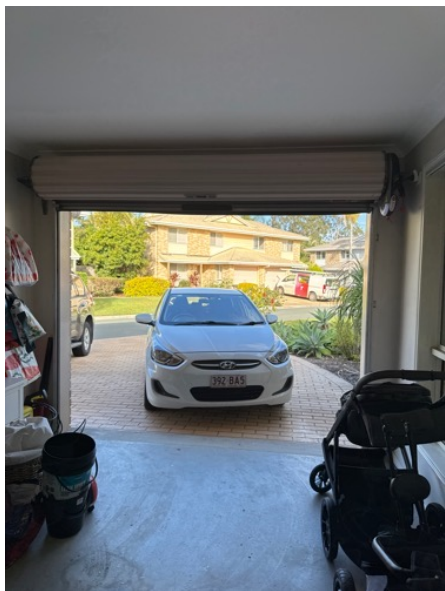
Observation 3.13

Location: Garage
Finding: The garage door is serviceable.

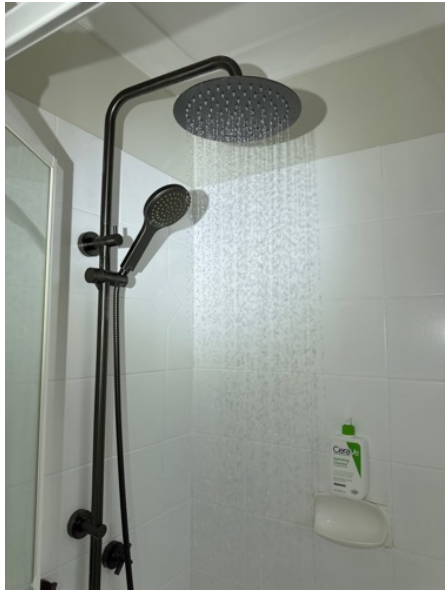
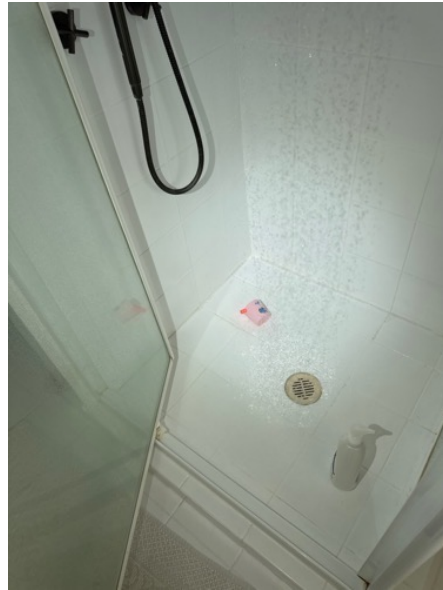
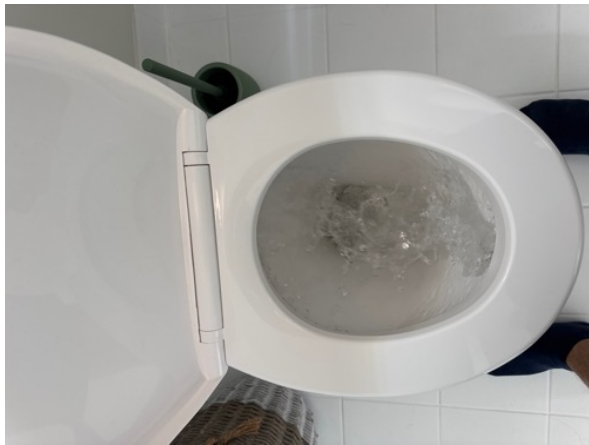
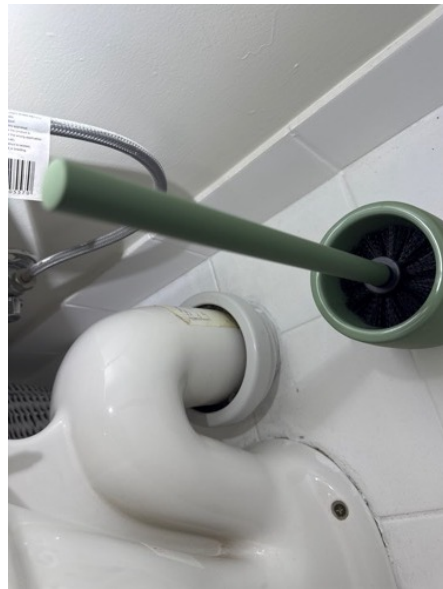
Observation 3.14

Location: Ensuite

Finding: No visible Leak

No visible leak was observed at the time of inspection.
The flexible hoses are prone to deteriorate. It is always recommended to replace the flexible hoses every five years.

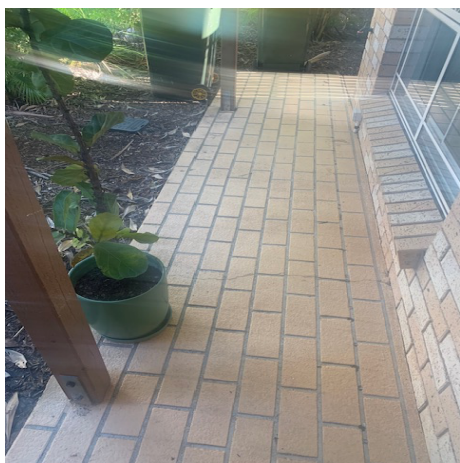
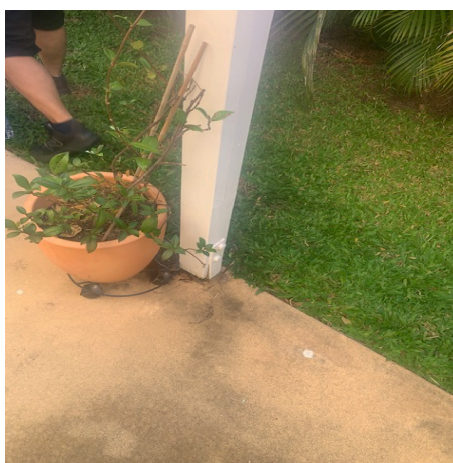
The following evidence was found evidence was found.

Trim end of posts in stirrup, so that it not on ground
