# **VISUAL BUILDING INSPECTION REPORT**

Inspection Date: 22/07/2025.

27 Cramp St, Goodna QLD 4300.

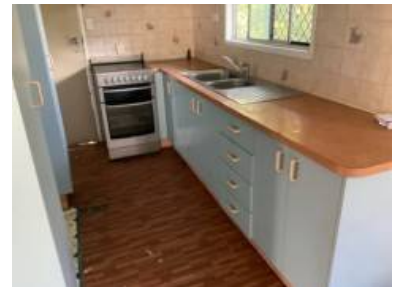
This area is generally in poor condition, and due to the level of maintenance/repairs needed, would rate this area as below average.

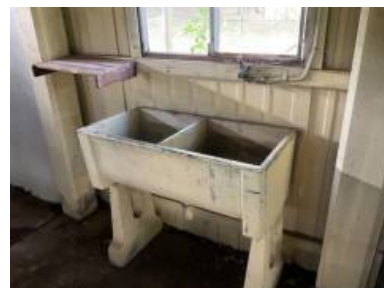
Old Style.

The tub is loose and should be secured to the wall.

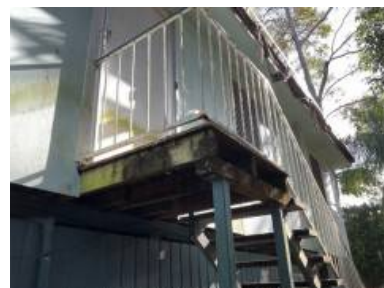
**Position/Location:** Right hand side elevation.

**Construction & Condition:** Constructed from timber and metal The general condition of this structure is fair.

**Defects or Maintenance Items:** Moderate to extensive rust/corrosion to metal posts supporting structure. Rectification required.

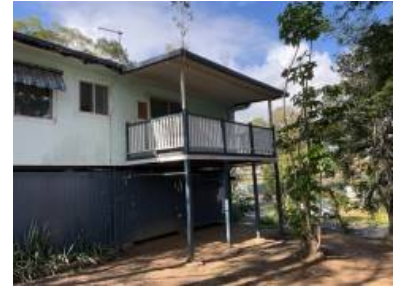
Constructed from timber, The general condition of this structure is fair.

Leaves and debris are present in gutters. These should be cleared. Removal of debris will extend life of guttering and prevent water penetration to roof cavities.

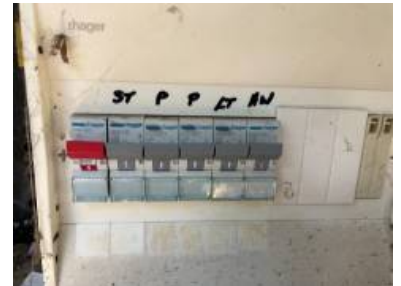
A safety switch was found to be installed.  
Note: only a licensed electrician can verify if safety switch is connected to appropriate circuits.

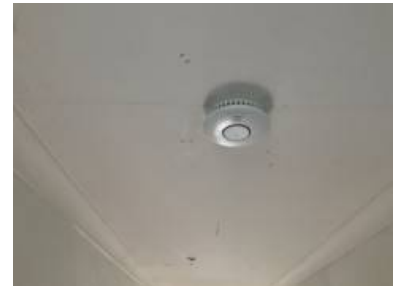
Smoke detectors are fitted. The Inspector has not checked the type or quality of the alarm/s, the battery condition or if they are hardwired to the 240 volt power supply or are compliant with current standards. It is essential to check the smoke alarms when you take possession of the property. For more information about smoke alarms go to the web site [www.qfes.qld.gov.au/community-safety/smokealarms](http://www.qfes.qld.gov.au/community-safety/smokealarms) Dwellings being sold, leased or and existing leases renewed, new smoke alarm requirements are effective from 1 January 2022. It is essential that a licenced electrician be consulted to check on positioning and installation of the smoke alarm(s) to whether the smoke alarm(s) meet the requirements of the legislation, homeowners should contact the Queensland Fire & Rescue Service Regional Manager Community Safety for advice.

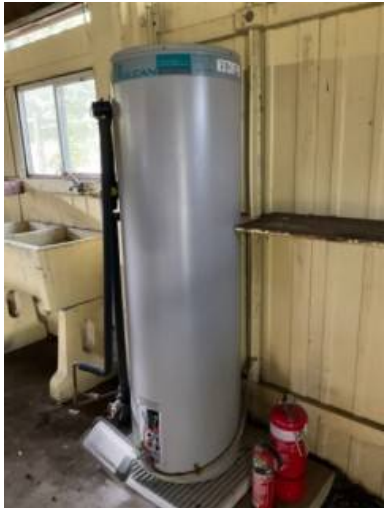
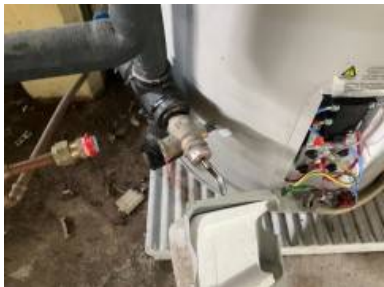
**Hot water is provided by the following:** Mains electric hot water system: Located under the house:

The hot water system was not in service at the time of inspection and accordingly no comment on this system is offered.

**Age of Unit:** The unit was manufactured in 2022.
