## Building Inspection Report

Inspection Date: Wed, 24 Sep 2025

Property Address: 35/1 Grenada Way, Parrearra QLD 4575,  
Australia

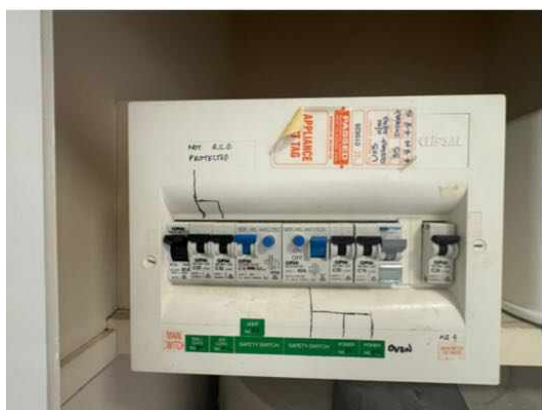
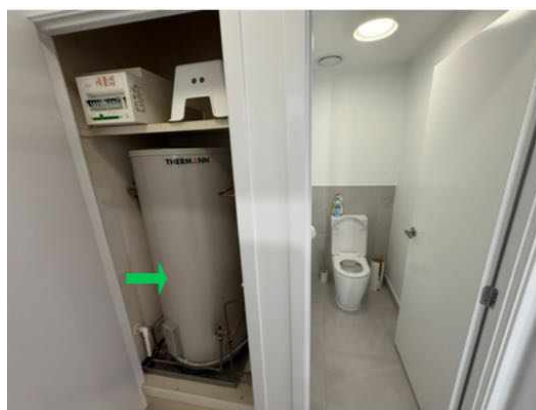
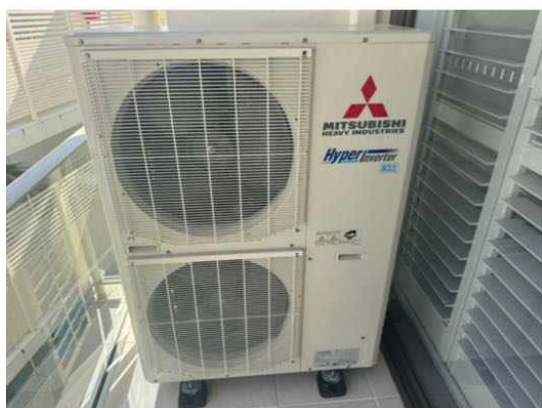
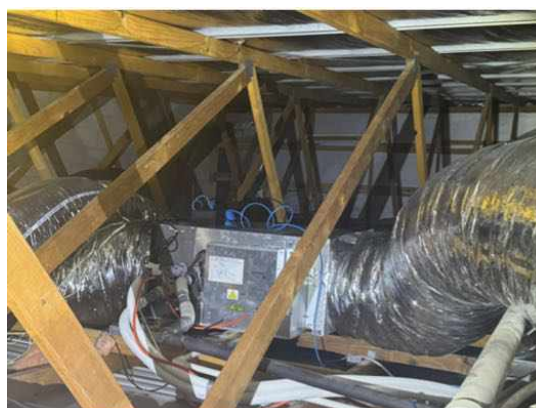
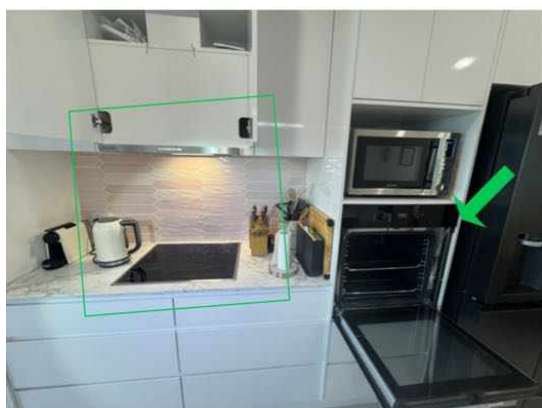
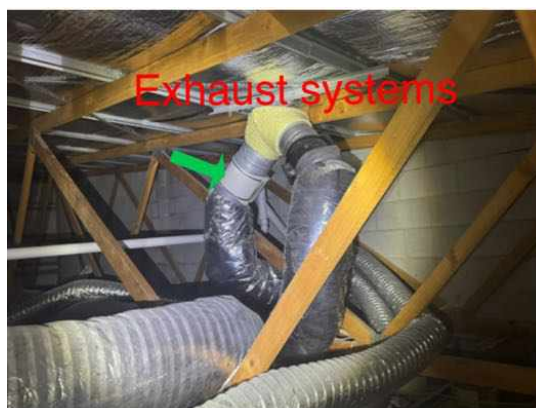
Building: Not Applicable  
 Location: All Areas > All Areas  
 Finding: Plumbing and Electrical  
 Information: Plumbing and electrical inspections are outside the scope of the building inspection and must be conducted by a Licensed and registered Trades person.

Whilst we note and comment of visually apparent defects that present during the building inspection, legislation requires the checking and documenting of compliance for plumbing and electrical requirements be done by licensed electrician and plumbers respectively to ensure they are functioning correctly.

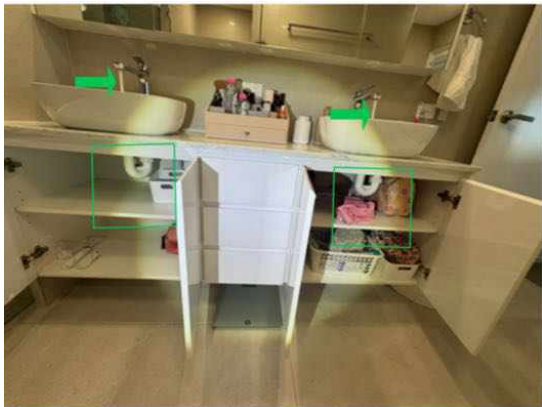
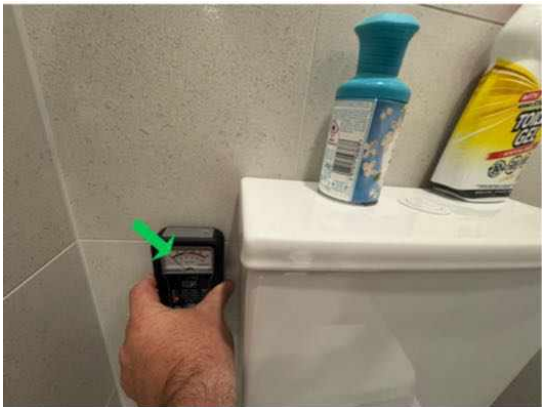
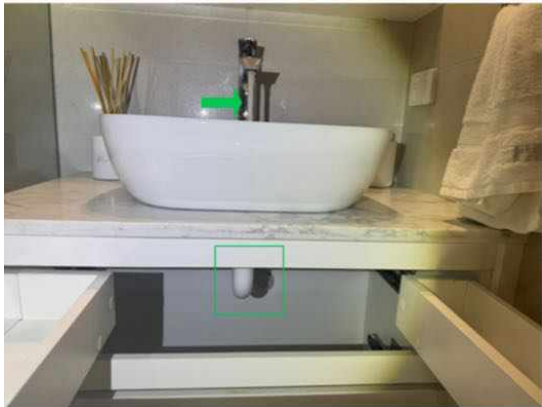
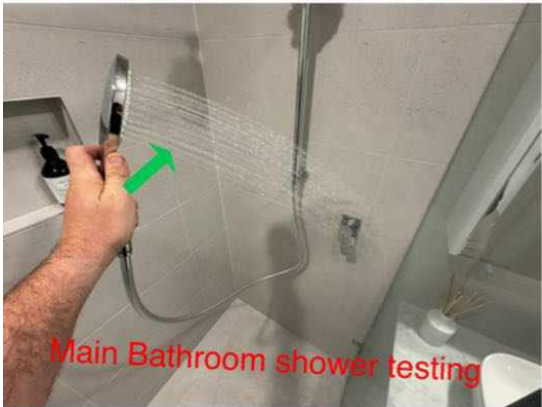
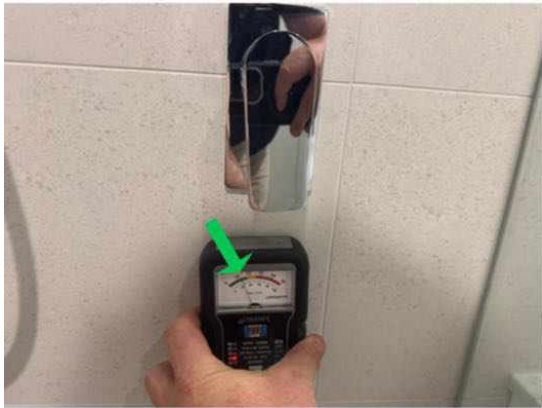
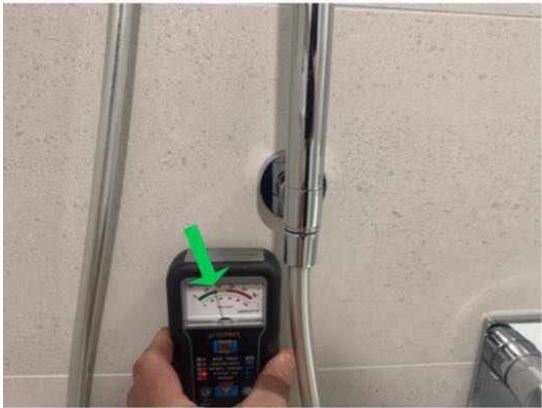
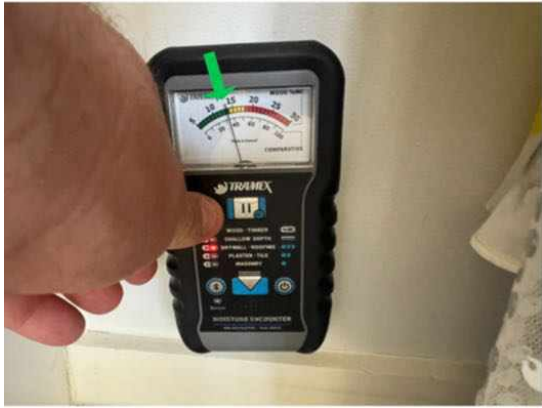
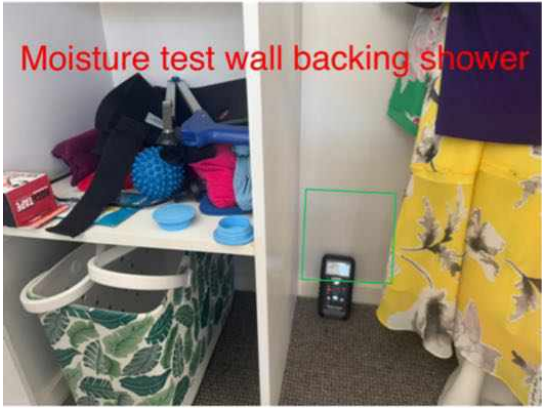
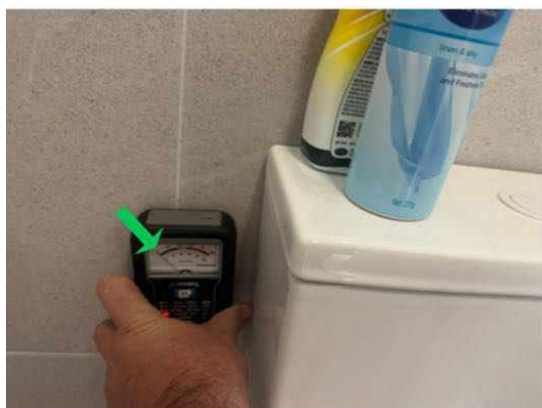
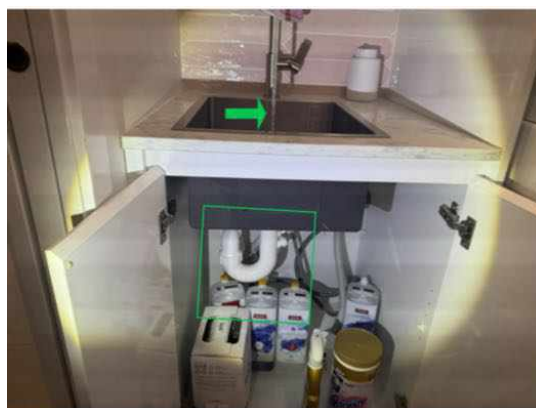
Building: Main Building  
 Location: All Internal Plumbing Areas > All Areas  
 Finding: Shower/ plumbing testing  
 Information: No evidence of any water leaks to the showers, vanities or sinks when water was run for minimum 5 mins over all walls of showers and 30 secs in vessels (sinks and vanities)

Moisture meter testing completed on all opposition sides of shower wet areas flooded and all findings were found to be within the normal range.

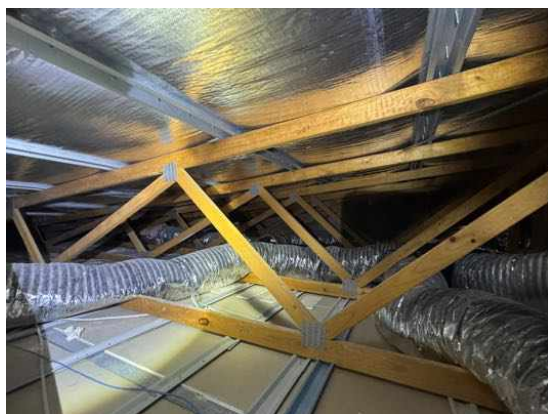
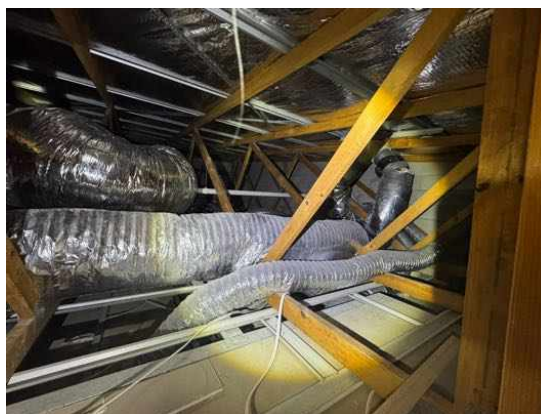
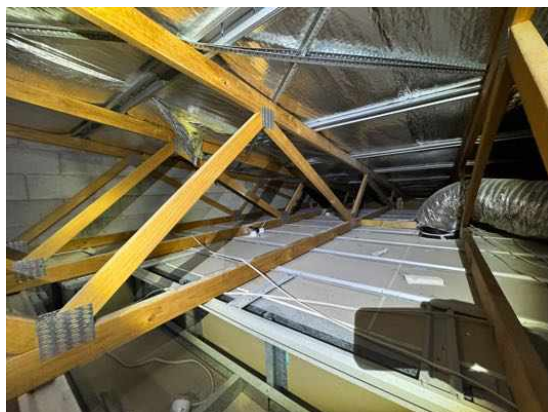
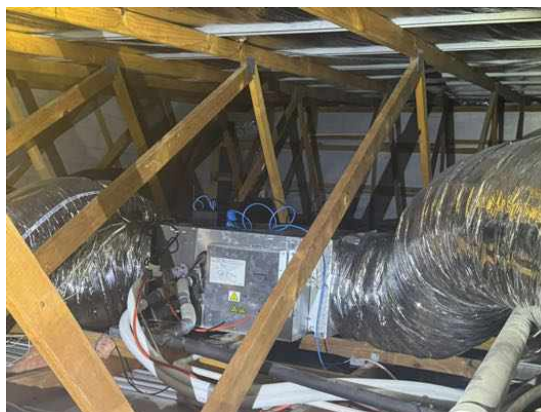
Information: These photographs are an indication of the obstructions and limitations which impeded full inspection of the property at the time of inspection. These obstructions can hide an array of defects and should be removed to allow full inspection to be carried out. A re-inspection is recommended once the areas are made accessible.

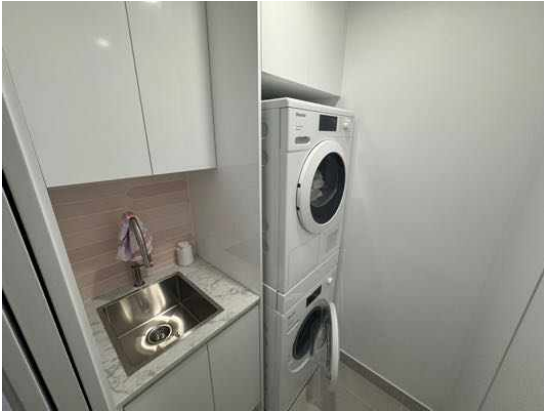
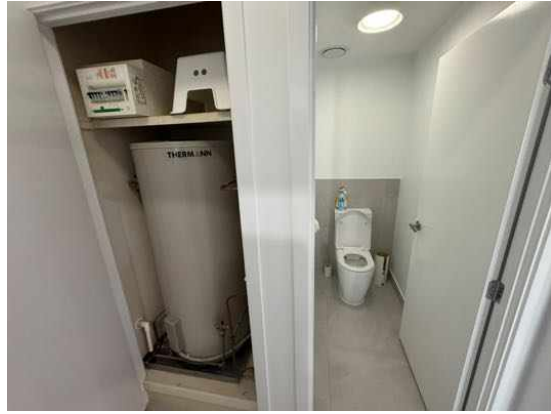
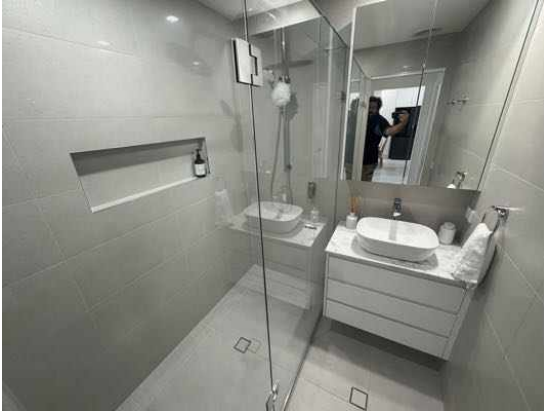
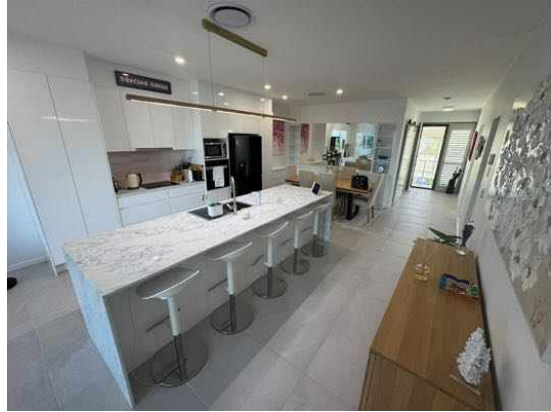
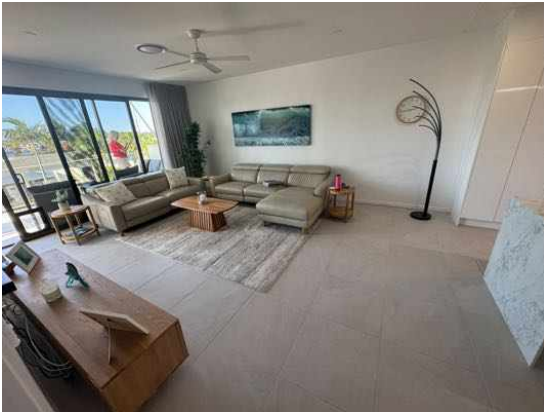
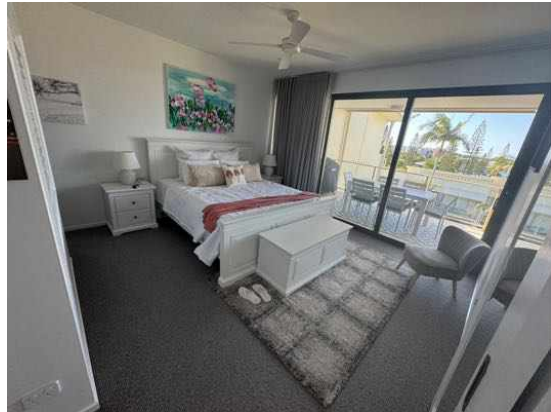
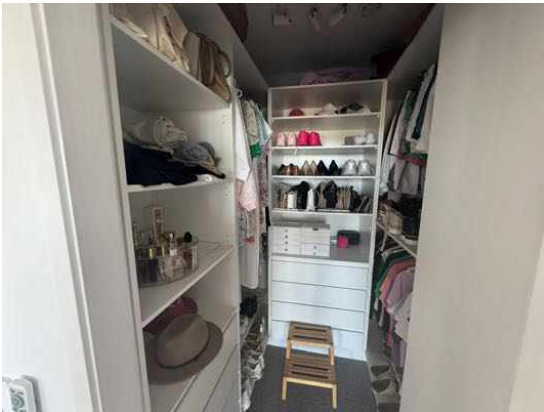
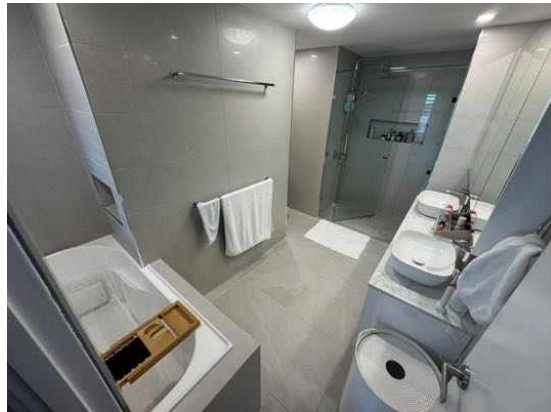
Building: Main Building  
 Location: All Internal Areas > All Areas  
 Finding: Additional Photos - Obstructions and Limitations (Internally)  
 Information: These photographs are an indication of the obstructions and limitations which impeded full inspection of the property at the time of inspection. These obstructions can hide an array of defects and should be removed to allow full inspection to be carried out. A re-inspection is recommended once the areas are made accessible.

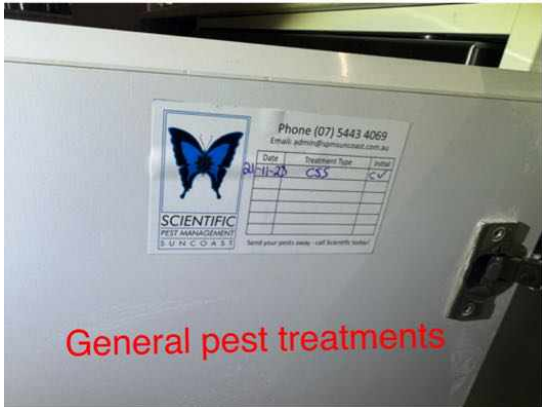
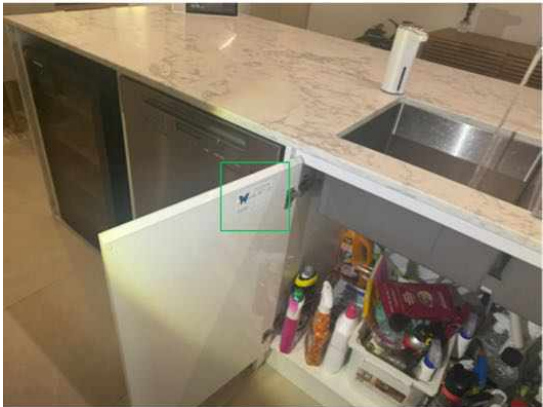
Building: Main Building  
Location: All Areas > All Areas  
Finding: Additional Photos  
Information: Additional photos are provided for your general reference
