**Inspector Homes Limited**

## **Building Inspection Report on...**

**19 Bramley Drive, Omokoroa**

## CERTIFICATE OF INSPECTION IN ACCORDANCE WITH NZS 4306:2005 Standard Residential Property Inspection

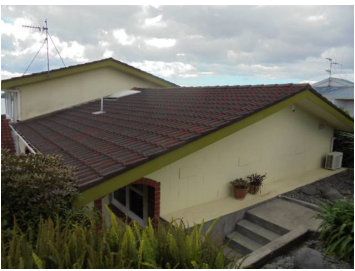
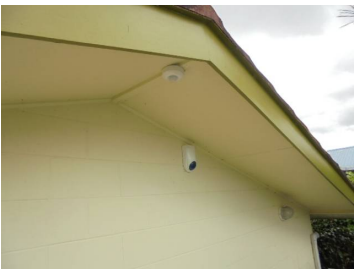
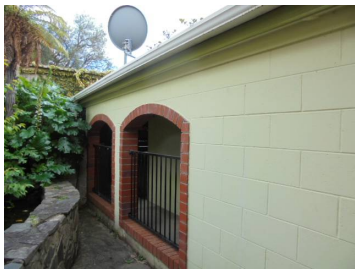
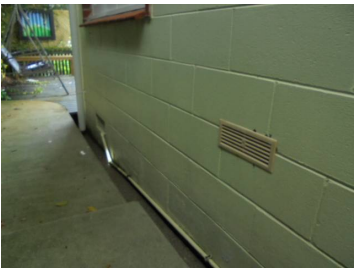
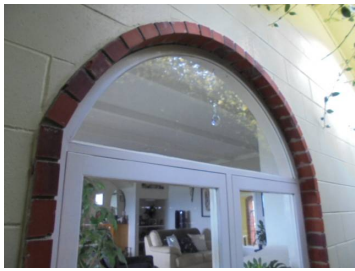
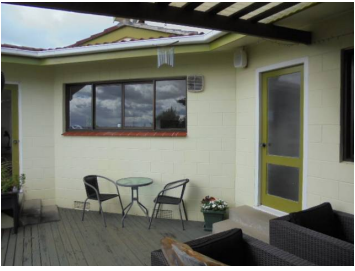
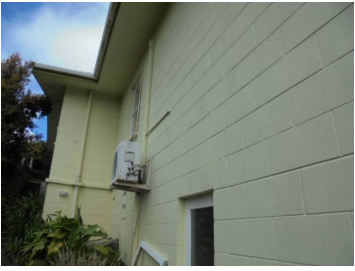
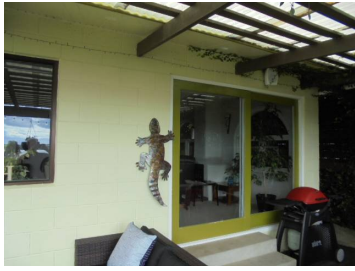
The exterior of the blockwork and the plastered upper floor cladding and are in generally functional condition but coming due for repainting; the plastered fibre cement sheet upper floor cladding has some cracking to the sheet joins and these should be ground out, sealed and re-plastered prior to repainting. The window joinery is in good and functional condition for its age; easing to some window sashes is recommended.

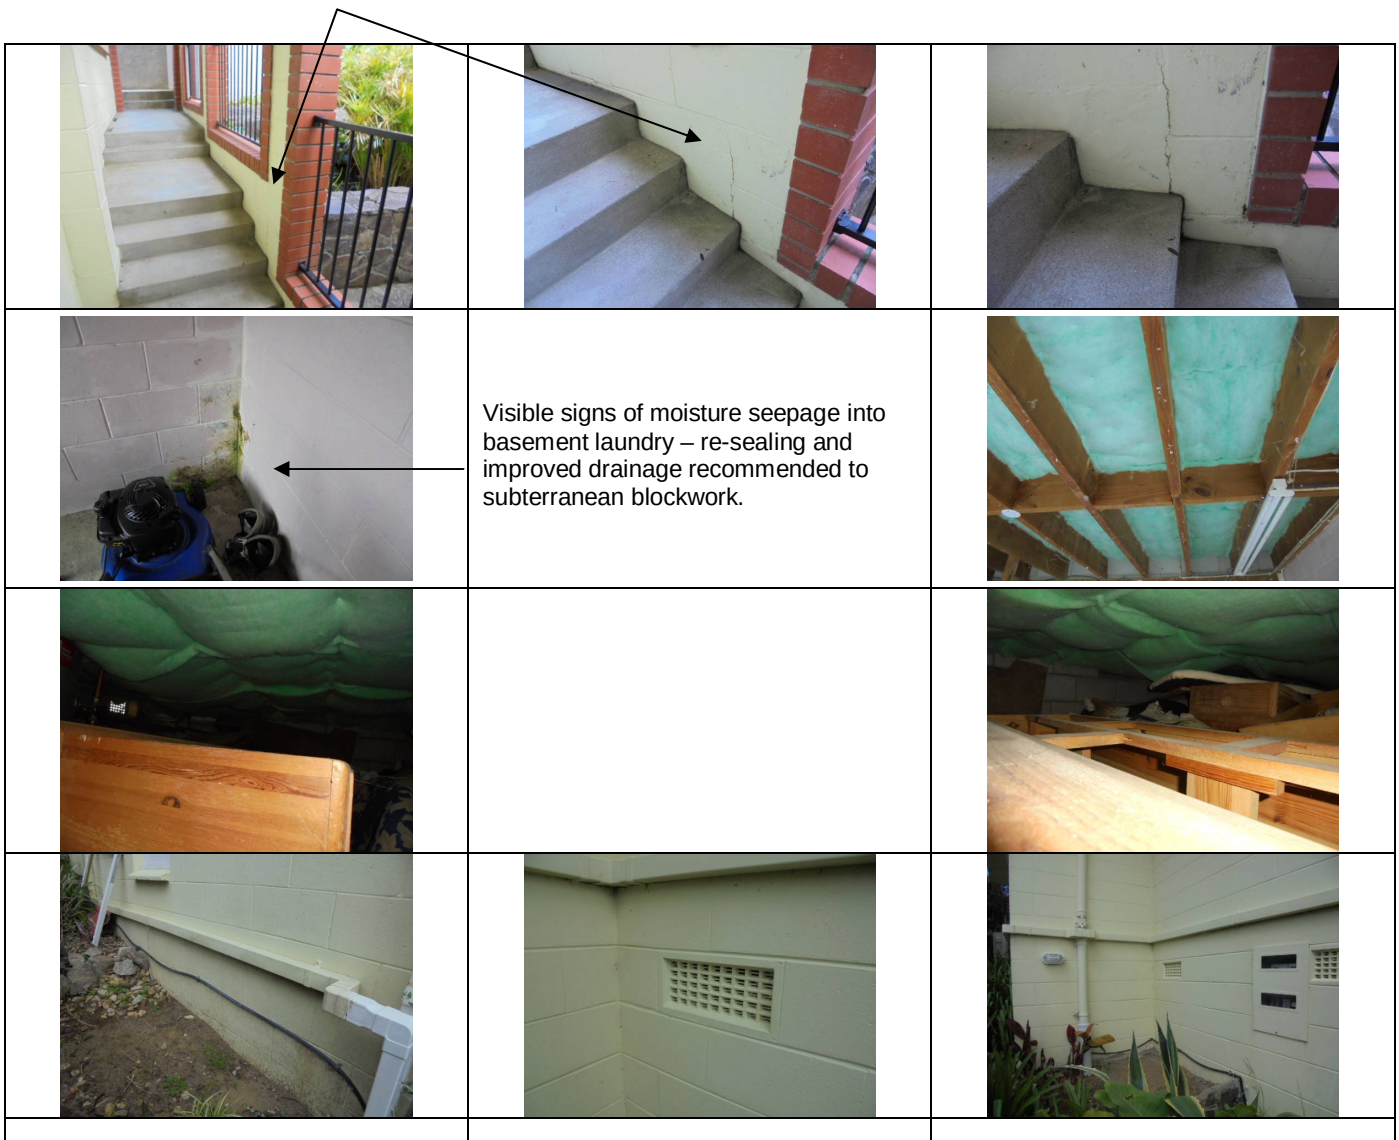
No movement, cracking or subsidence was noted to any area of this dwelling in relation to the foundations. One small area of minor 'step-cracking' was sighted adjacent to the entrance door foyer but in our opinion is considered normal and not of concern at this time.

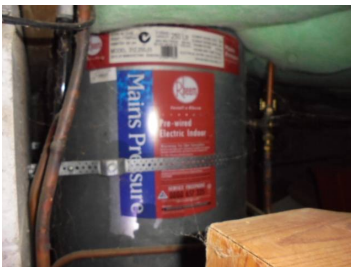
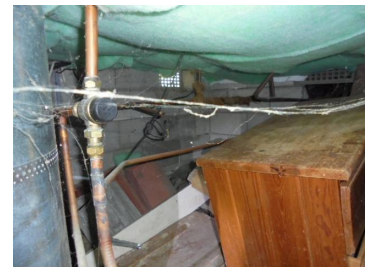
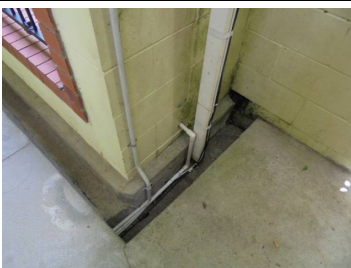
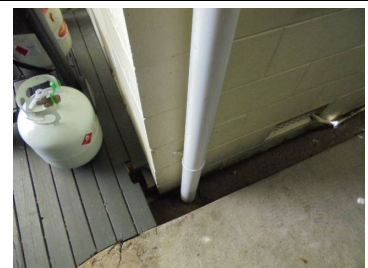
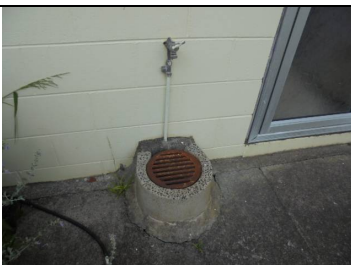
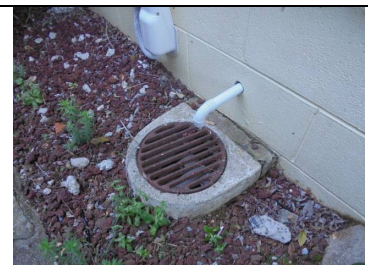
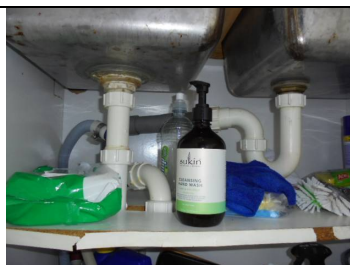
The plumbing and drainage components to this property are in generally functional condition and no serious defects were noted.

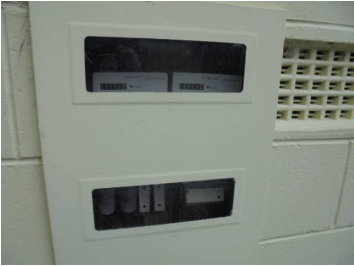
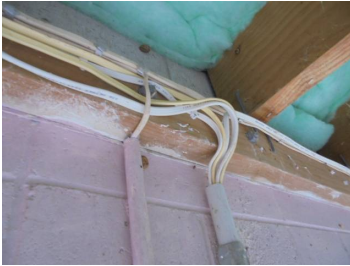
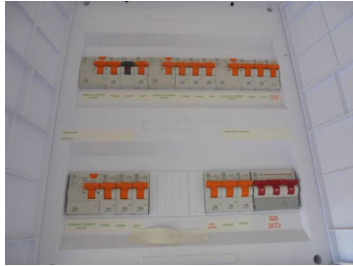
No serious issues or defects were noted to the electrical systems on this property – no testing of hotpoints was carried out. No specific circuit or breaker was sighted for the spa pool.

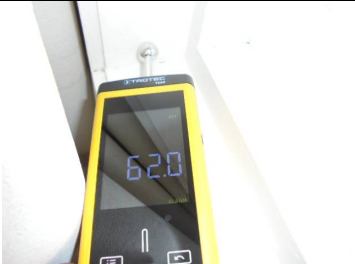
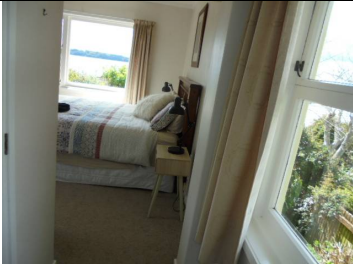
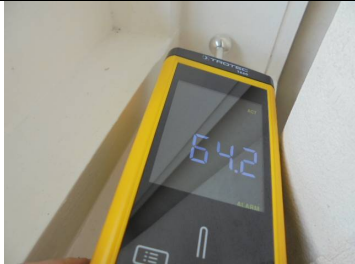
| <p>The readings to this window were slightly higher due its more exposed nature – keeping it well maintained is important</p> | | |

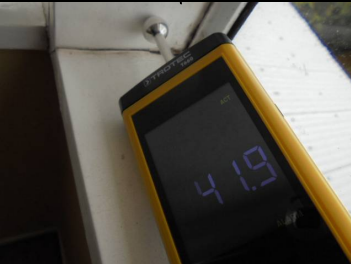
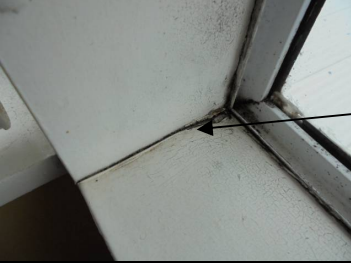
| | | <p>Visible signs of moisture affected timber to sill (minor) - internal condensation can also be a factor, so good ventilation is important.</p> |
| | <p>Maintaining rubber glazing gaskets and sealing aluminium joinery to plaster cladding is important</p> | |

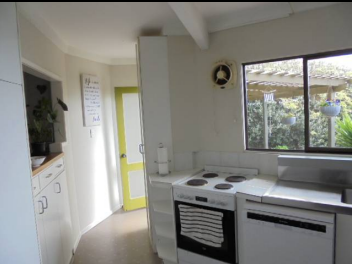
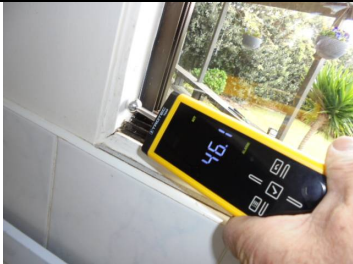
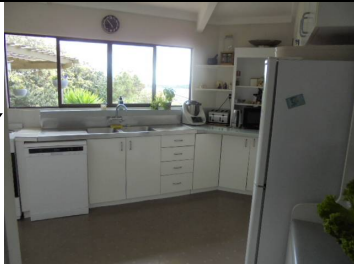
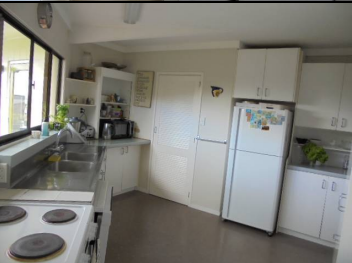
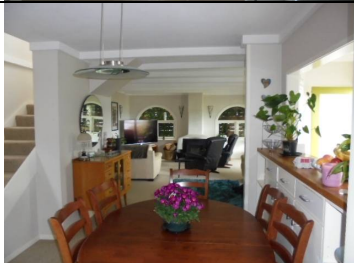
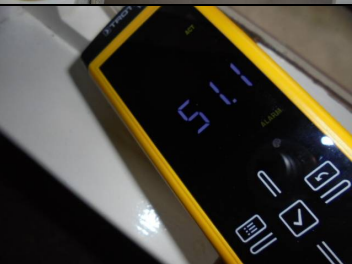
The kitchen, dining and living areas are in good functional and well maintained condition, showing normal wear and tear consistent for the age of the property, but the décor is a bit dated. No serious defects were identified and no moisture issues were detected. A random selection of indicative moisture readings are shown below.

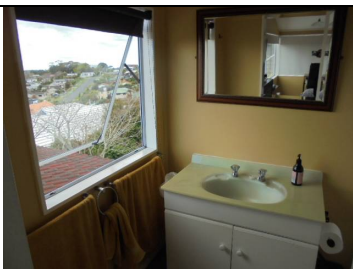
The main bathroom appears to have been refurbished in recent years and is in good order with no defects or moisture issues detected to the windows. Excessive moisture was detected to the base of the ensuite shower which is coming due for refurbishment.

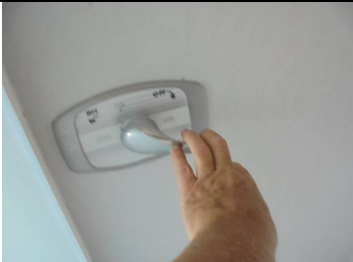
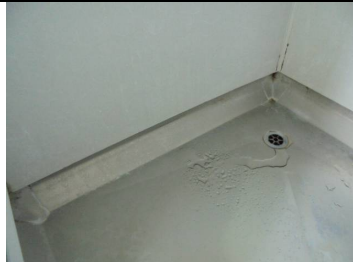
| <p>This shower mixer is due for replacement.</p> | | <p>Even though these aqua panel shower wall linings are in reasonably good order for their age, they do have a limited lifespan and refurbishment is coming due.</p> |

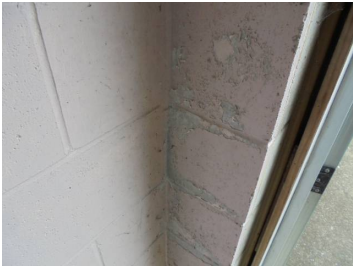
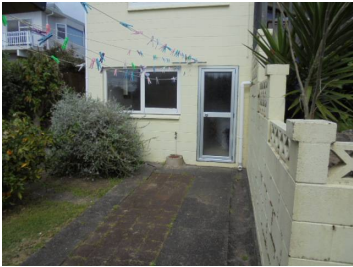
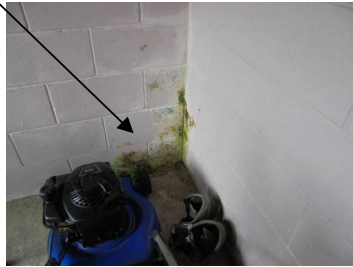
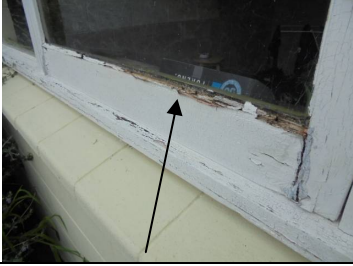
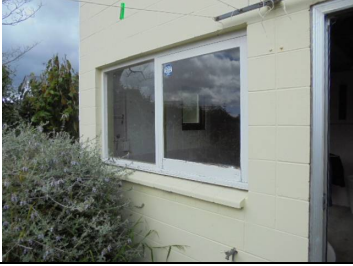
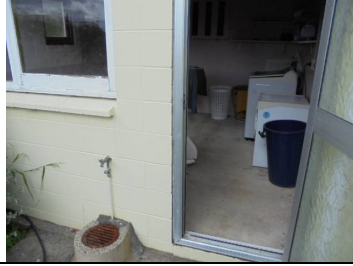
The laundry is located in the basement with no internal access and is in basic functional condition. The concrete block walls form part of the foundation of the dwelling above. Some dampness to the block walls below the exterior ground level was noted.

| The window needs repairs and maintenance | | |
