# FIRE SAFETY & BUILDING CODE OF AUSTRALIA ASSESSMENT REPORT (BCA 2013 Edition)

**18 THROSBY STREET, WICKHAM**

# Peer review of fire engineering report

18 Throsby Street, Wickham

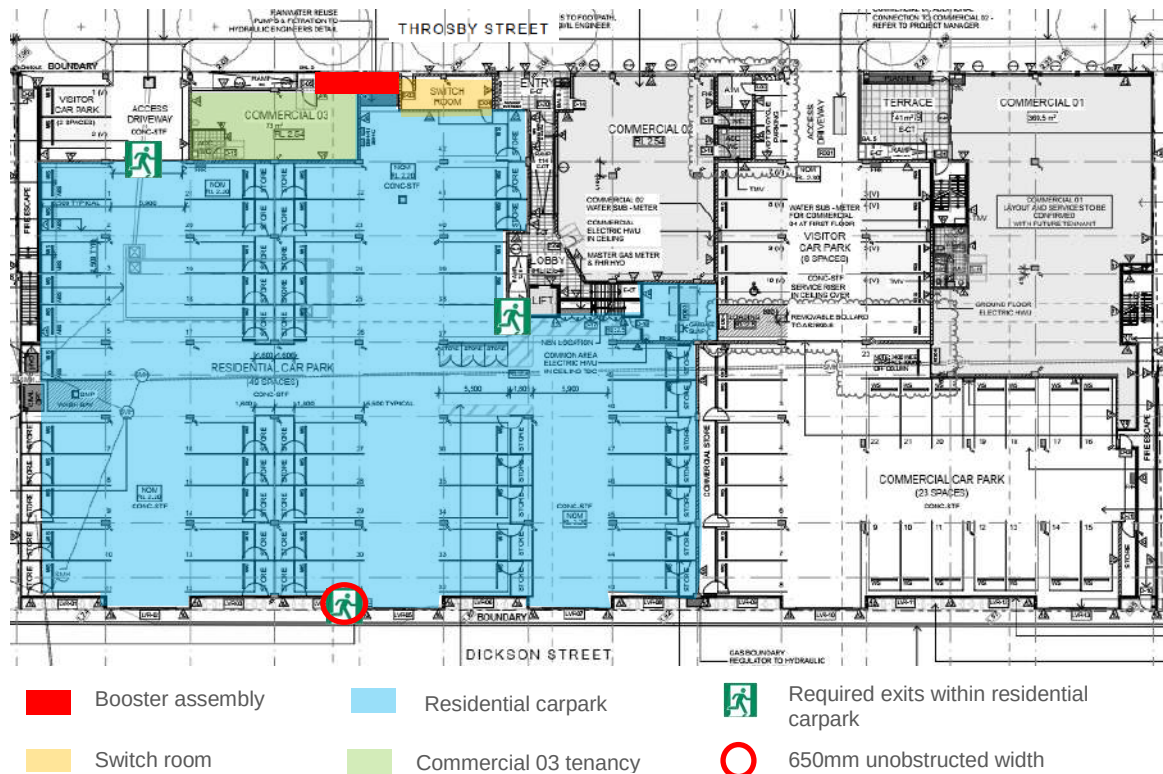
**Figure 3** Location of the hydrant booster assembly and residential carpark exits – ground floor

6. The southern exit doorway within the residential carpark which provides egress onto Dickson Street may have a reduced unobstructed width of 650mm instead of 750mm – refer to Figure 3.

8. A fire hydrant system must be installed throughout the building in accordance with requirements of clause E1.3 of the BCA and AS 2419.1-2005, with the exception that the booster assembly is not provided with fire rated protection extending 2m on each side of and 3m above the upper hose connections in the booster assembly. The booster assembly is located within the northern external façade of the building, adjacent to the switch room and the Commercial 03 tenancy. Refer to Figure 3.

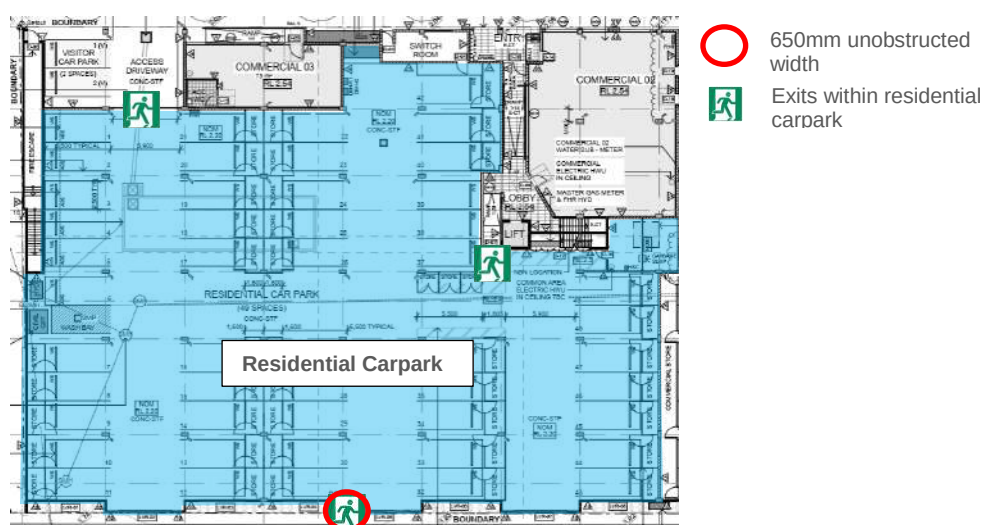
Figure 4 Exits within the residential carpark – ground floor

The southern exit door located on the ground floor residential carpark providing egress out to Dickson Street has an unobstructed width of 650mm instead of 750mm – refer to Figure 4.

Occupants within the residential carpark area expected to utilise the exit will mainly be associated with the residential sole-occupancy units of level 1 and 2. The population expected in the residential carpark is estimated to be 53 in accordance with table D1.13 of the BCA. The residential carpark is provided with three required exits in compliance with the travel distance requirements of clauses D1.4 and D1.5 of the BCA – refer to Figure 4. Assuming an even distribution of occupants through all three available exits, each exit is expected to serve 17 – 18 occupants. On this basis, no significant crowding is expected at the southern exit. It should also be noted that the assumed population is substantially less than the 100 persons implied by clause D1.6 of the BCA to be catered for by an unobstructed exit with a 750mm doorway.

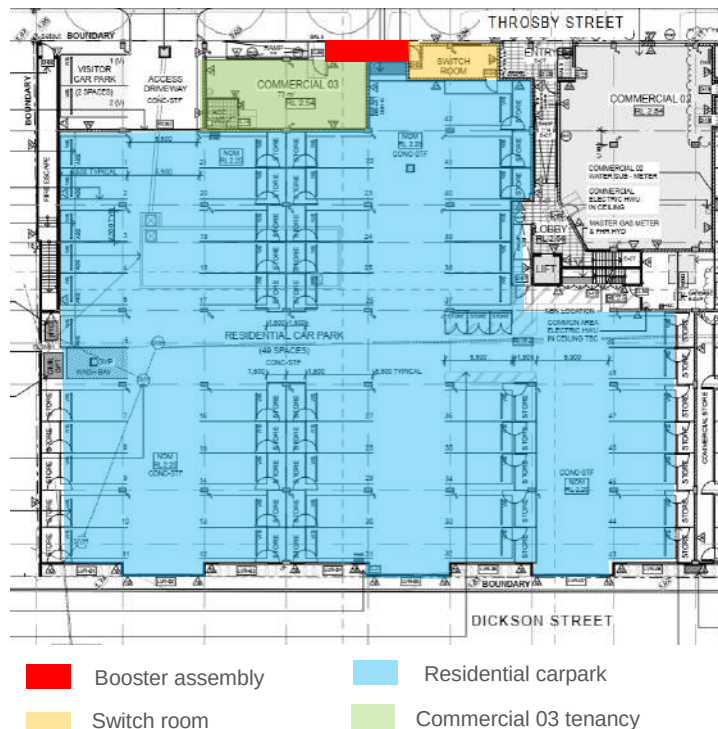
Figure 5 Location of booster assembly – ground floor

The hydrant booster assembly is not provided with fire rated protection extending 2m on each side of the suction and booster valves and for a height of not less than 3m above the upper hose connection.

The fire hydrant booster assembly is located within the northern external façade of the building, adjacent to the switch room and the Commercial 03 tenancy. To the south of the booster is the residential car park. Directly above the booster assembly on level 1 are residential sole-occupancy units Unit 4 and Unit 5. The main vehicular and pedestrian entries to the building are from Throsby Street to the north. Refer to Figure 5.
