## Timber Pest Inspection Report

40 Arthur Way, Ormeau, QLD, 4208

Inspection prepared for: Han Na Cho

Date of Inspection: 1/10/2025 Time: 9:00 AM

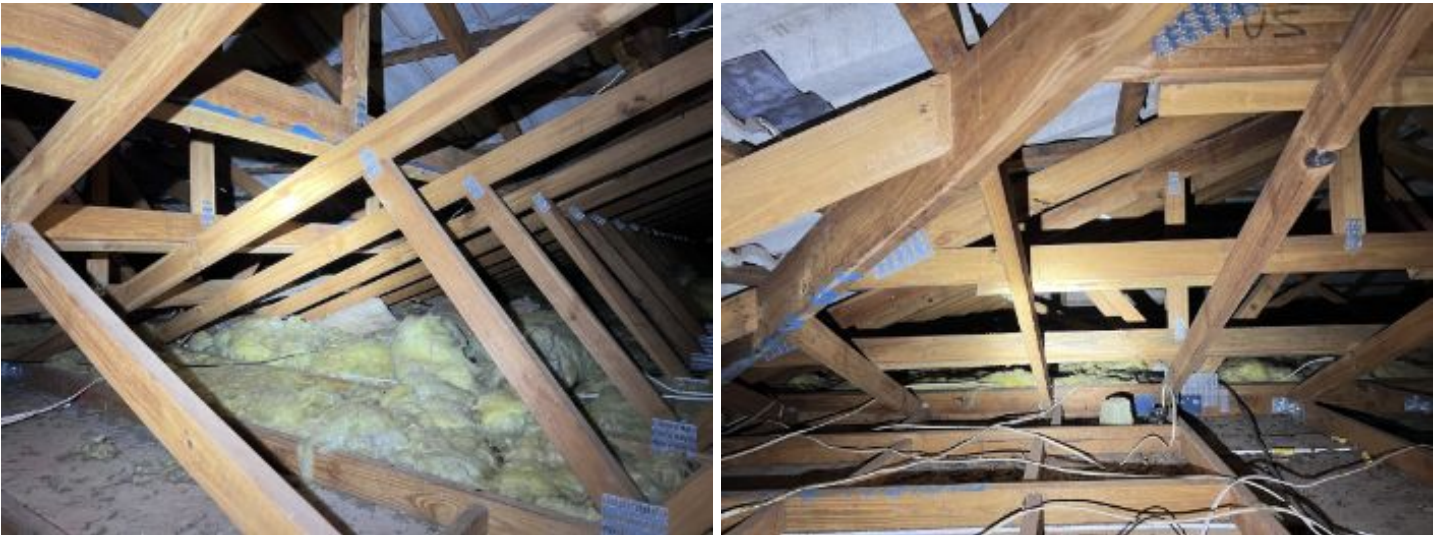
- The Roof space visual inspection was obstructed or restricted because: insulation, pitch and frame design.

Important: If a complete inspection of the above areas was not possible, timber pest activity and/or damage may exist in these areas. Further Inspections are strongly recommended to areas where Reasonable Access is Unavailable, Obstructed or Restricted or a High Risk of possible Timber Pests and /or Damage exists.

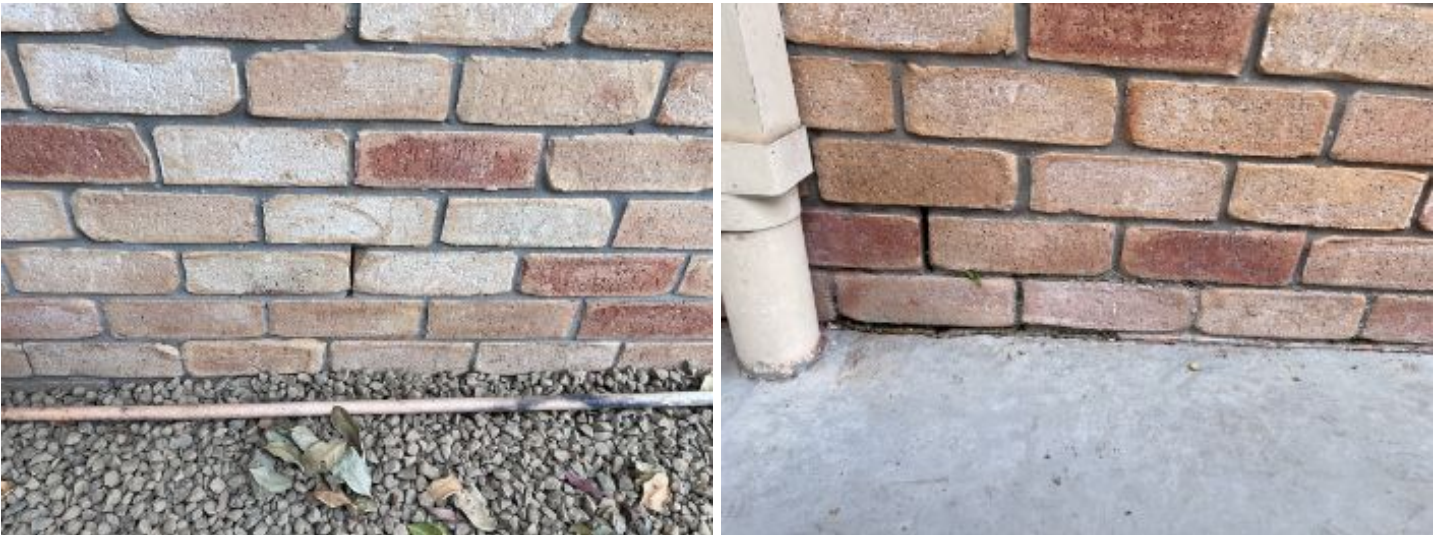
- The weep holes were clear allowing the free flow of air.
