TD BUILDING & INSPECTIONS
Offering Real Values

Vendor Pre-Sale Building & Timber Pest Inspection Report

114 North Rd, Woodridge QLD, Australia

Vendor Pre-Sale Building and Timber Pest Inspection - Vendor Pre-Sale Building & Timber Pest Inspection Report w/ Photos**10 Sep 2025**

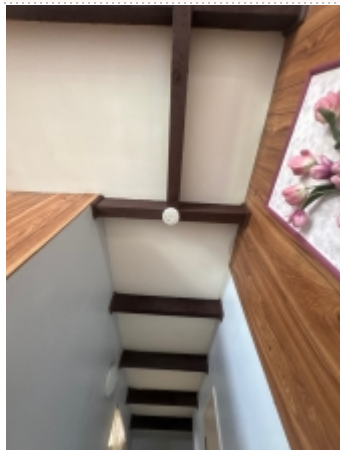
No manhole was observed

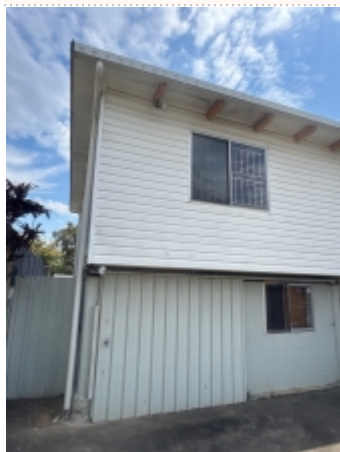
Showing examples of roof exterior

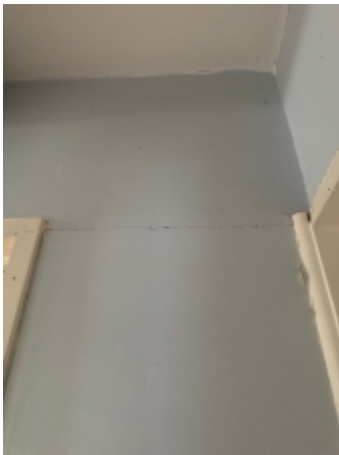
Defect Severity	Minor Defect
Defective Item	Walls
Defect	Cracks
Comment	Minor visible cracks present, but these do not affect structural integrity. Potentially caused by settlement or temperature change

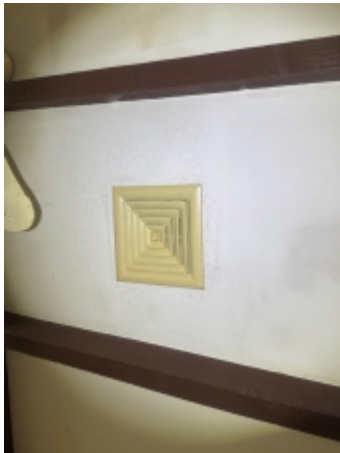
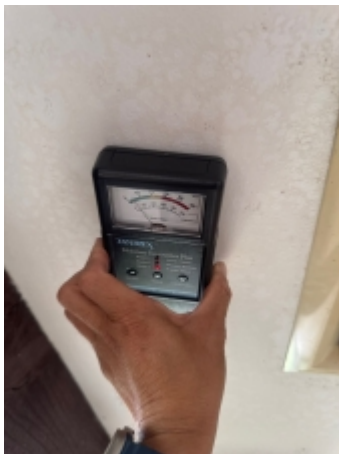
Defect Severity	Major Defect
Defective Item	Ceilings
Defect	Moisture
Comment	Signs of water staining were observed on the ceiling at multiple areas. However, no elevated moisture levels were detected at the time of inspection. It is recommended to engage a licensed builder for further investigation and necessary repairs to reduce the risk of water penetration and further deterioration.

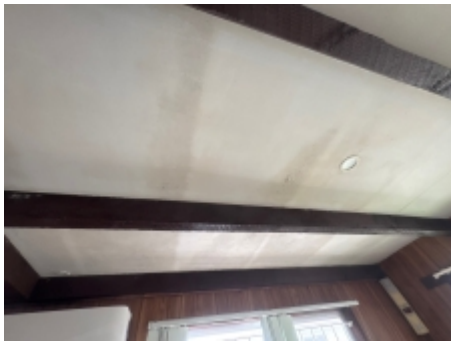
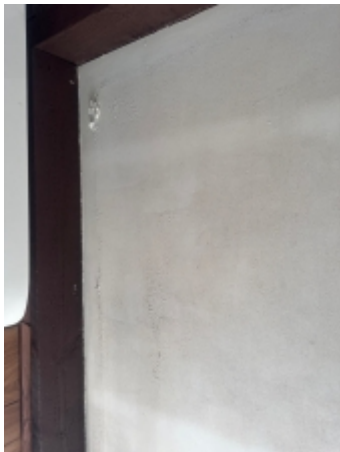
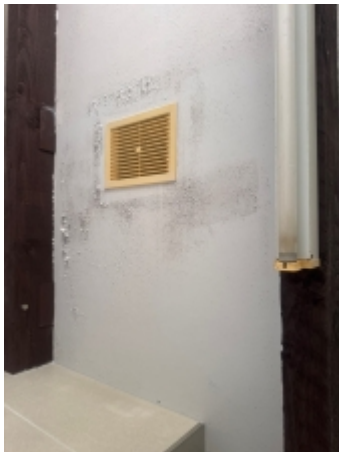
Defect Severity	Major Defect
Defective Item	Ceilings
Defect	Paint deterioration
Comment	Paint deterioration was noted on the ceilings. It is recommended to engage a painter to rectify the issue and reduce the risk of further deterioration.

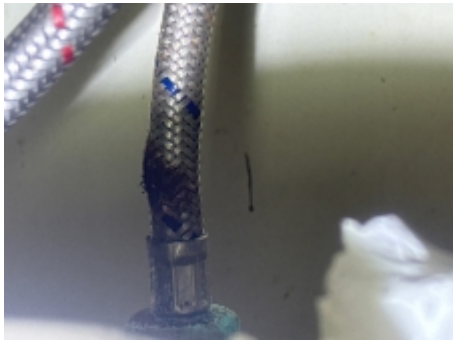
Defect Severity	Major Defect
Defective Item	Kitchen Sink/Taps
Defect	Rust hose

Comment	Rust and/or damage to braided inlet hose to taps. Recommend engaging a plumber to replace to reduce the risk of further deterioration and property damage.
---------	--

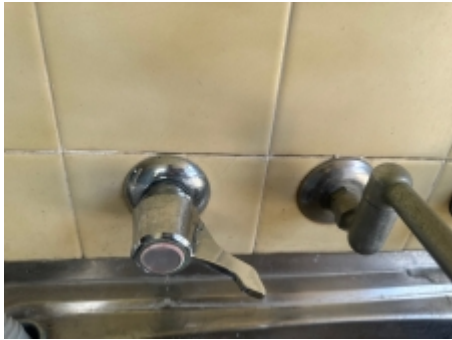
Defect Severity	Major Defect
Defective Item	Laundry Tiles
Defect	Cracks & grout
Comment	Cracked tiles and defective grout/sealant/silicone were observed in the wet area. It is recommended to engage a qualified tiler to carry out repairs in order to reduce the risk of water penetration and further deterioration.

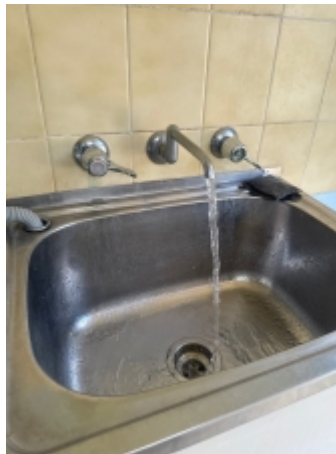
Defect Severity	Major Defect
Defective Item	Laundry Taps
Defect	Leaks
Comment	Water leakage observed from the taps, potentially resulting in water wastage and possible water damage. It is recommended to engage a licensed plumber to rectify the issue to minimise the risk of water-related problems.

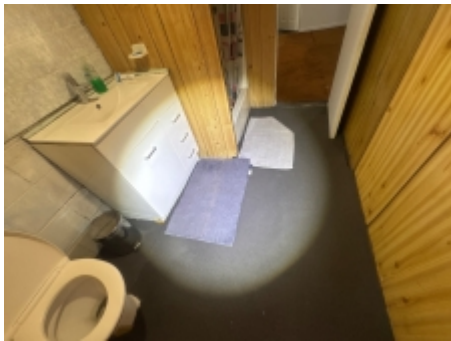
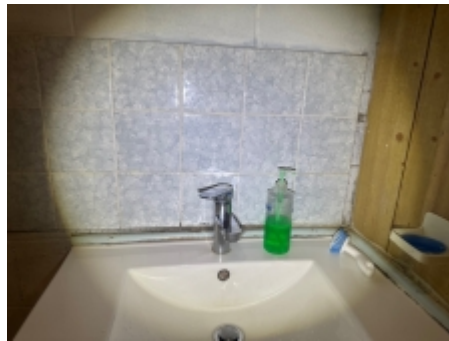
Defect Severity	Major Defect
Defective Item	Bathroom Tiles
Defect	No tiles
Comment	Tiles are not present in the bathroom downstairs. It is recommended that tiles be installed by a licensed tiler to prevent water-related problems.

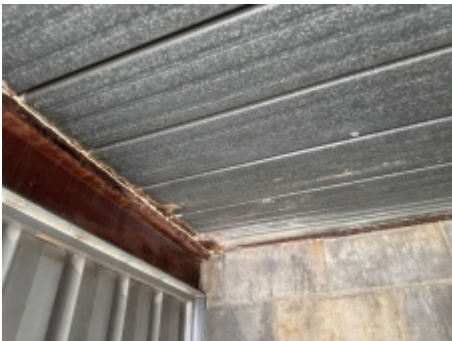
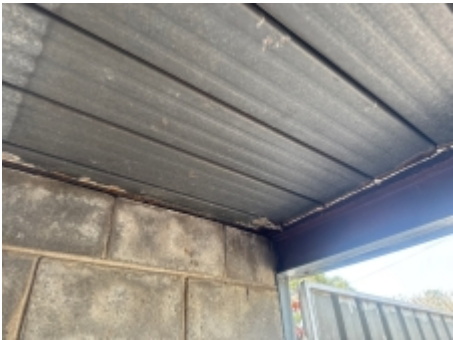
Defect Severity	Major Defect
Comment	Rust to parts of metal components. Recommend engaging a suitable trade person to rectify the issue to reduce the risk of further deterioration

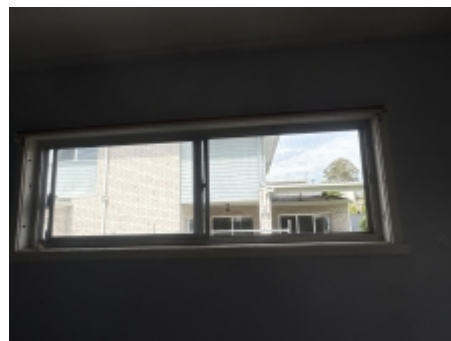
Defective Item	Doors and Windows
Defect	No fall prevention
Comment	Fall prevention measures were not observed on the upper-level windows. It is recommended to engage a builder to install appropriate safety measures to reduce the risk of falls.

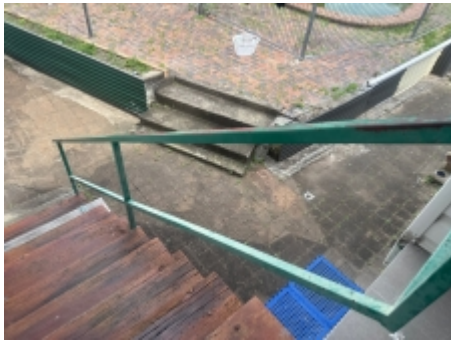
Defect Severity	Major Defect
Defective Item	Balustrades
Defect	Non-Compliant Balustrade Spacing
Comment	There are gaps within the balustrades that exceed the maximum allowable opening. As per NCC requirements, a 125 mm sphere must not be able to pass through any part of the balustrade. It is recommended that the balustrades be modified to comply with the spacing requirements to ensure occupant safety and regulatory compliance.

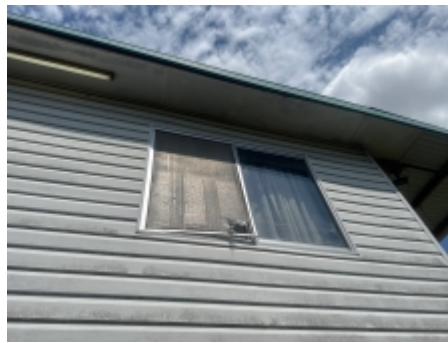
Comment	<p>The doors and/or window frames appear aged, weathered, and show signs of material deterioration, likely due to prolonged exposure to environmental elements. This may impact their functionality, appearance, and weather resistance. It is recommended to engage a licensed carpenter or suitable tradesperson to assess the condition and undertake repairs or replacements as necessary to restore proper function and prevent further deterioration.</p>
---------	---

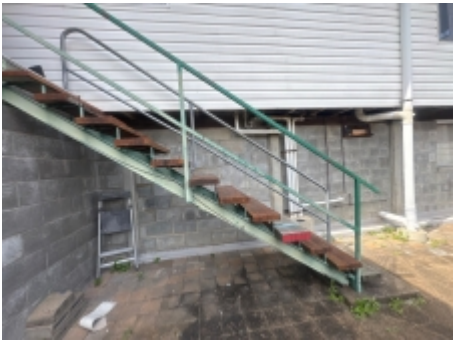
Defect Severity	Major Defect
Comment	Timber stair treads show evidence of wood rot. It is recommended to engage a licensed carpenter or builder to replace the affected stair treads.

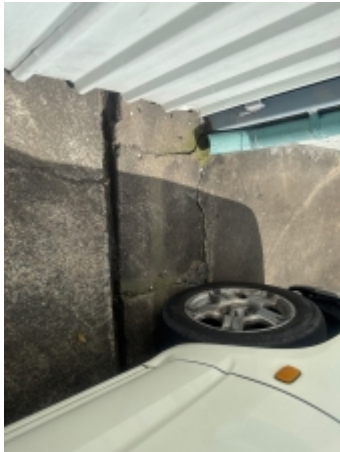
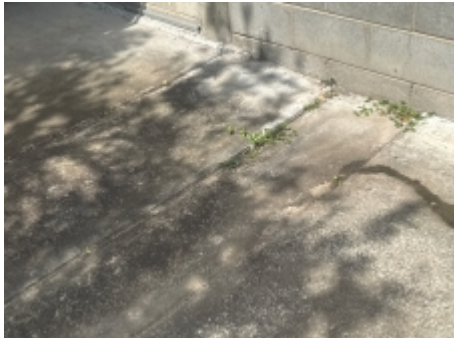
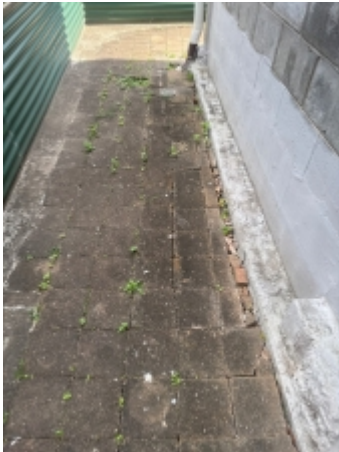
Defect Severity	Safety Hazard
Defective Item	Paths and driveways
Defect	Uneven or Trip Hazards
Comment	Signs of uneven surfaces or potential trip hazards observed on the paths, posing a risk to safety. It is recommended to engage a builder or a suitable trade person to rectify the issue and reduce the risk of personal injury

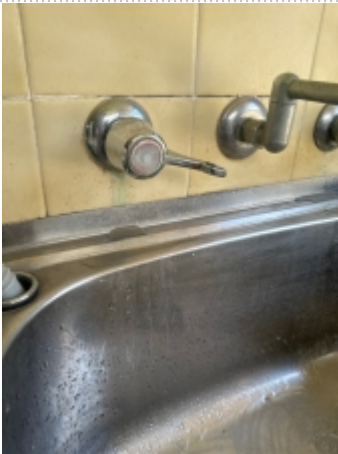
Were water leaks found at the time of inspection? **Yes**

Visible leaks were located in the following areas: **Taps**

If leaks are detected, it is recommended that a suitably qualified plumber or builder is engaged to rectify as soon as possible.

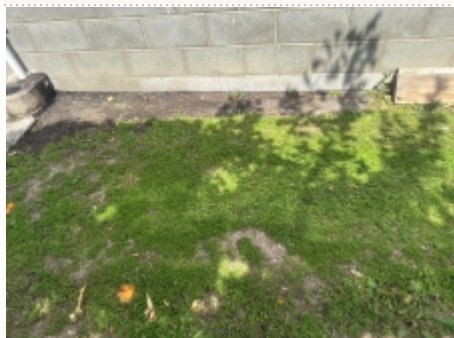
Inadequate

Where site drainage is deemed inadequate, remedial action should be undertaken by an engineer, plumber, drainer or licensed builder.

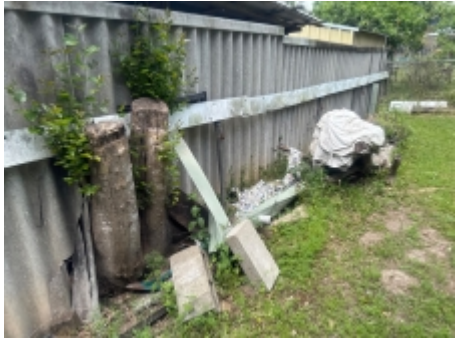
Details of other conducive conditions	Stumps and timber debris were observed throughout the yard. It is recommended to remove all timber and stumps to maintain site cleanliness and safety.
---------------------------------------	--
