# Property Inspection Report

55 Clearwater Street,  
Bethania, 4205, QLD

Inspection Prepared for:  
Phuong Mai

Date of Inspection: 24/10/2025 | Time: 4:30 PM

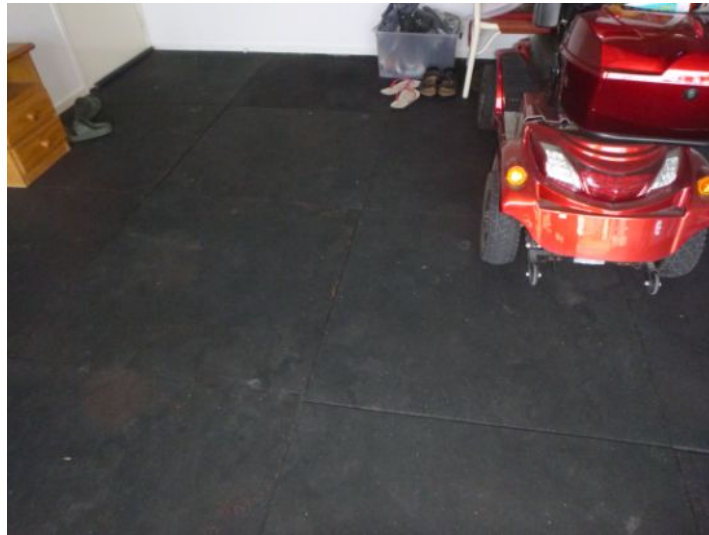
## 1. Slab Foundation

- As our inspection is a AS4349.1-2007 visual inspection, we cannot conclusively state the condition of the foundations. Foundations can be subject to various forms of movement such as wetting and drying causing shrinkage and expansion or earth movement. The inspection does not involve physical structural testing of any component of the building nor did it involve excavation of the site or removal and testing of any materials upon the site or components of the structure.
- Any significant tree within close proximity to the structure may have an influence upon the foundation material/footings and if applicable we would recommend that further advice be sought from an expert.
- Visible sections of the concrete slab appeared satisfactory.
- Most areas of the concrete slab not visible due to floor coverings.

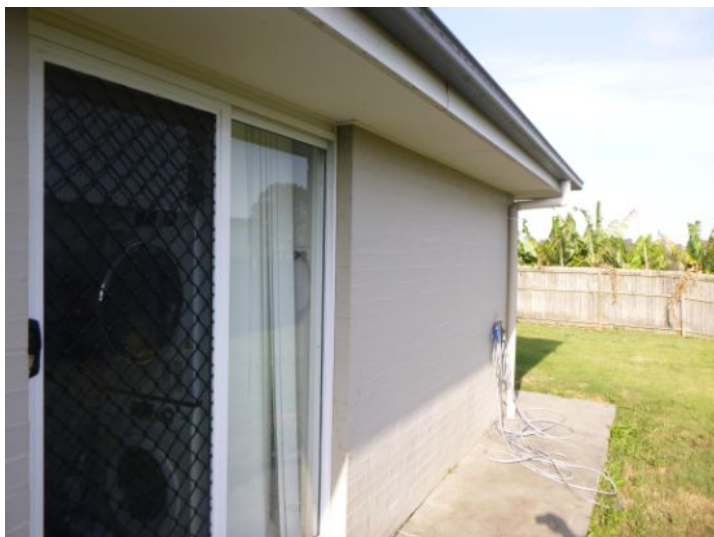
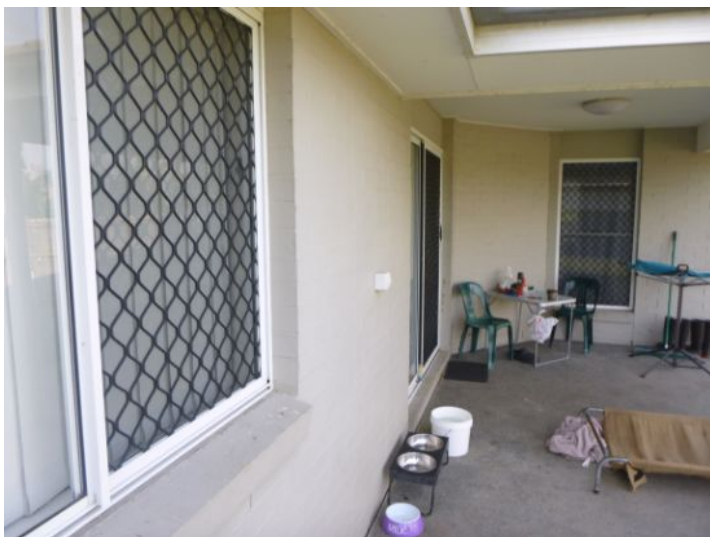
## 1. Wall Structure

- The wall structure components appeared functional.
- External walls are of a timber frame with a brick veneer construction.

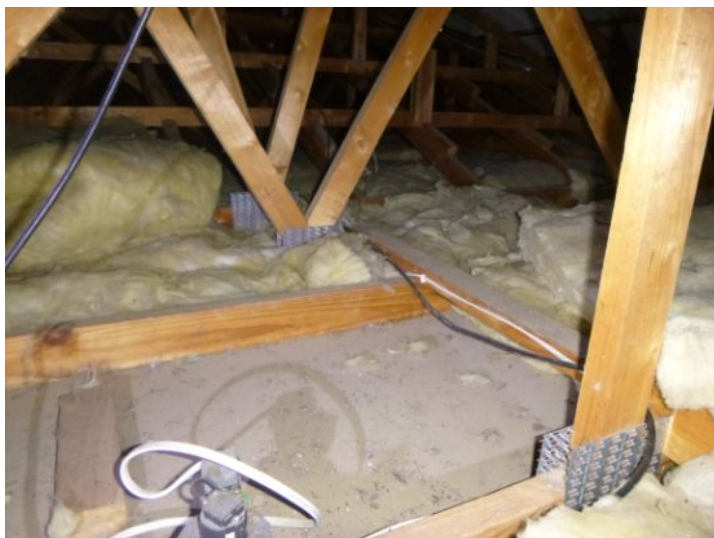
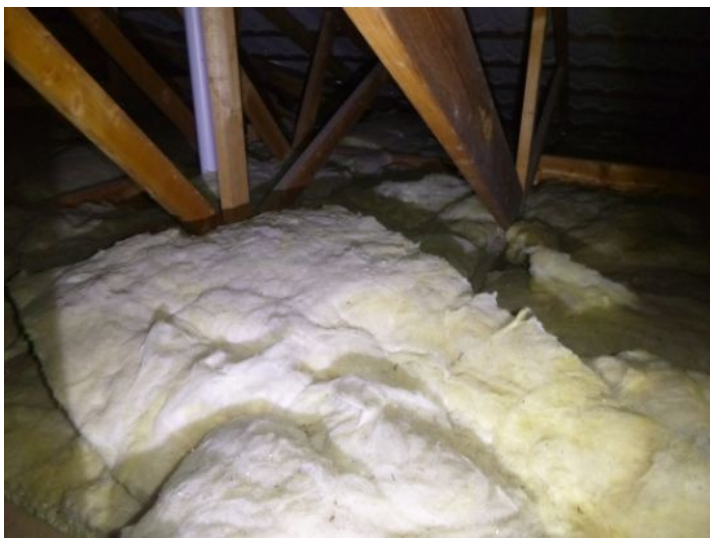
## 2. Ceiling Structure

- The ceiling structure appeared functional.
- Due to the placement of insulation on the top of the ceilings it is not possible to fully inspect the condition of the ceiling structure and supports. Inspection was limited and based on what was visually accessible at the time of the inspection.

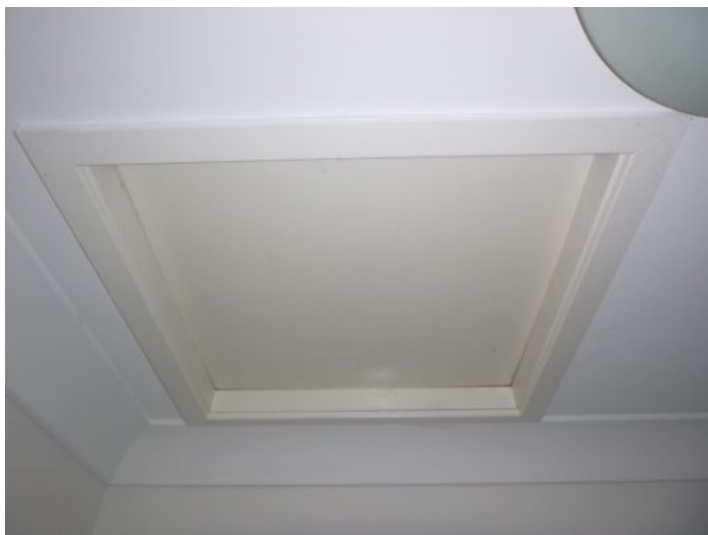
### 1. Access

- Access was available through a manhole in the laundry.
- Due to space constraints the inspection of the roof space was limited.

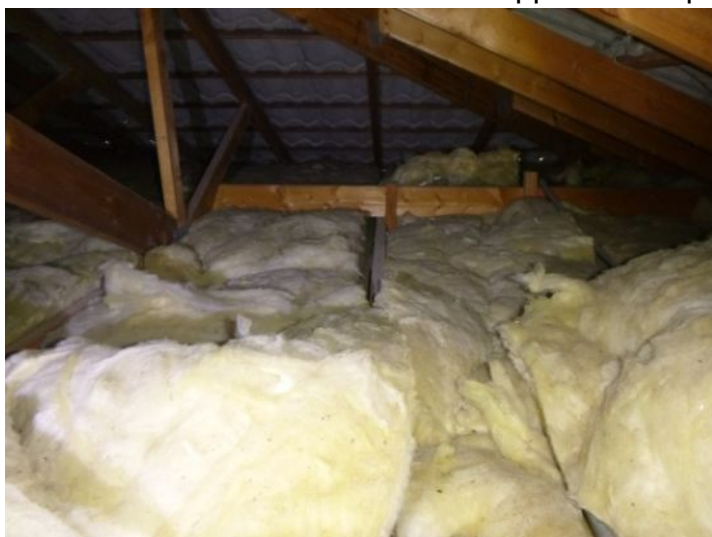
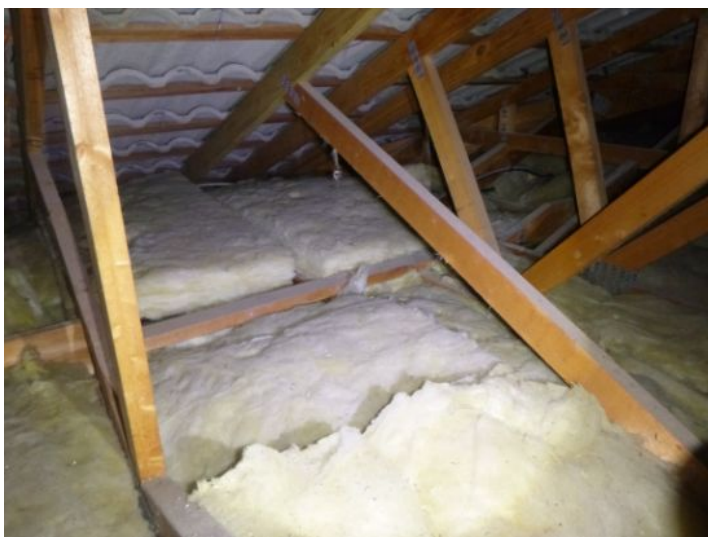
## 2. Insulation

- Fibreglass batts insulation noted in the accessible ceiling space.

- Insulation averages about 150mm in depth.
- Insulation appears adequate.

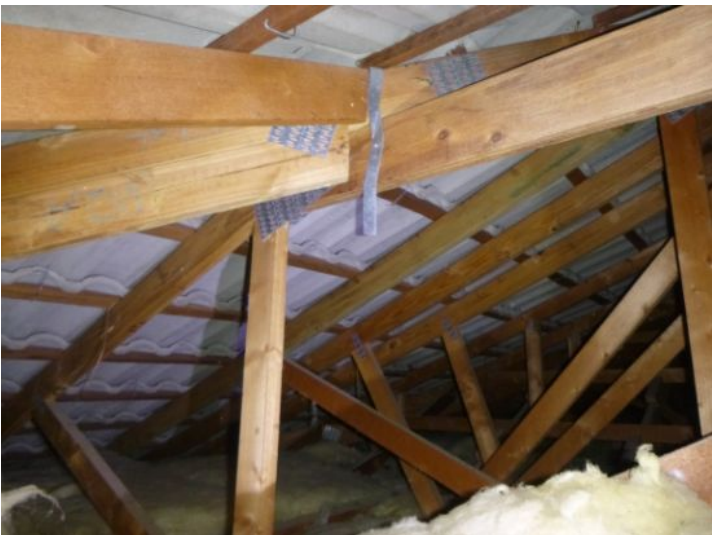
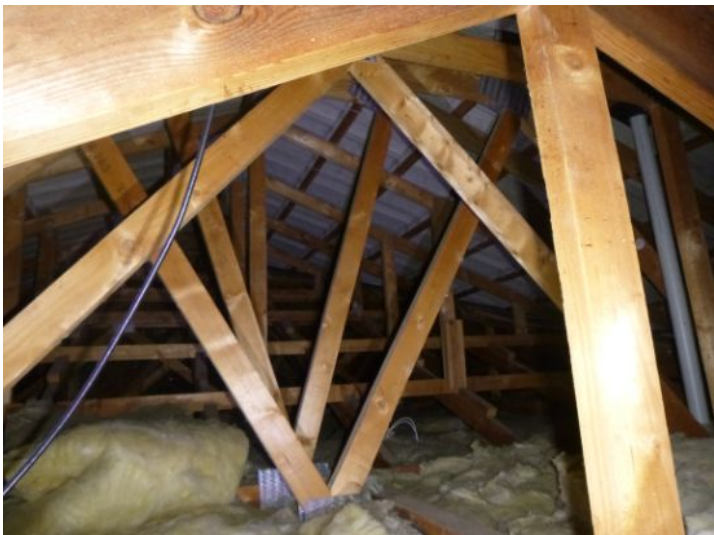
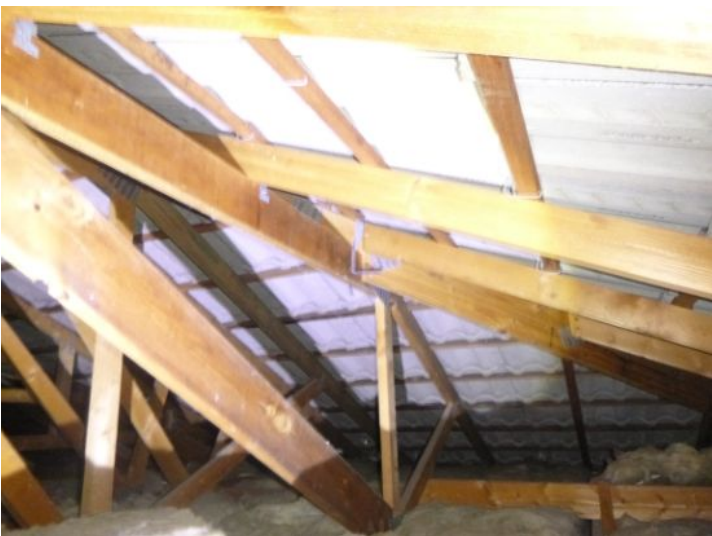
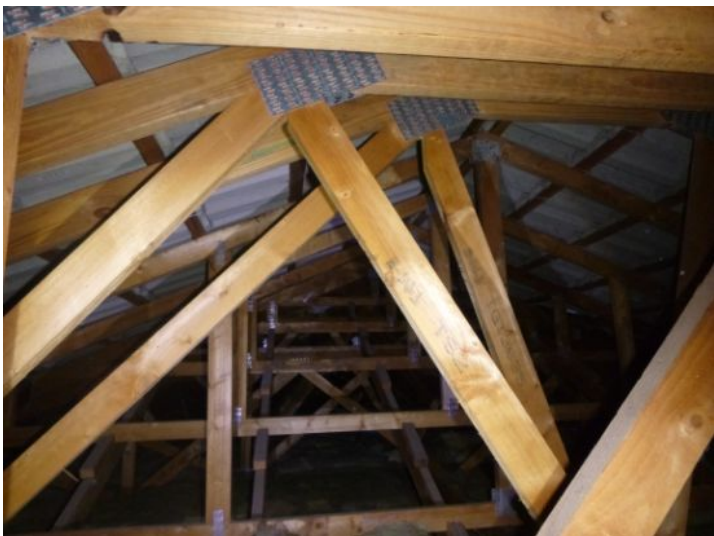
### 1. Roof Structure

- The timber roof structure appears sound.
- Could not access all areas of the roof space due to limited space.

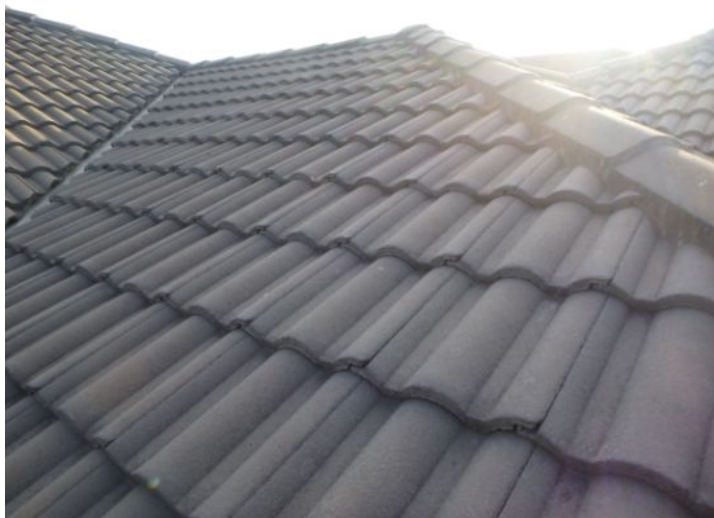
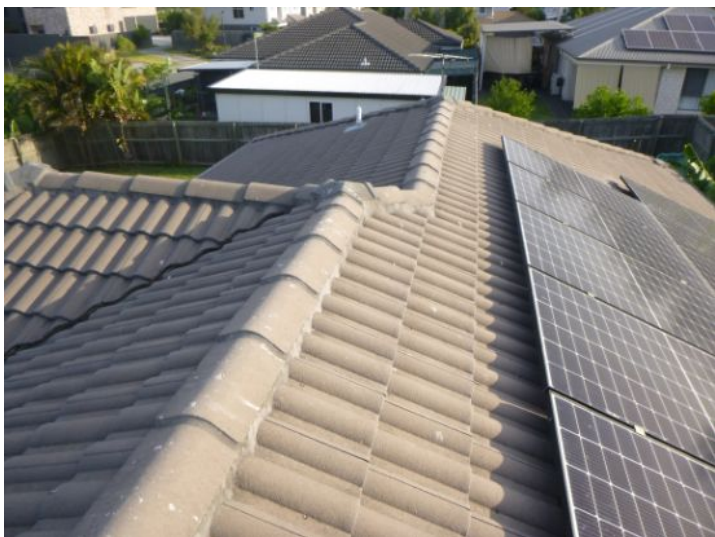
2. Roof Covering

- The concrete tile roofing material appeared to be in satisfactory condition other than noted.

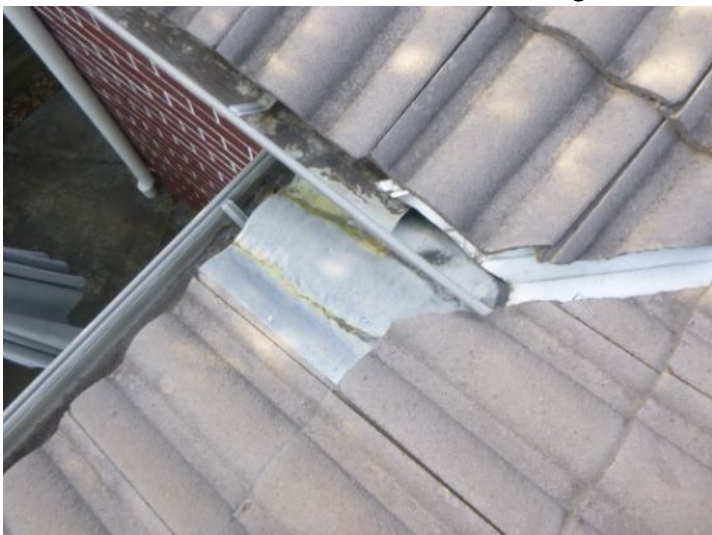
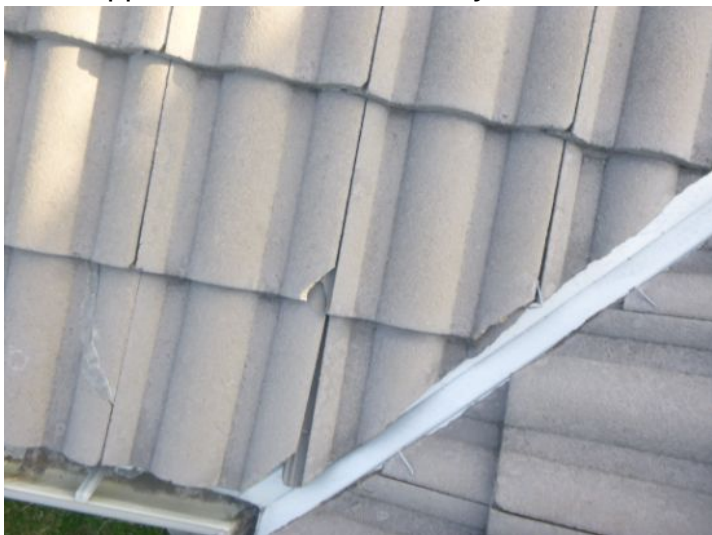
- Flashing is an impervious material (usually galvanized sheet metal) that comes in a variety of shapes and sizes and is used to cover, waterproof, and direct water away from roof penetrations and from valleys and intersections between the roof covering and other materials.
- The roof flashing, where visible, appears to be in satisfactory condition.

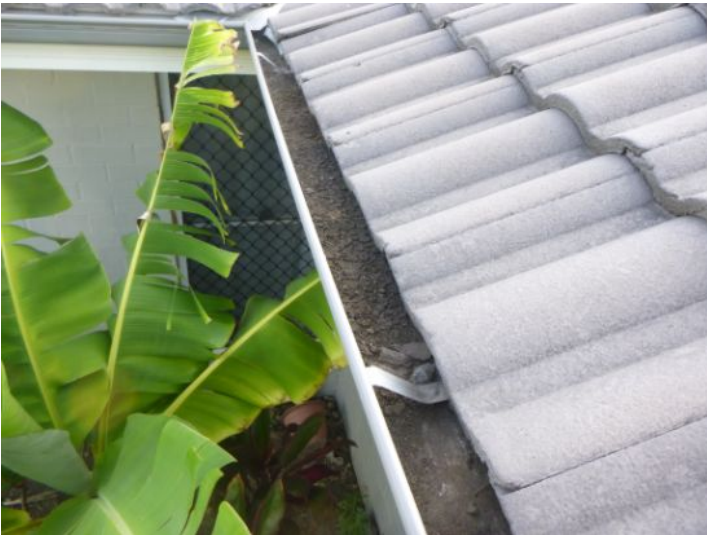
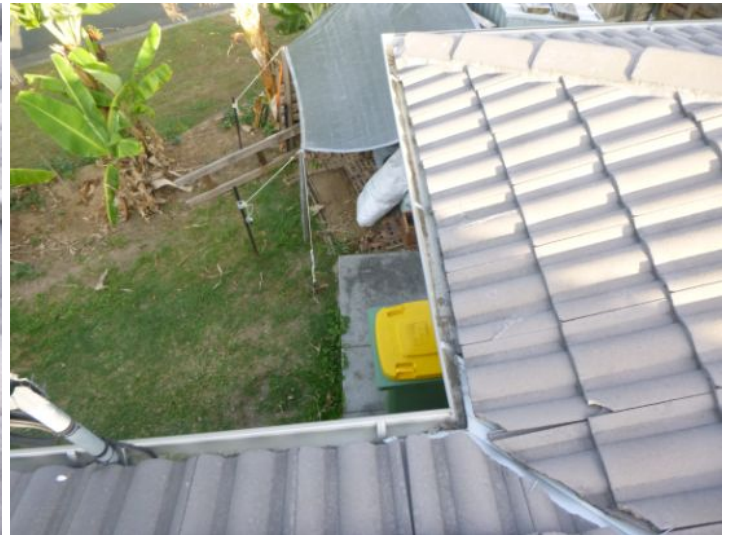
#### 5. Roof Drainage

- No major function concerns noted at the time of inspection.

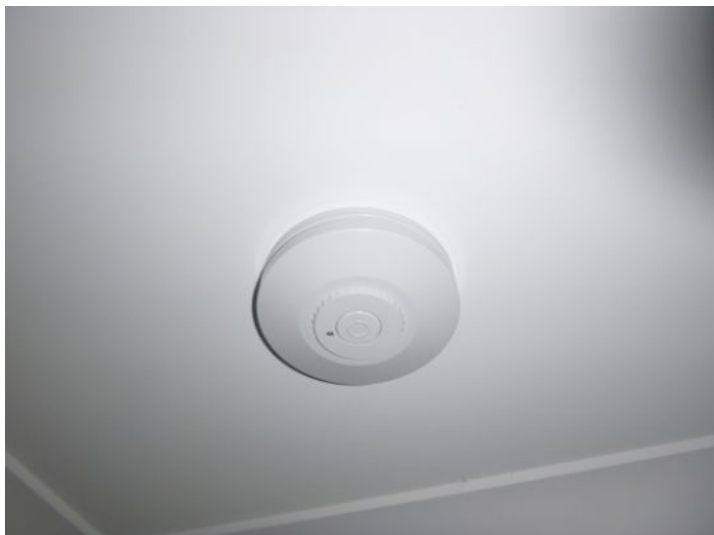
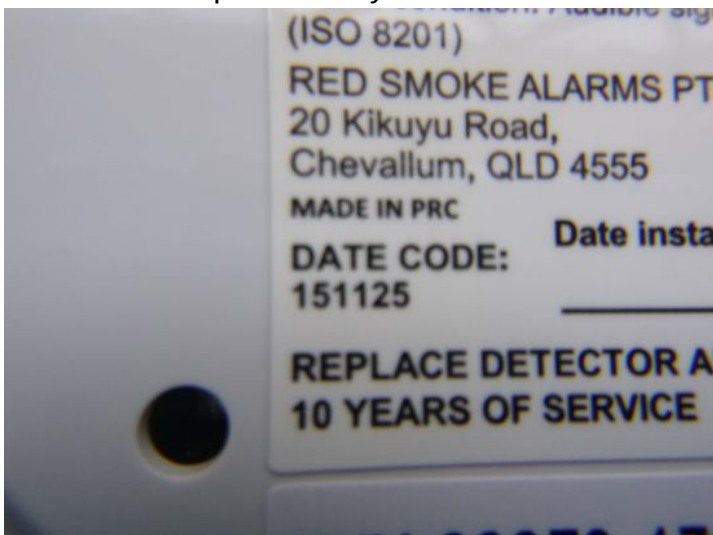
- Testing of smoke alarms is not included in this inspection. Pushing the "Test" button only verifies that there is power at the alarm--either a battery or hardwired to the house power--and not the operational workings of the alarm. The operational check is done by filling the sensor with smoke and is beyond the scope of this inspection. Battery operated smoke alarms should be checked routinely and the batteries changed frequently.
- From 1 January 2022, all dwellings being sold in Queensland require hardwired and or non-removable 10-year battery interconnected, photoelectric, smoke alarms installed in every bedroom, in hallways which connect bedrooms and the rest of the dwelling, and on each storey.
- There appears to be interconnected smoke alarms installed in the hallways and bedrooms of the home. The service replacement year is noted as 2035

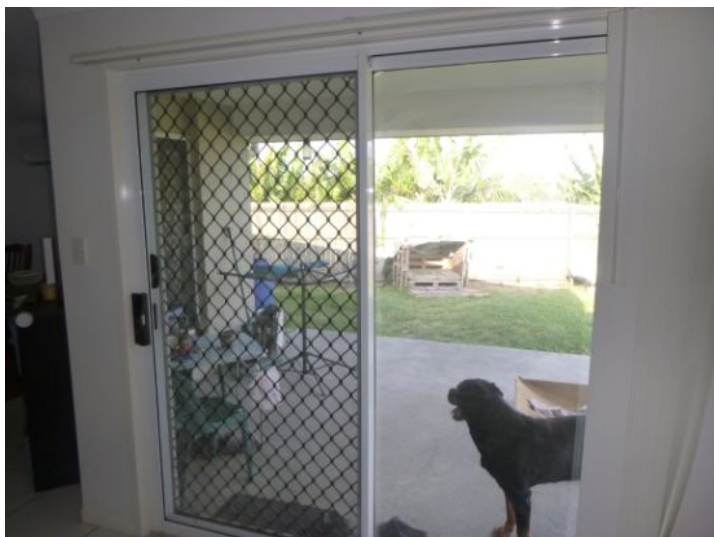
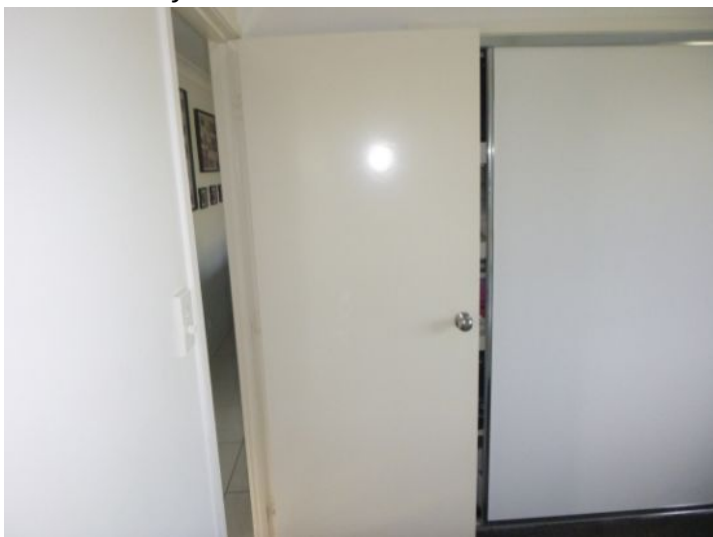
### 4. Doors

- The exterior doors function satisfactorily.
- The interior doors function satisfactorily.

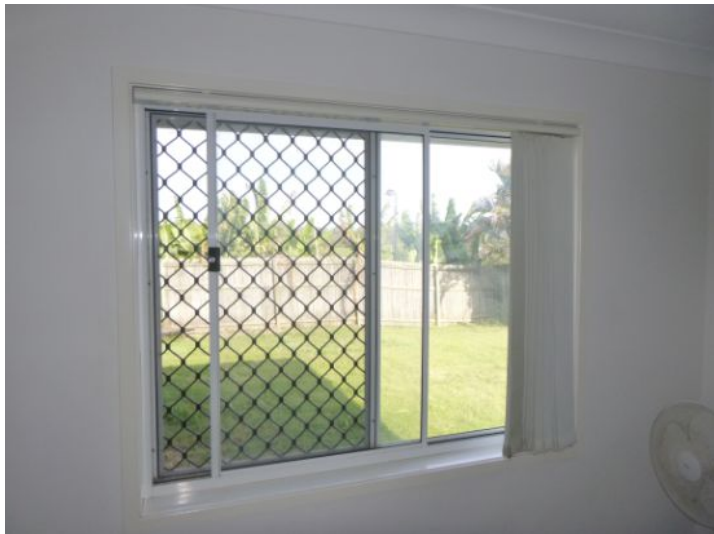
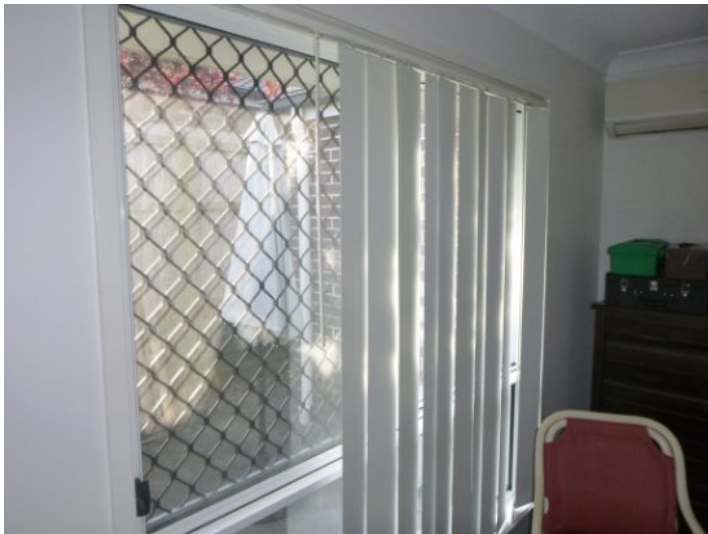
## 5. Window Condition

- Aluminum framed windows noted.

- Windows operated during the inspection appeared functional.

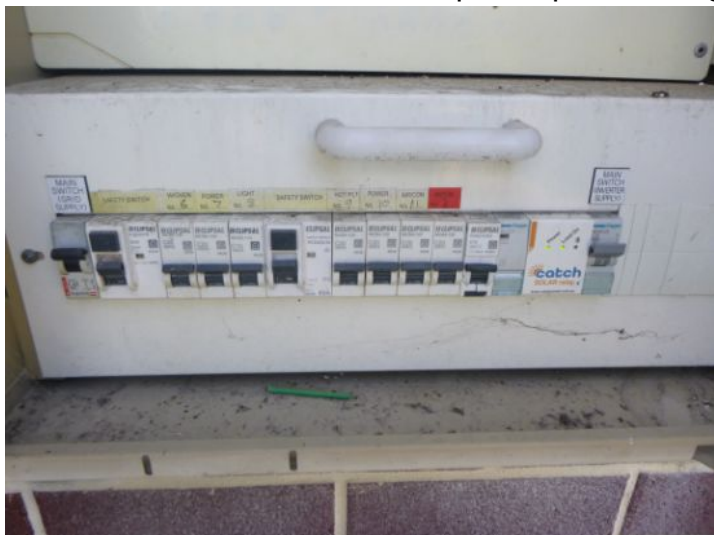
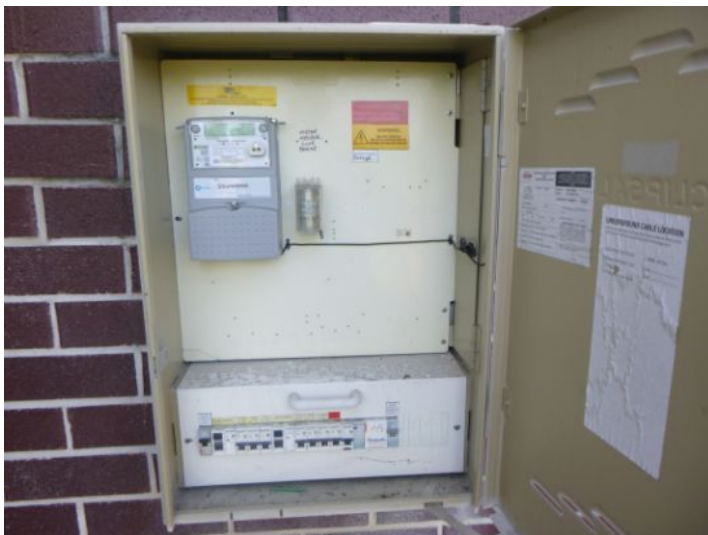
## 1. Electrical Panel

- Main Panel Location:
- North side of the house.

Observations: There are at least 2 RCD's installed which appear to protect both the power point and light circuits.

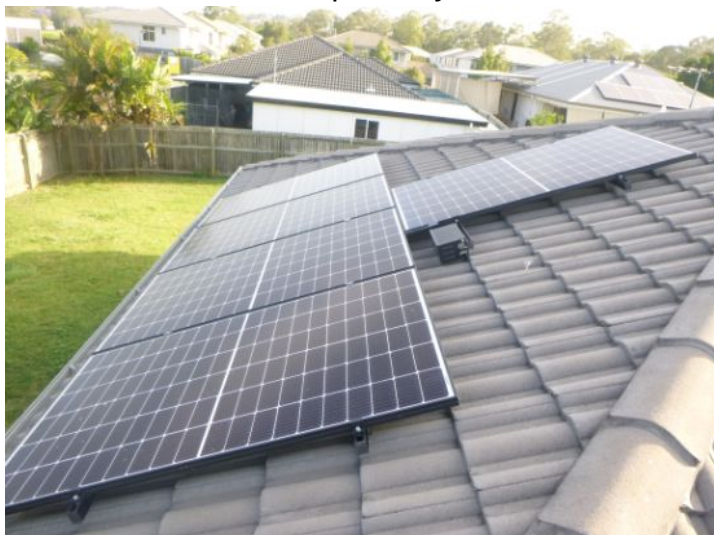
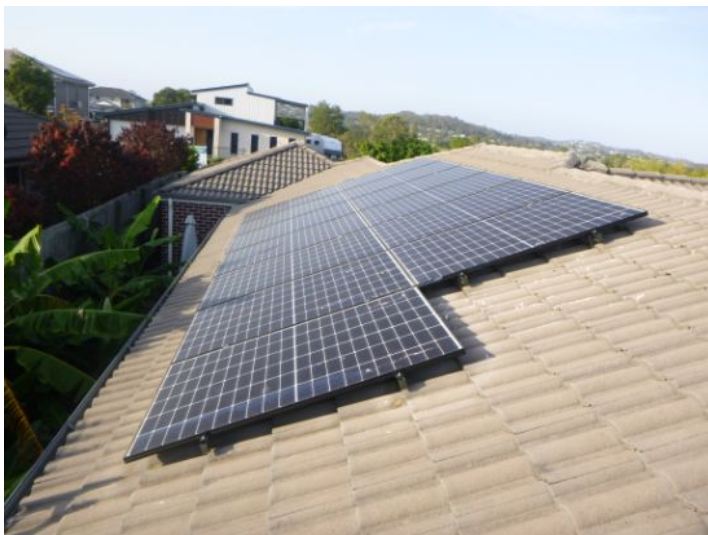
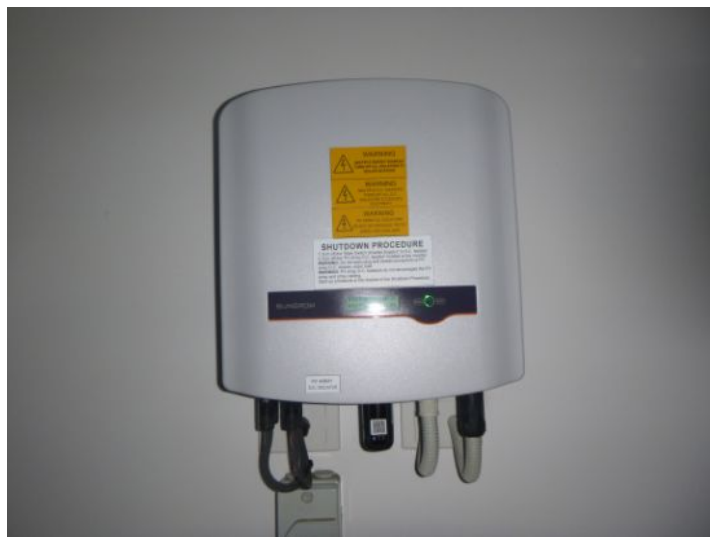
## 2. Photo Voltaic Panels

- The inverter for the PV system was located in the garage and appears to be functioning.
- As part of the inspection we can not confirm the effectiveness of the solar panel system.

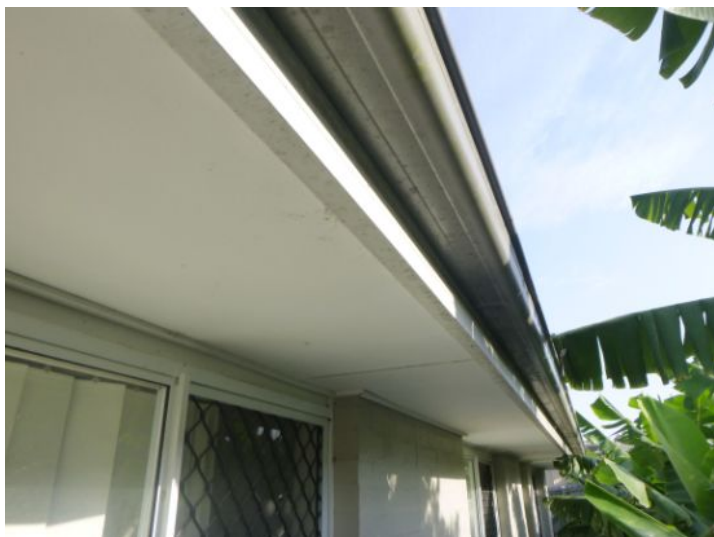
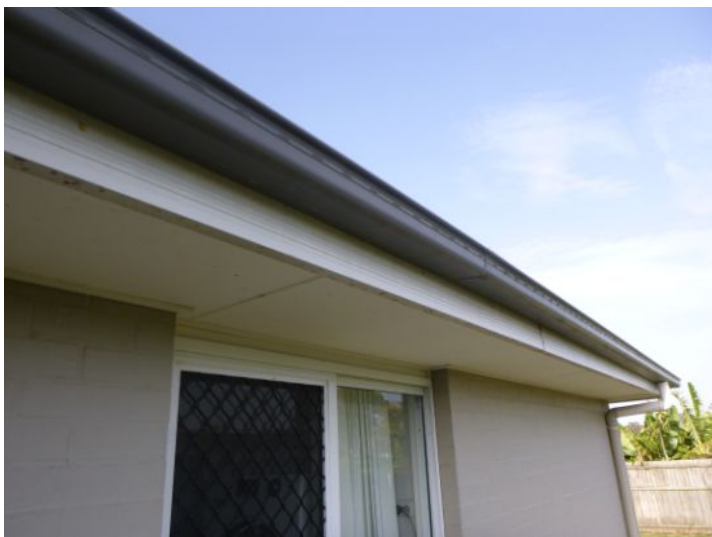
### 1. Eaves & Fascia

- The eaves are in satisfactory condition.
- The metal fascia covering the ends of rafter or truss tails appeared to be in generally serviceable condition at the time of the inspection.

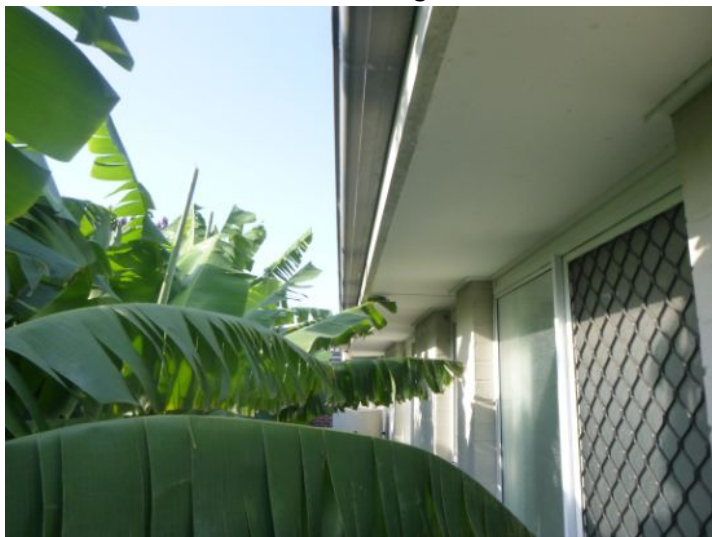
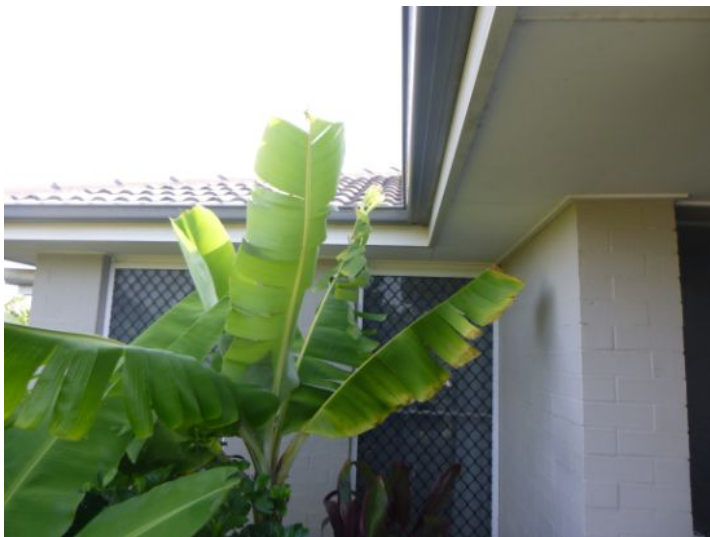
- Trees that begin to grow too close to or overhang property should be trimmed back; this will help reduce the frequency of having to clean out the gutters which should be done on a regular basis.
- Tree limbs within 3 metres of roof should be trimmed away to provide air and sunlight to roof, while minimizing debris, dampness and abrasion damage.

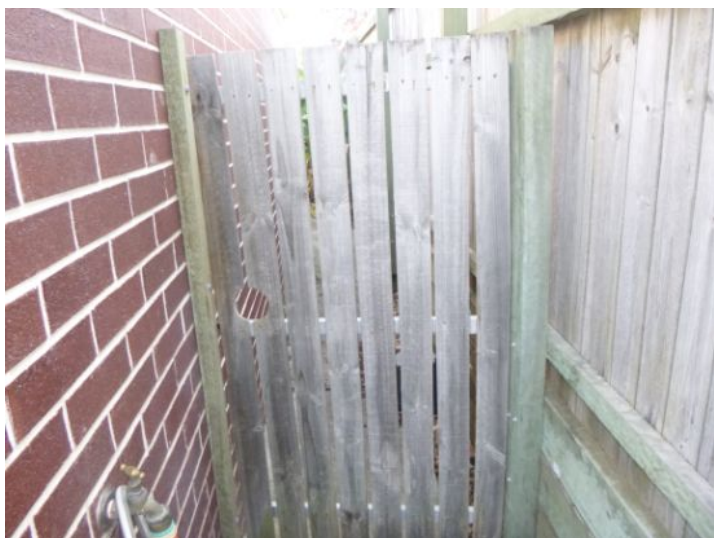
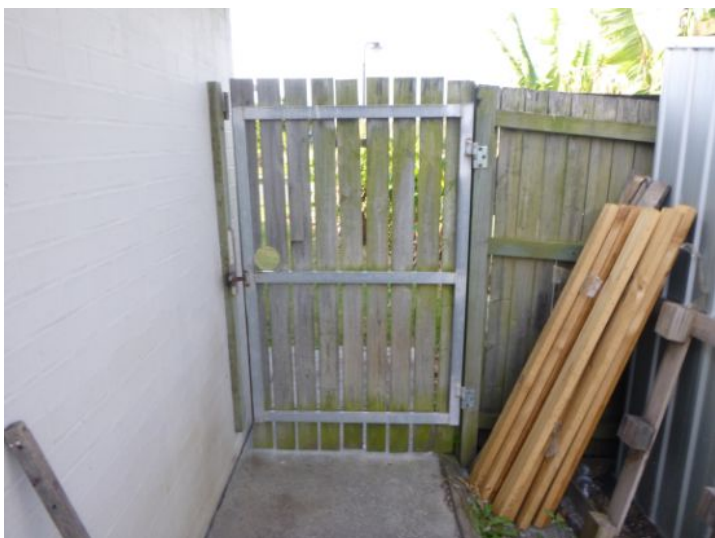
### 5. Gate Condition

- Timber gates in good condition.

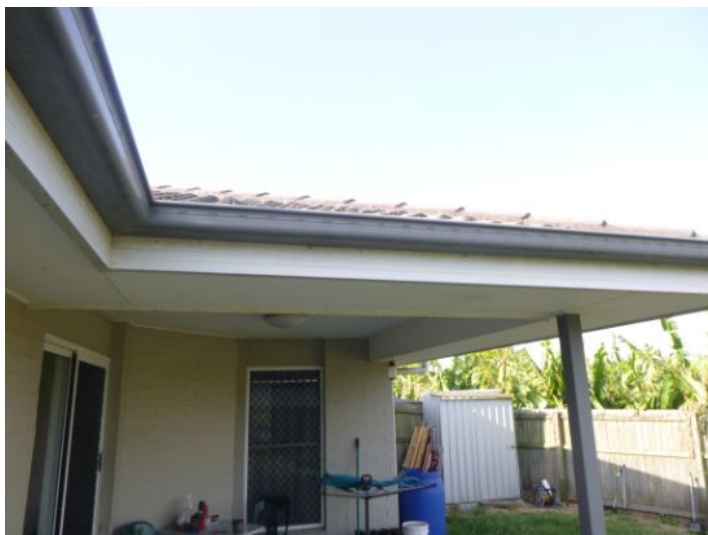
### 6. Patio & Pergola

- No deficiencies noted. Appears to be structurally sound.

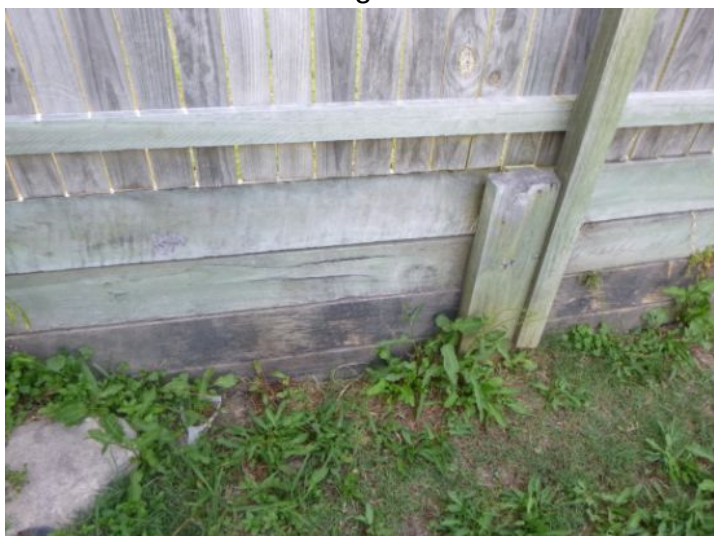
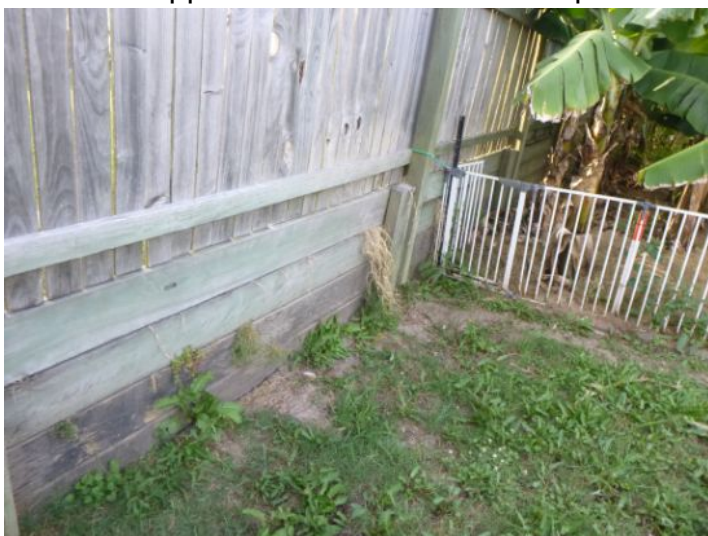
## 7. Yard Walls

- The yard walls appear to be functional and structurally sound.
- Evaluation of retaining wall strength, adequacy, and drainage falls outside the scope of a Resicert building inspection. Such evaluation will require the services of a geotechnical engineer. Our evaluation is limited to reporting significant defects that are visible and apparent at the time of the inspection.

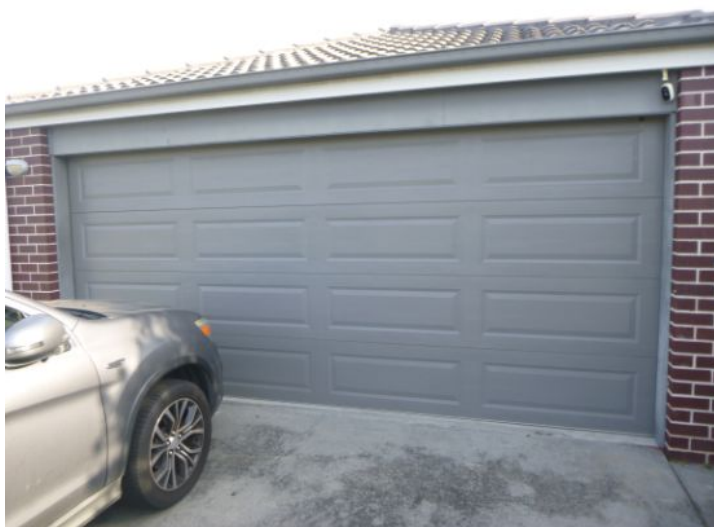
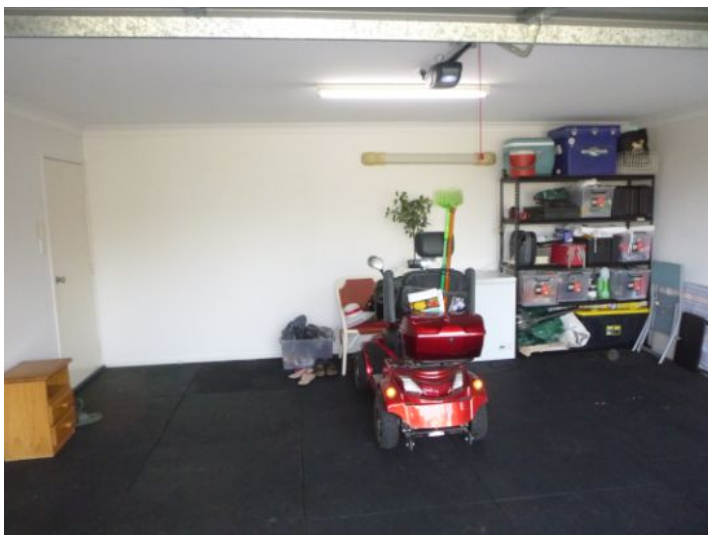
- The attached brick garage appears structurally sound.
