## BUILDING AND TIMBER PEST REPORT

2 Pipit Cl  
Mango Hill, QLD 4509

BYB  
12/08/2025

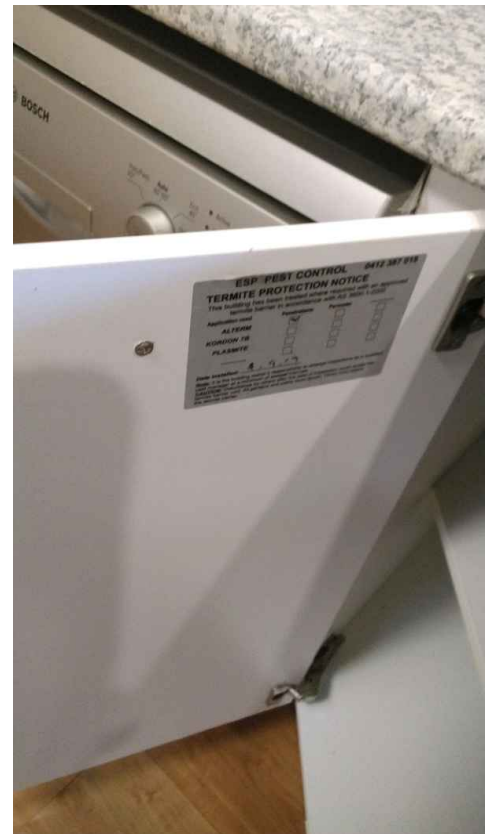
### 20.3.1 Termite Management Systems

#### SYSTEM INFORMATION / DOCUMENTATION

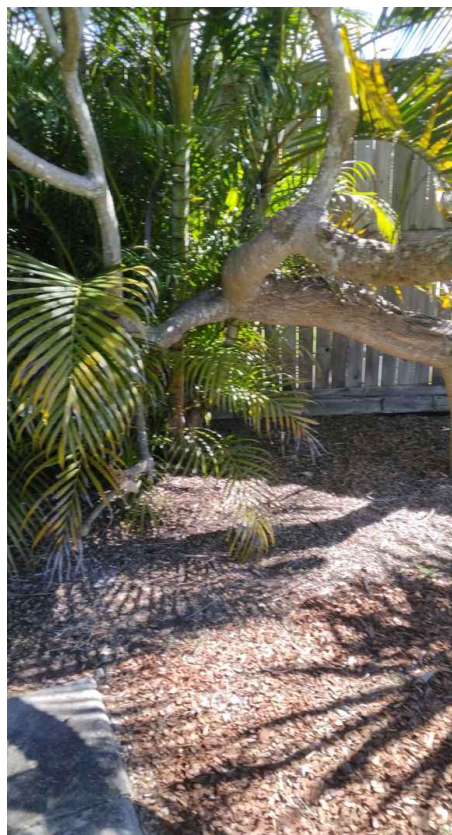
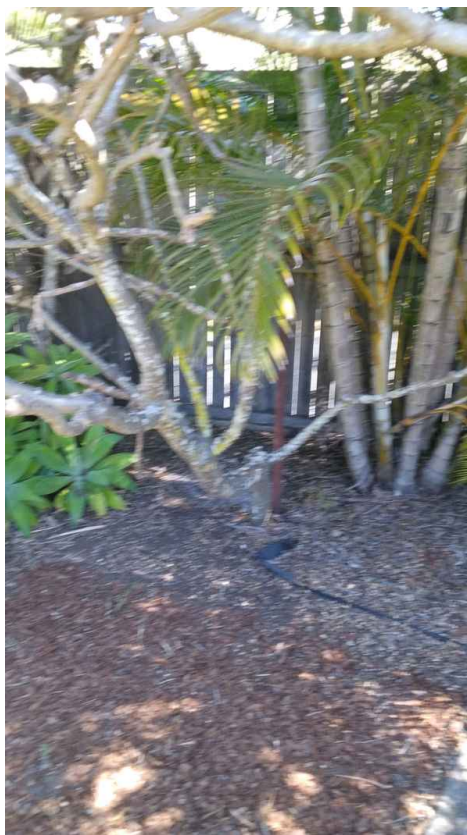
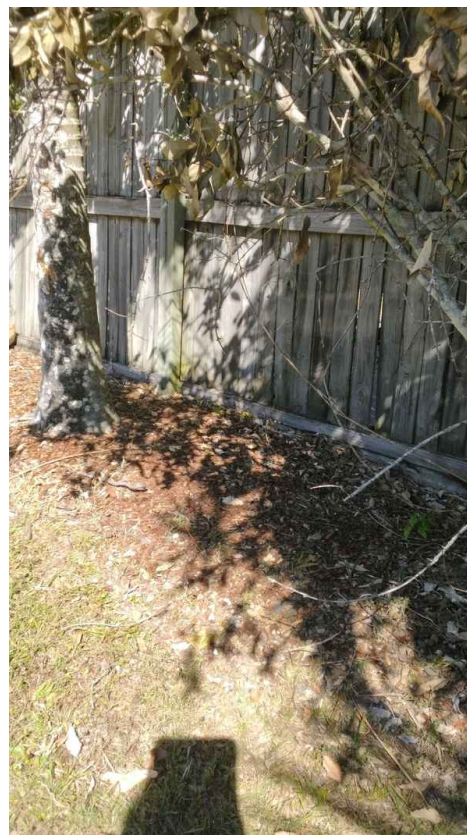
### Site and Exterior: Fence Palings in contact with the ground

Timber in contact with the ground and or soil will shorten the life of a fence

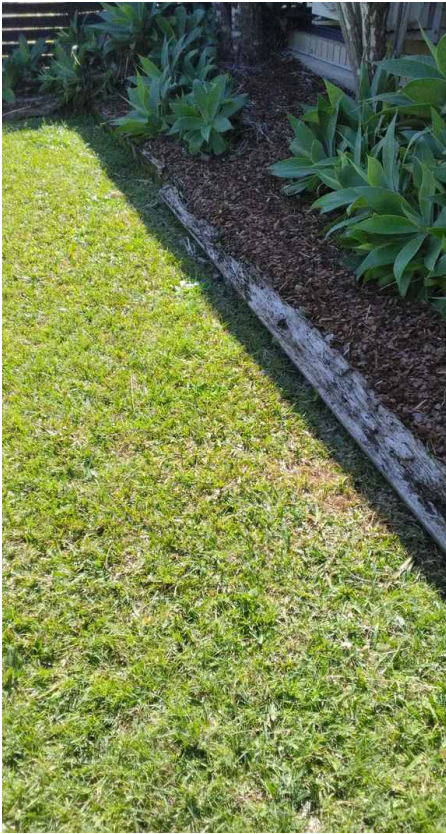
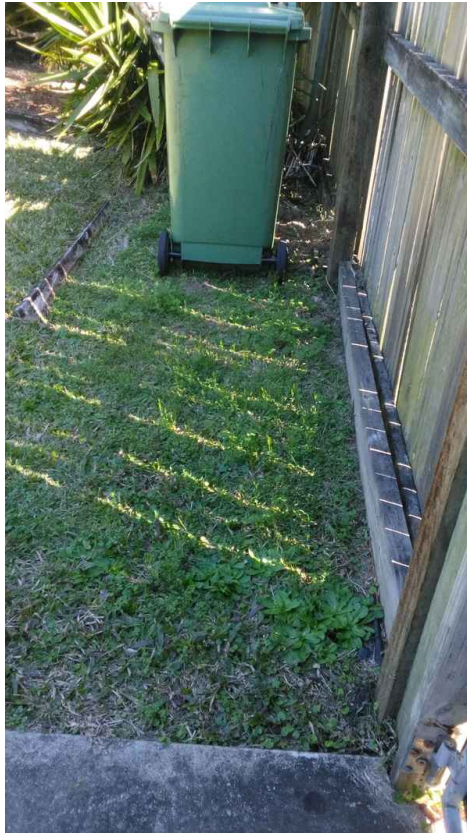
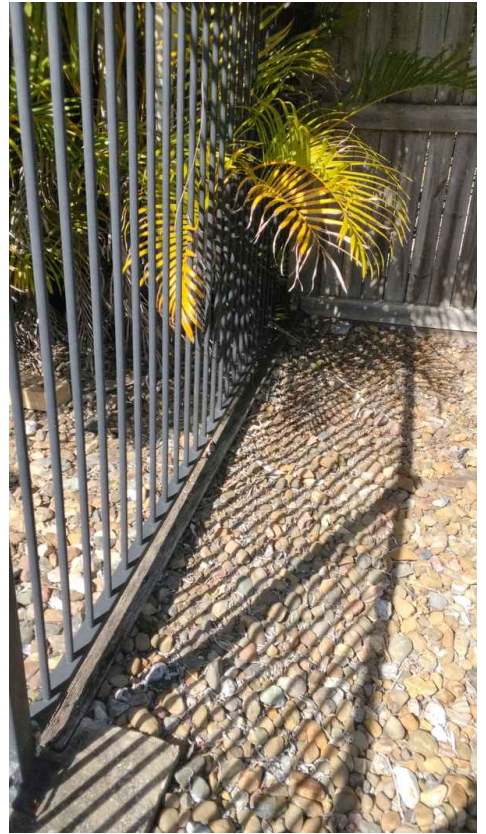
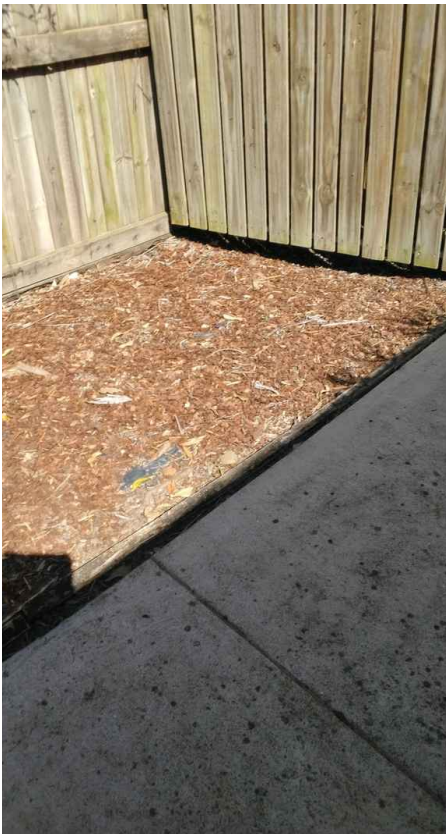
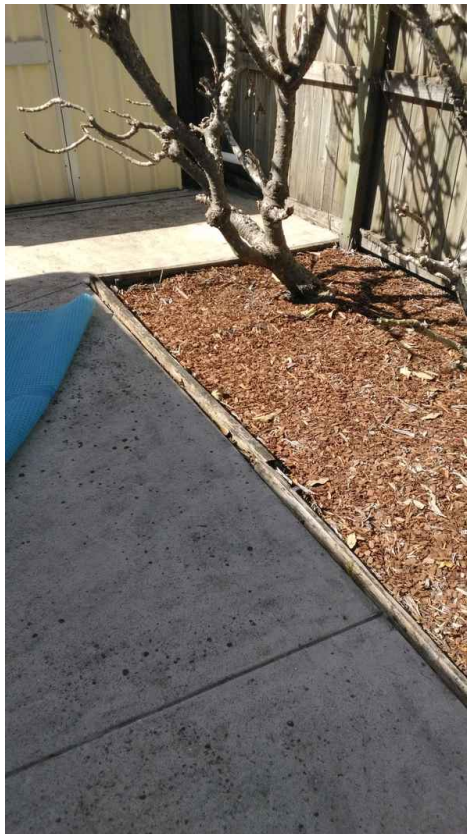
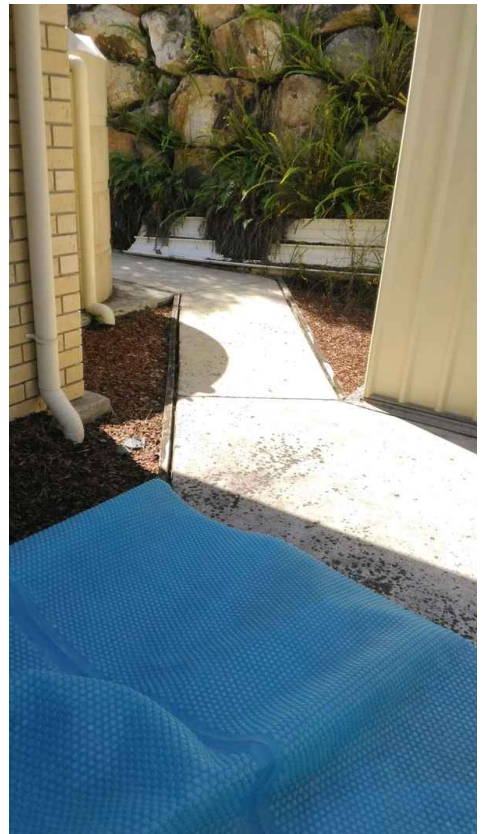
### Site and Exterior: Gardens against / close vicinity to building

This condition can create conditions that encourage timber pest, and may allow hidden access for termites

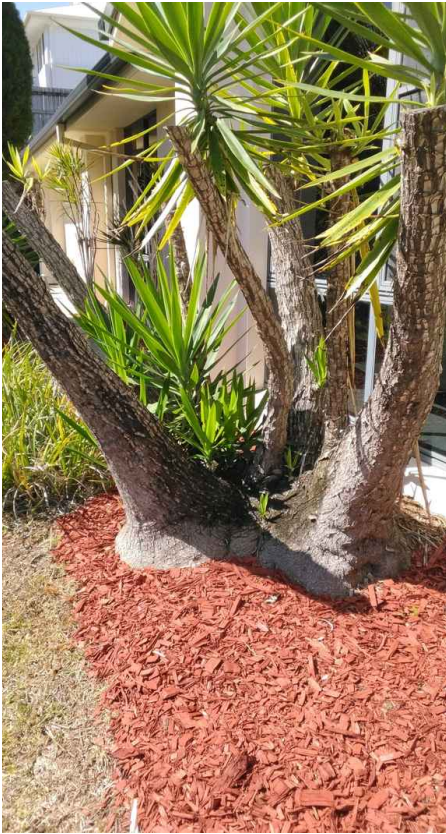
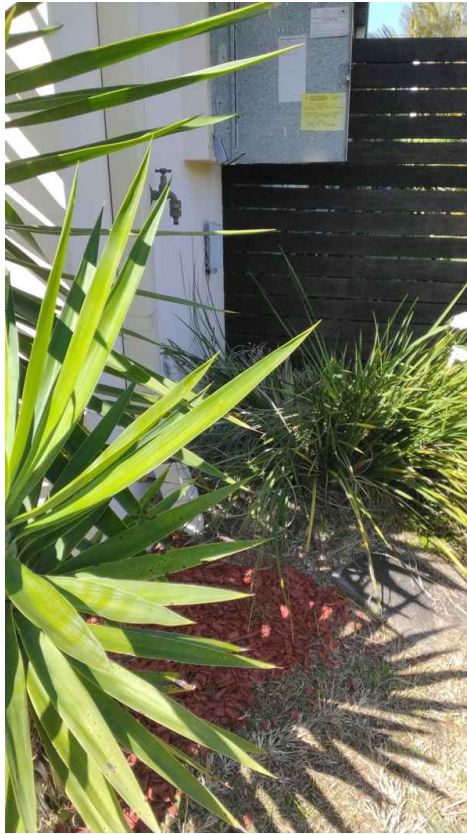
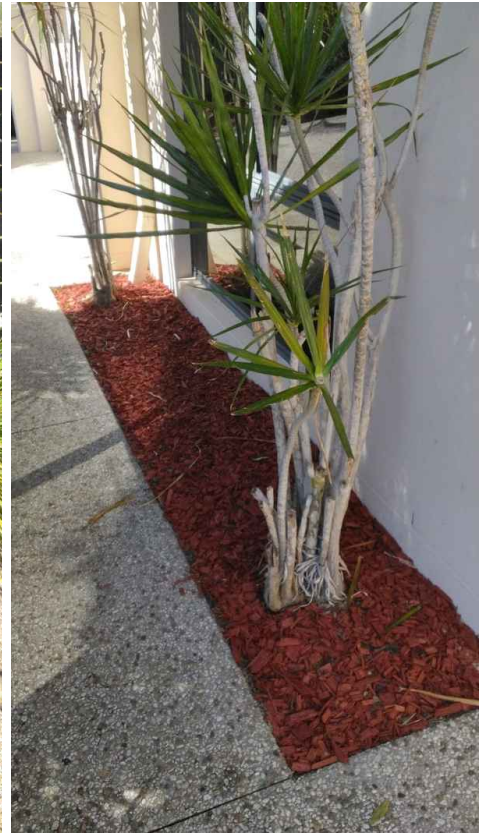
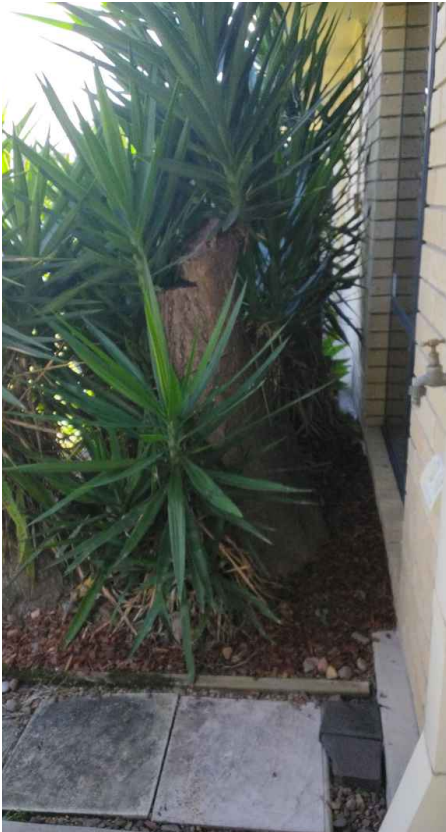
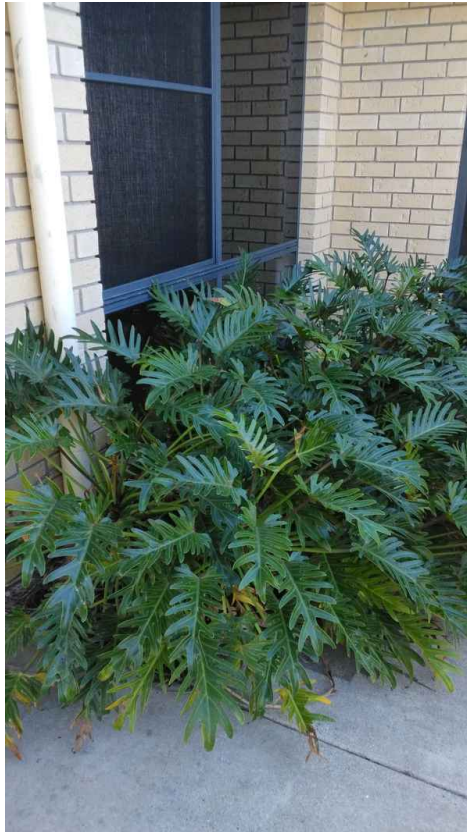
### Site and Exterior: Timber in ground contact

Timber in contact with the ground will raise the moisture content of timber creating conditions conducive to fungal decay. Action is required to remove this condition in order to prevent timber pest activity and structural damage occurring.
