# Pre-Inspection Building And Timber Best Report

Inspection Date: 17 Sep 2025

Property Address: 9 & 9A Refalo Place Quakers Hill 2763

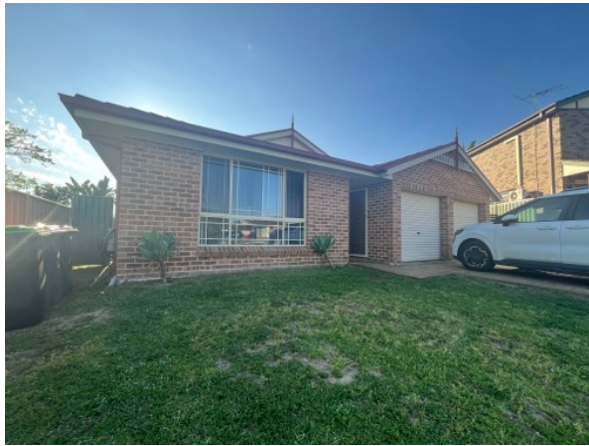
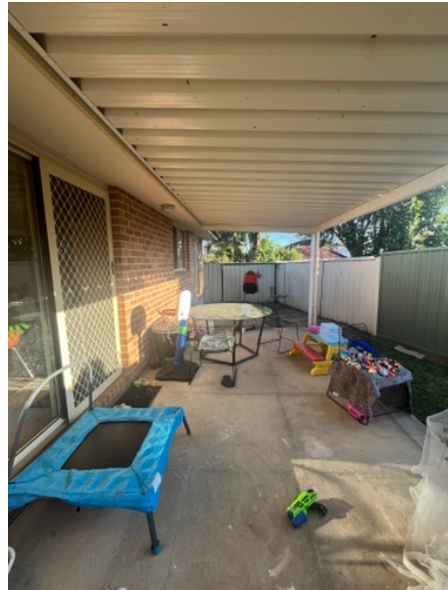
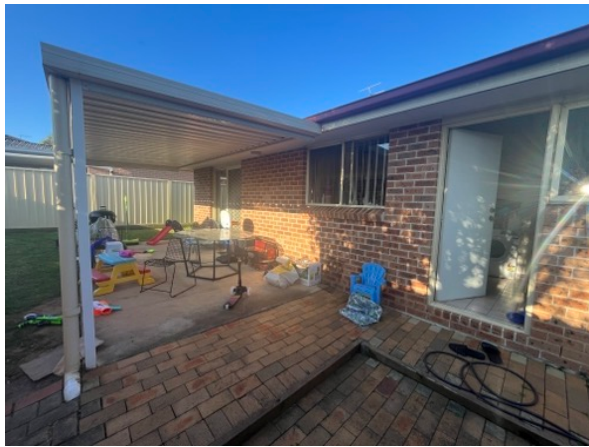
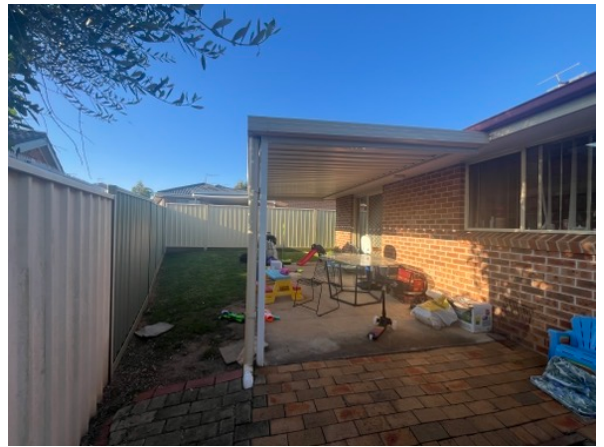
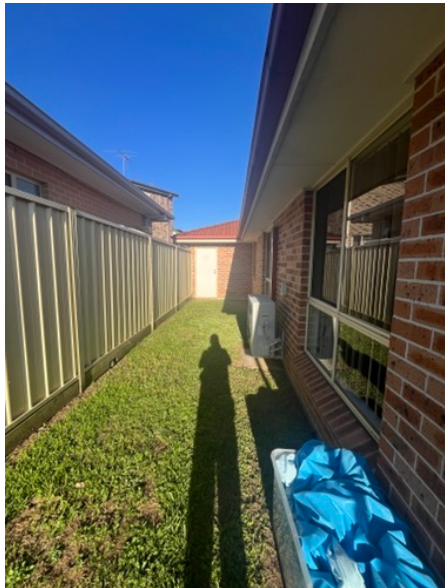
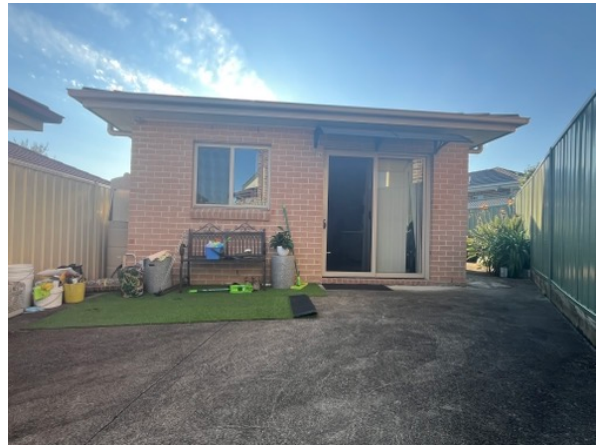
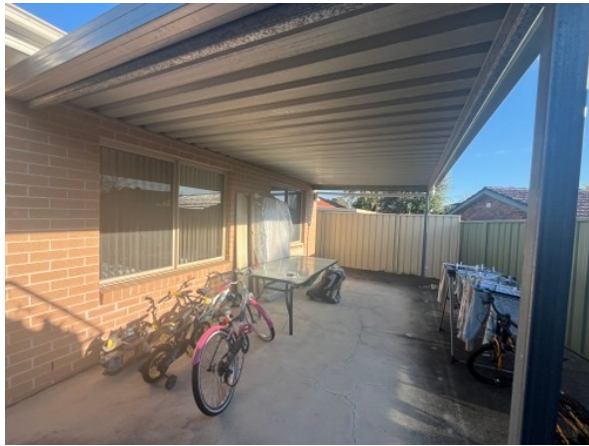
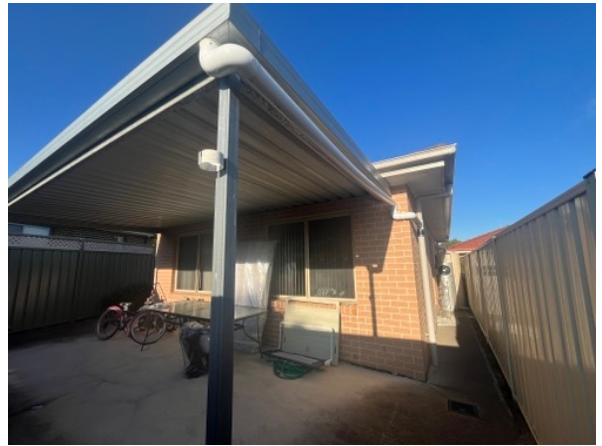
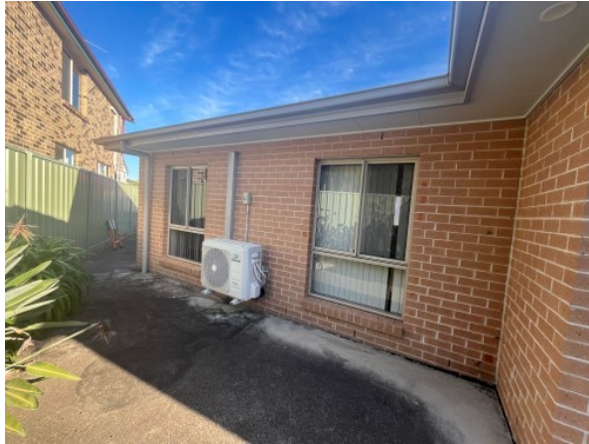
During a comprehensive inspection of the property's external areas conducted at ground level, a thorough assessment of all visible exterior components was performed. The evaluation included the exterior walls, gutters, downpipes, windows, doors, driveway, pathways, fencing, gates, landscaping, and exterior paint finishes. Additionally, whatever could be observed of the roof from the ground level was also examined.

The inspection aimed to identify any apparent minor and major defects affecting the integrity and aesthetic appeal of the property's exterior. As this was a visual inspection, the identification of issues was limited to those areas that were clearly observable and accessible. Any anomalies or imperfections detected during this process will be comprehensively outlined in the subsequent report, thereby equipping prospective buyers with the necessary information to make an informed decision regarding the property's condition and potential need for repairs or maintenance. It is paramount for potential purchasers to carefully review this report to understand all current and potential issues, thereby safeguarding their investment in the property.

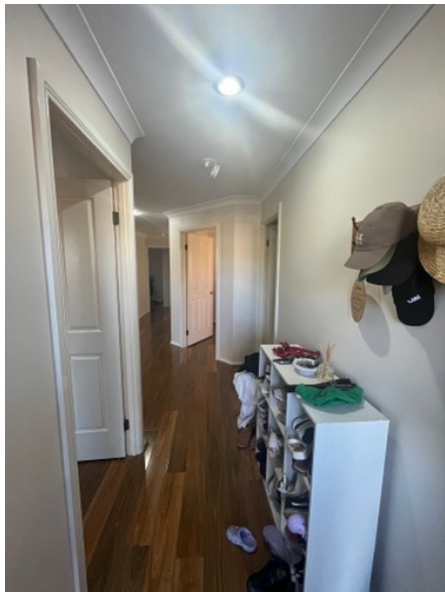
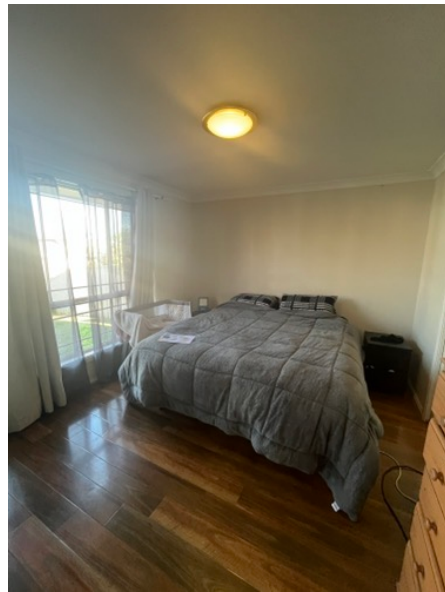
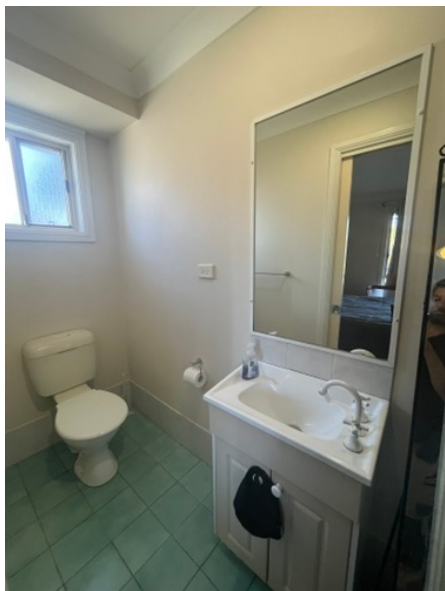
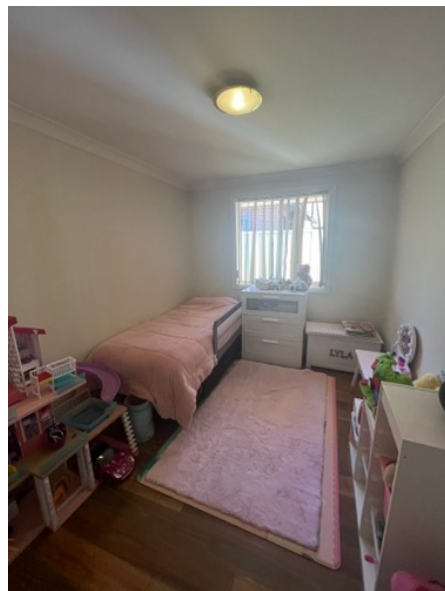
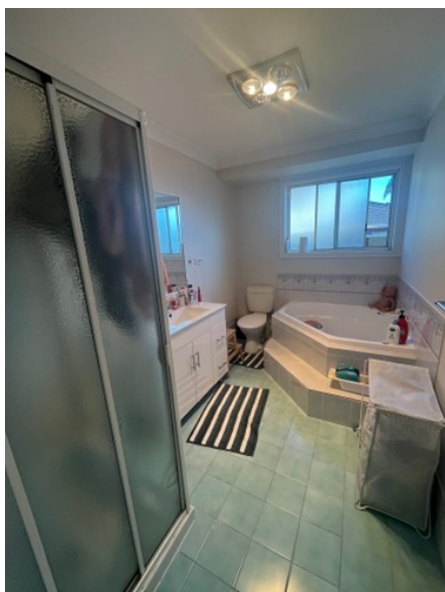
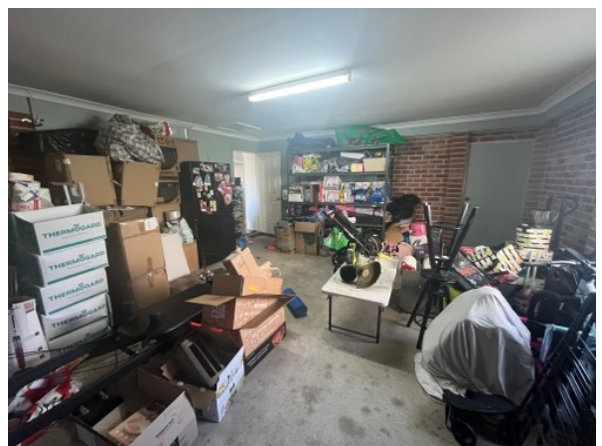
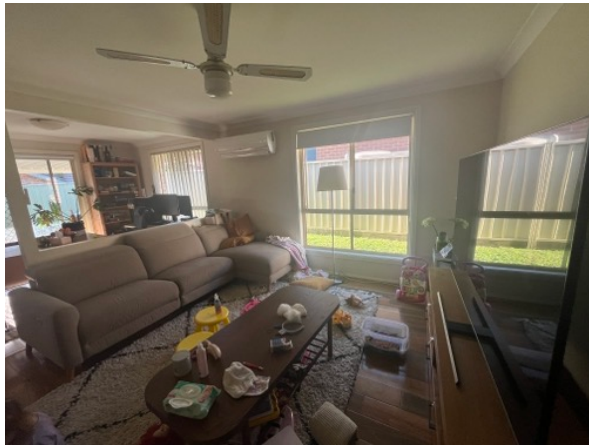
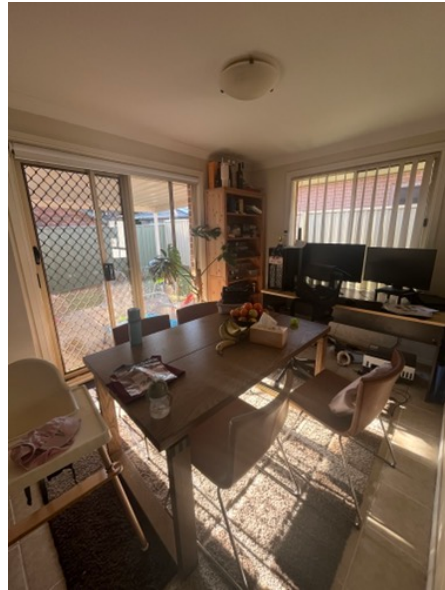
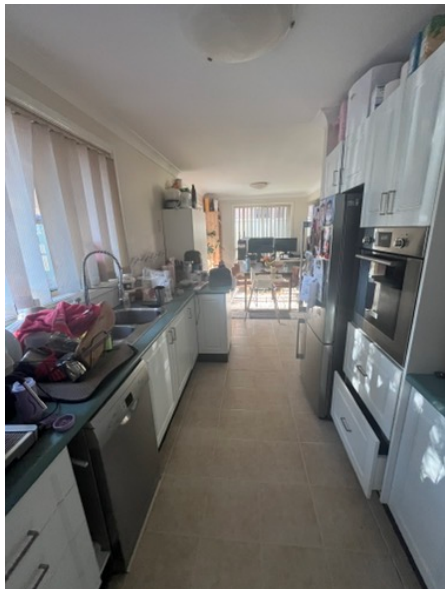
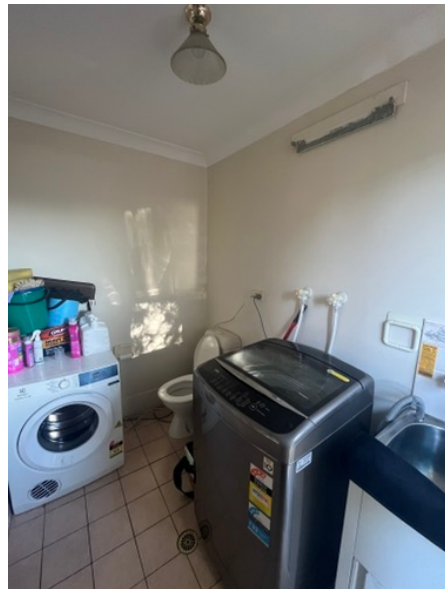
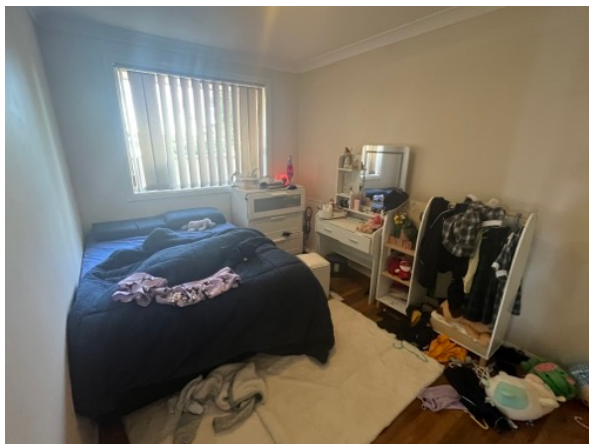
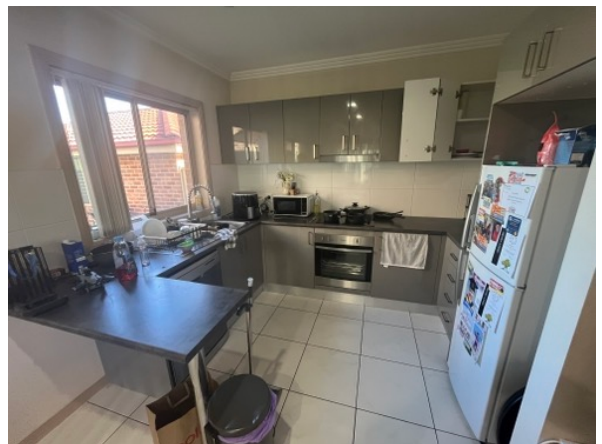
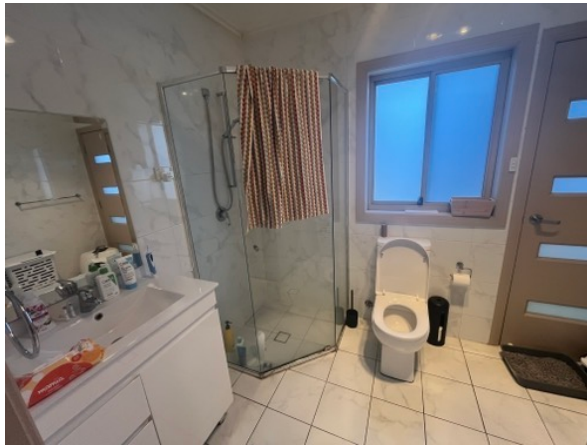
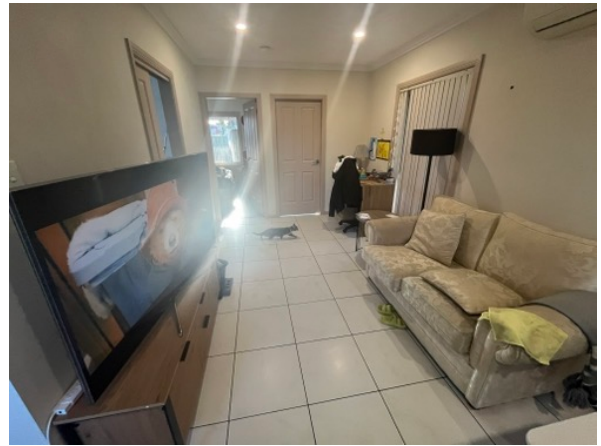
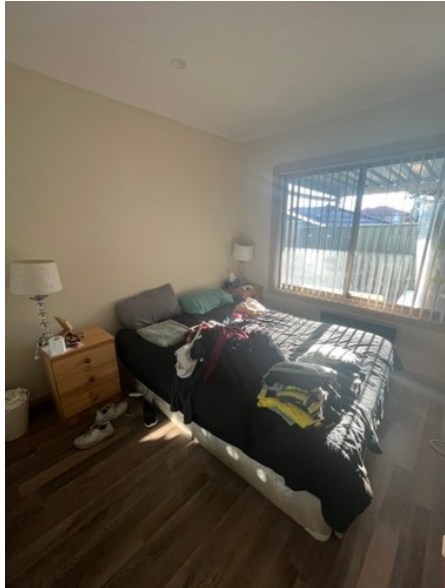
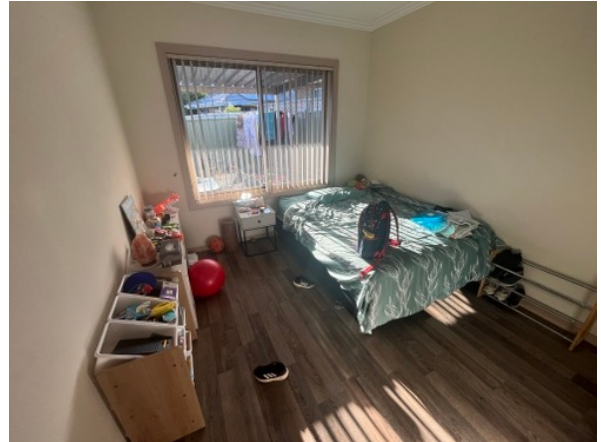
## For your information 2.02

**Location:** All Internal Areas

Upon inspection of the internal areas of the residence, a comprehensive assessment was conducted to identify any visible defects or issues that may impact the dwelling. The inspection encompassed all internal areas, with an evaluation of potential defects such as visible cracks, water damage, and overall structural integrity. Specific attention was given to the condition of walls and floors, as well as the presence of water hammer or any other safety concerns that might compromise the inhabitants' well-being.

It is important to note that if no significant defects are identified during the inspection, regular maintenance and periodic checks are recommended to ensure the continued condition and safety of the property.
